From: Brad Sullivan, P.E., Stantec

Date: January 7, 2026

Reference: SKB Rosemount Industrial Waste Facility 2025 Annual CCR Inspection Report

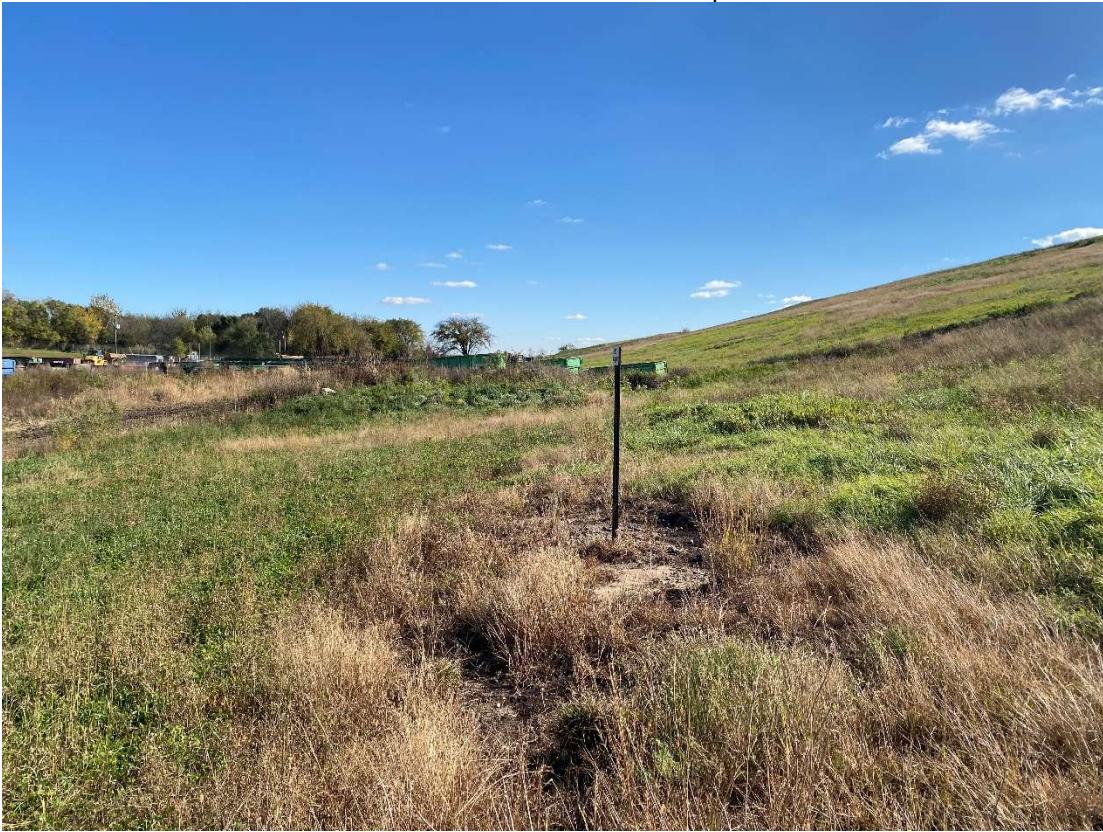
Location 1 – Looking Southeast, Cell 3A & 3B Waste Slope & Anchor Trench

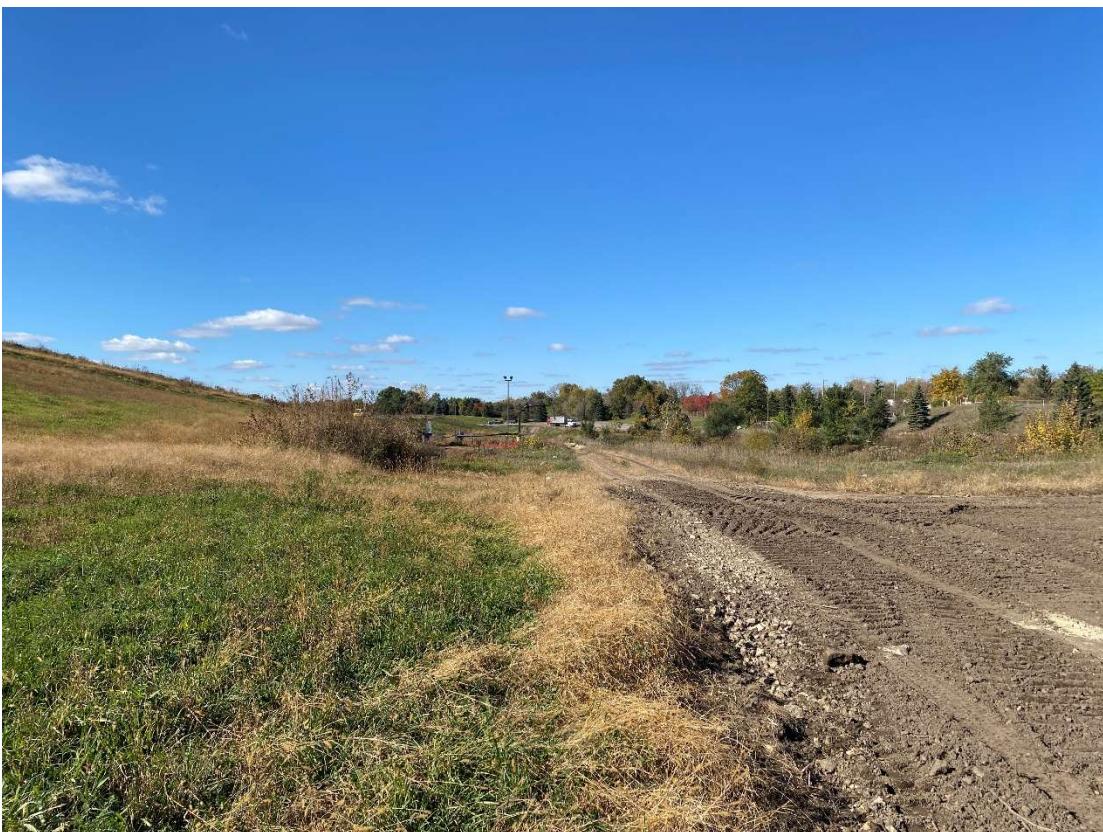
Location 1 – Looking Northwest, Cell 3 Berm

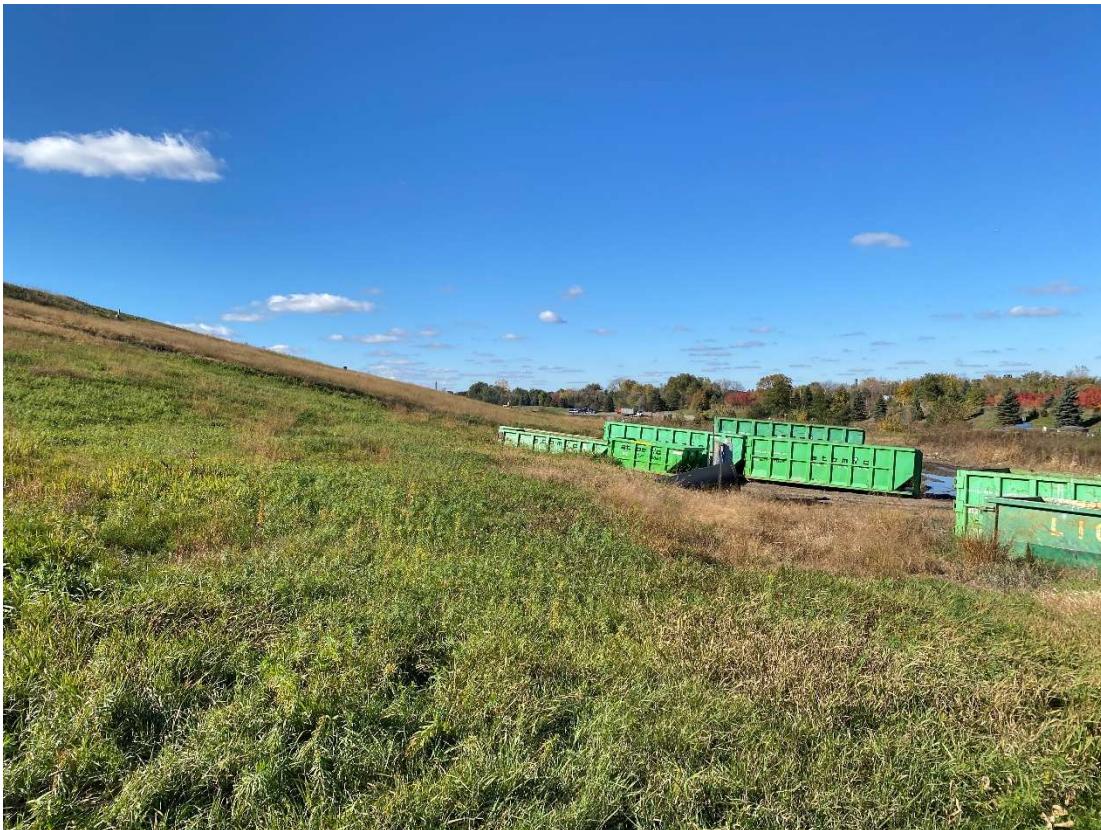
Location 2 – Looking Northwest, Cell 3 Anchor Trench and Waste Slope

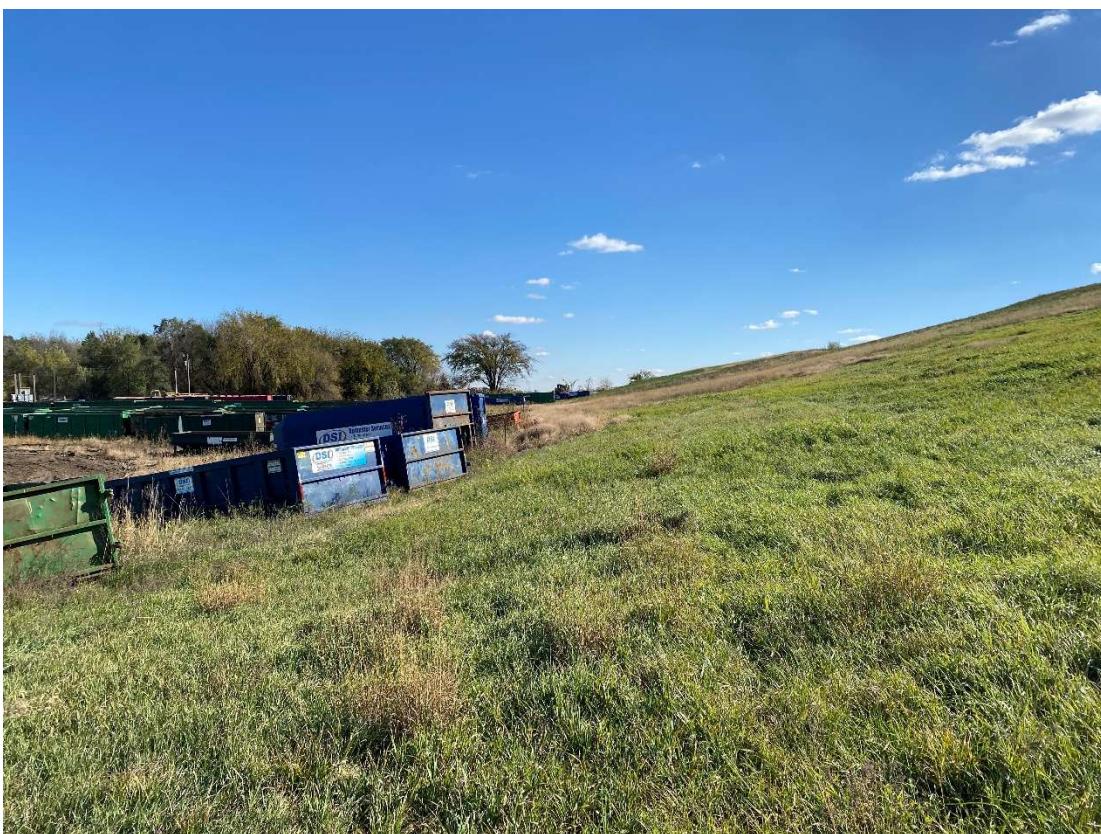
Location 2 – Looking Southeast, Cell 3A Anchor Trench and Northeastern Waste Slope

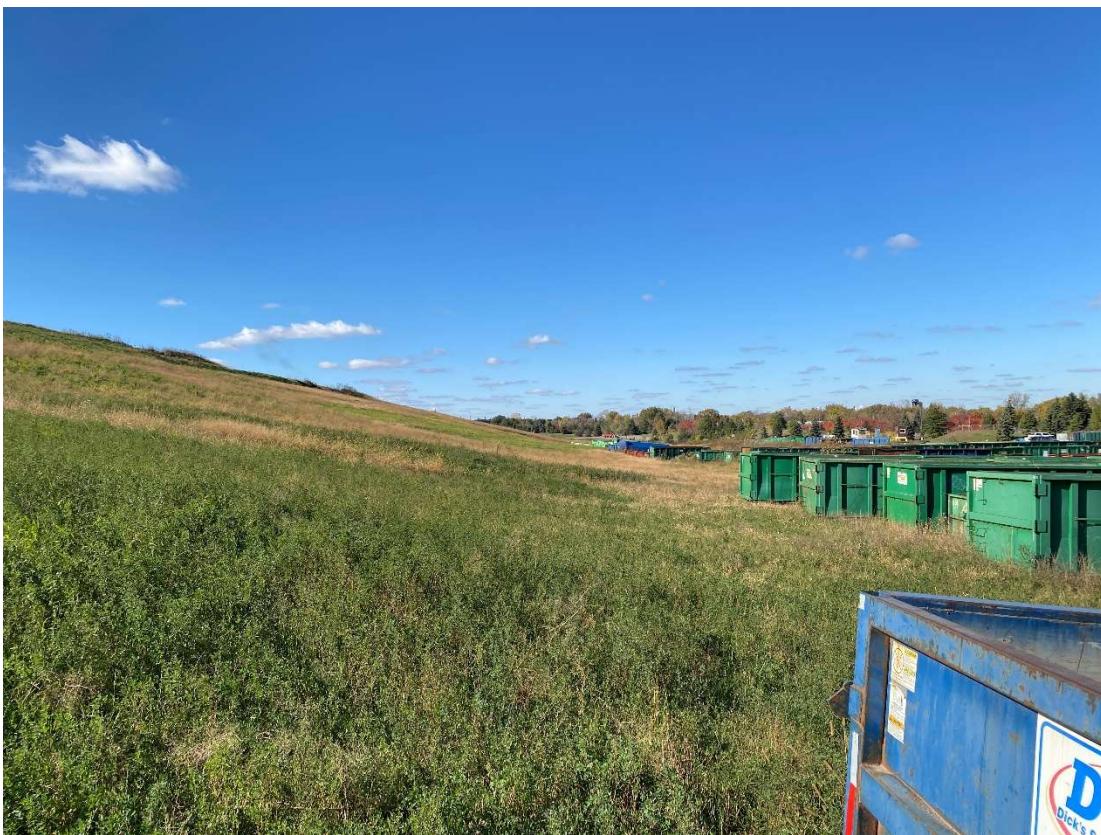
Location 3 – Looking Northwest, Cell 3A Anchor Trench and Northeastern Waste Slope

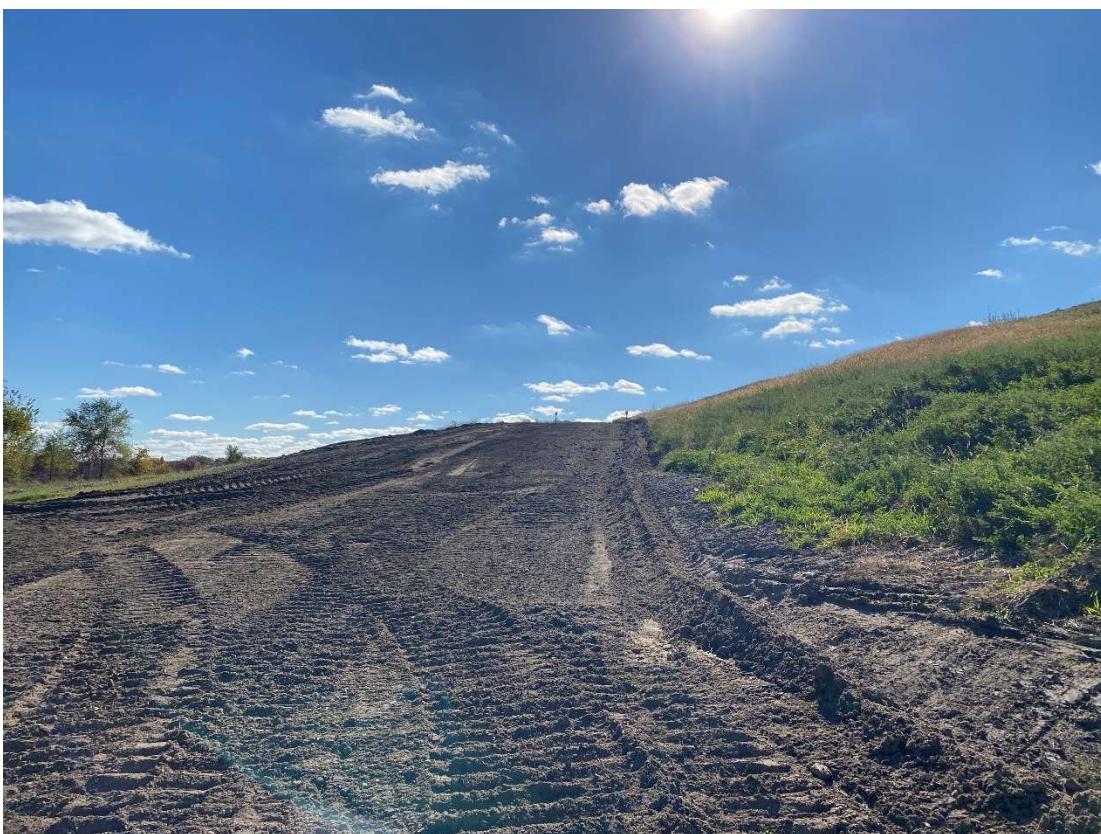
Location 3 – Looking Southwest, Cell 3 East Corner at toe of Interior Access Road

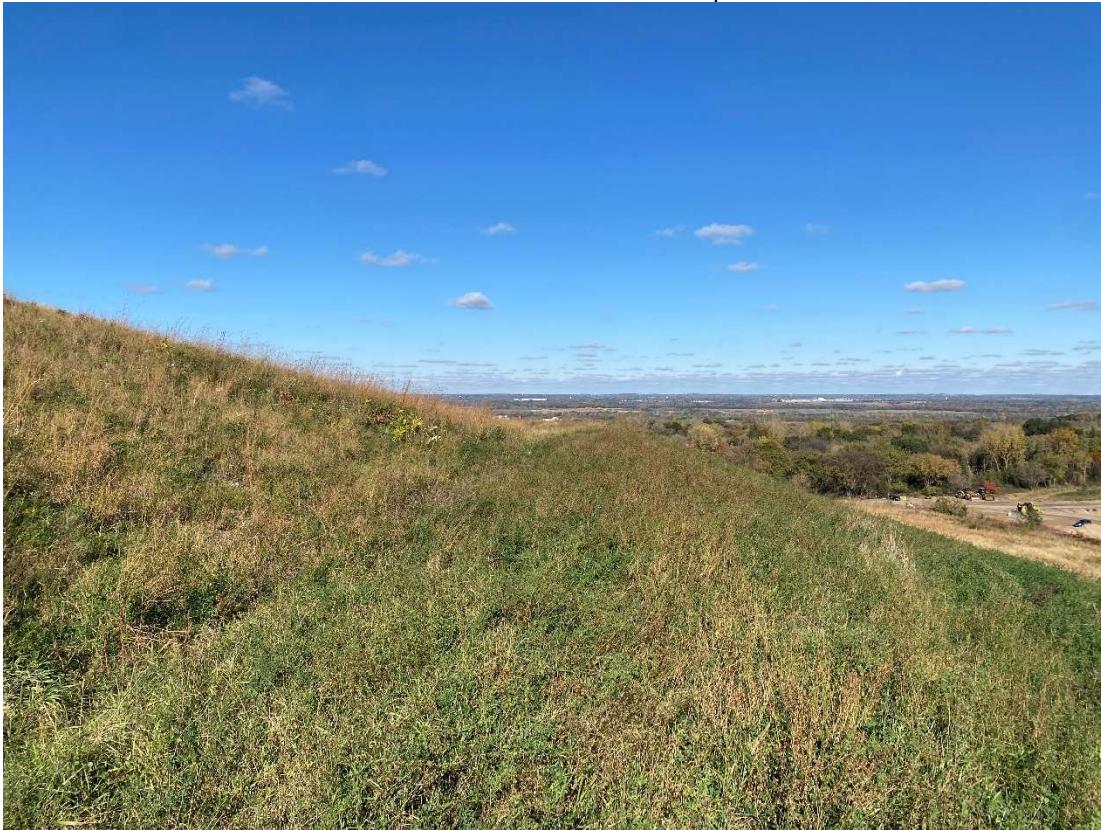
Location 4 – Looking Northeast, Cell 3 Liner Limit

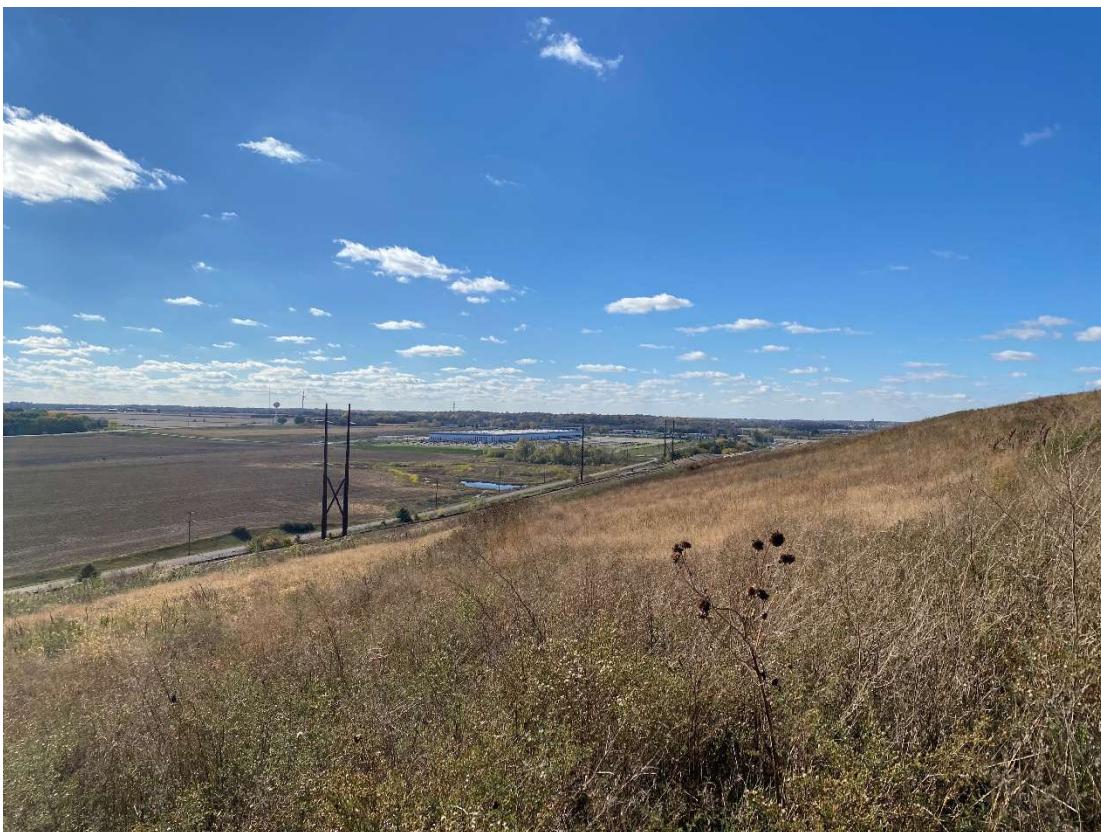
Location 5 – Looking Southwest, Phase 3 Liner Limit

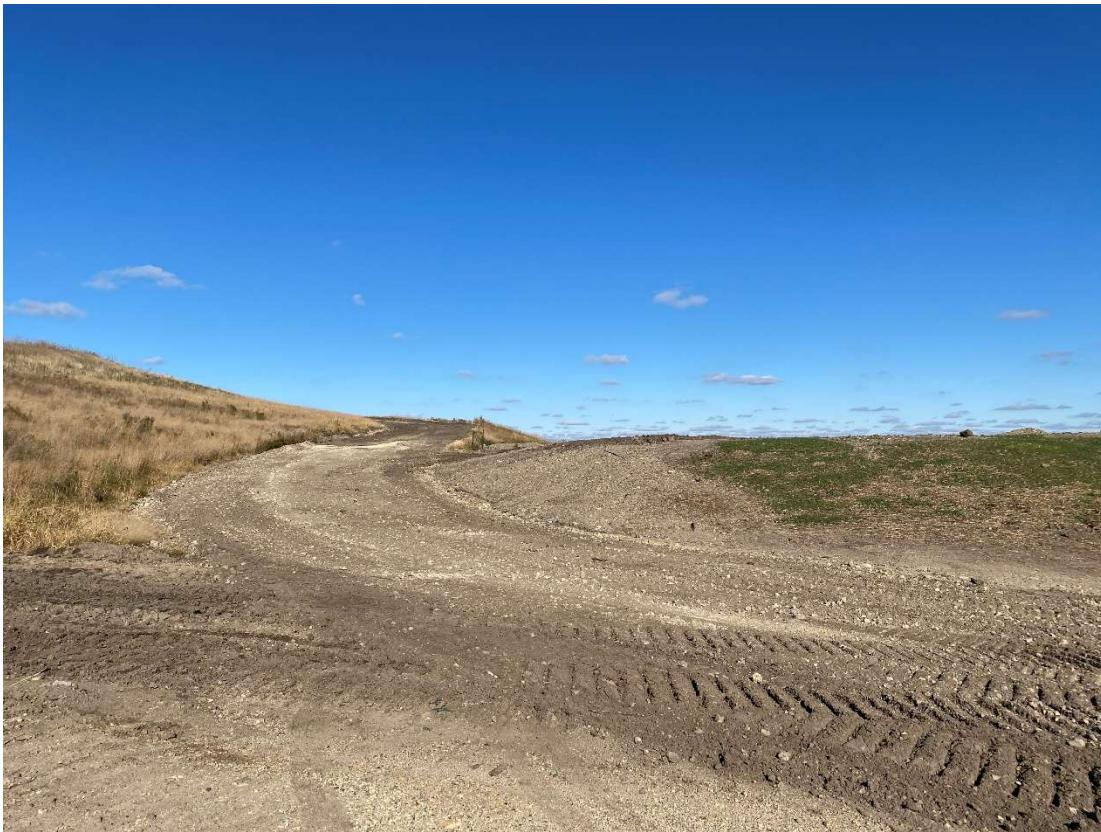
Location 5 – Looking Northeast, Phase 3 Liner Limit

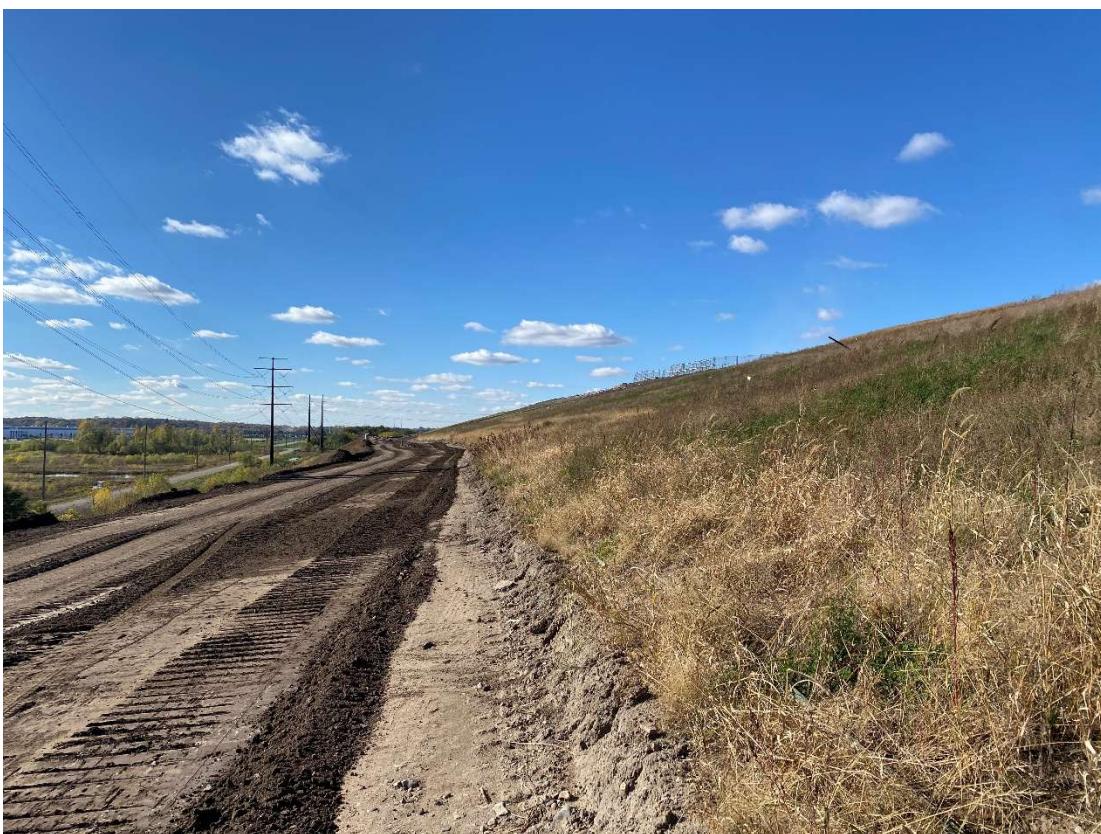
Location 6 – Cell 6 southeast corner, toe of southern waste slope, looking west

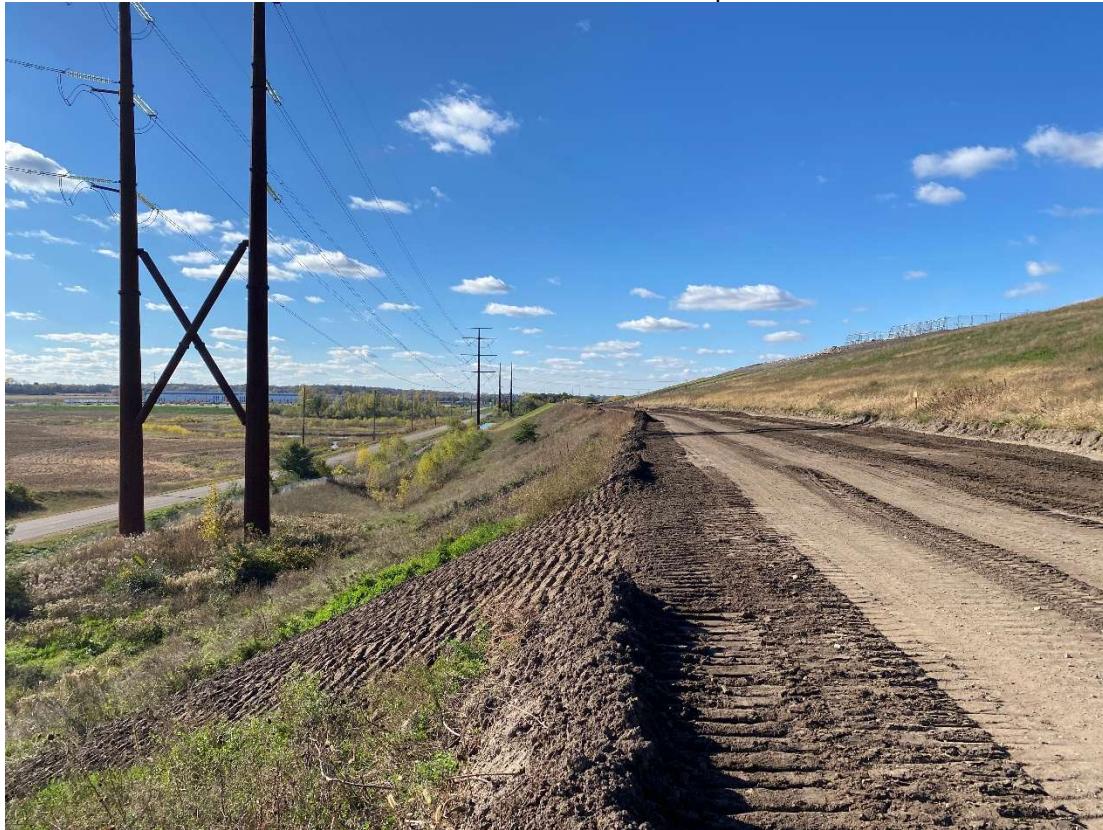
Location 6 – Cell 6, southeast corner, outer berm, looking west

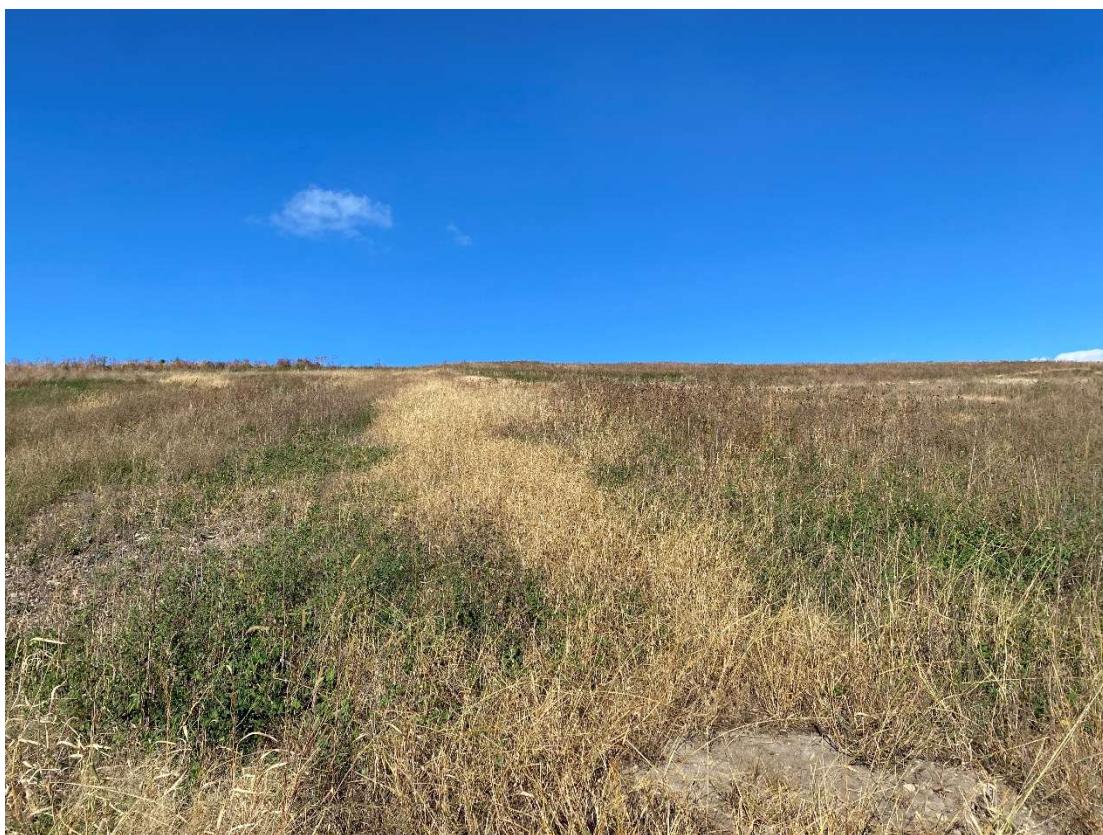
Location 6 – Cell 6, southeast corner, looking north at edge of overlay liner

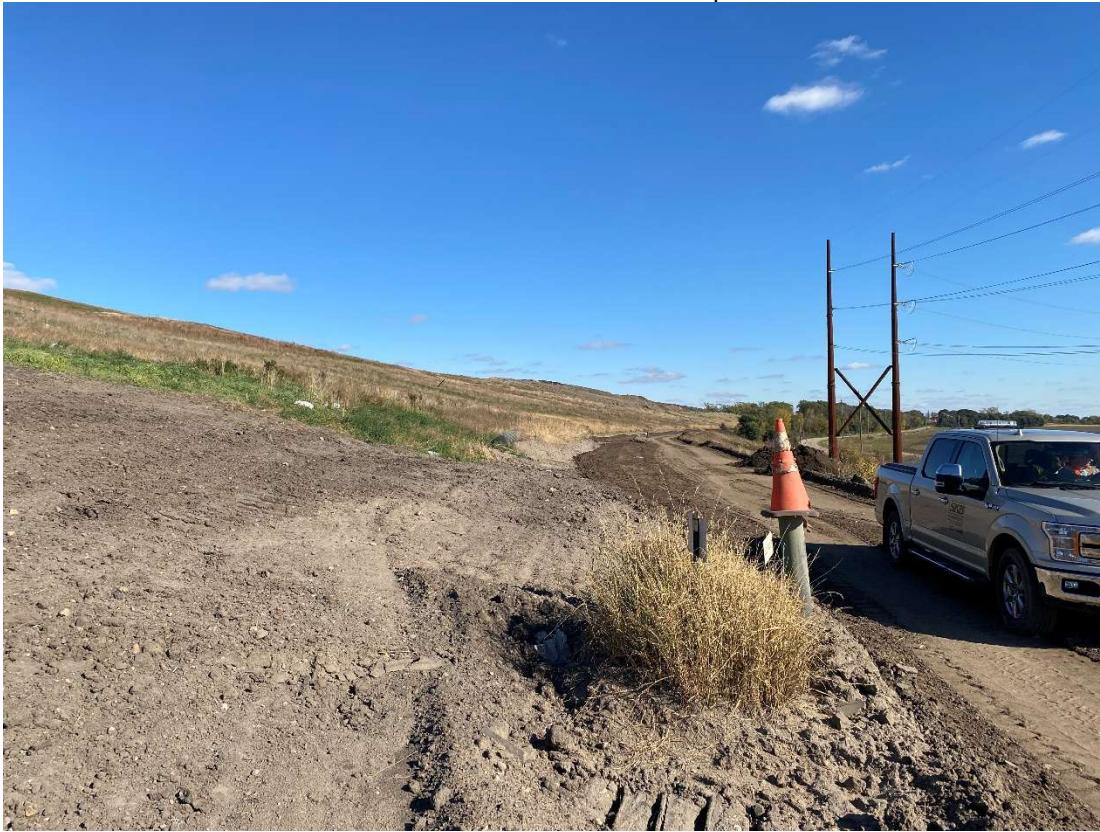
Location 7 – Cell 6, toe of southern waste slope, looking east

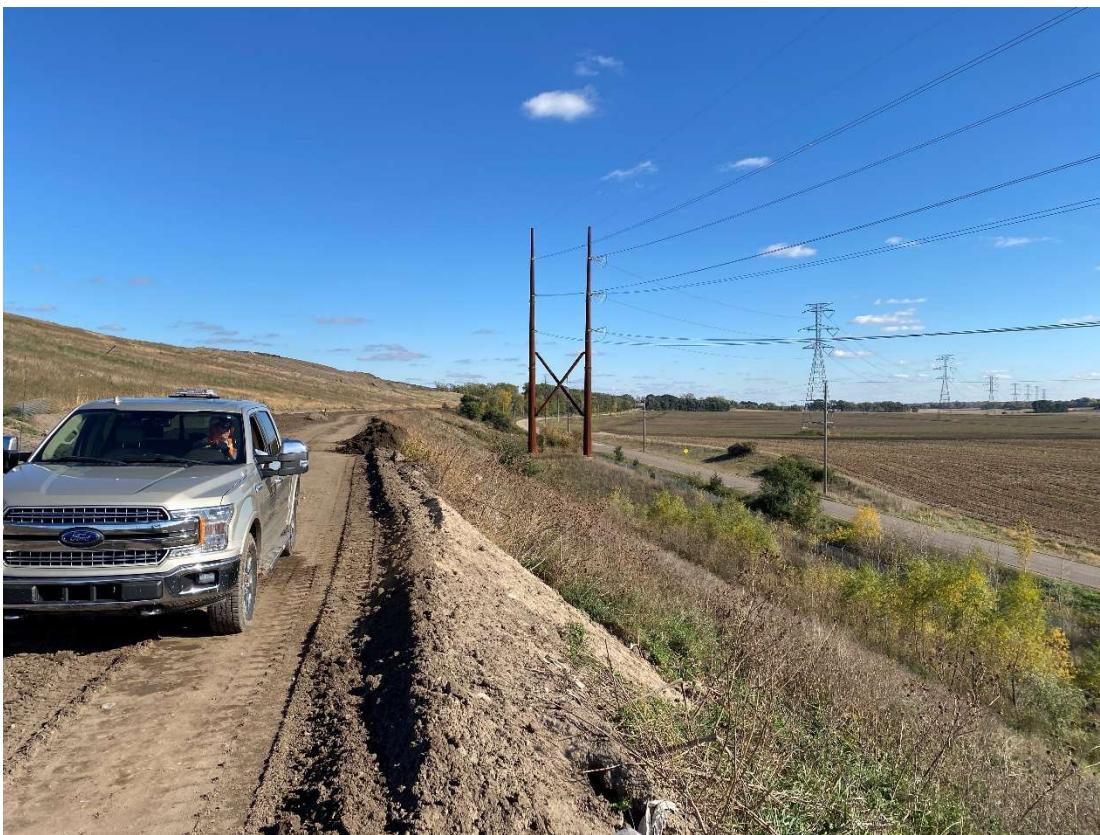
Location 7 – Cell 6, southern outer berm, looking east

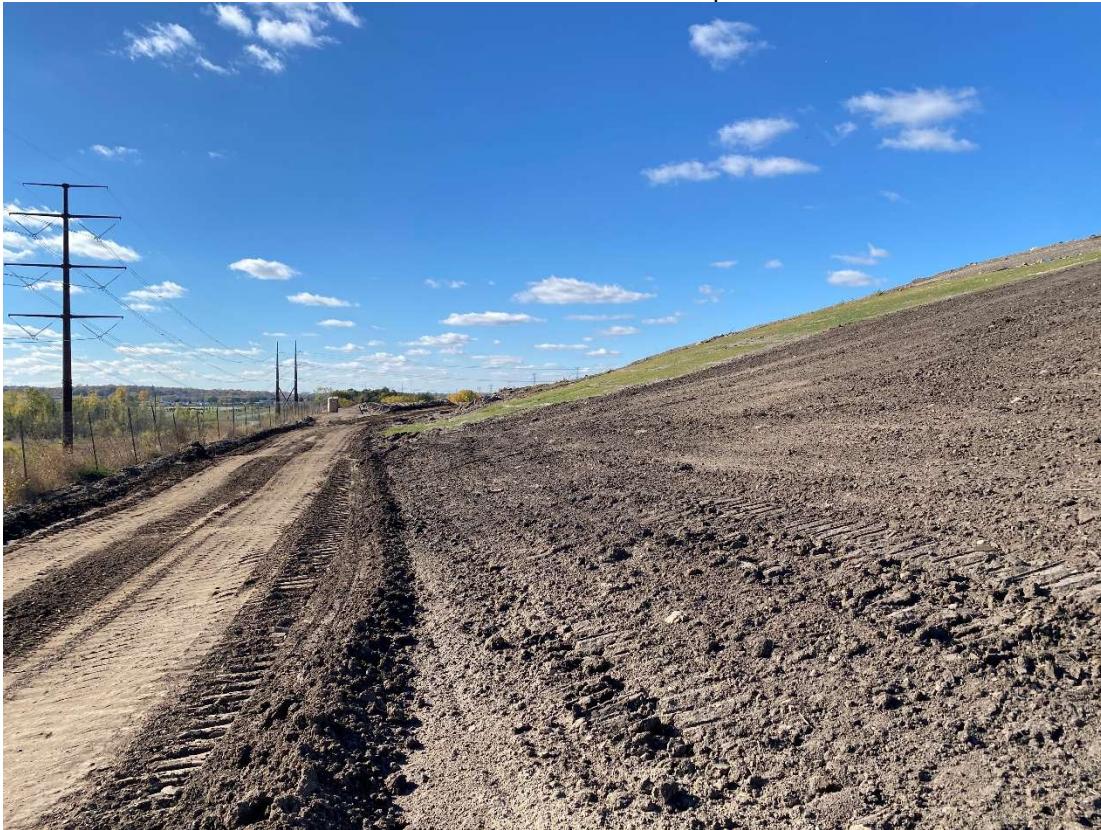
Location 7 – Cell 6, interior of southern landfill berm, looking west

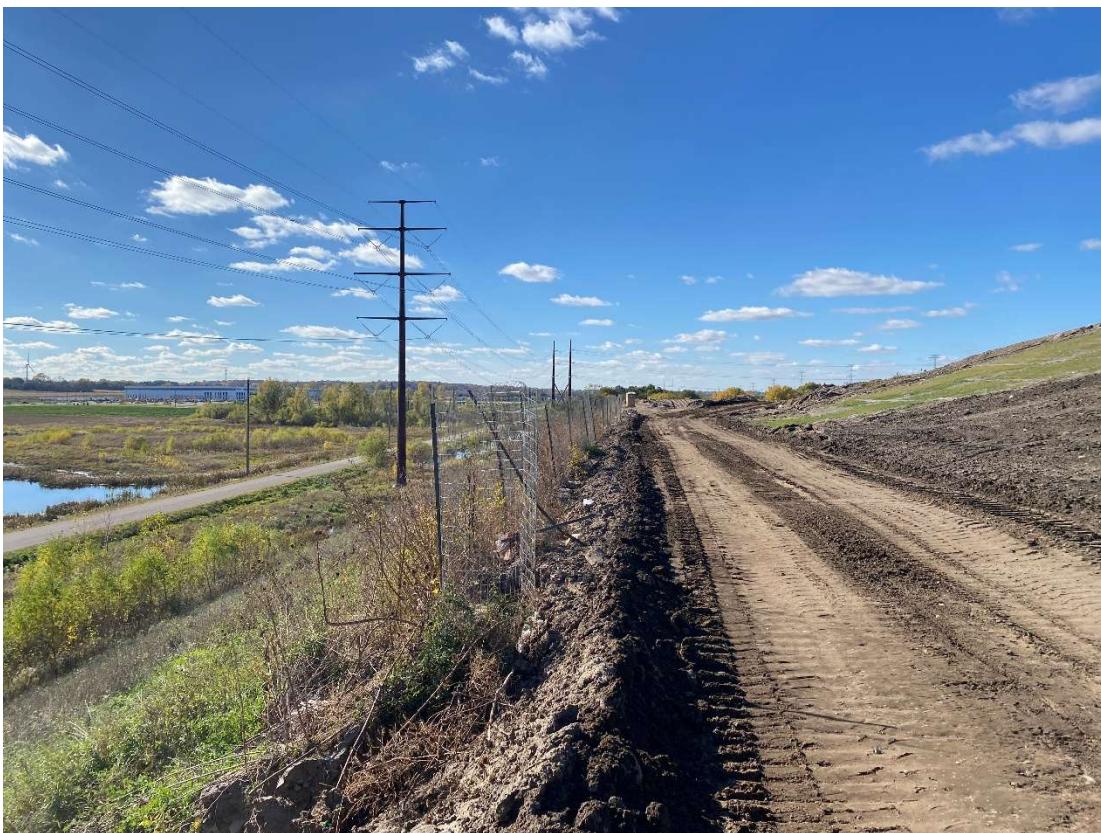
Location 7 – Cell 6, exterior of southern landfill berm, looking west

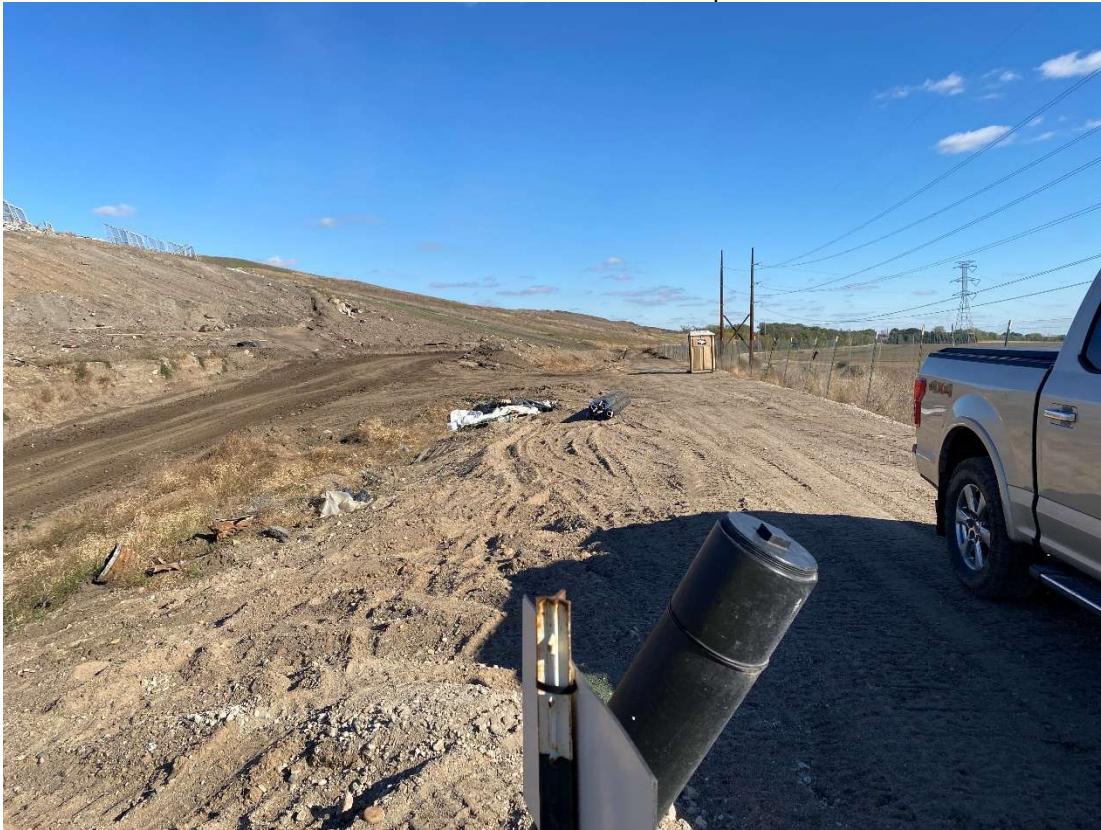
Location 8 – Cell 6, interior of southern landfill berm, looking west

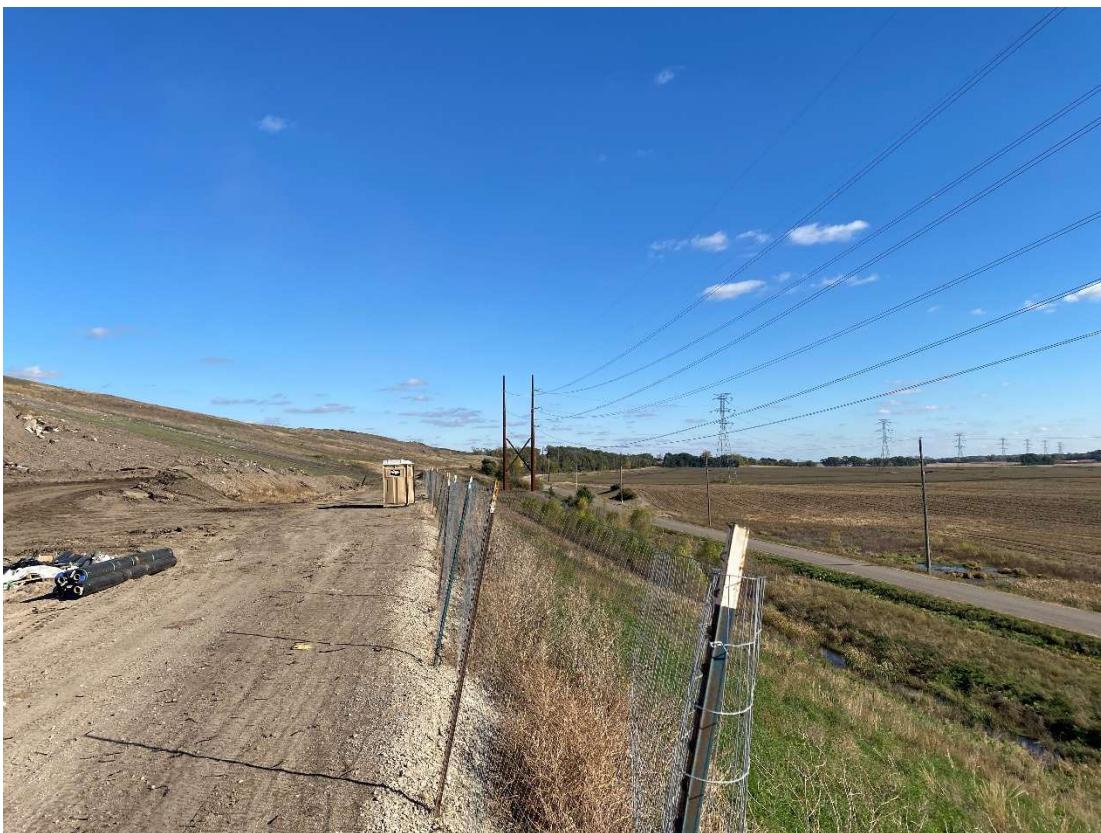
Location 8 – Cell 6, exterior of southern landfill berm, looking west

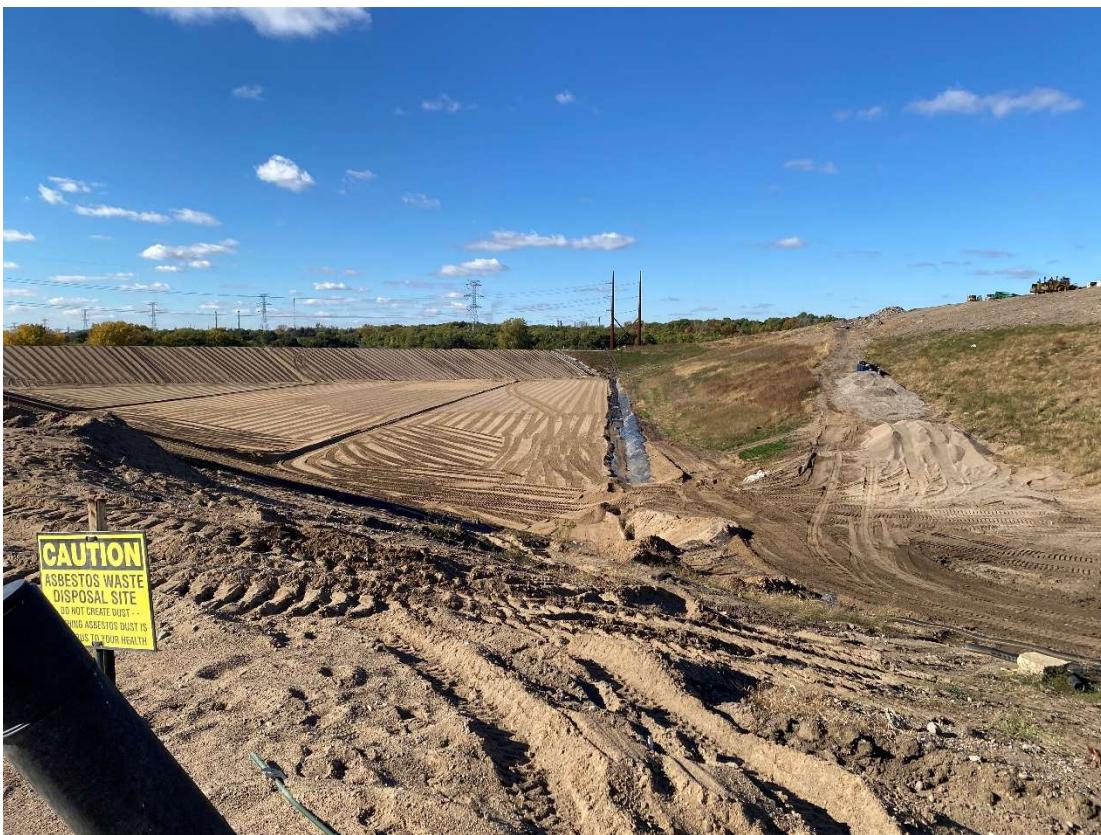
Location 8 – Cell 6, looking north along temporary phase construction berm

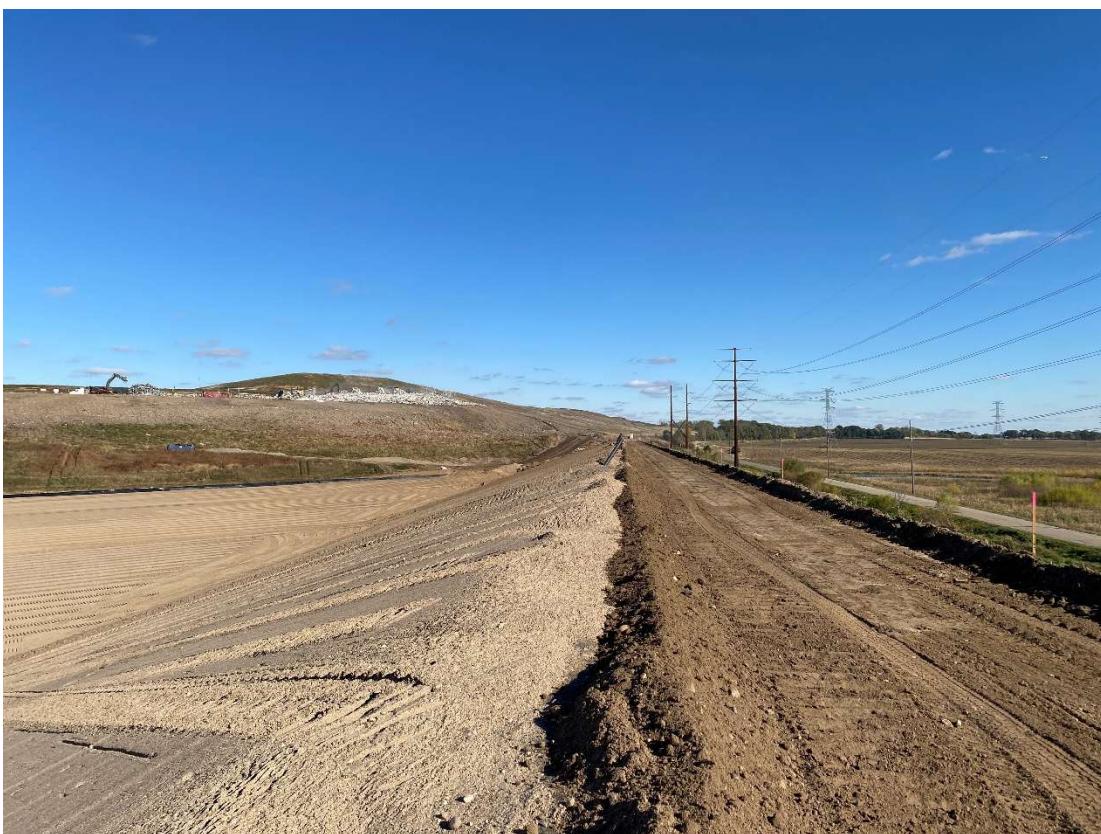
Location 9 – Cell 6, looking east along anchor trench

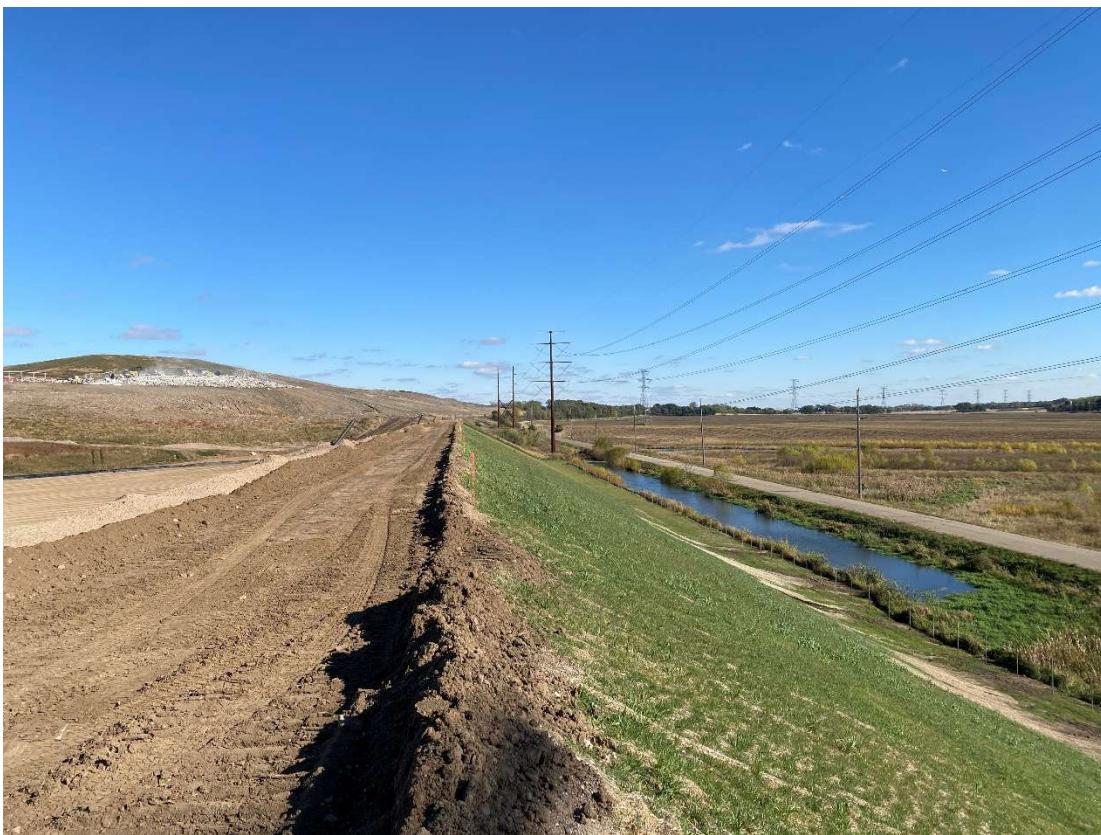
Location 9 – Cell 6, looking east along landfill berm southern slope

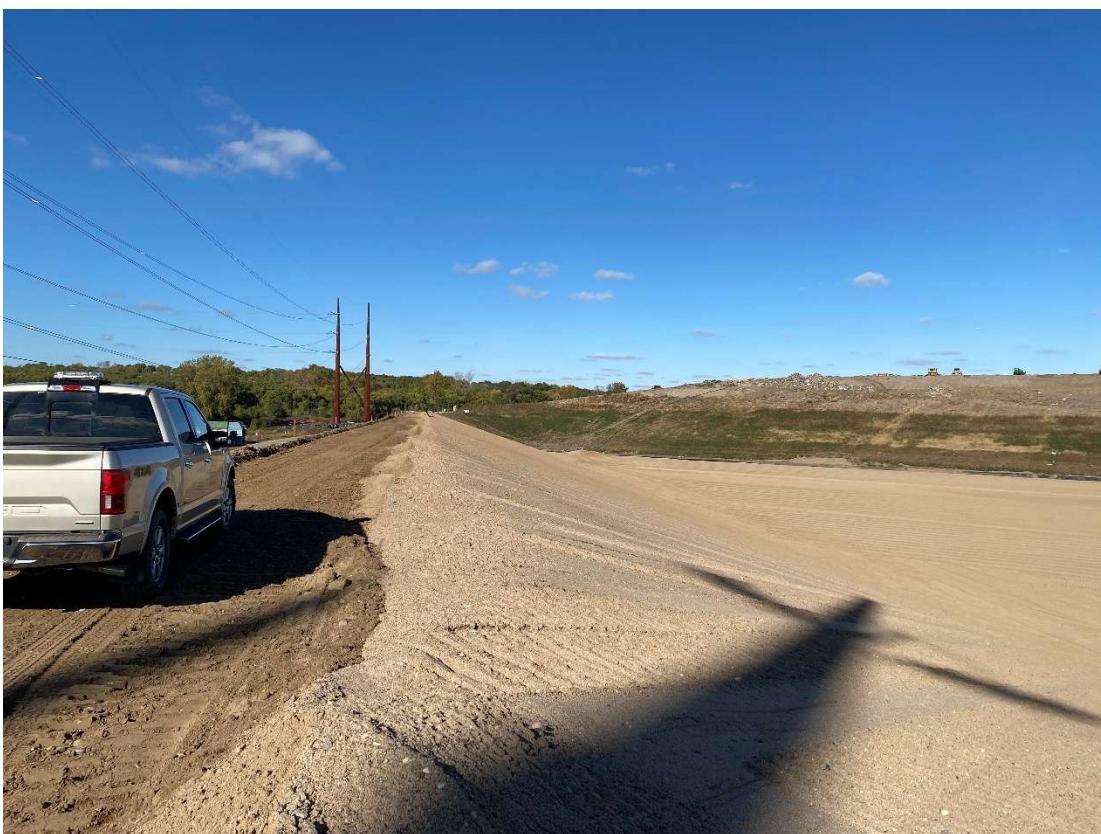
Location 9 – Cell 6, looking north along anchor trench

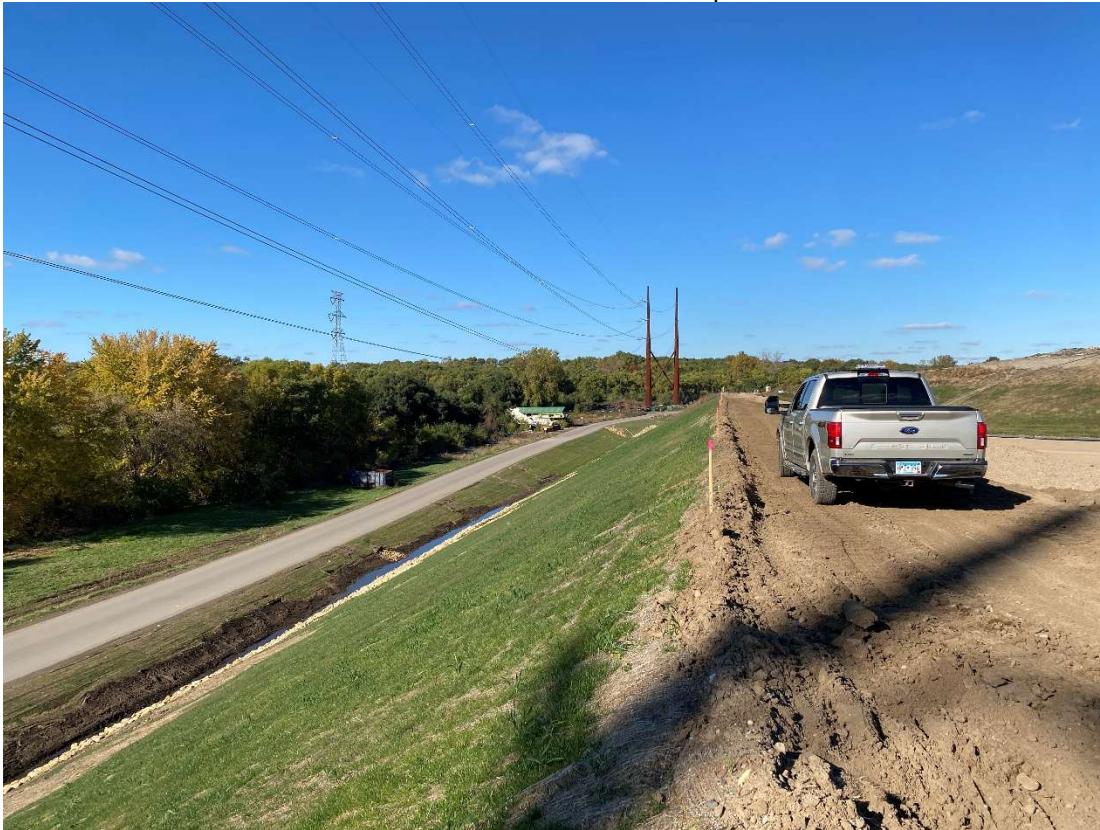
Location 9 – Cell 6, looking north along landfill berm western slope

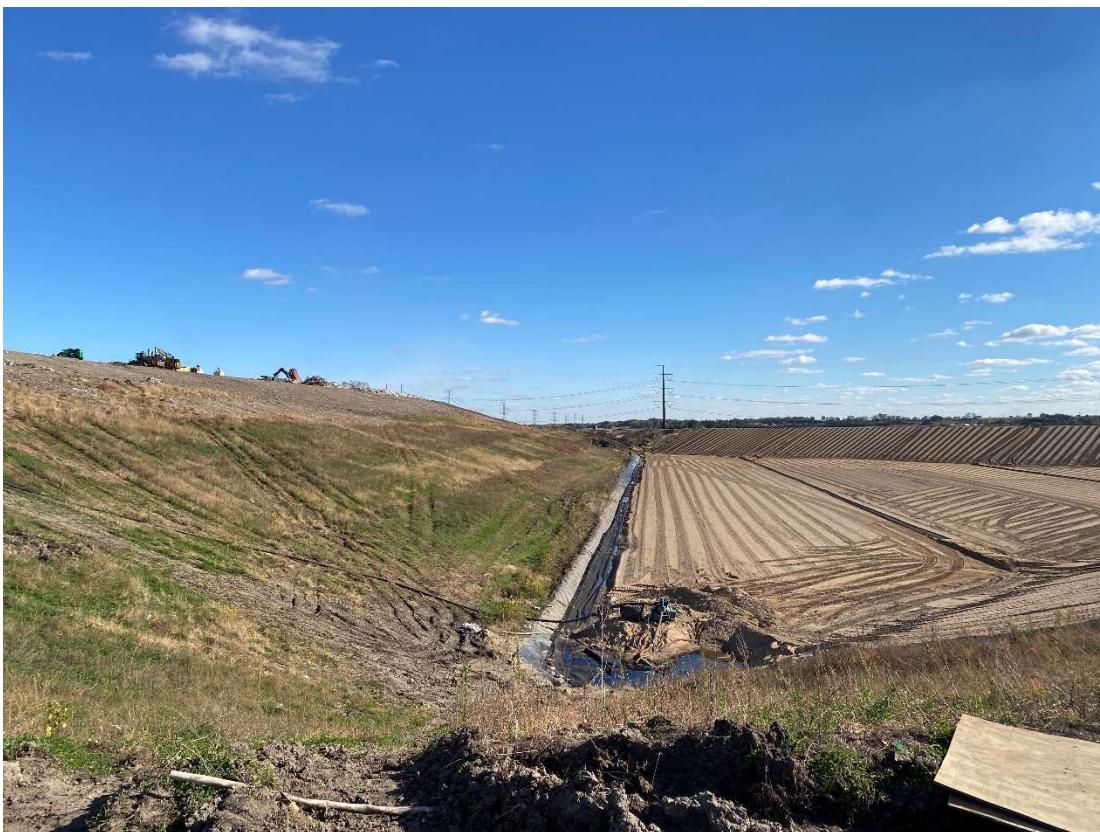
Location 10 – Cell 6, looking east along temporary phase construction berm

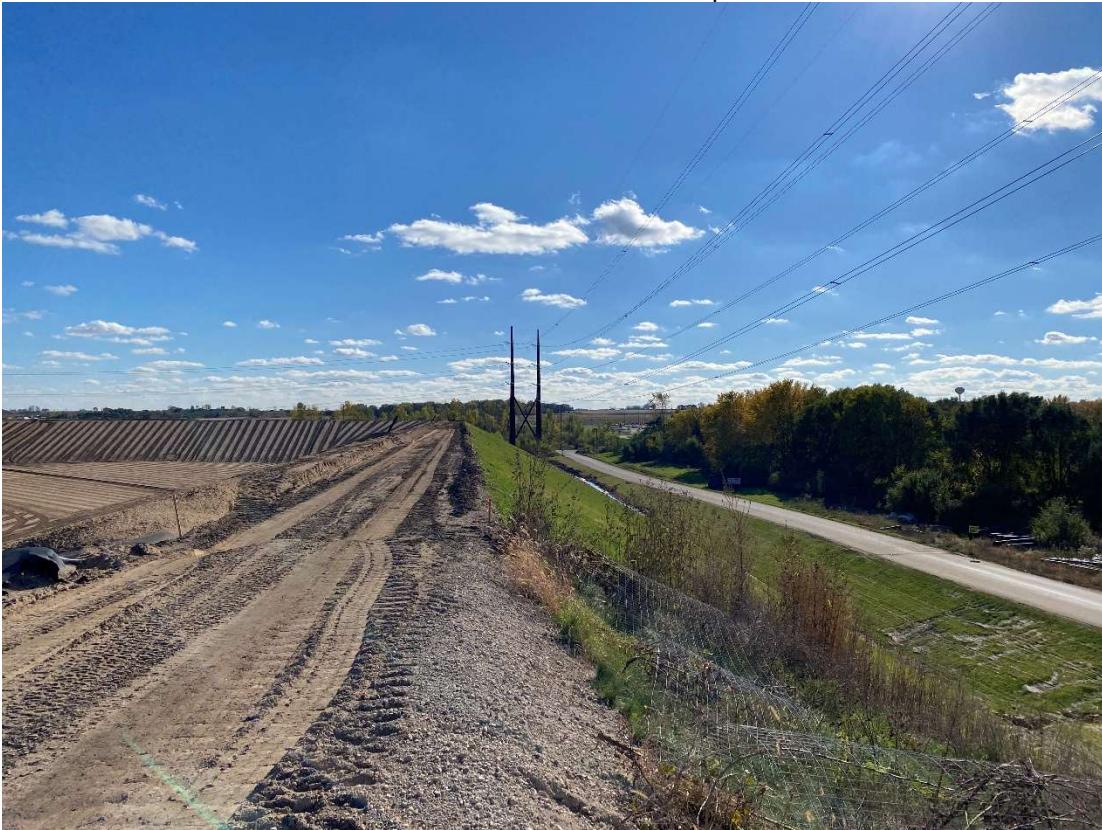
Location 10 – Cell 6, exterior top of berm, looking south
