From: Brad Sullivan, P.E., Stantec

Date: January 7, 2026

Reference: SKB Rosemount Industrial Waste Facility 2025 Annual CCR Inspection Report

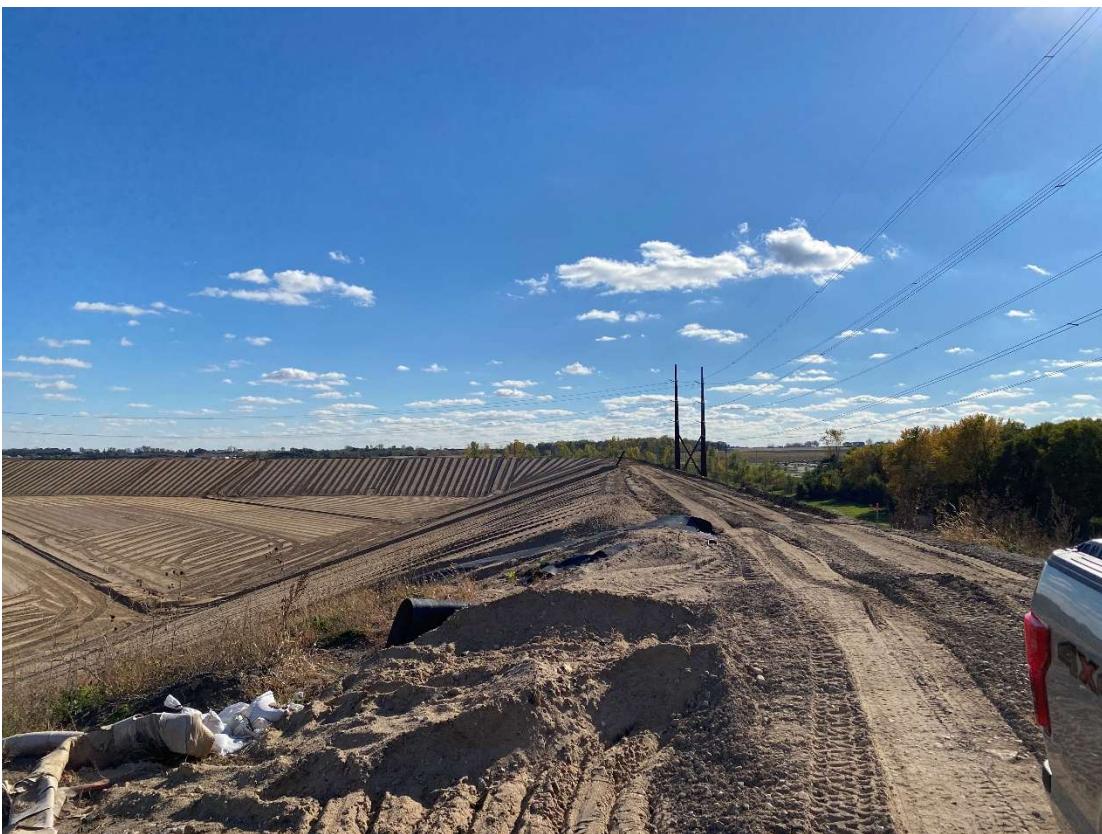
Location 10 – Cell 6, interior top of berm, looking south

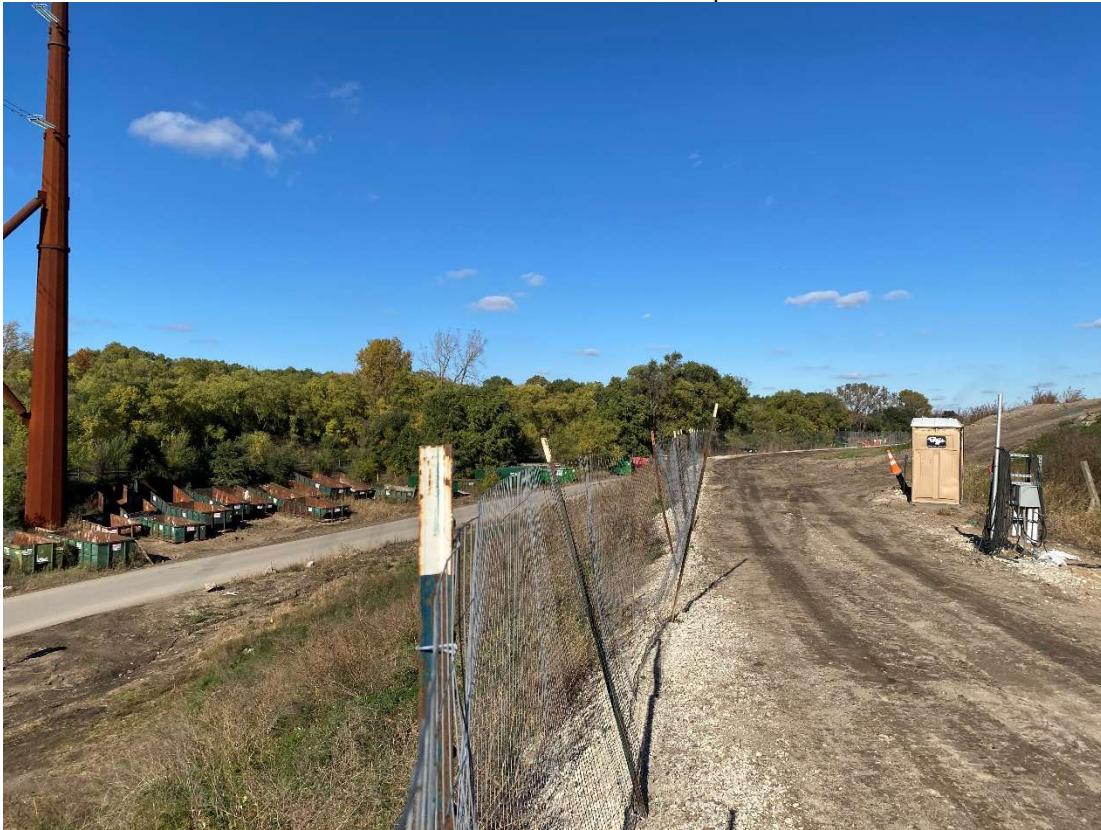
Location 10– Cell 6, exterior top of berm, looking northeast

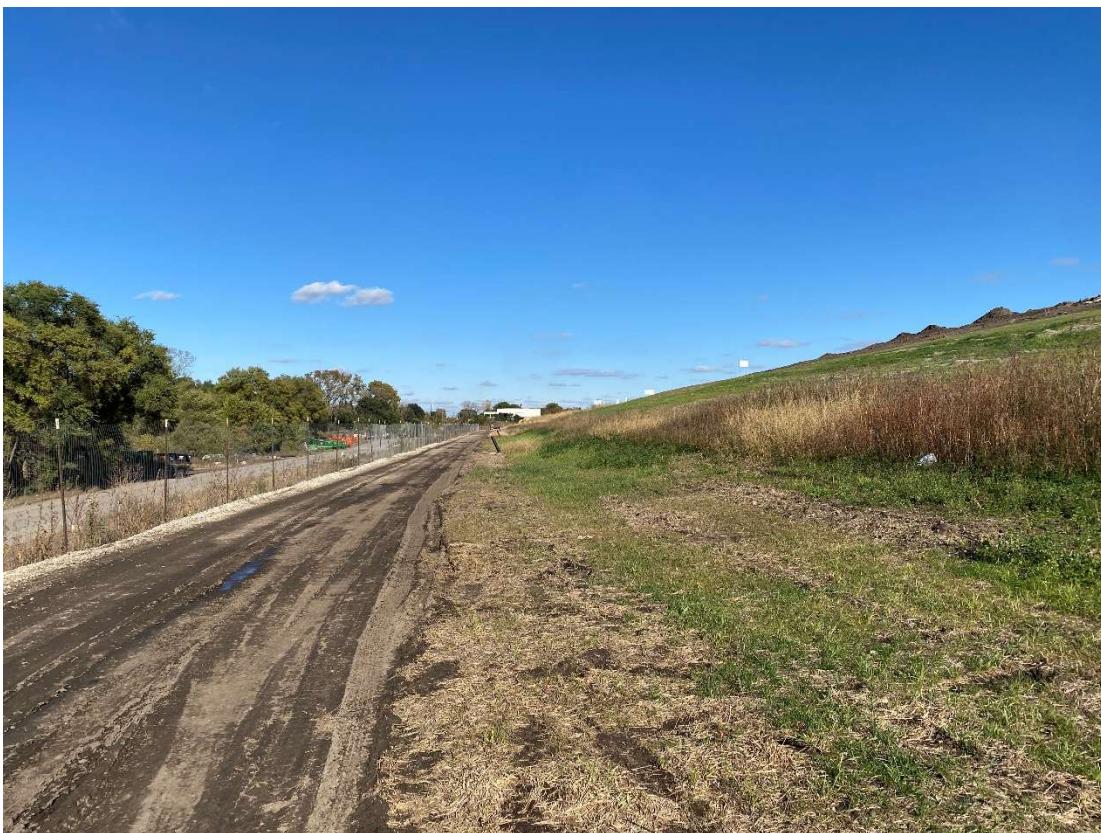
Location 11– Cell 6, interior top of berm, looking northeast

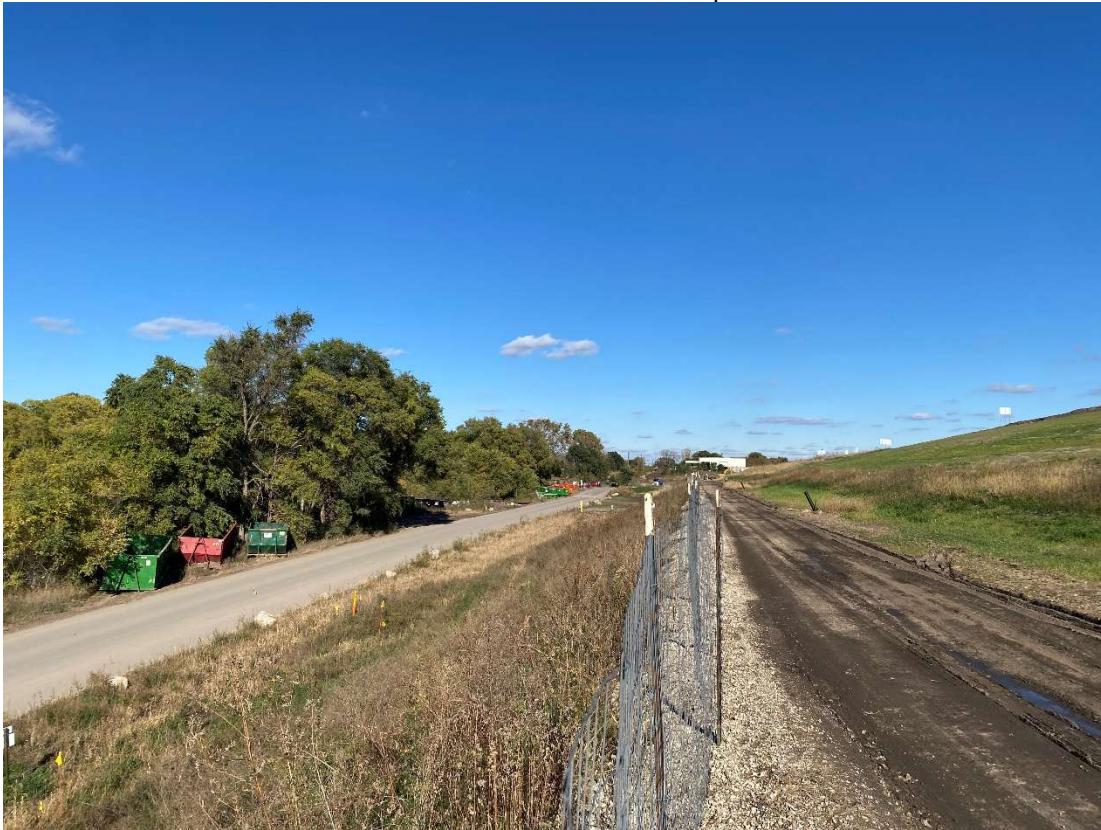
Location 11– Cell 6, exterior top of berm, looking northeast

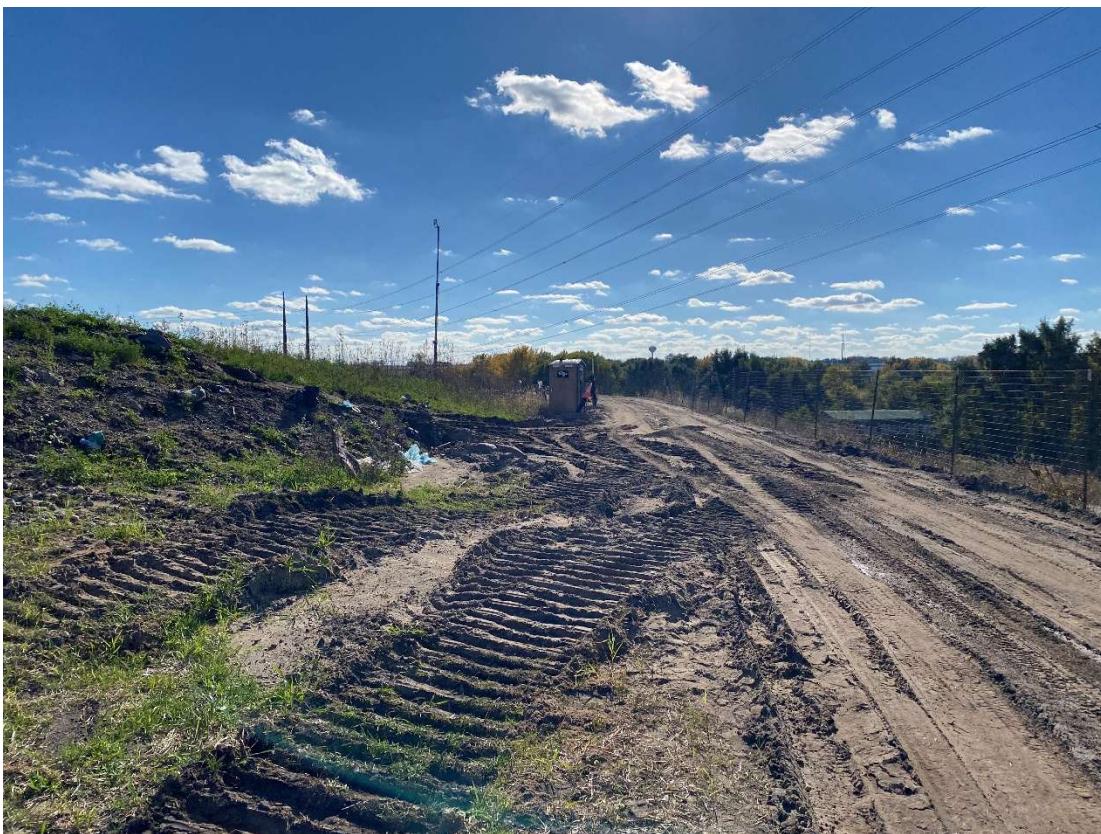
Location 11– Cell 6, interior top of berm, looking southwest

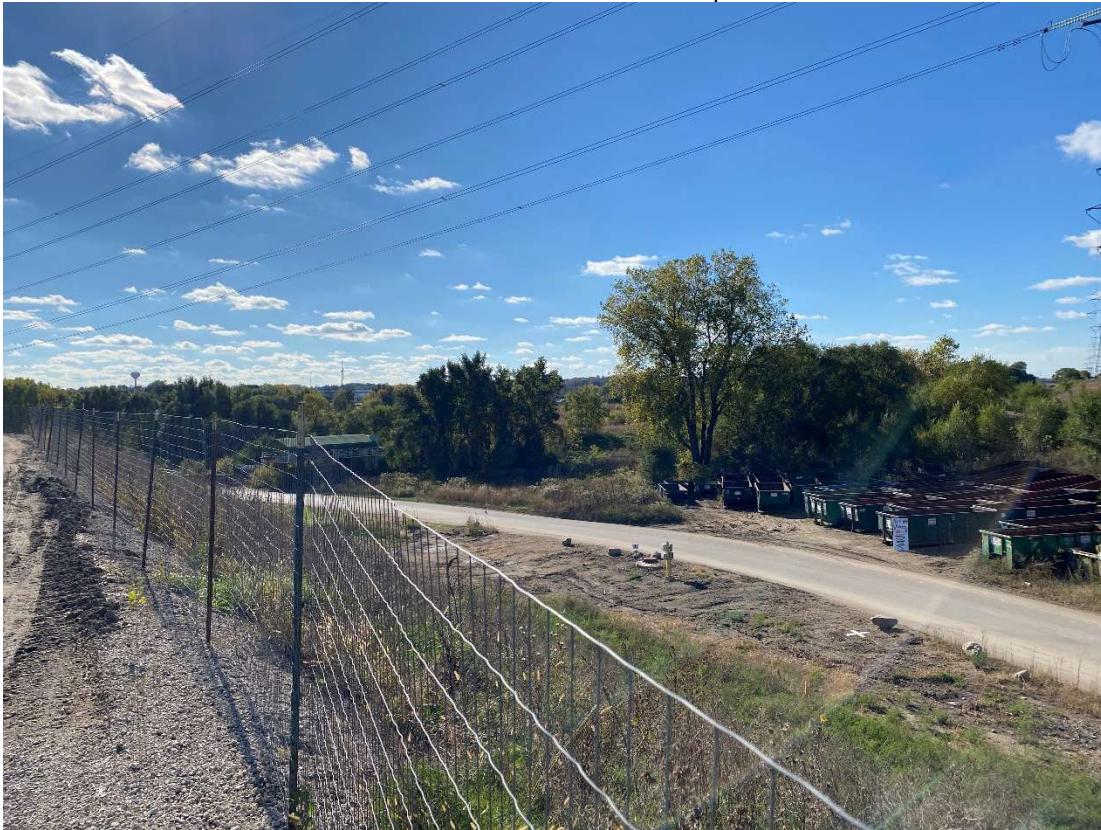
Location 11– Cell 6, exterior top of berm, looking southwest

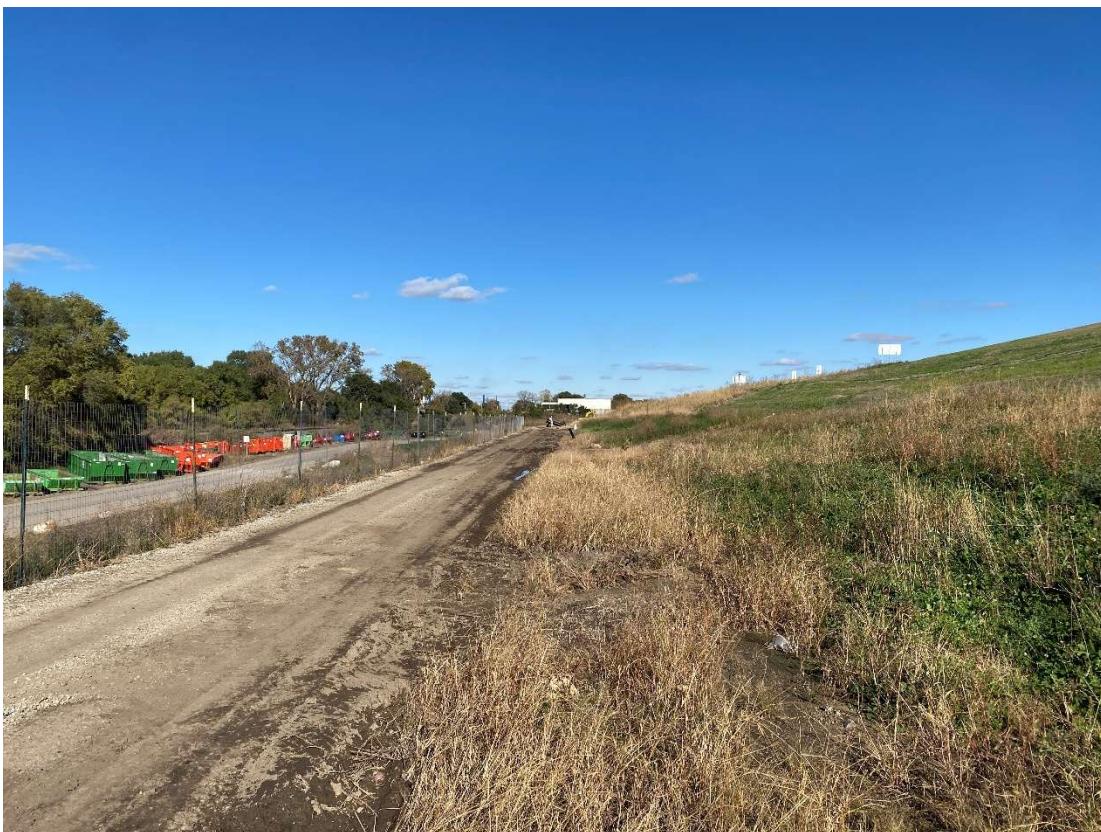
Location 11 – Cell 6, interior top of berm, looking north

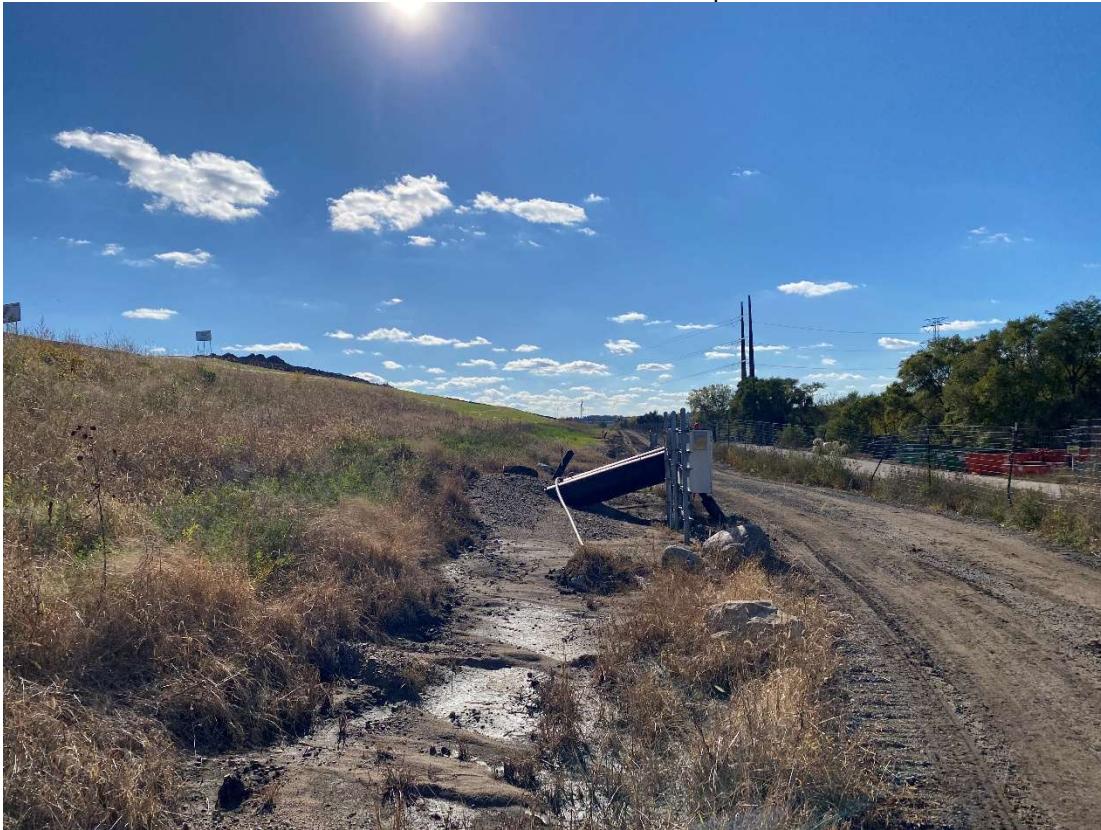
Location 12 – Cell 6 northwestern interior top of berm, looking southwest

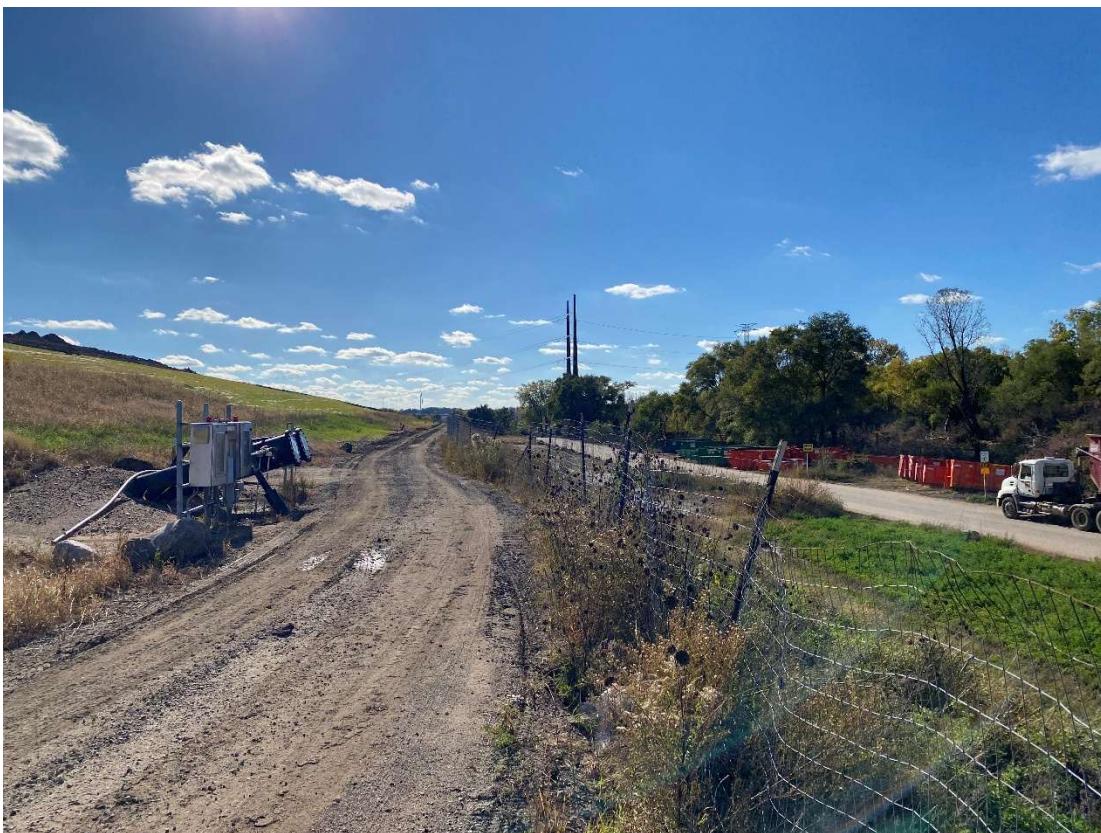
Location 12 – Cell 6 northwestern exterior top of berm, looking southwest

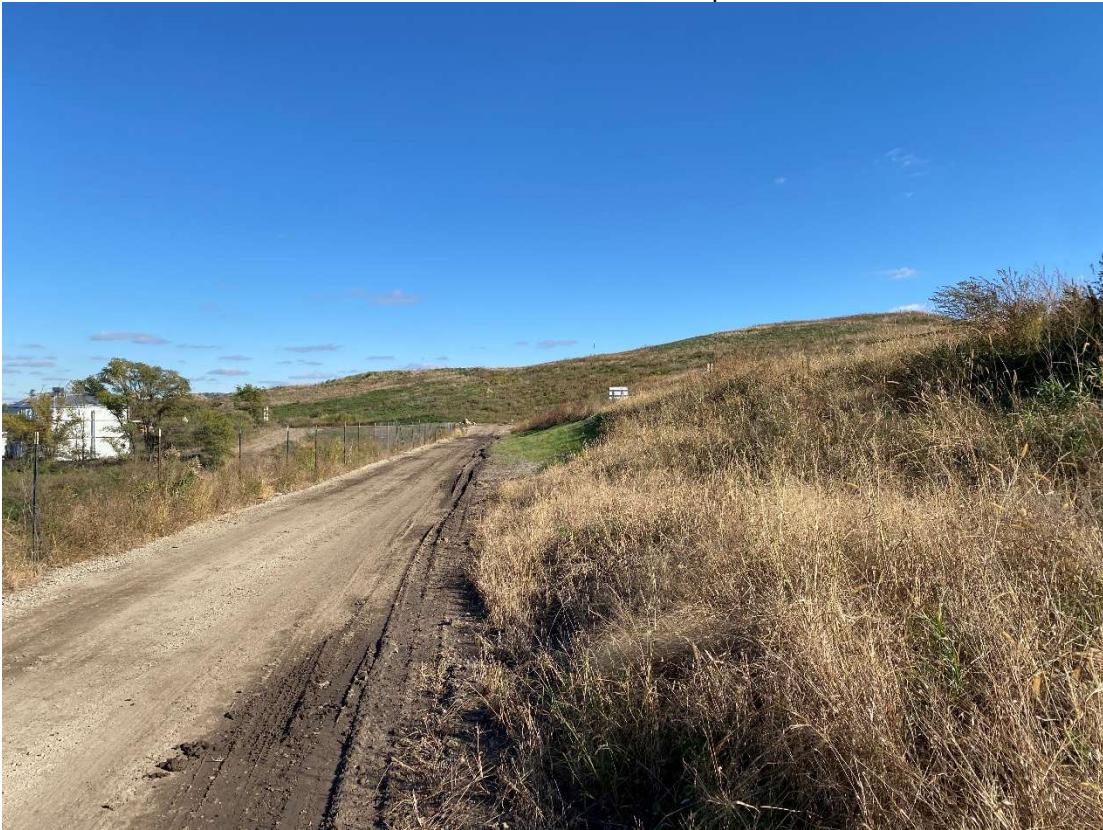
Location 12 – Cell 6 northern top of berm, looking northeast

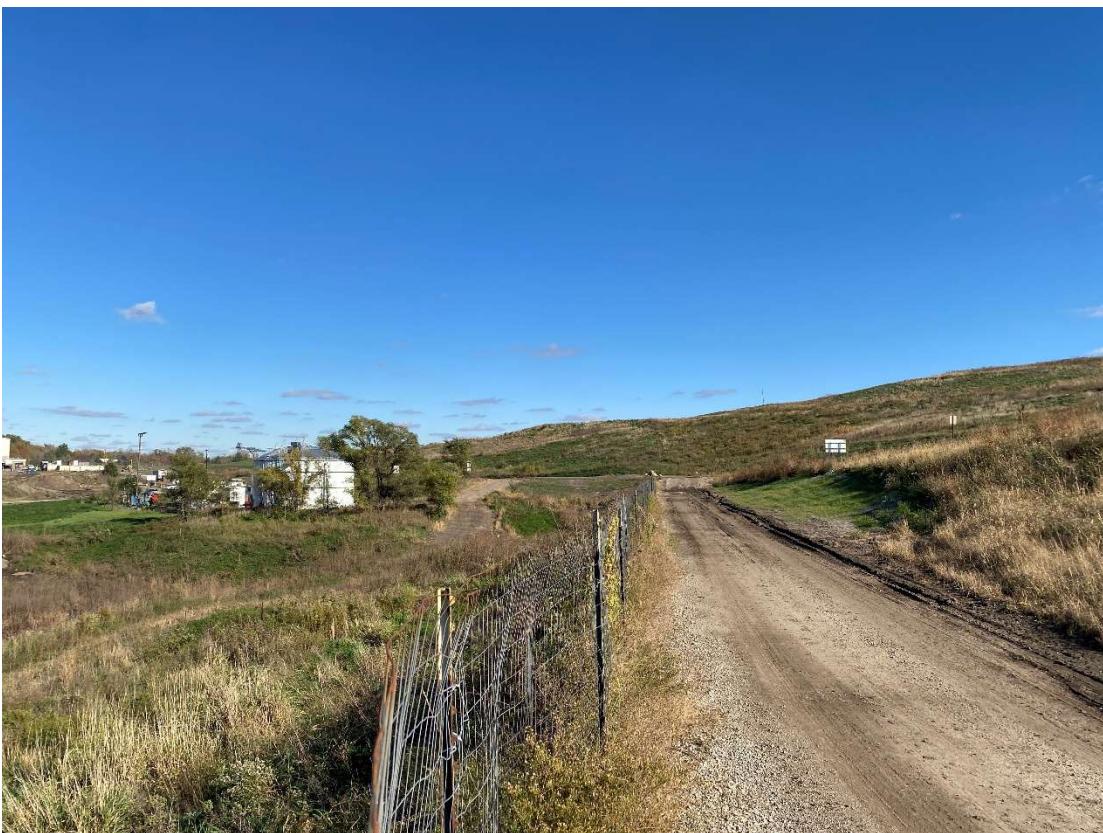
Location 12 – Cell 6 northern outer berm, looking northeast

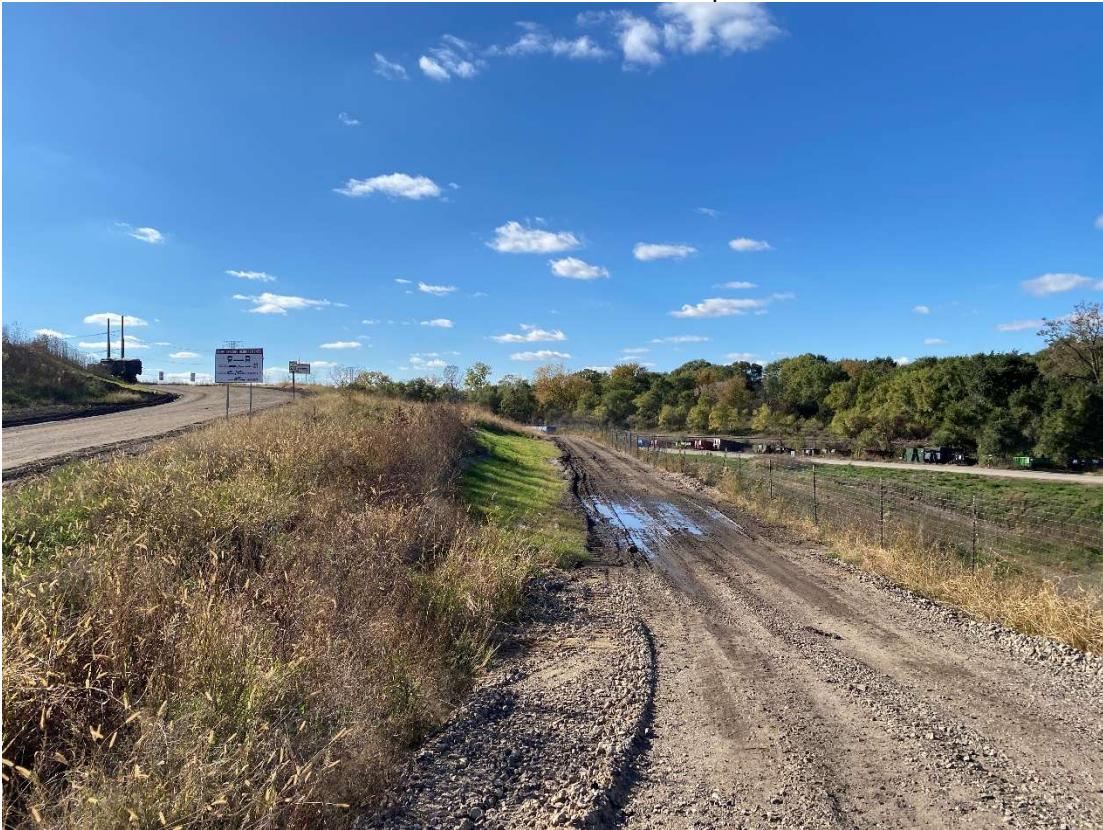
Location 13 – Cell 6 northern top of berm, looking southwest

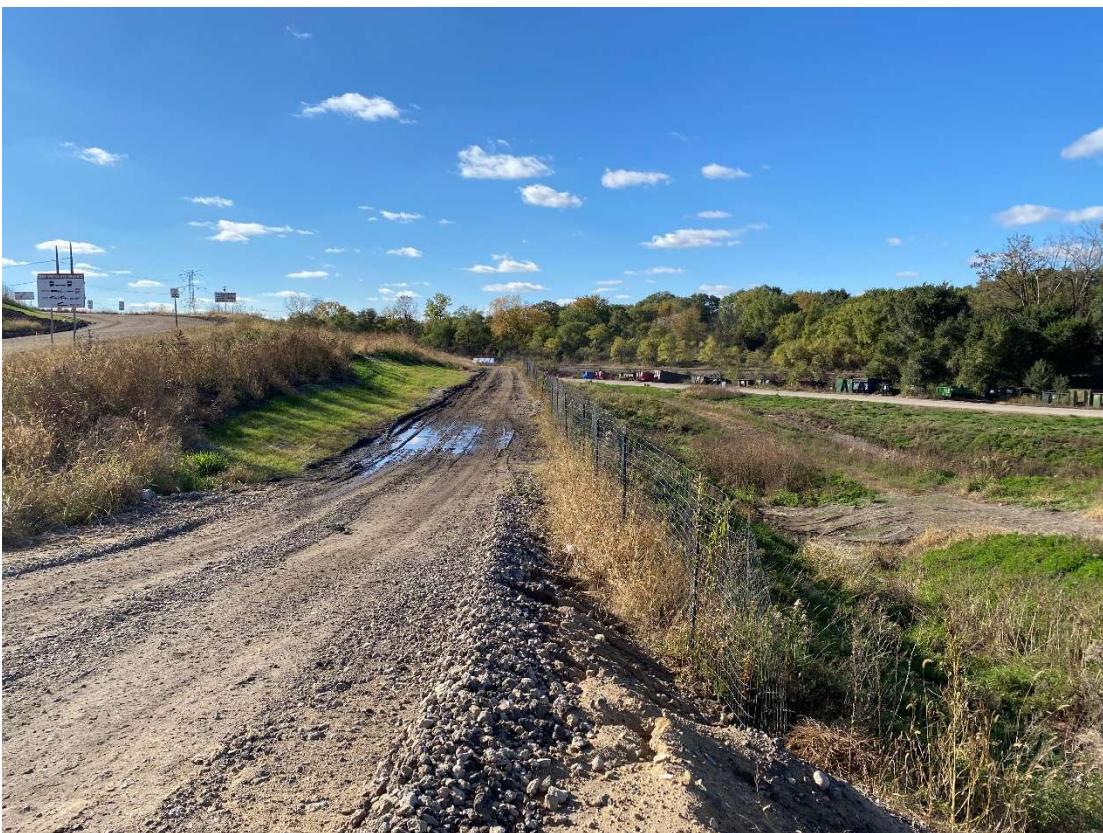
Location 13 – Cell 6 northern outer berm, looking southwest

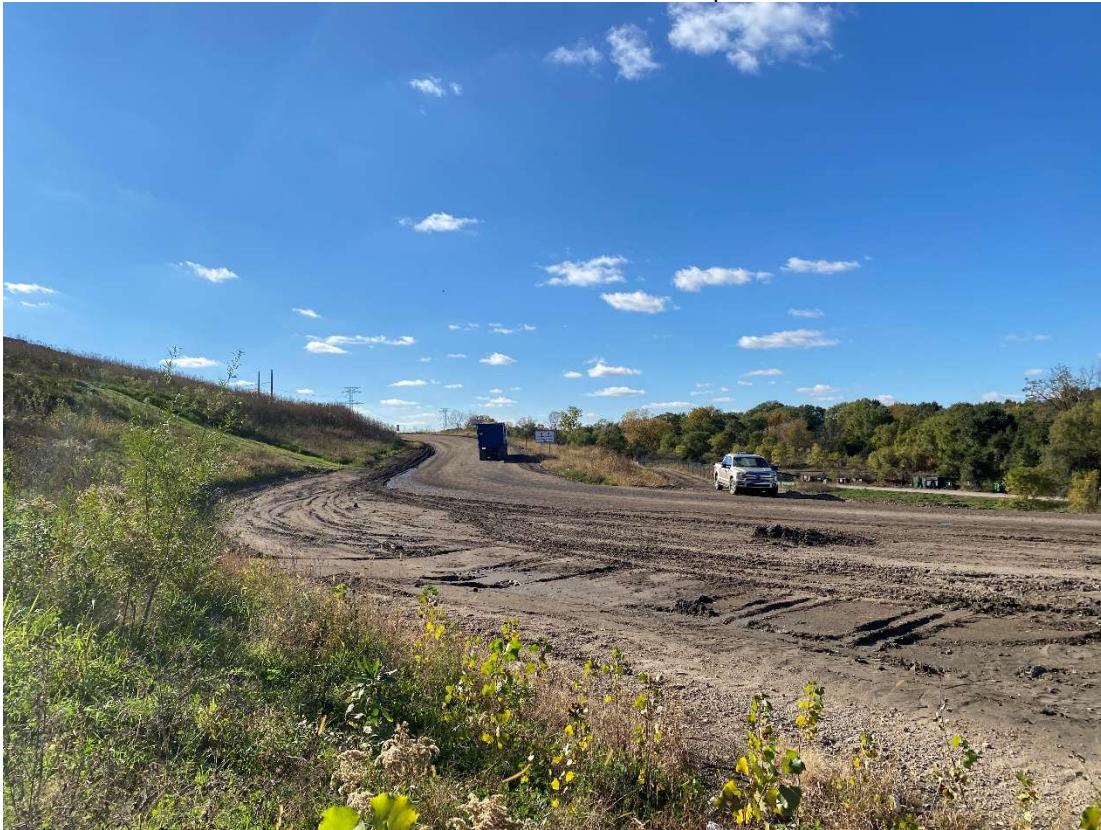
Location 14 – Cell 6, looking southwest

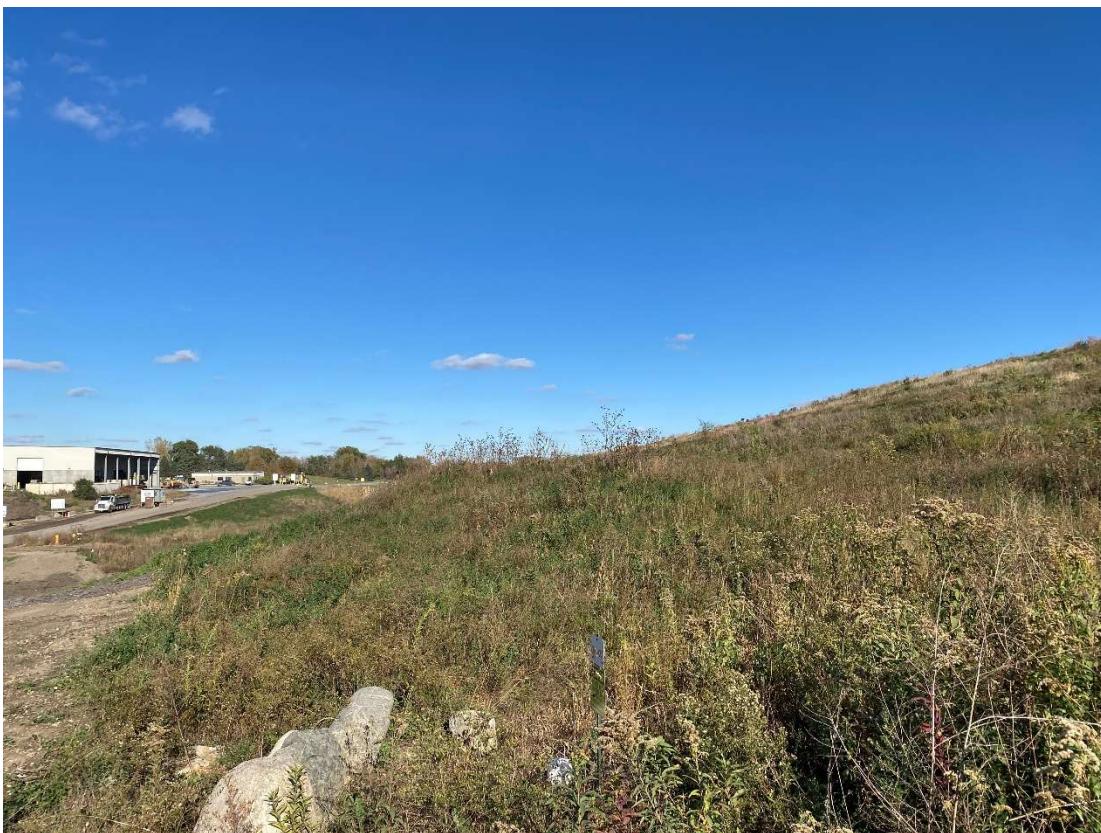
Location 14 – Cell 1, looking northeast

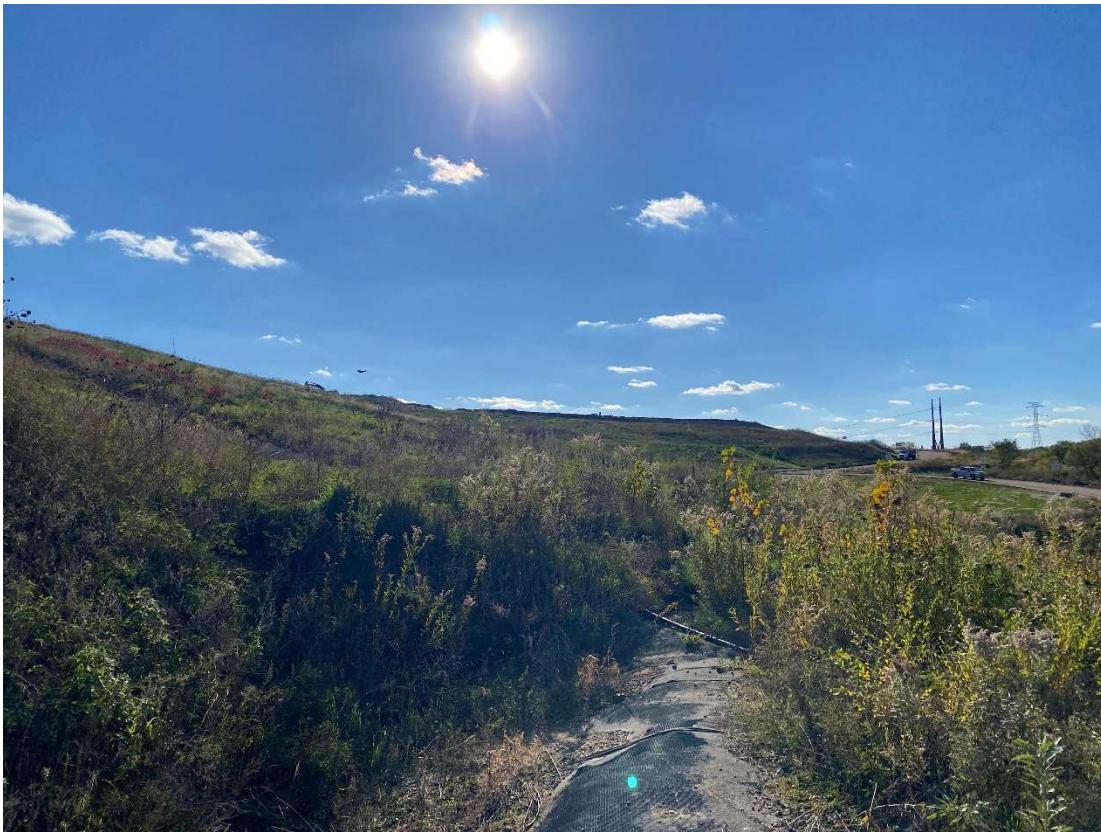
Location 15 – Cell 1 Toe of Waste Slope, looking southwest

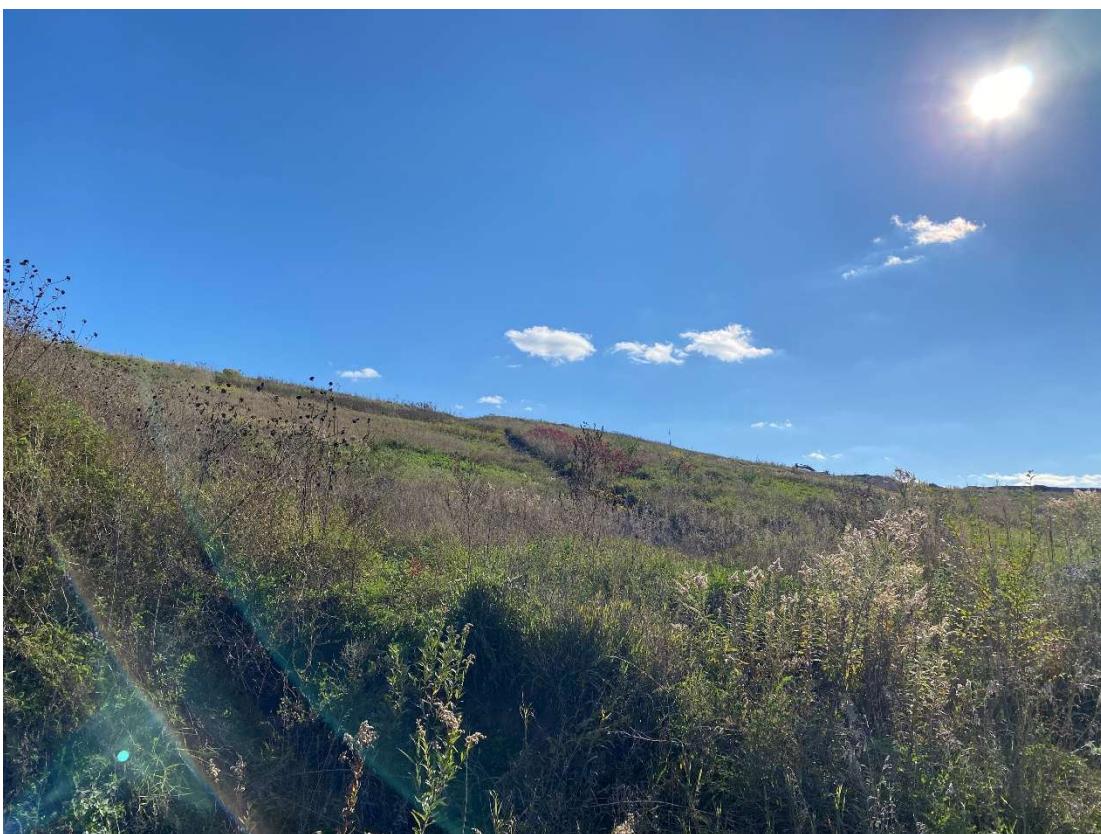
Location 15 – Cell 1 edge of cap, looking south
