# Technical Memo

**To:** Geoff Strack, SKB Environmental, Inc.  
**From:** Dave Parenteau, PE (MN), Wenck Associates, Inc.  
**Date:** January 14, 2016  
**Subject:** Annual Inspection SKB Rosemount Industrial Waste Facility - Report of CCR Landfill Inspection  
Wenck Project # B3053-0032

**Photos of Coal Ash Inspection  
SKB Industrial Waste Facility, Rosemount, MN  
December 28, 2015**

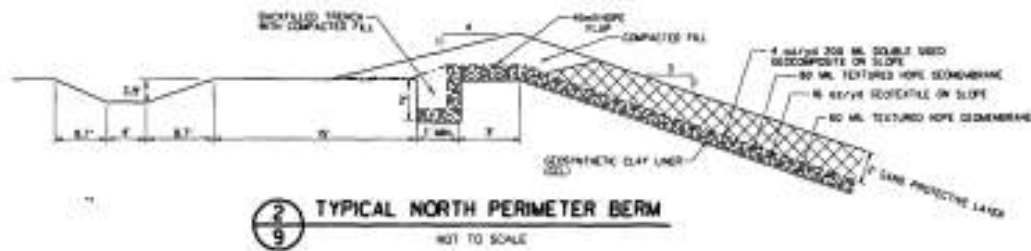
In general, most landfill cell embankments were constructed using granular soils and placed as engineered fill, compacted to 95% of Standard Proctor Dry Density in lift thicknesses ranging from 8 inches to 12 inches. A typical perimeter section, taken from the Cell 3A Construction Documentation Report, prepared by Foth & Van Dyke in October, 2005 is shown below.

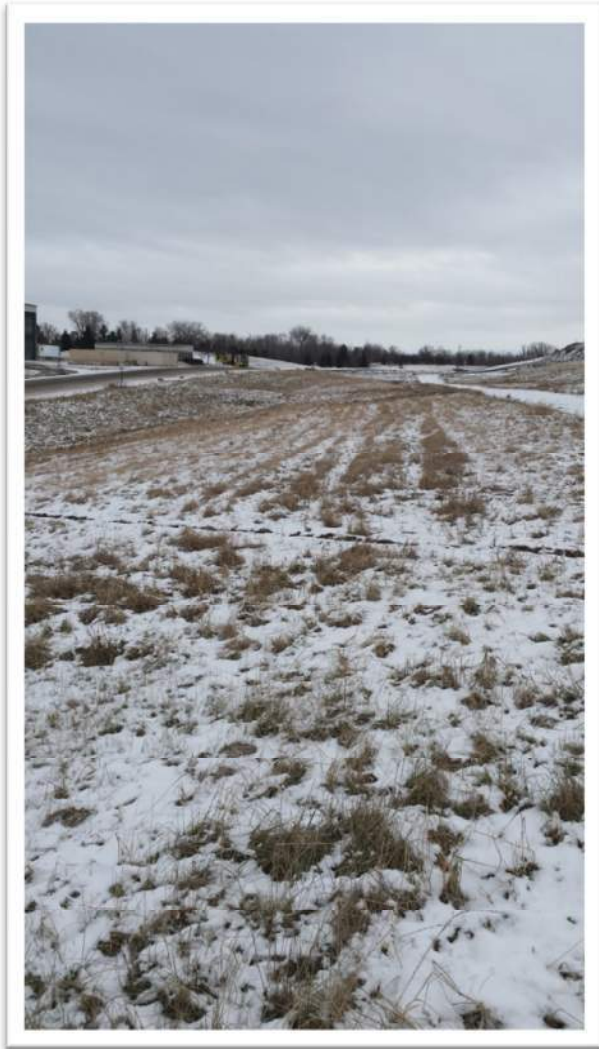
1. NW Outer Slope  
Bottom of Slope  
Facing NE

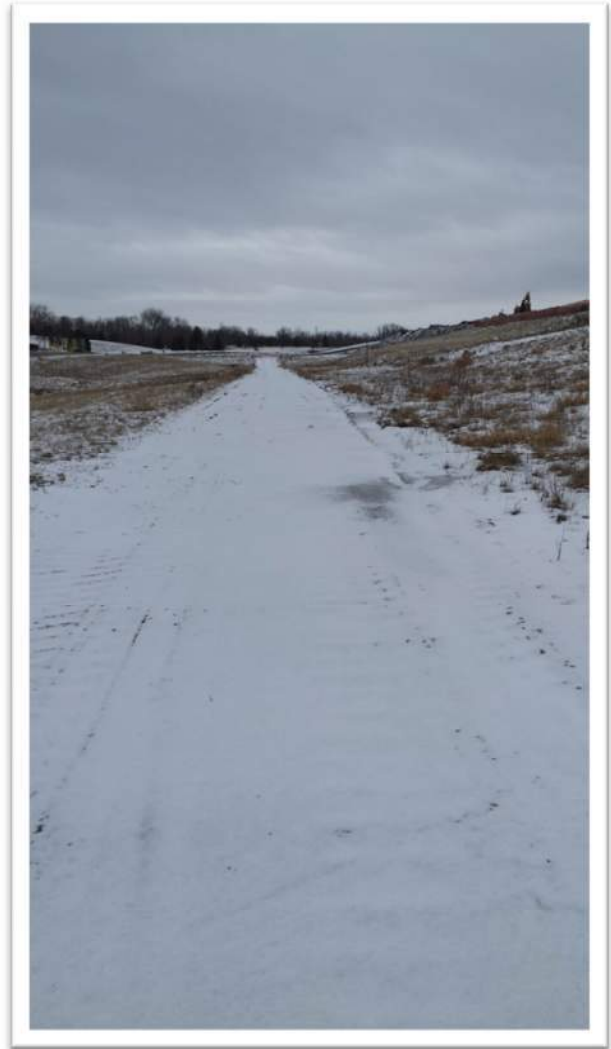
2. NW Outer Slope  
Middle of Slope  
Facing NE

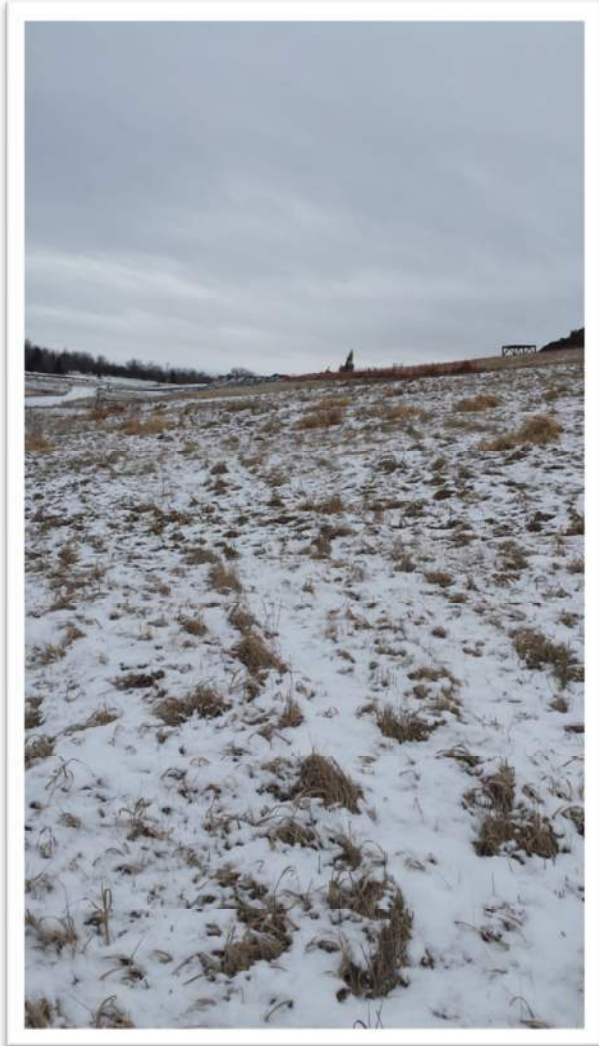
3. NW Outer Slope  
Top of Slope  
Facing NE

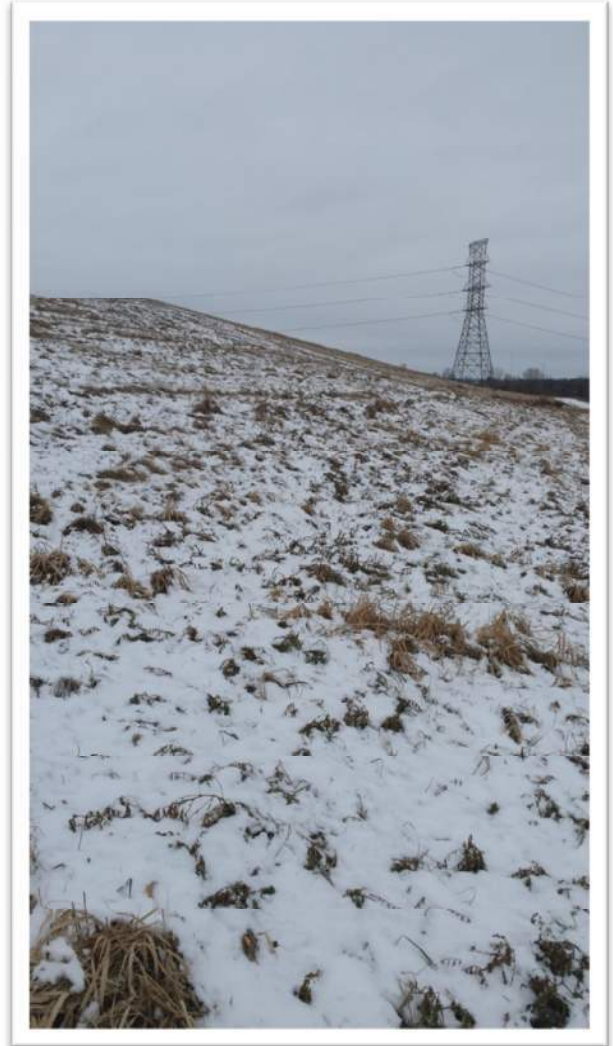
4. NW Outer Slope  
Top of Slope  
Facing SW

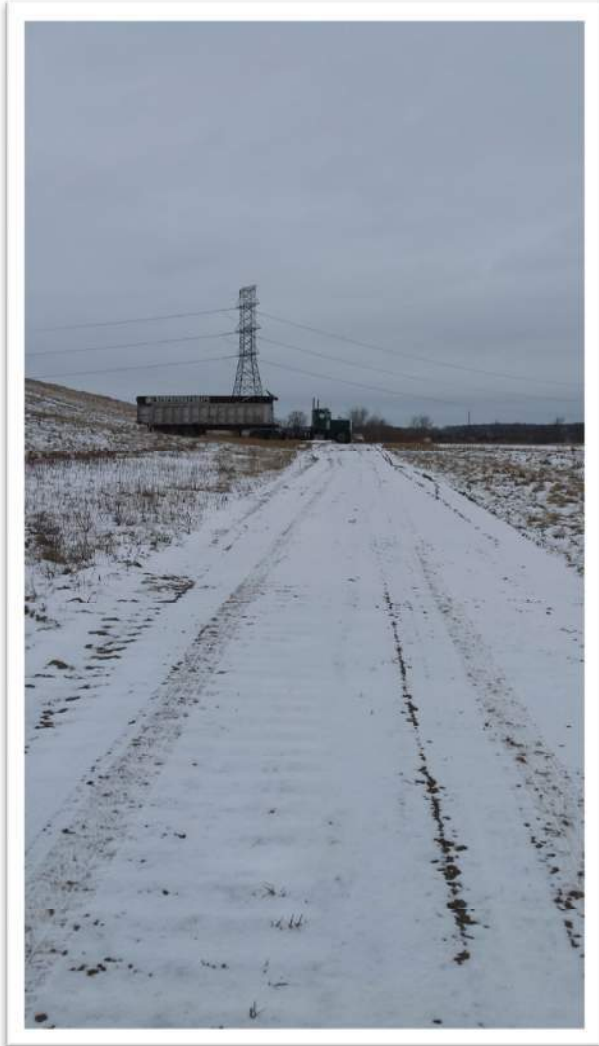
5. NW Outer Slope  
Middle of Slope  
Facing SW

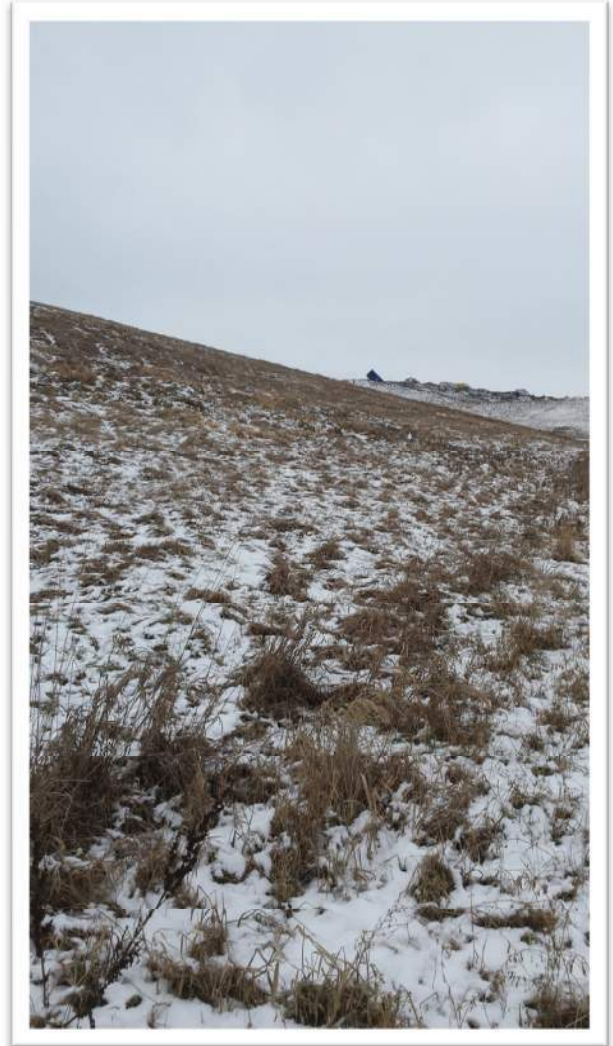
6. WSW Interior Slope  
Top of Slope  
Facing SE

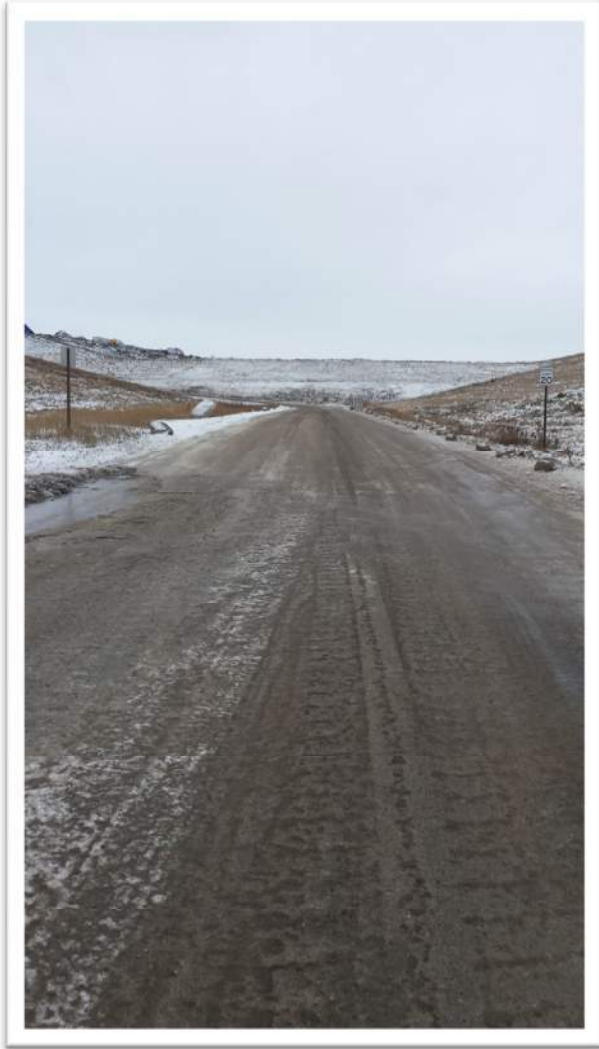
7. WSW Interior Slope  
Middle of Slope  
Facing SE

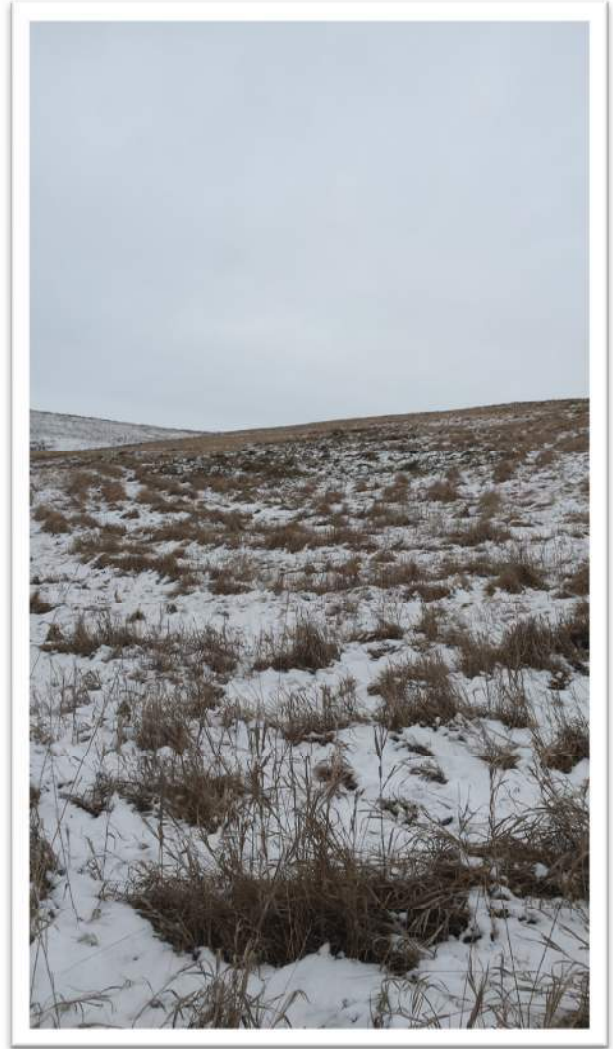
8. WSW Interior Slope  
Bottom of Slope  
Facing SE

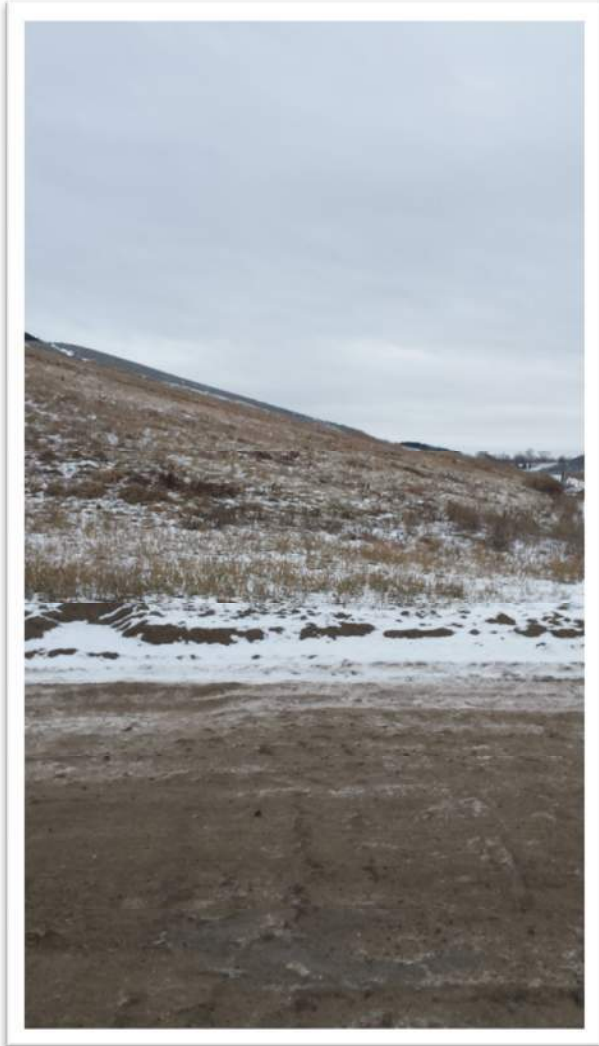
9. WSW Interior Slope  
Middle of Slope  
Facing NE

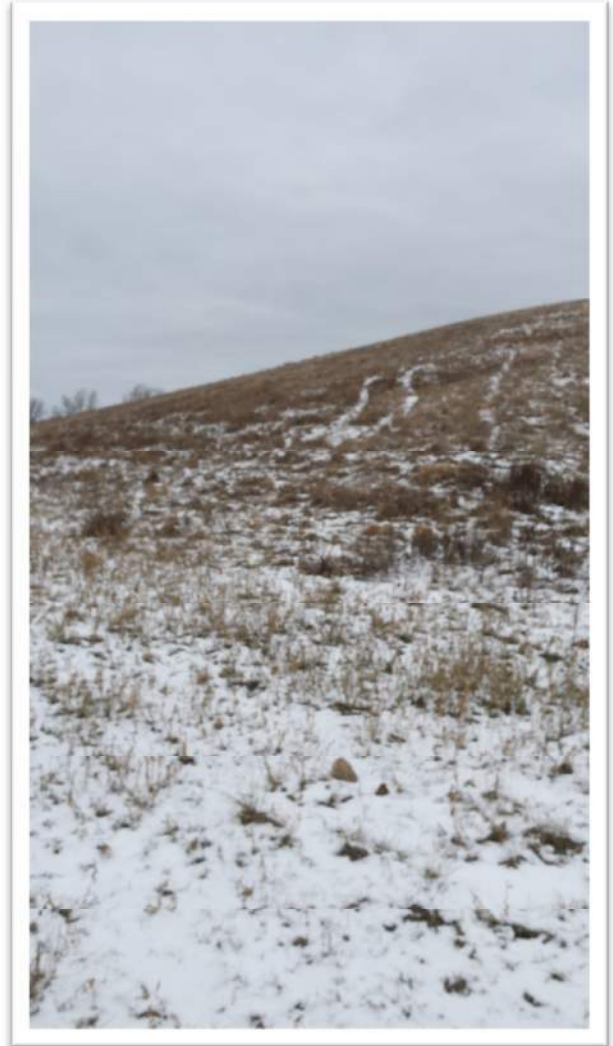
10. WSW Interior Slope  
Top of Slope  
Facing NW

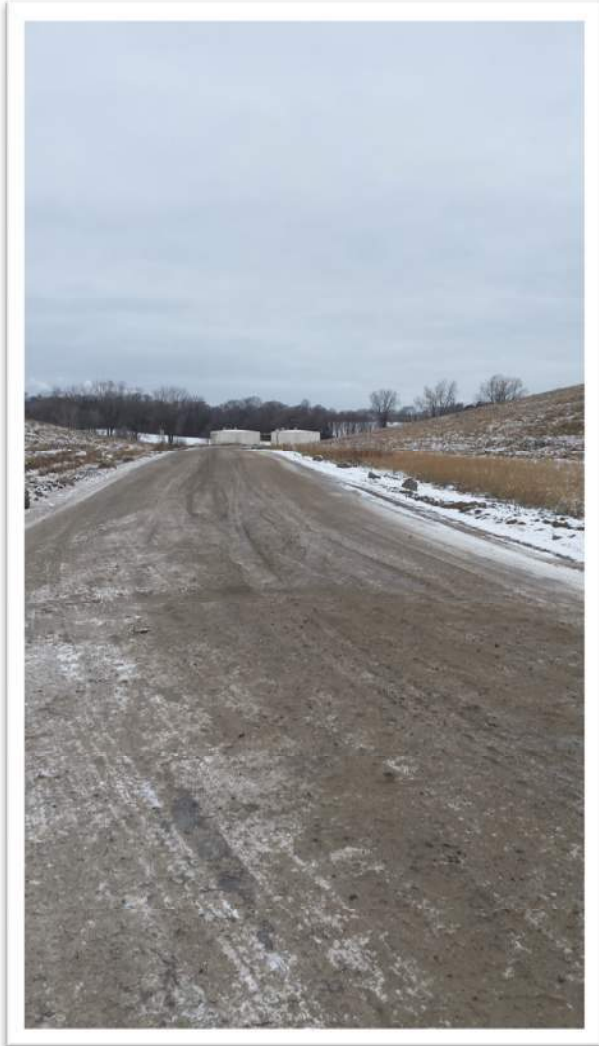
11. WSW Interior Slope  
Middle of Slope  
Facing NW

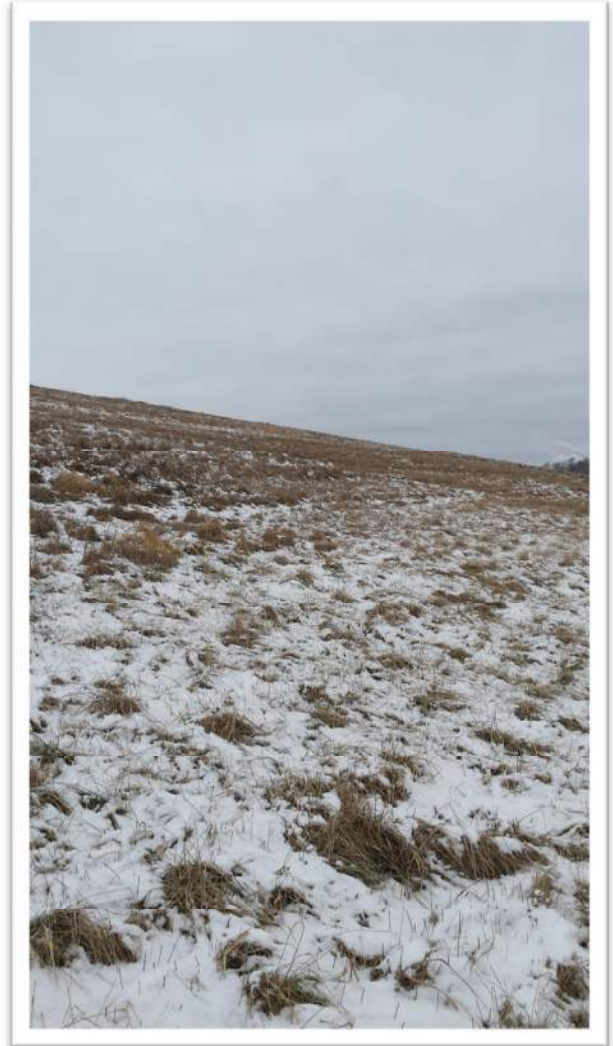
12. WSW Interior Slope  
Middle of Slope  
Facing W

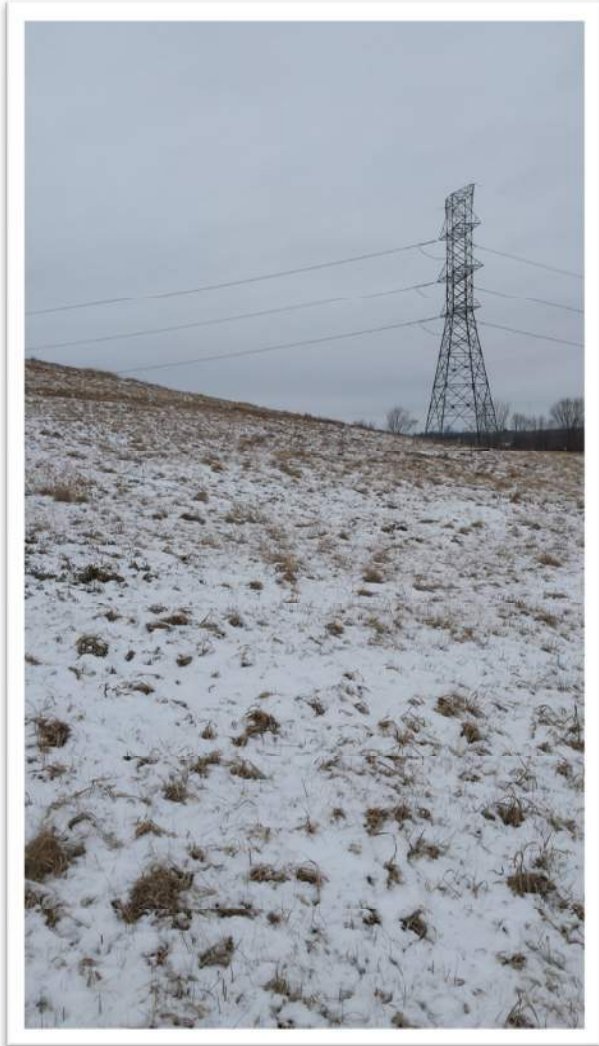
13. W Corner Outer Slope  
Top of Slope  
Facing SW

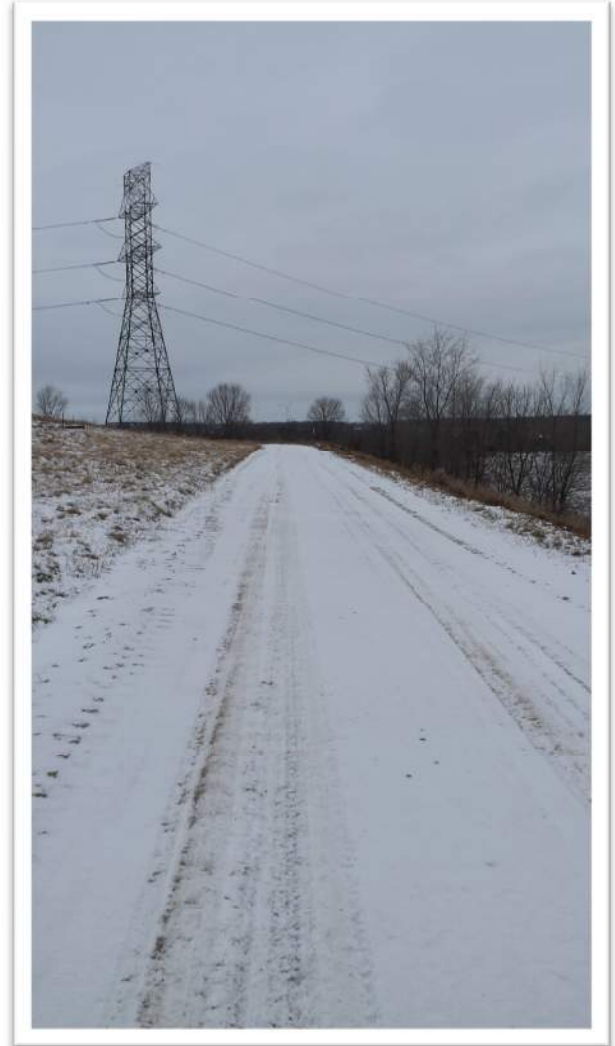
14. W Corner Outer Slope  
Middle of Slope  
Facing SW

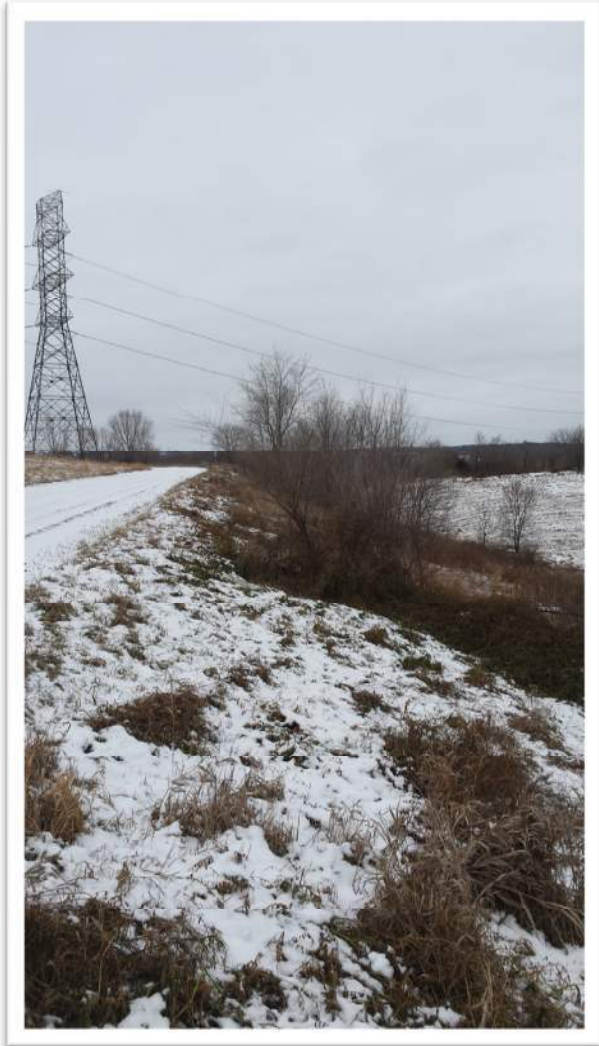
15. W Corner Outer Slope  
Bottom of Slope  
Facing SW

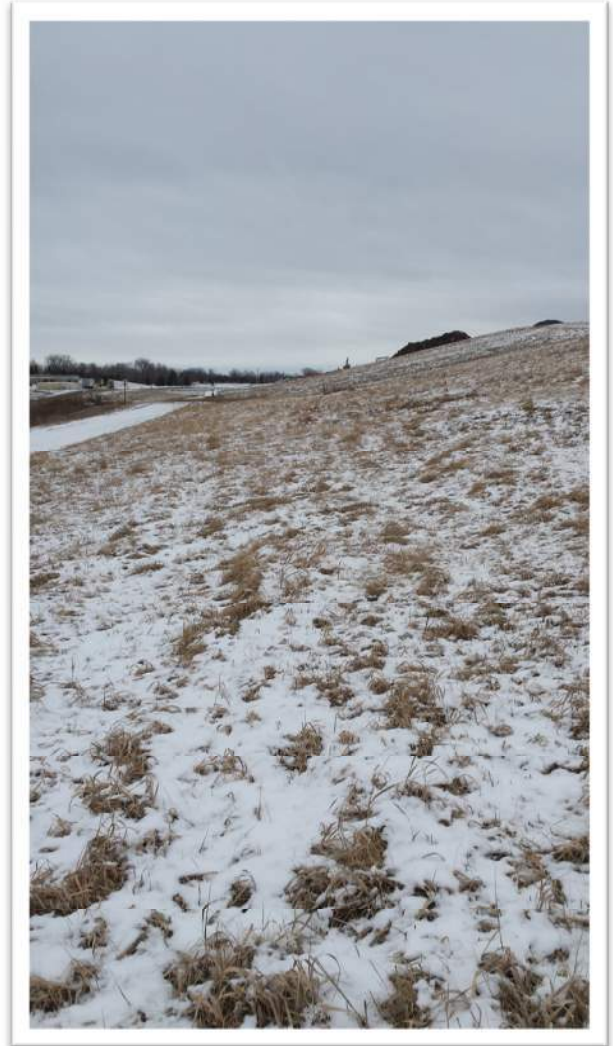
16. W Corner Outer Slope  
Top of Slope  
Facing NE

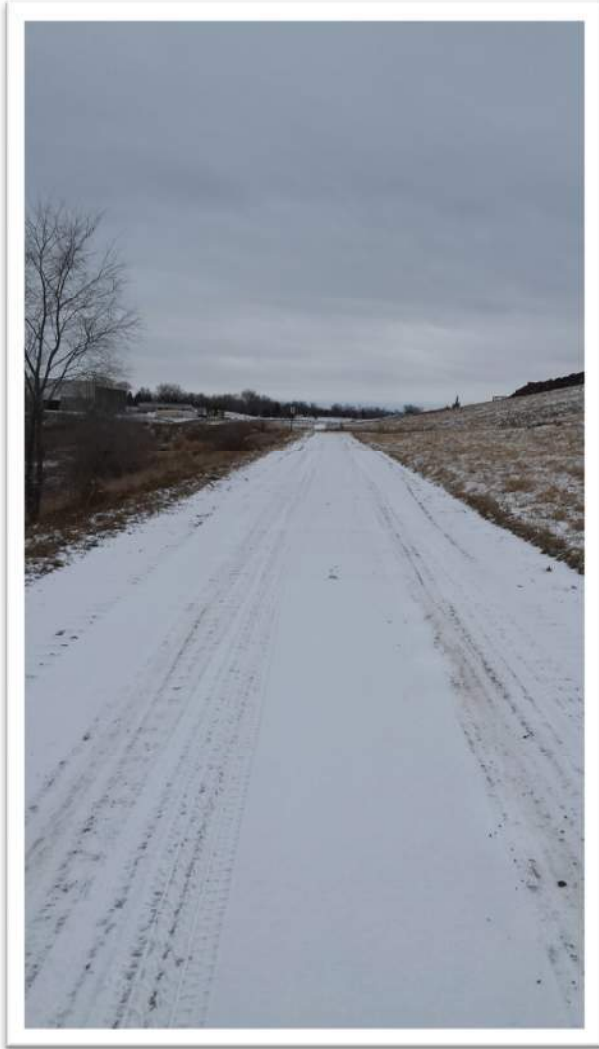
17. W Corner Outer Slope  
Middle of Slope  
Facing NE

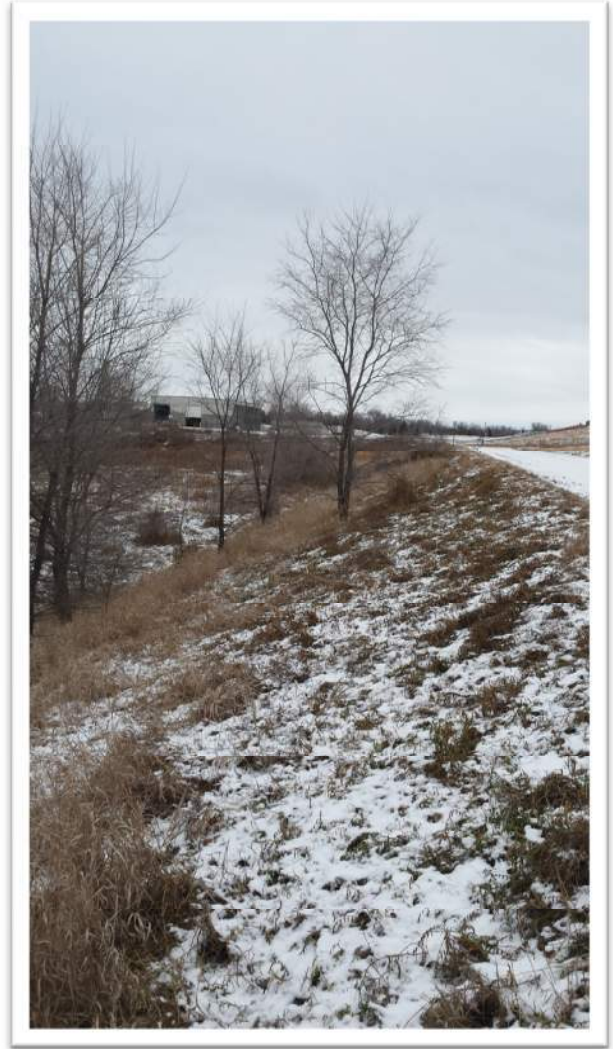
18. W Corner Outer Slope  
Bottom of Slope  
Facing NE

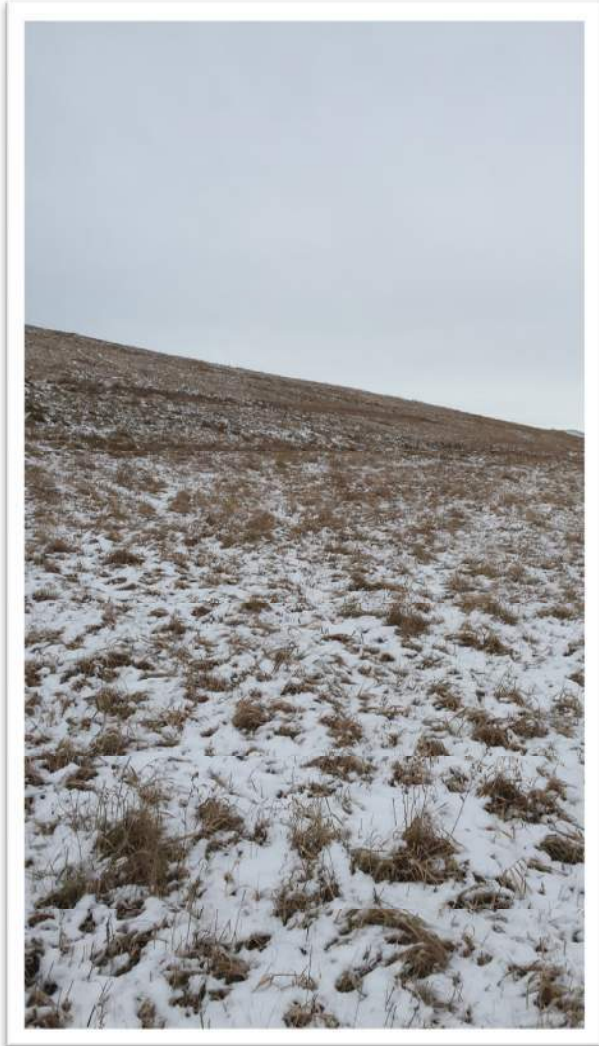
19. SW Outer Slope  
Top of Slope  
Facing SE

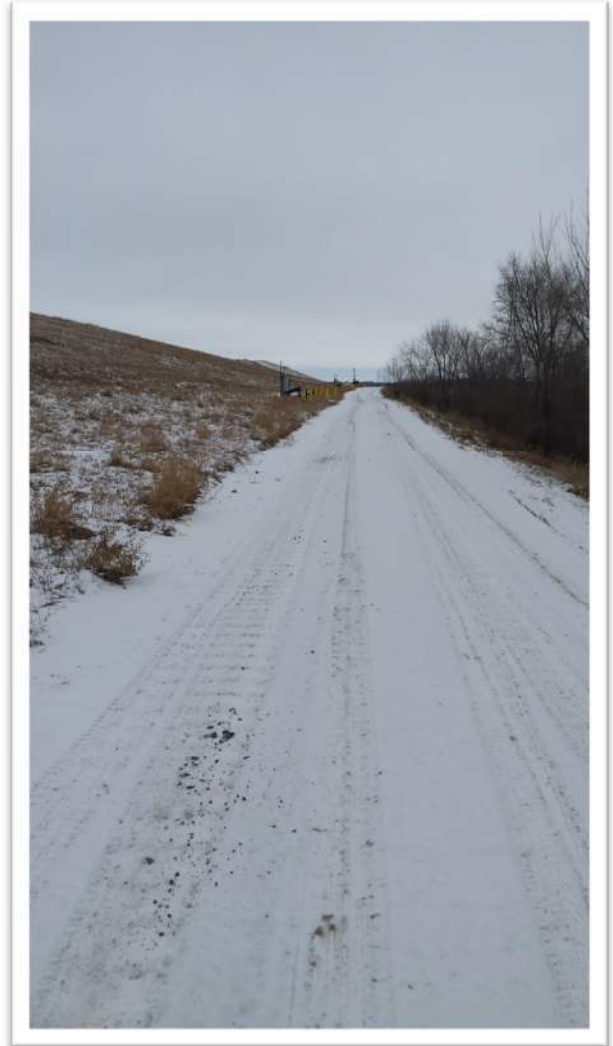
20. SW Outer Slope  
Middle of Slope  
Facing SE

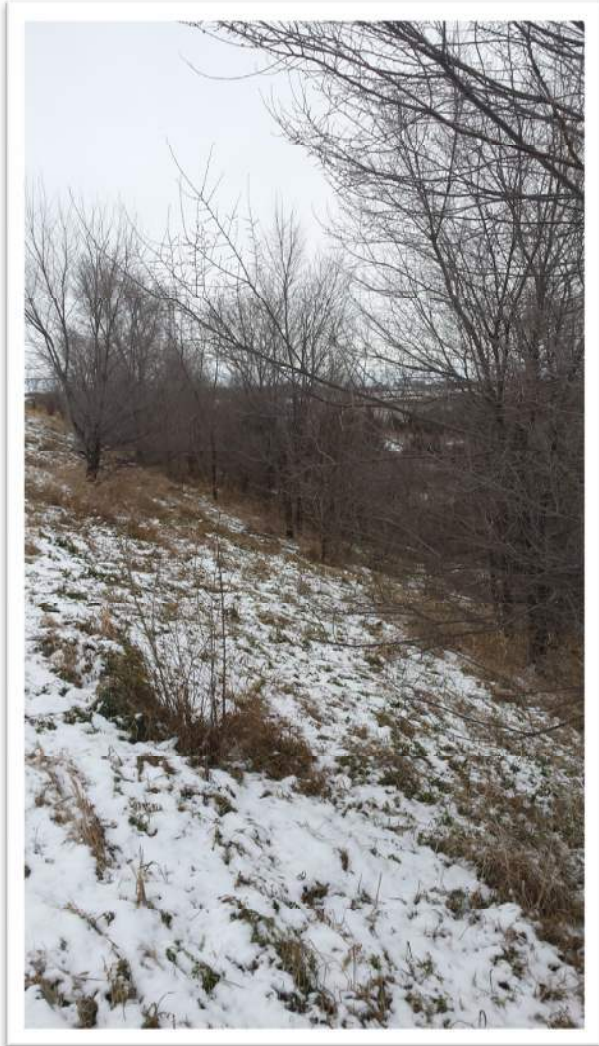
21. SW Outer Slope  
Bottom of Slope  
Facing SE

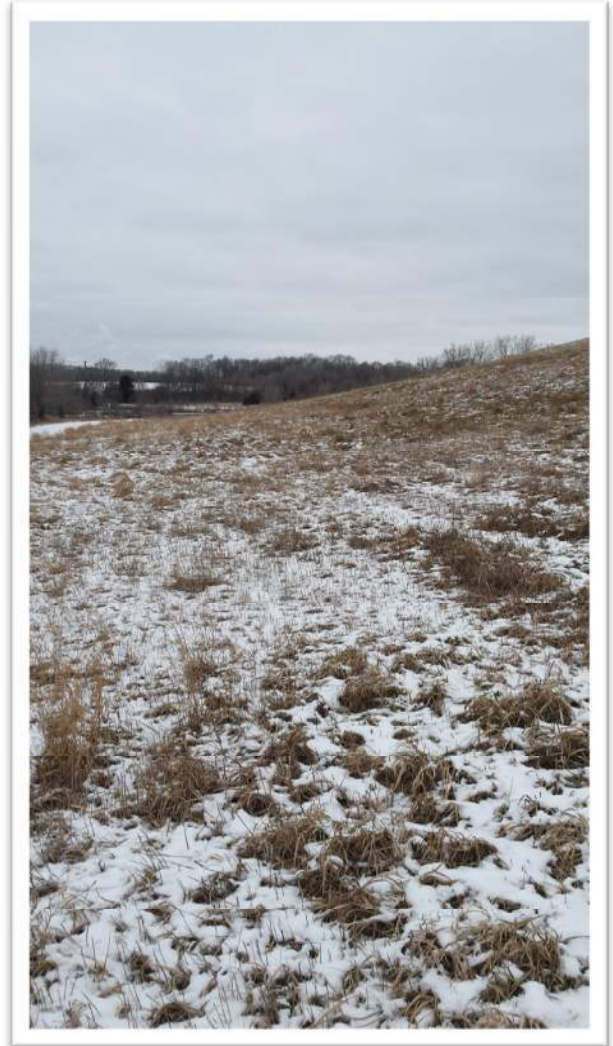
22. SW Outer Slope  
Top of Slope  
Facing NW

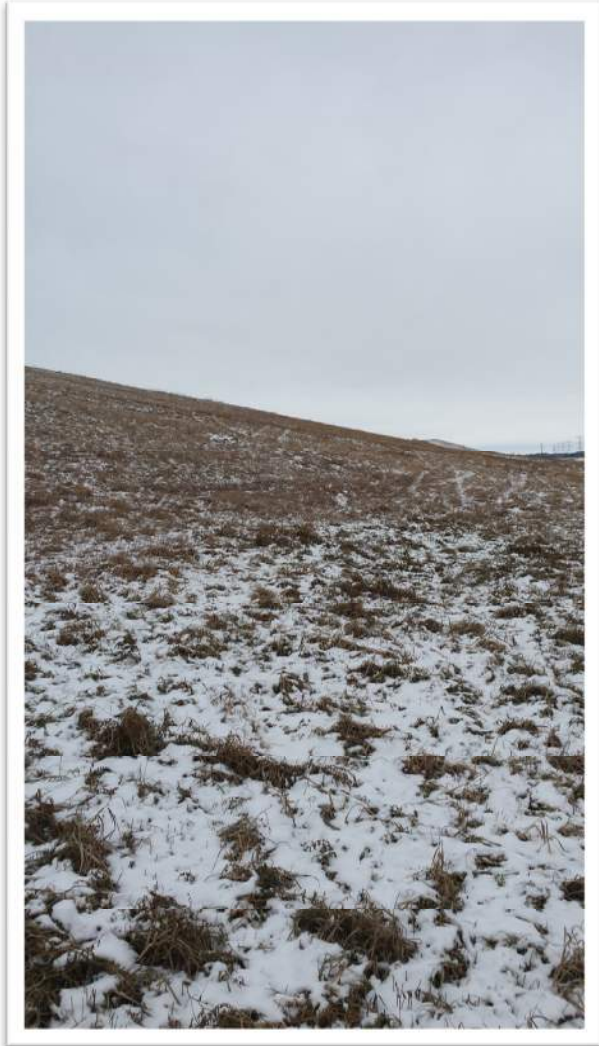
23. SW Outer Slope  
Top of Slope  
Facing SE

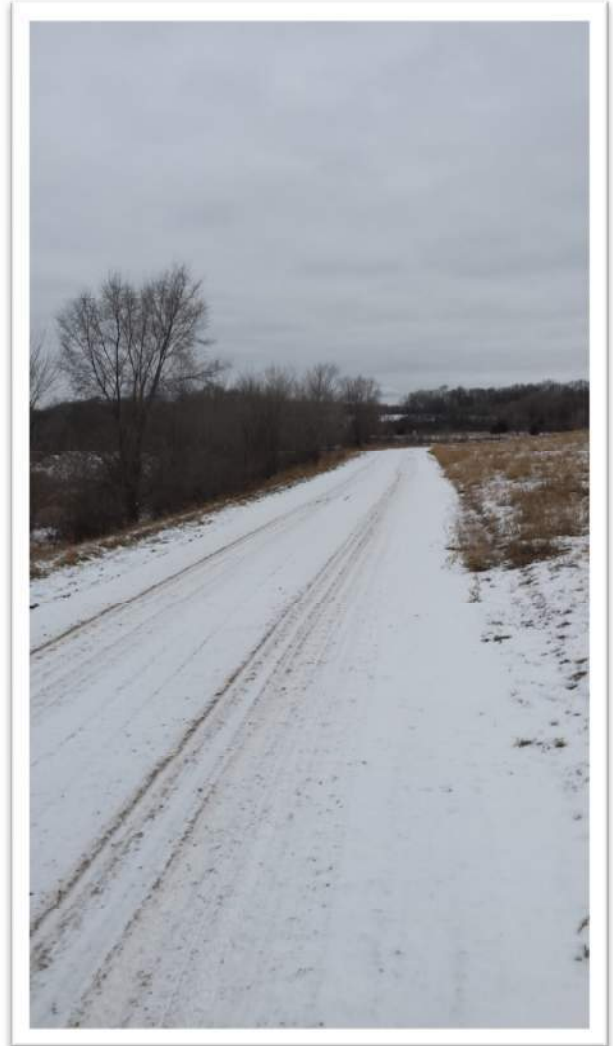
24. SW Outer Slope  
Middle of Slope  
Facing NW

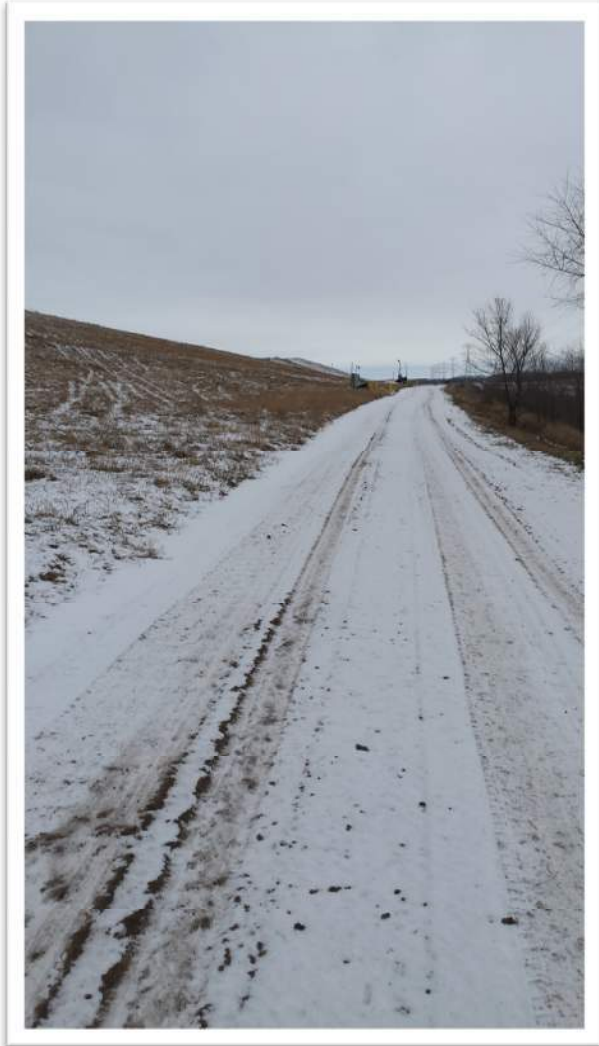
25. SW Outer Slope  
Middle of Slope  
Facing SE

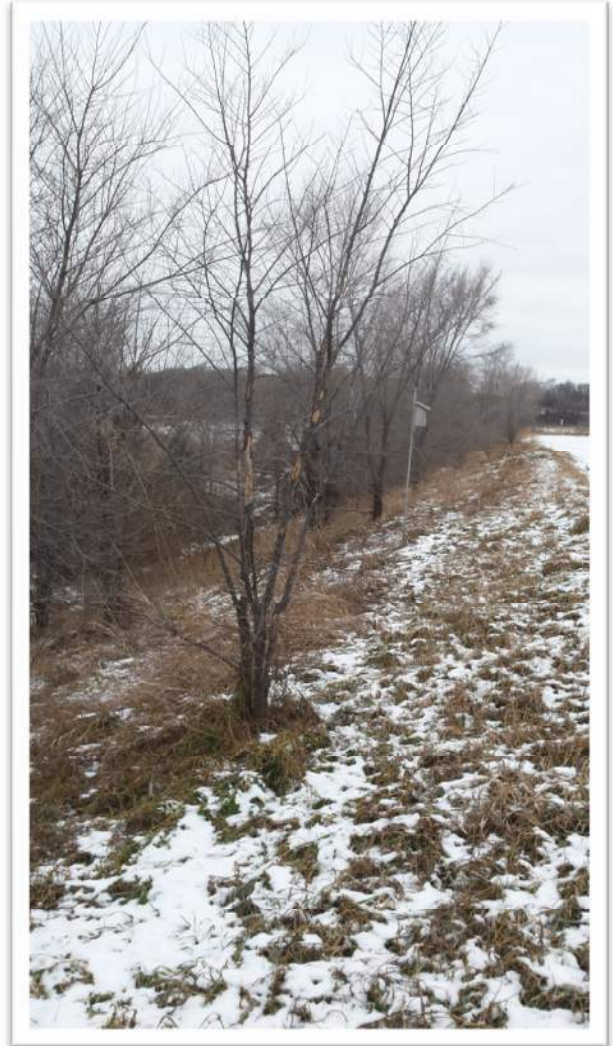
26. SW Outer Slope  
Bottom of Slope  
Facing NW

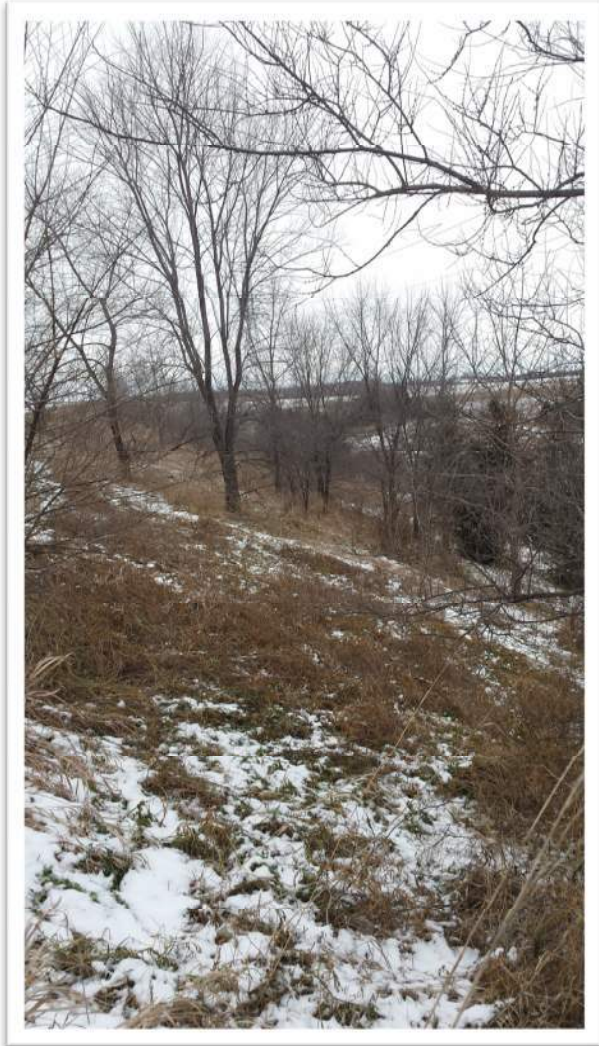
27. SW Outer Slope  
Bottom of Slope  
Facing SE

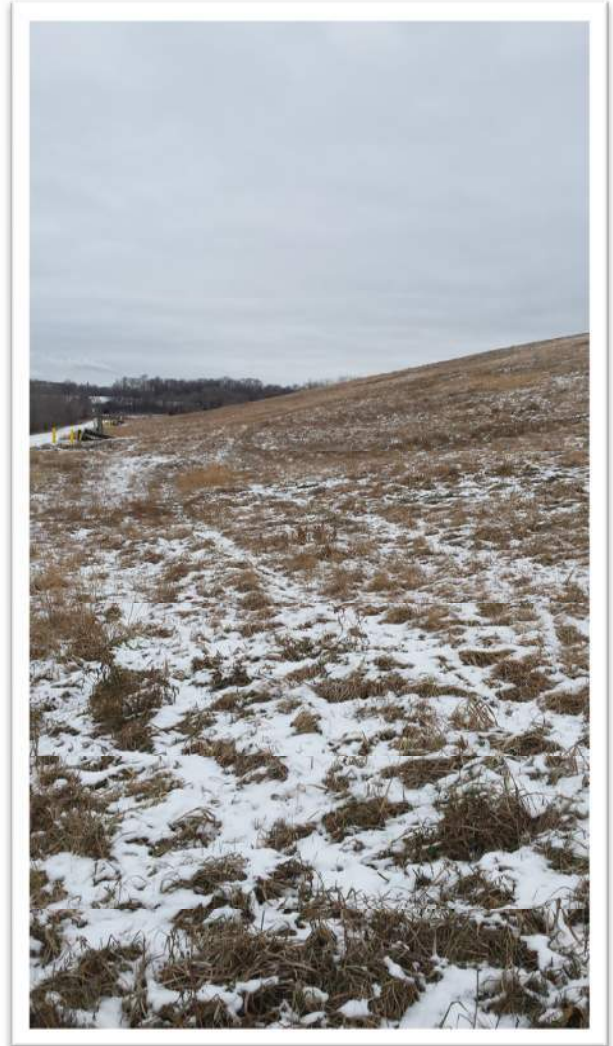
28. SW Outer Slope  
Top of Slope  
Facing NW

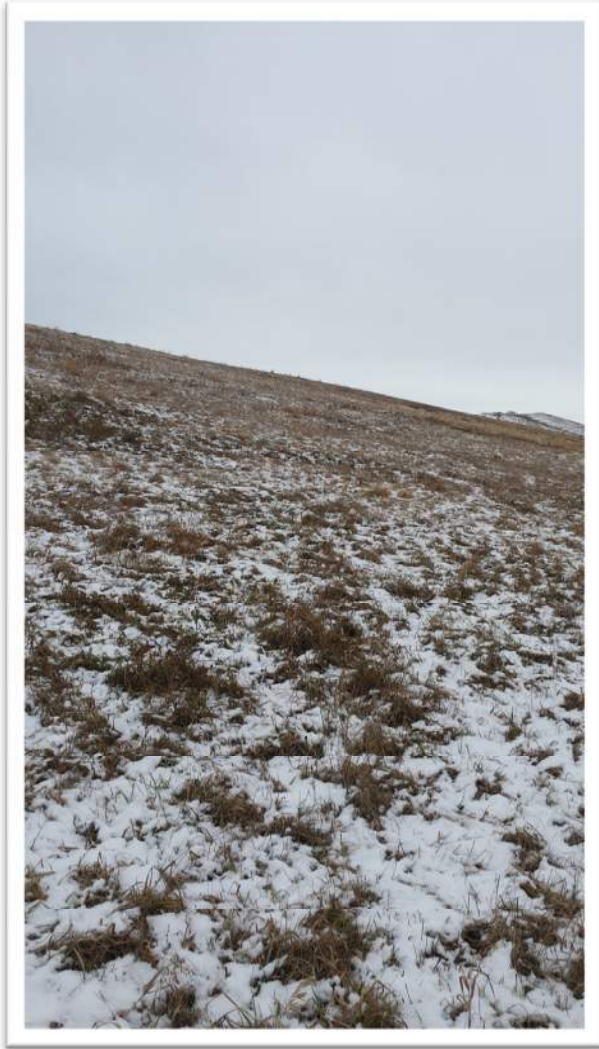
29. SW Outer Slope  
Top of Slope  
Facing SE

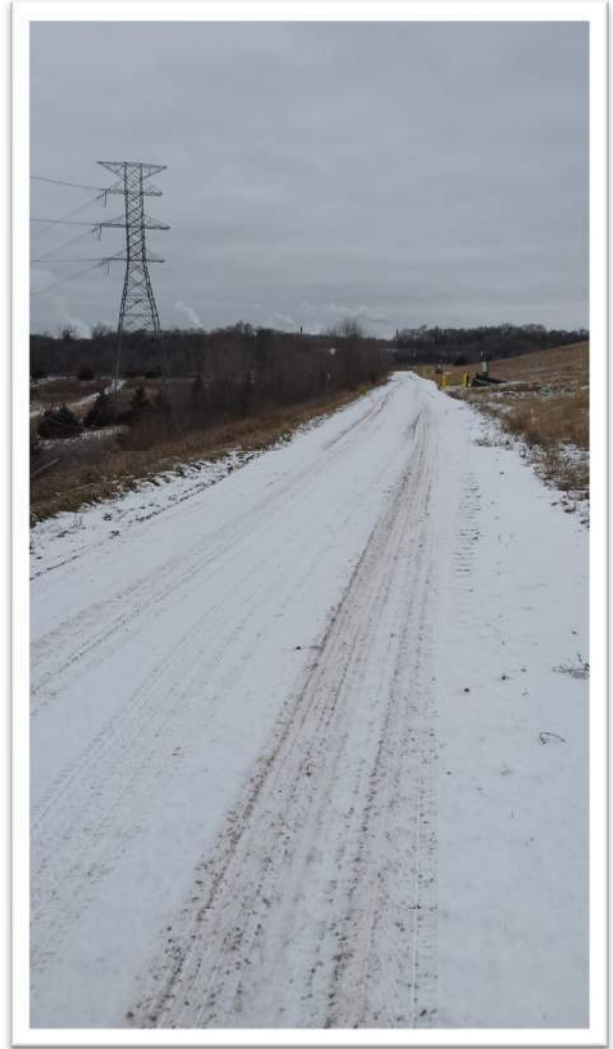
30. SW Outer Slope  
Middle of Slope  
Facing NW

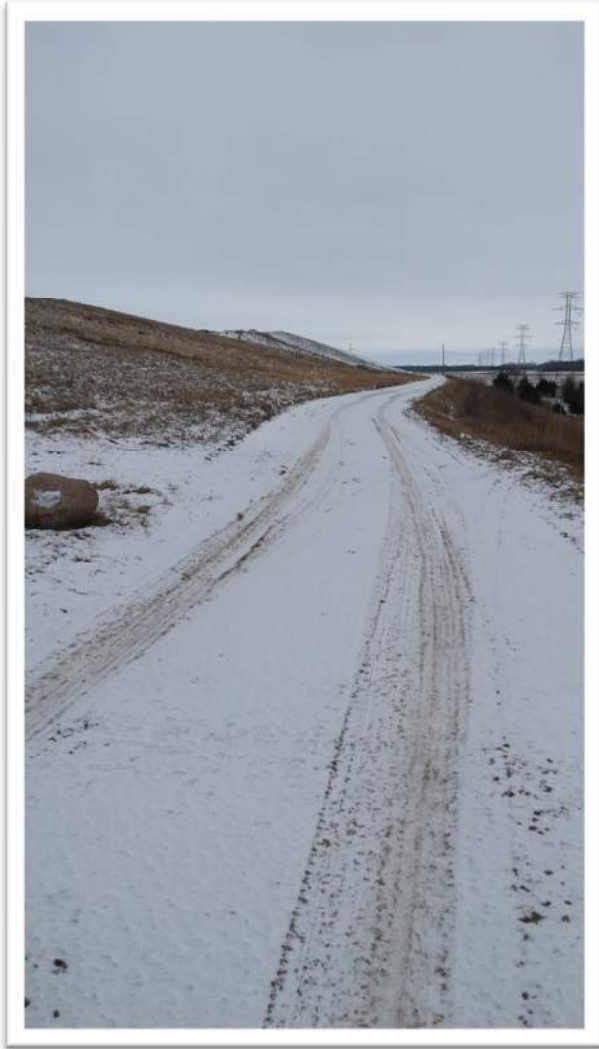
31. SW Outer Slope  
Middle of Slope  
Facing SE

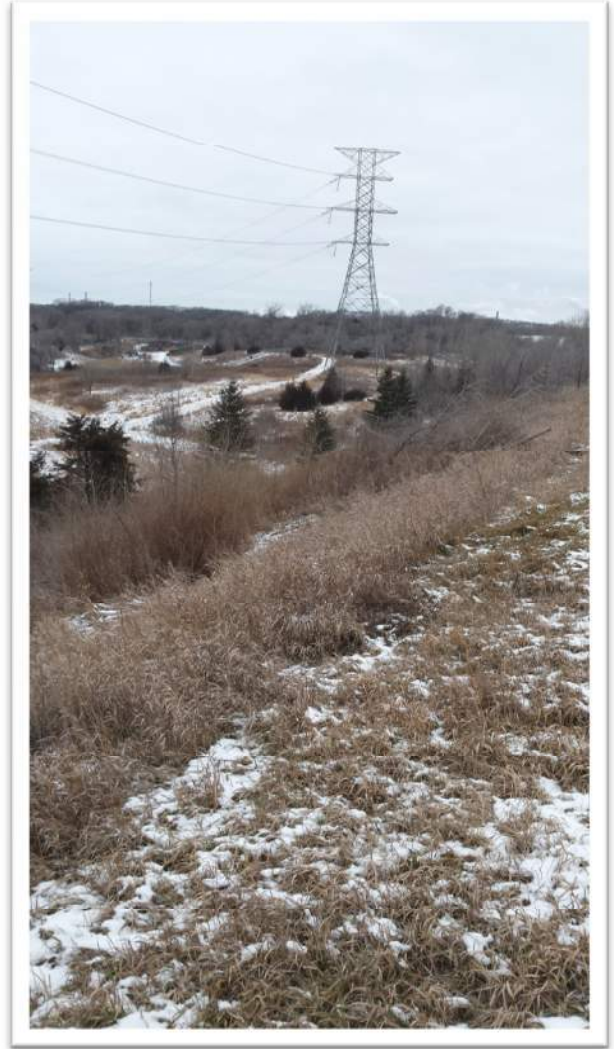
32. SW Outer Slope  
Bottom of Slope  
Facing NW

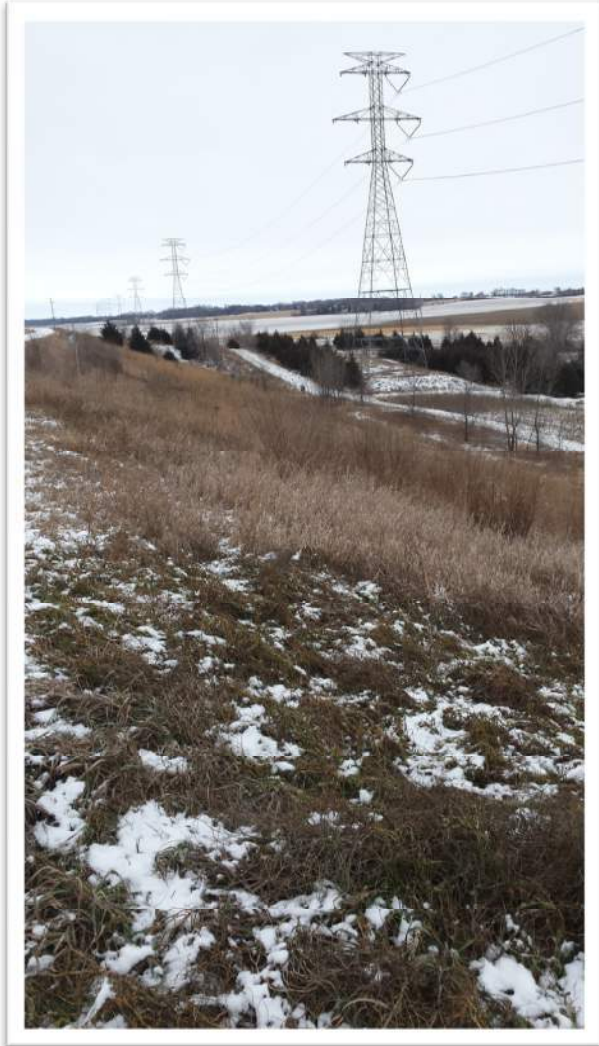
33. SW Outer Slope  
Bottom of Slope  
Facing SE

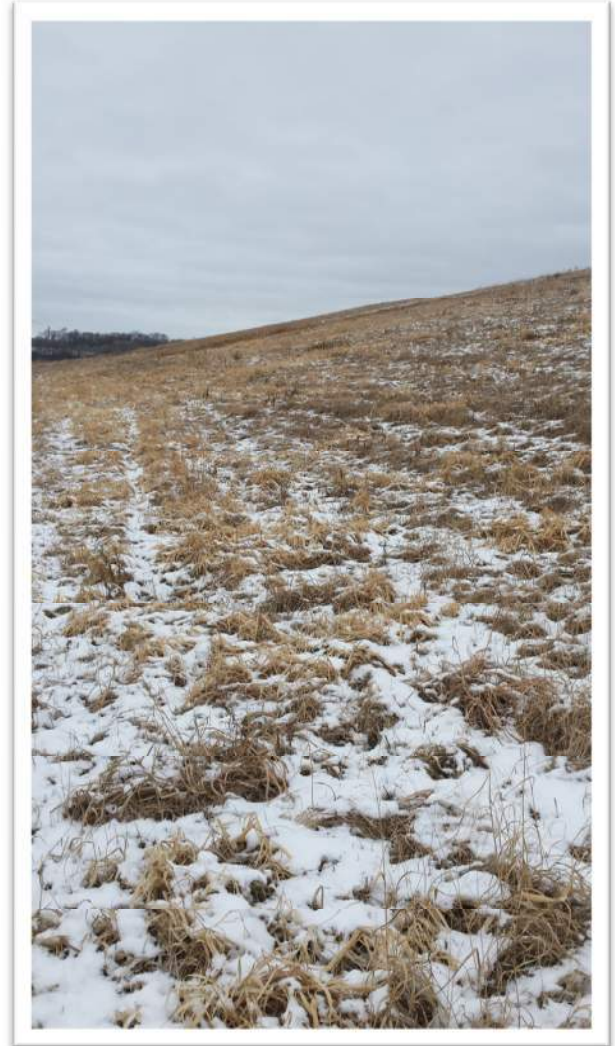
34. SW Outer Slope  
Top of Slope  
Facing NW

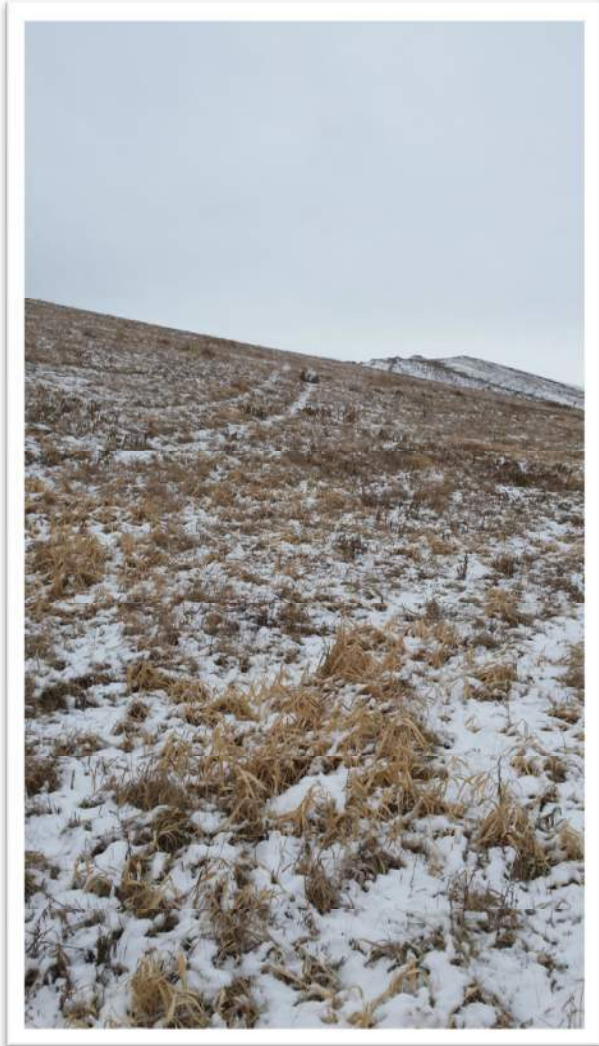
35. SW Outer Slope  
Top of Slope  
Facing SE
