# Technical Memo

**To:** Geoff Strack, SKB Environmental, Inc.  
**From:** Dave Parenteau, PE (MN), Wenck Associates, Inc.  
**Date:** January 14, 2016  
**Subject:** Annual Inspection SKB Rosemount Industrial Waste Facility - Report of CCR Landfill Inspection  
Wenck Project # B3053-0032

**Photos of Coal Ash Inspection  
SKB Industrial Waste Facility, Rosemount, MN  
December 28, 2015**

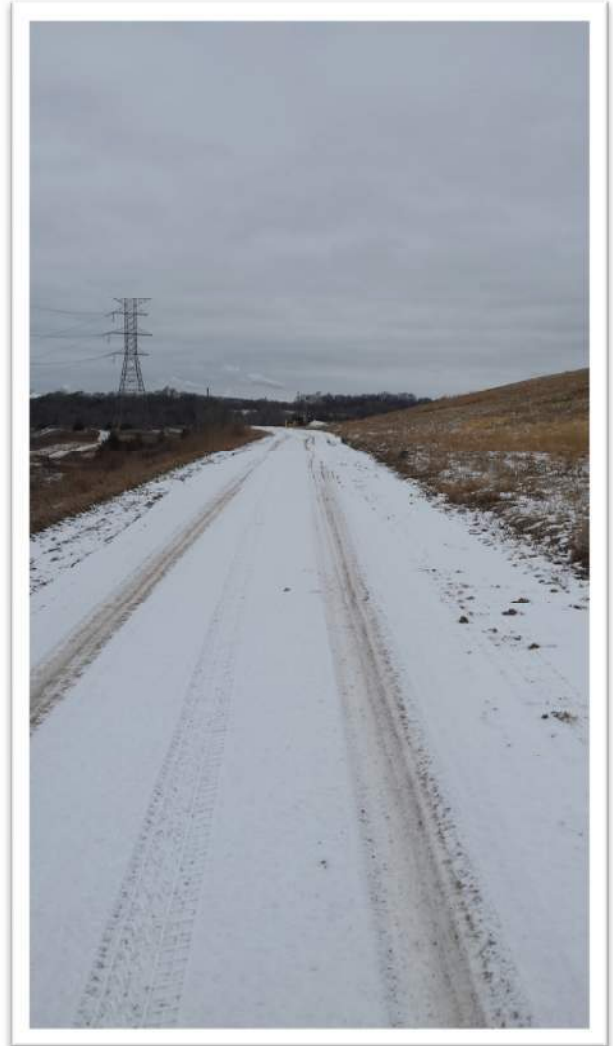
36. SW Outer Slope  
Middle of Slope  
Facing NW

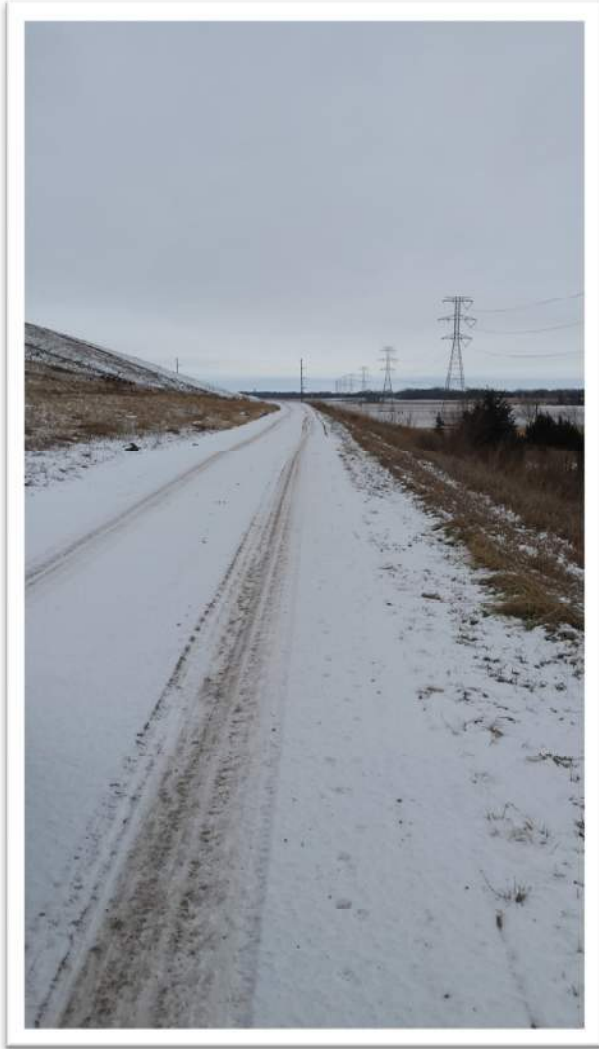
37. SW Outer Slope  
Middle of Slope  
Facing SE

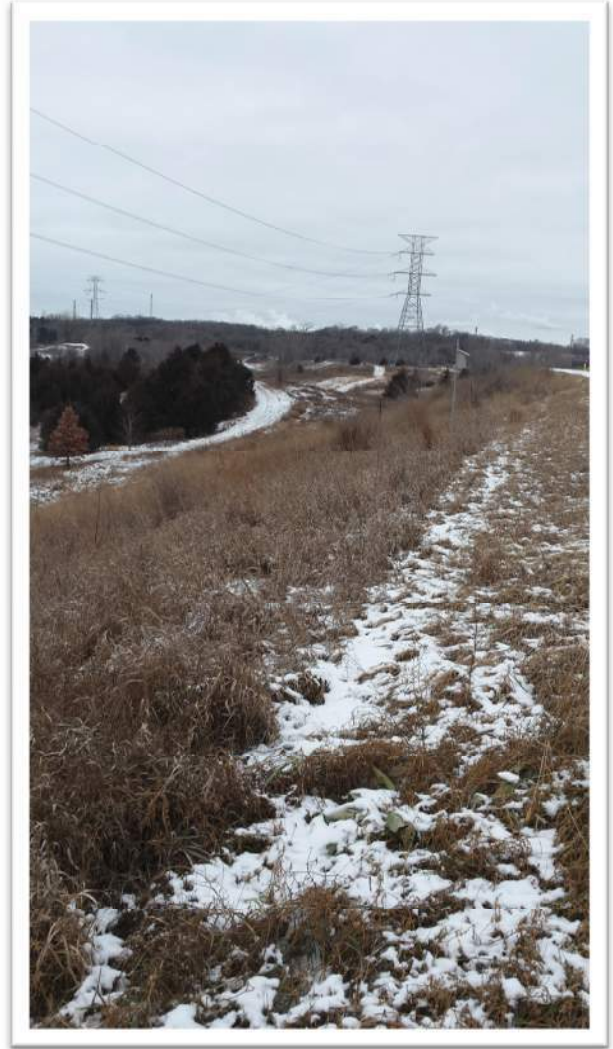
38. SW Outer Slope  
Bottom of Slope  
Facing NW

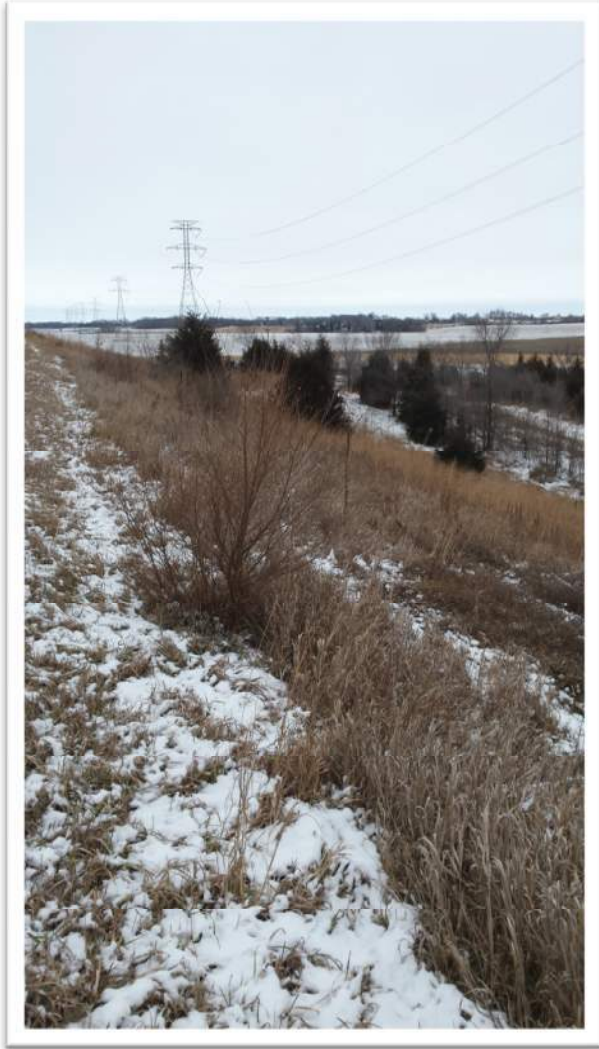
39. SW Outer Slope  
Bottom of Slope  
Facing SE

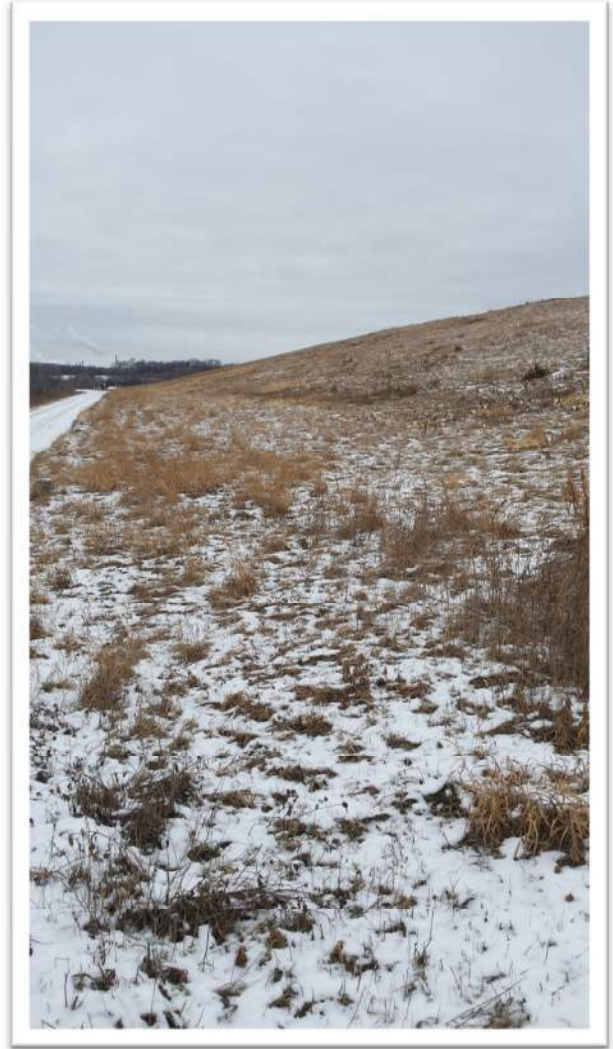
40. S Corner Outer Slope  
Top of Slope  
Facing NW

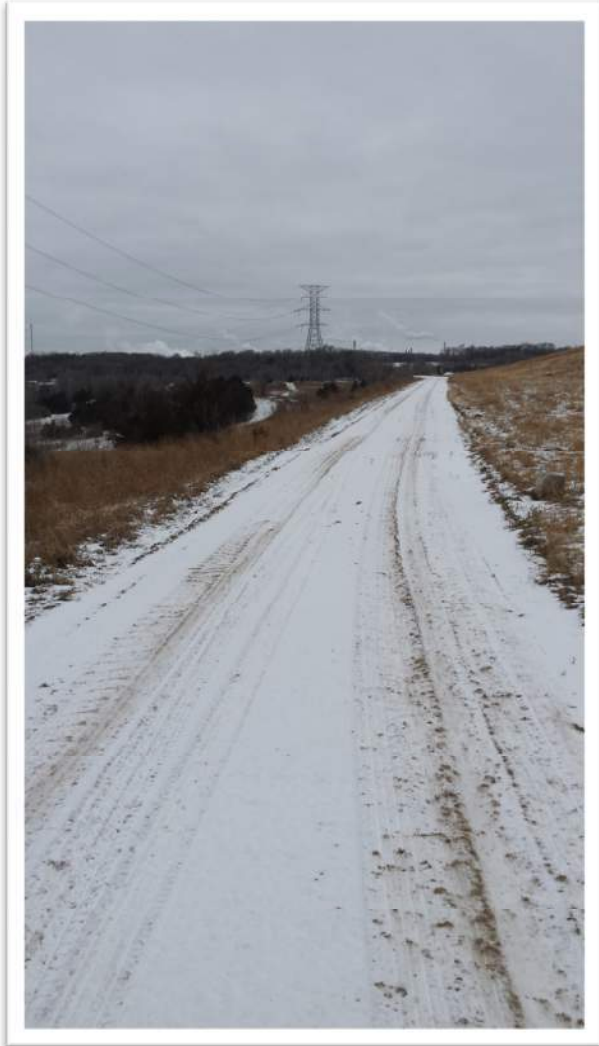
41. S Corner Outer Slope  
Middle of Slope  
Facing NW

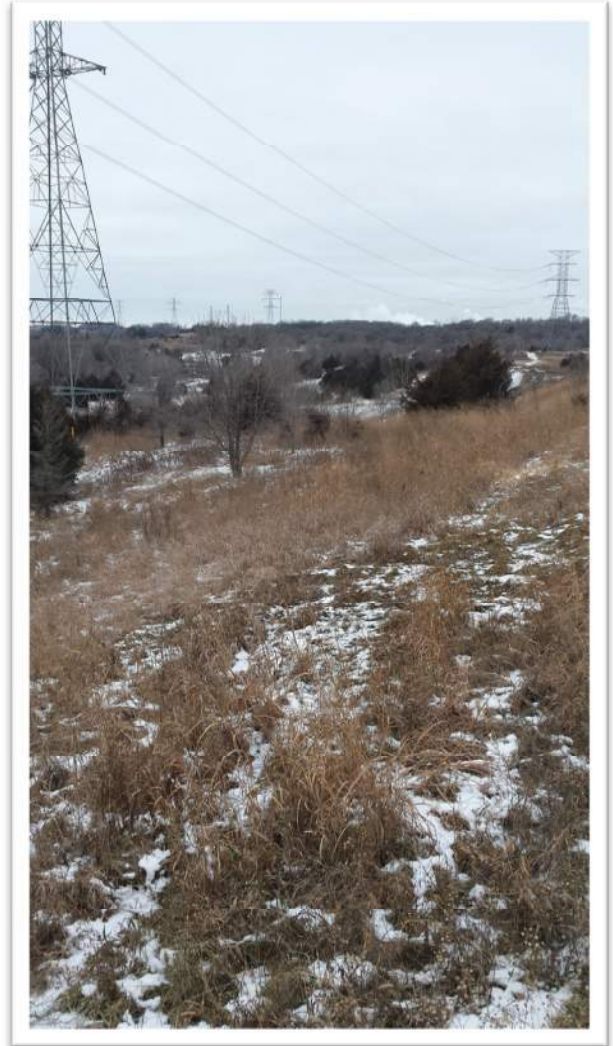
42. S Corner Outer Slope  
Bottom of Slope  
Facing NW

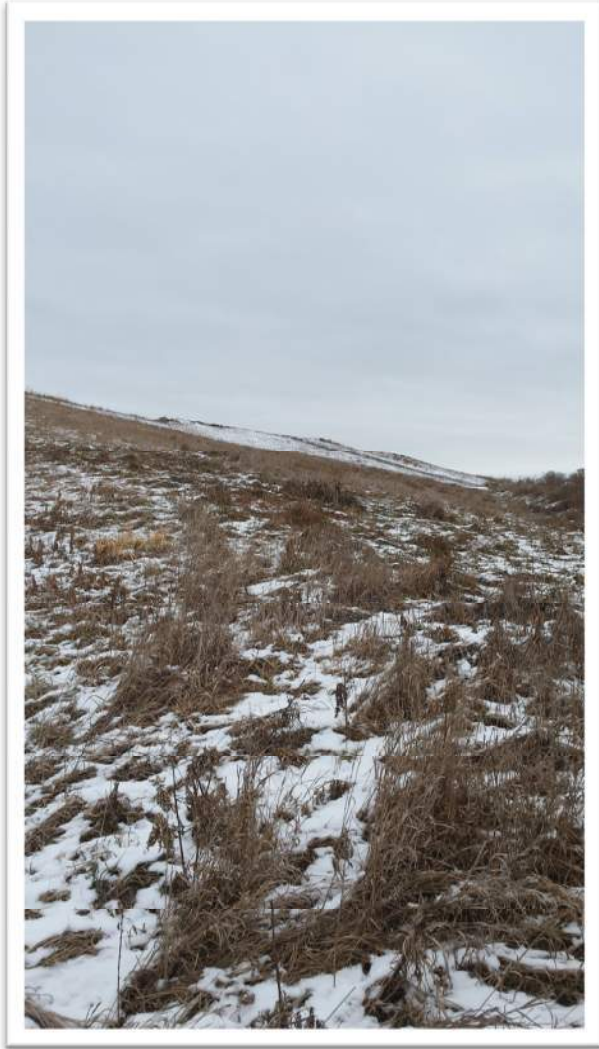
43. S Corner Outer Slope  
Top of Slope  
Facing NE

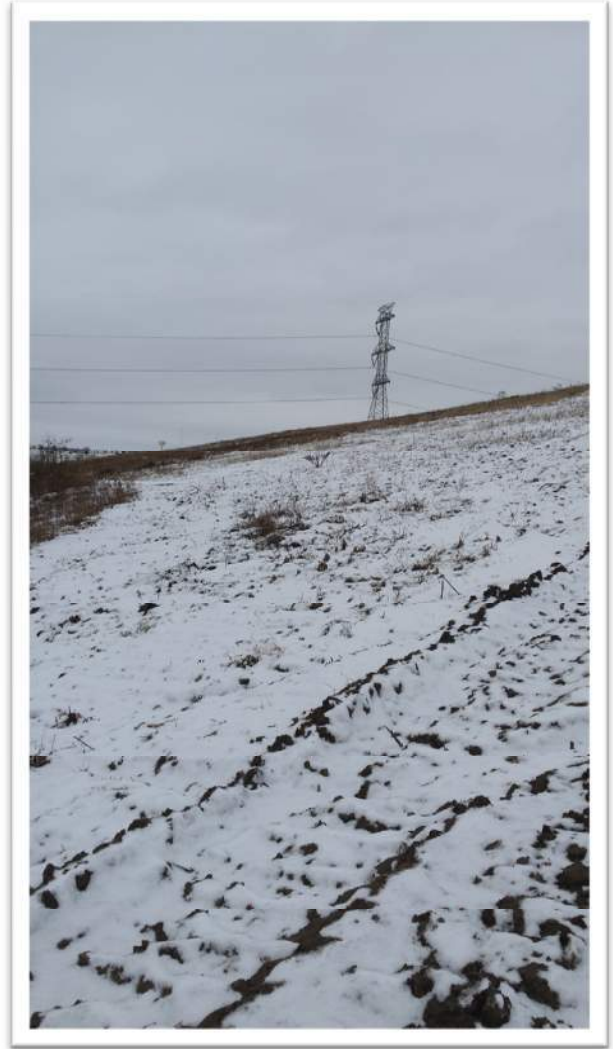
44. SE Outer Slope  
Top of Slope  
Facing SW

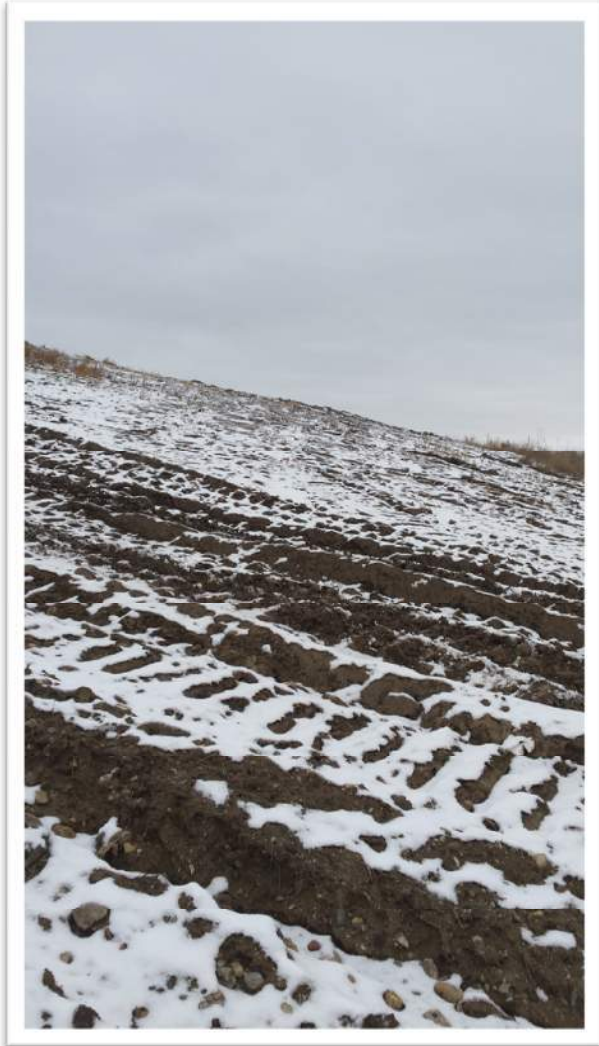
45. SE Outer Slope  
Top of Slope  
Facing NE

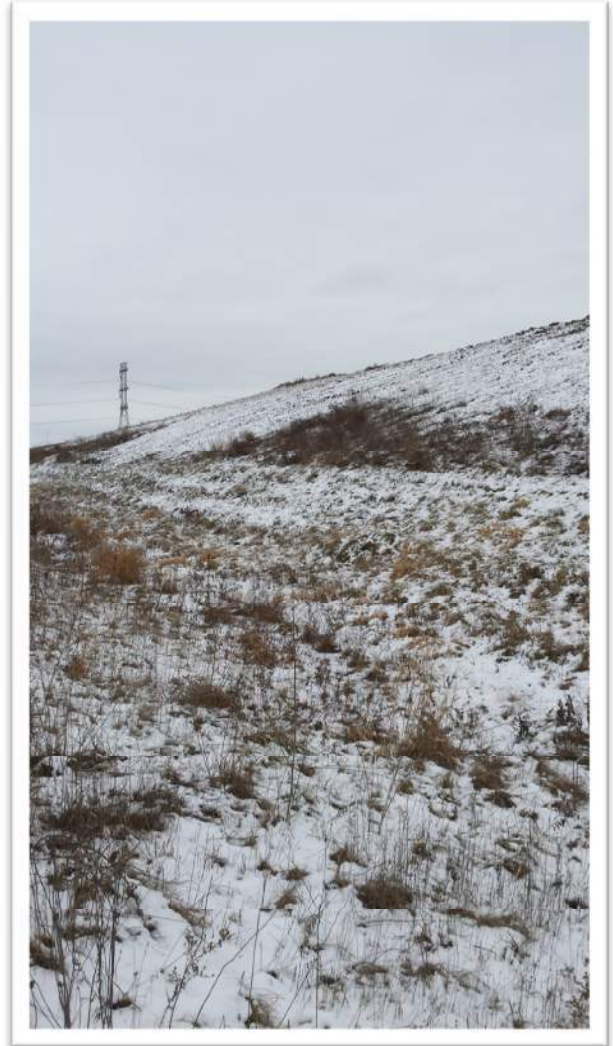
46. SE Outer Slope  
Top of Slope  
Facing SW

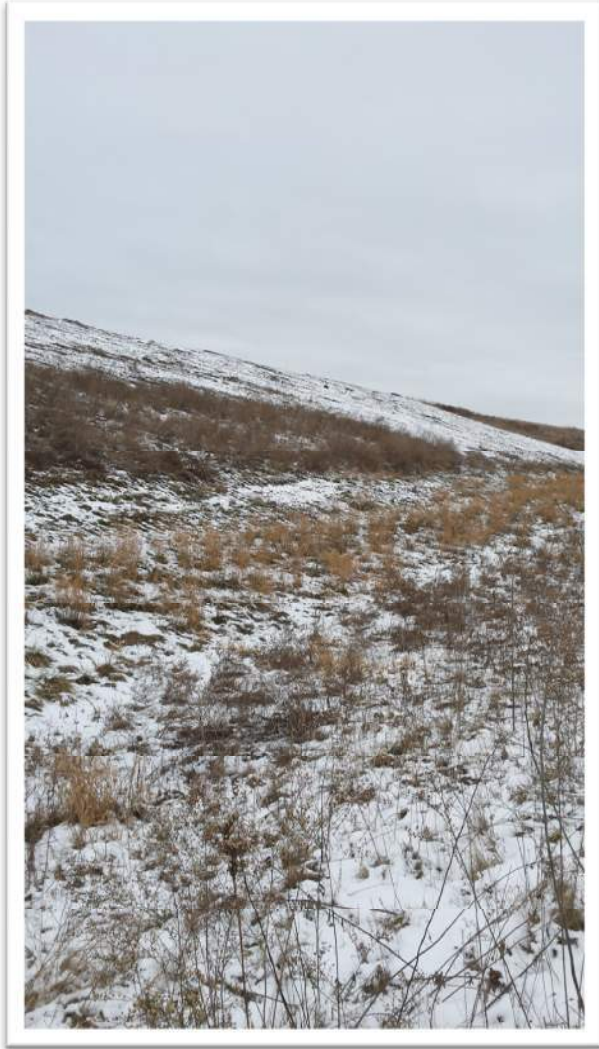
47. SE Outer Slope  
Top of Slope  
Facing NE

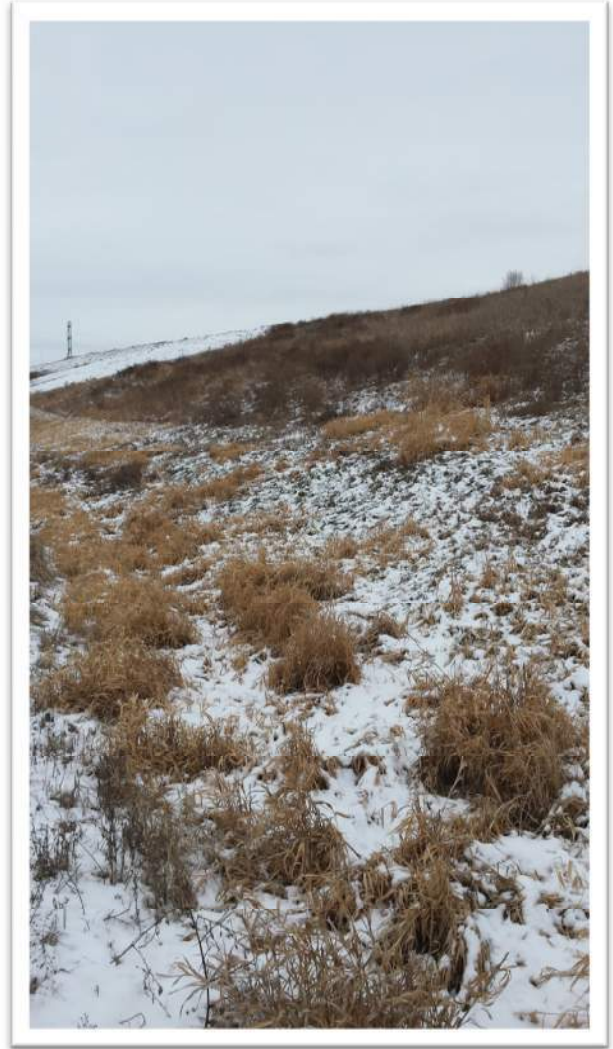
48. E Corner Outer Slope  
Top of Slope  
Facing SW

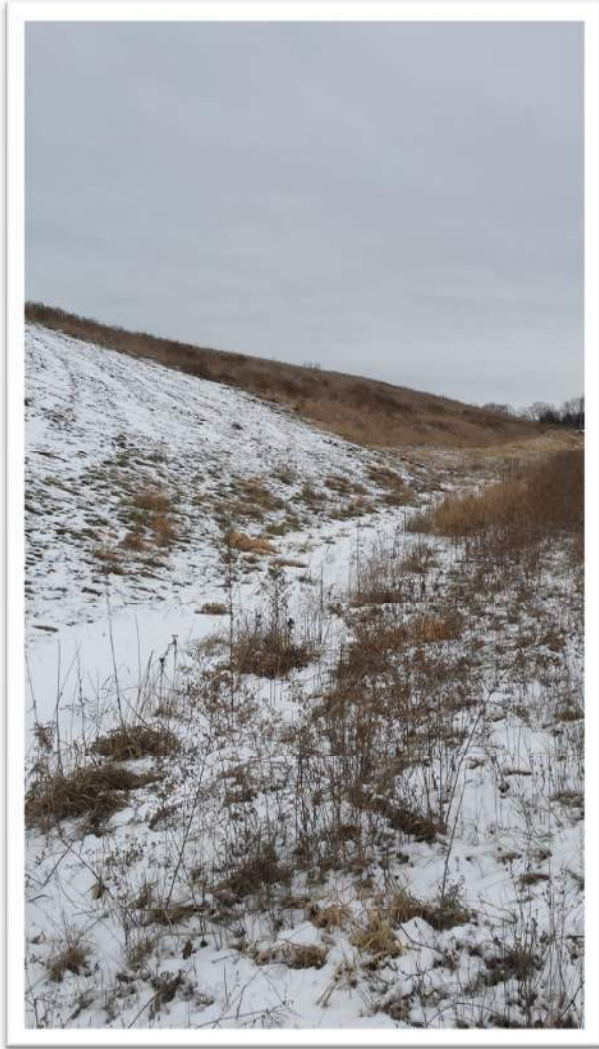
49. SE Outer Slope  
Top of Slope  
Facing NE

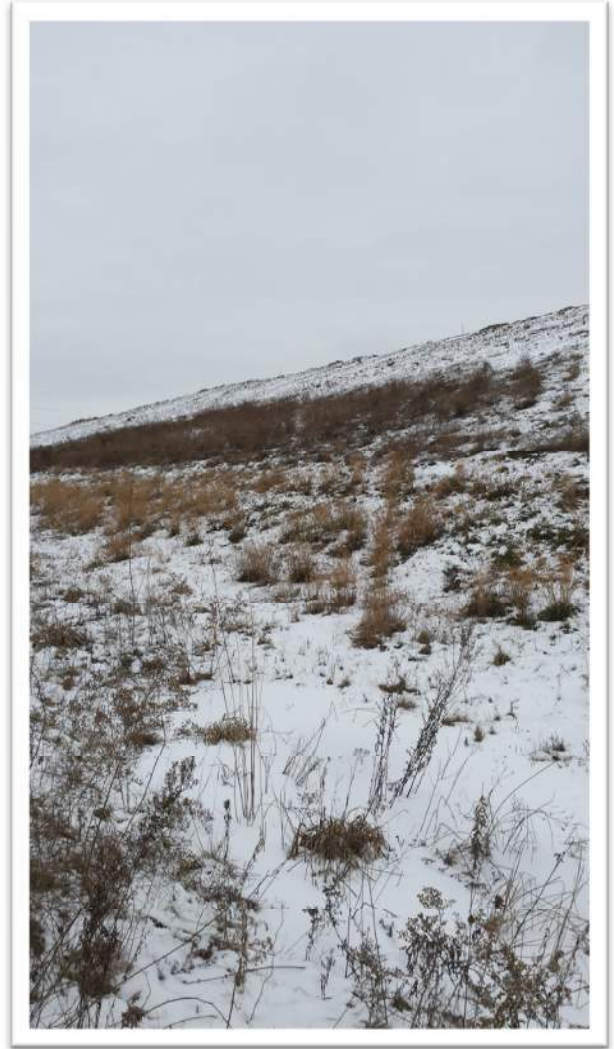
50. SE Outer Slope  
Top of Slope  
Facing SW

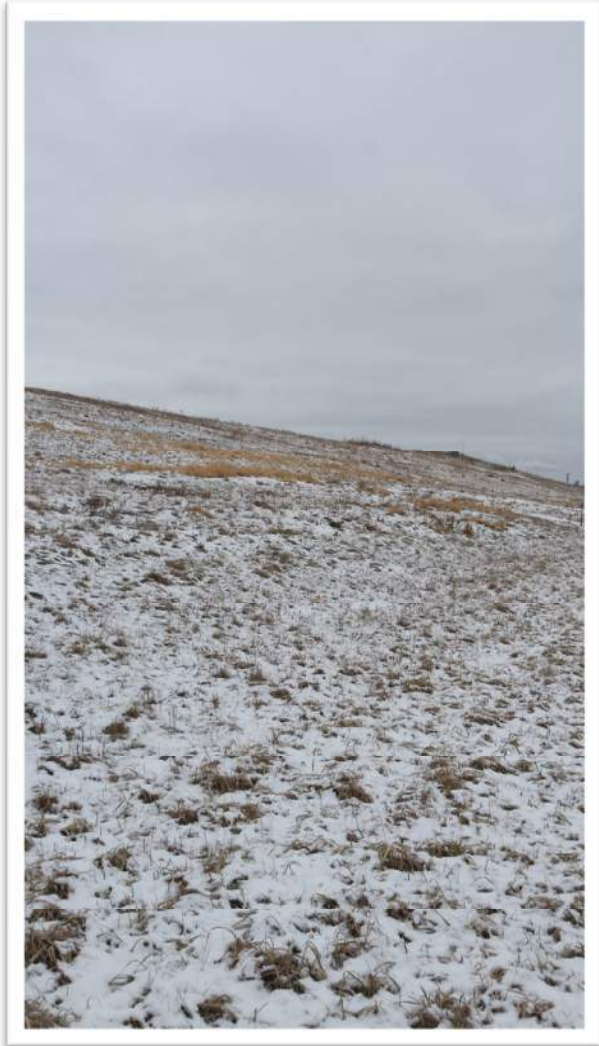
51. E Corner Outer Slope  
Top of Slope  
Facing NW

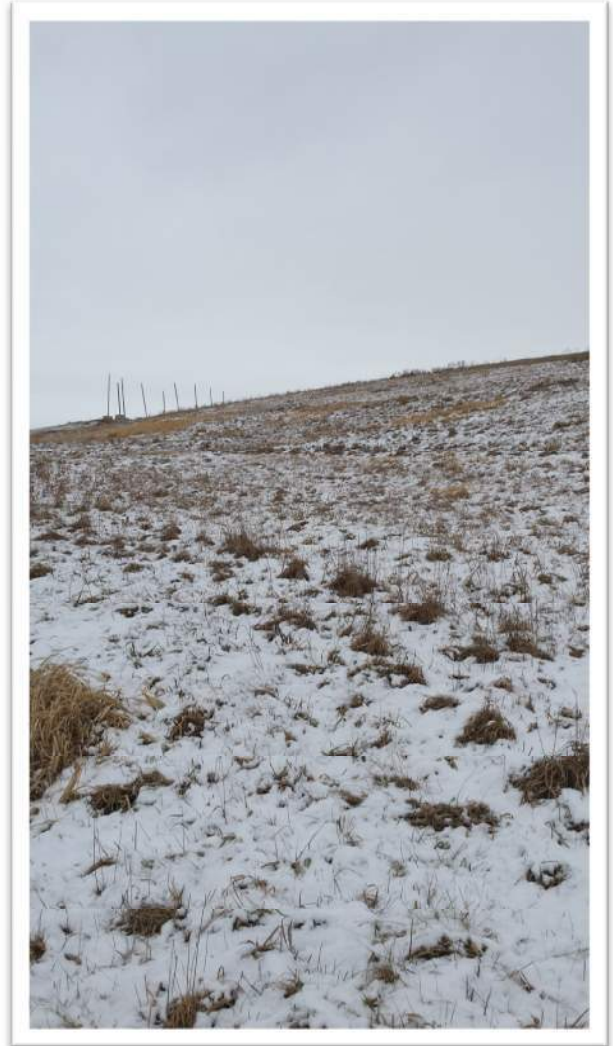
52. NE Outer Slope  
Top of Slope  
Facing SE

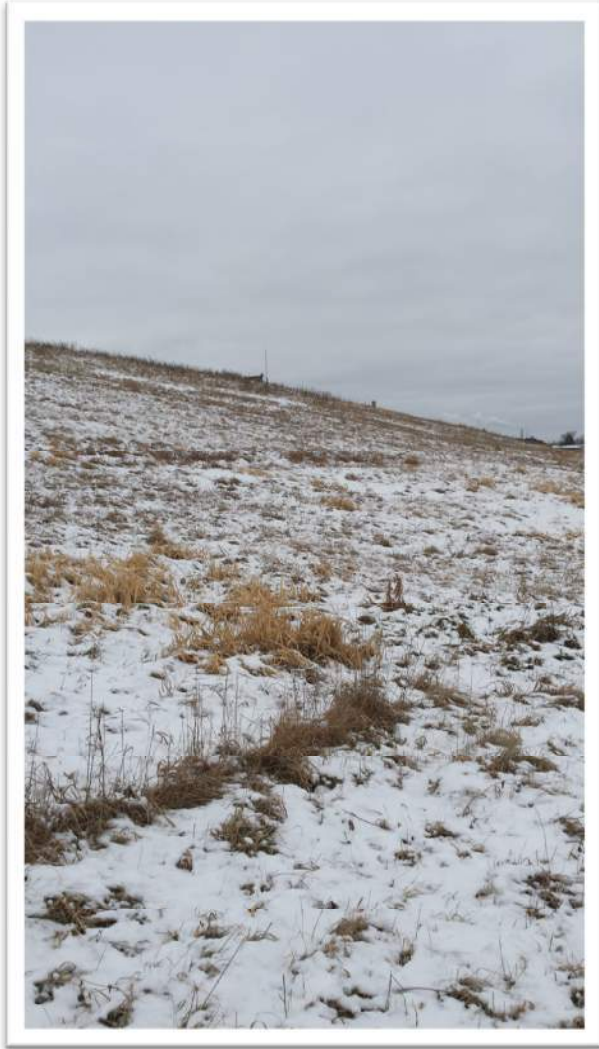
53. NE Outer Slope  
Top of Slope  
Facing NW

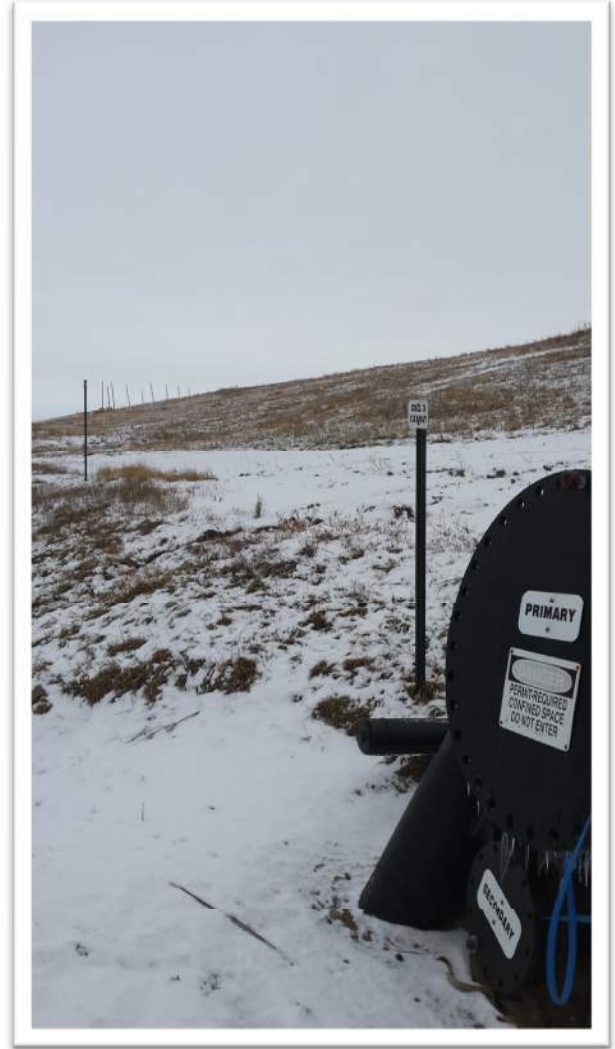
54. NE Outer Slope  
Top of Slope  
Facing SE

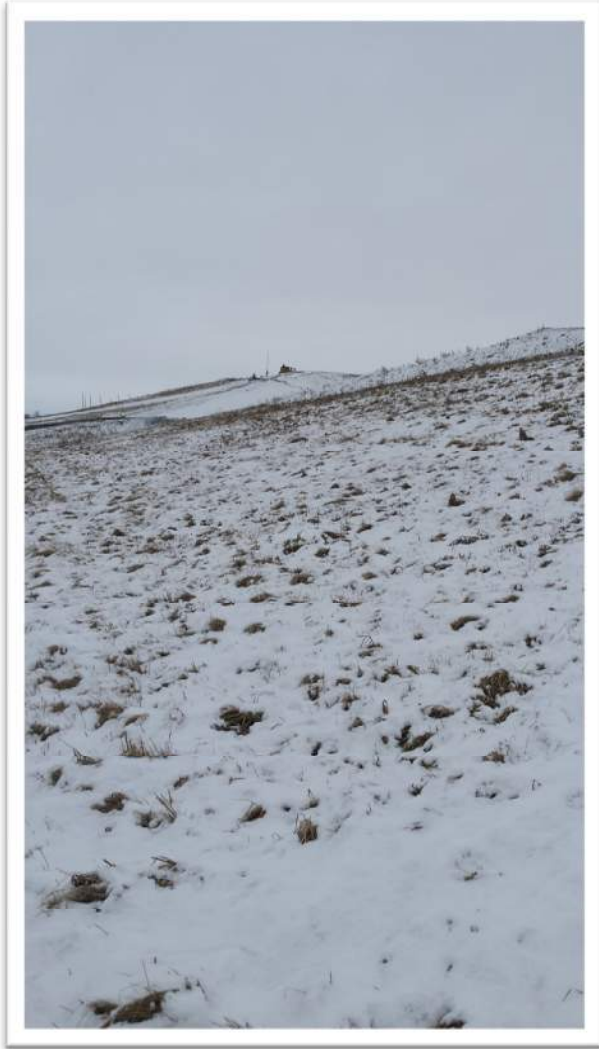
55. N Corner Outer Slope  
Top of Slope  
Facing SE

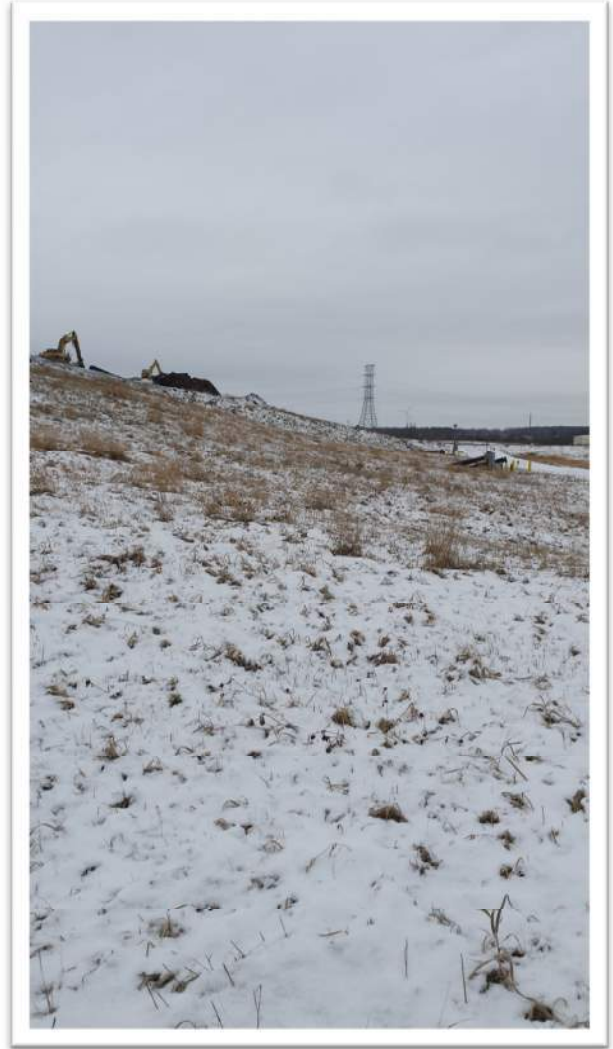
56. N Corner Outer Slope  
Top of Slope  
Facing SW

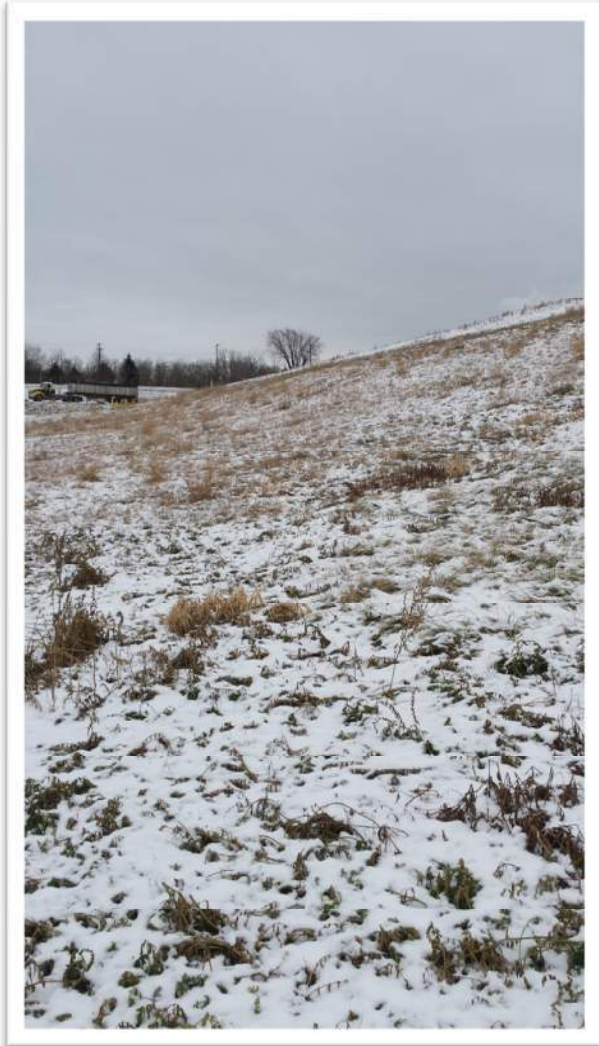
57. NW Outer Slope  
Bottom of Slope  
Facing NE

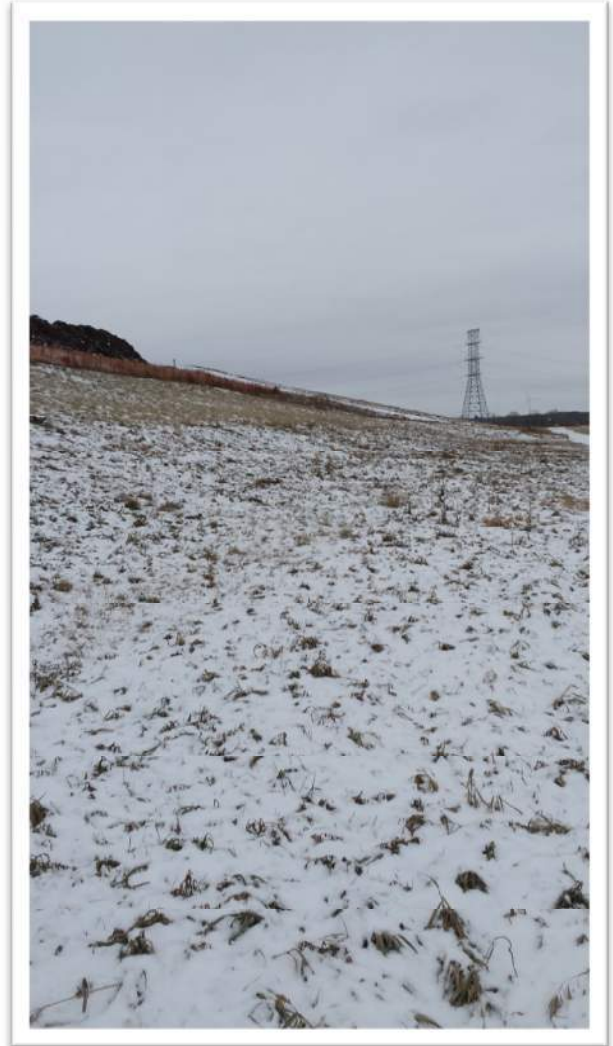
58. NW Outer Slope  
Bottom of Slope  
Facing SW
