Technical Memo

To: Geoff Strack, SKB Environmental, Inc.
From: Dave Parenteau, PE (MN), Wenck Associates, Inc.
Date: January 13, 2017
Subject: 2017 Annual Inspection SKB Rosemount Industrial Waste Facility - Report of CCR
Landfill Inspection
Wenck Project # B3053-0056

2017 Dike Integrity Inspection Report Photos SKB Rosemount Landfill

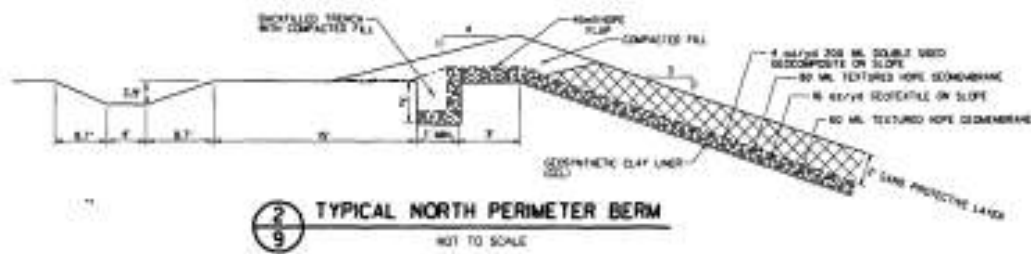
In general, most landfill cell embankments were constructed using granular soils and placed as engineered fill, compacted to 95% of Standard Proctor Dry Density in lift thicknesses ranging from 8 inches to 12 inches. A typical perimeter section, taken from the Cell 3A Construction Documentation Report, prepared by Foth & Van Dyke in October, 2005 is shown below.
