Technical Memo

To: Geoff Strack, SKB Environmental, Inc.
From: Dave Parenteau, PE (MN), Wenck Associates, Inc.
Date: January 9, 2018
Subject: Annual Inspection SKB Rosemount Industrial Waste Facility - Report of CCR Landfill Inspection
Wenck Project # B3053-0096

2018 Dike Integrity Inspection Report Photos SKB Rosemount Landfill

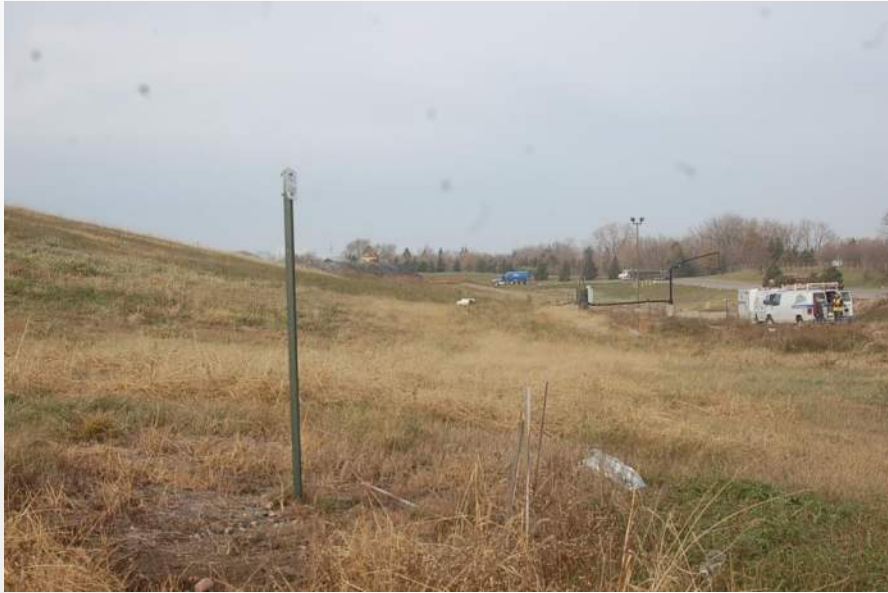
Photo 1 - Cell 3A North Landfill Face

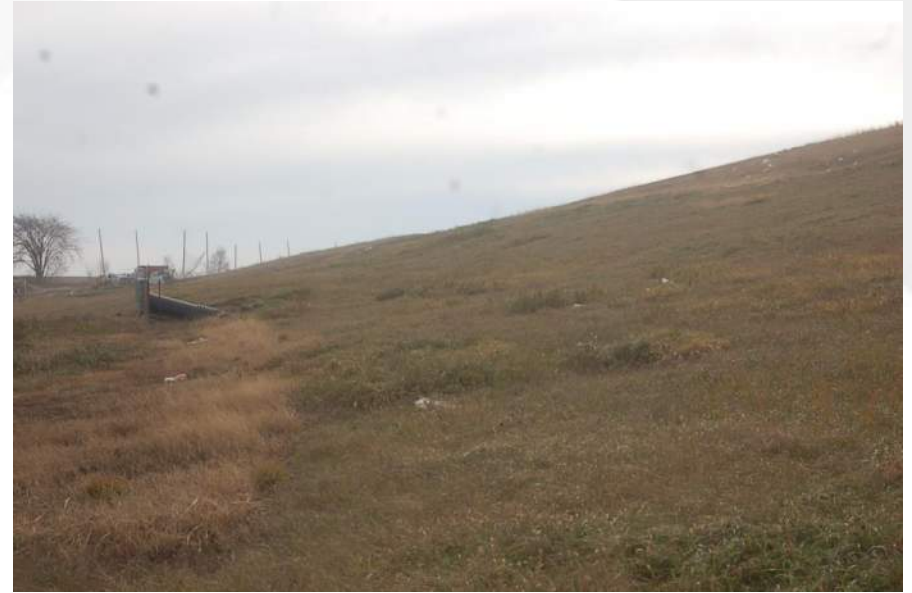
Photo 2 - Cell 3A/3B North Landfill Face

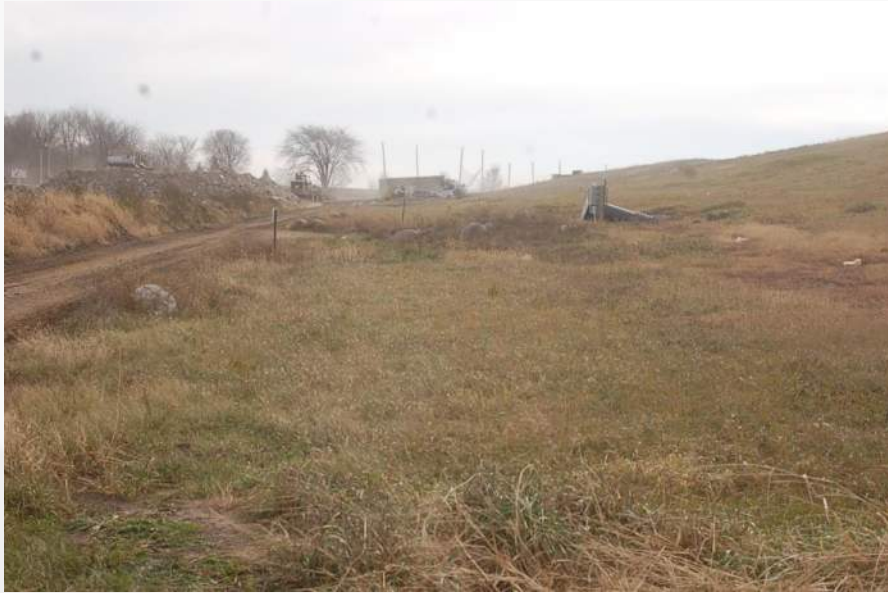
Photo 3 - Cell 3A/3B North Perim Rd/LF Toe

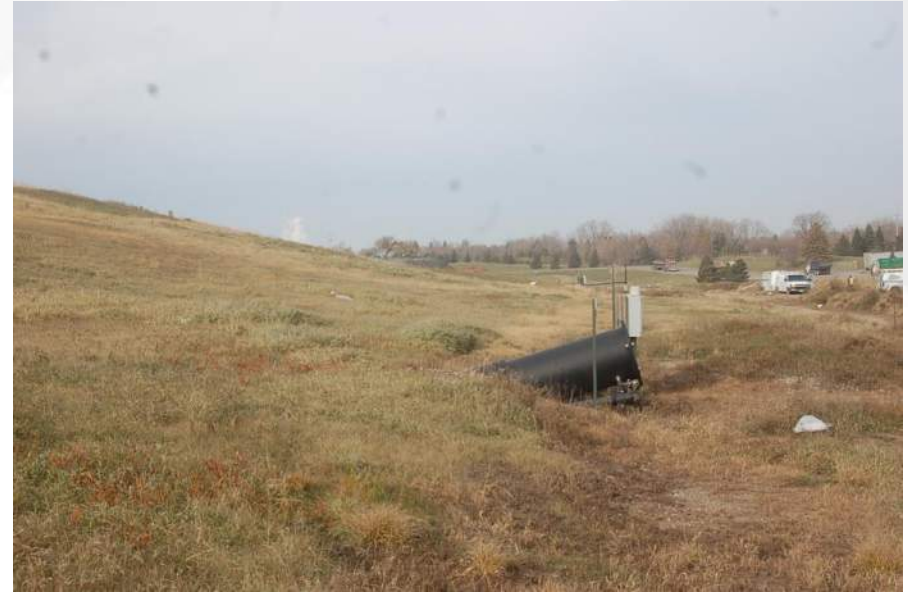
Photo 4 - Cell A North Landfill Face

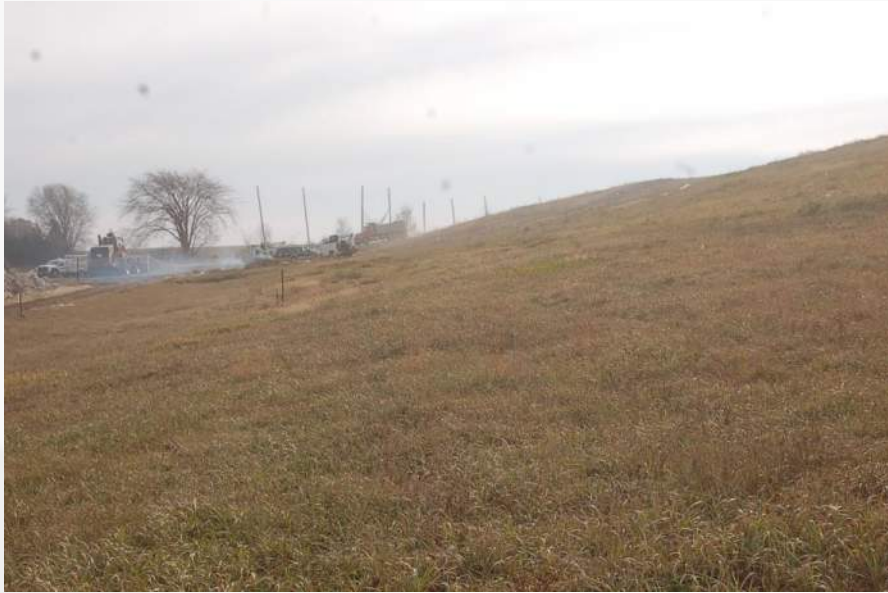
Photo 5 - Cell 3A North Landfill Face

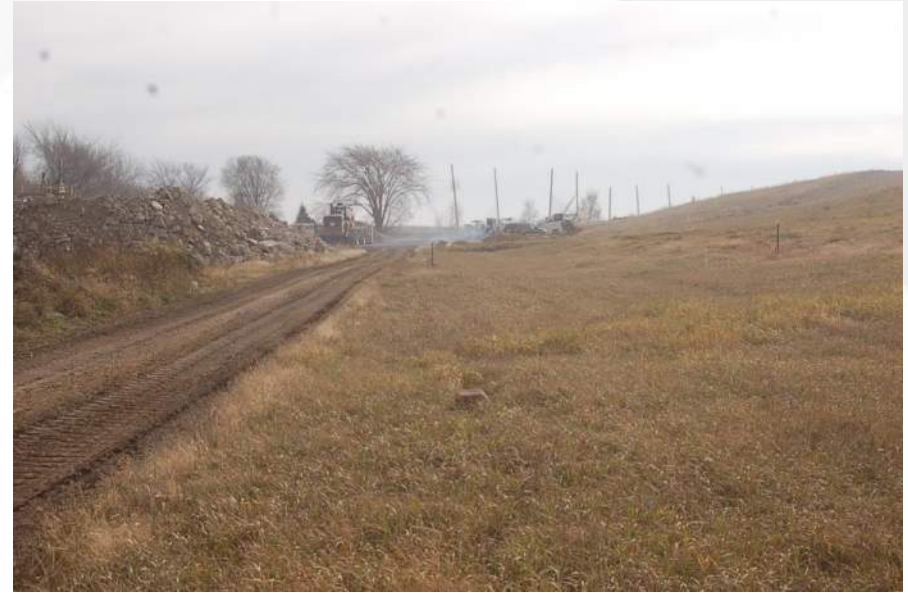
Photo 6- Cell 3A North Perimeter Rd/LF Toe

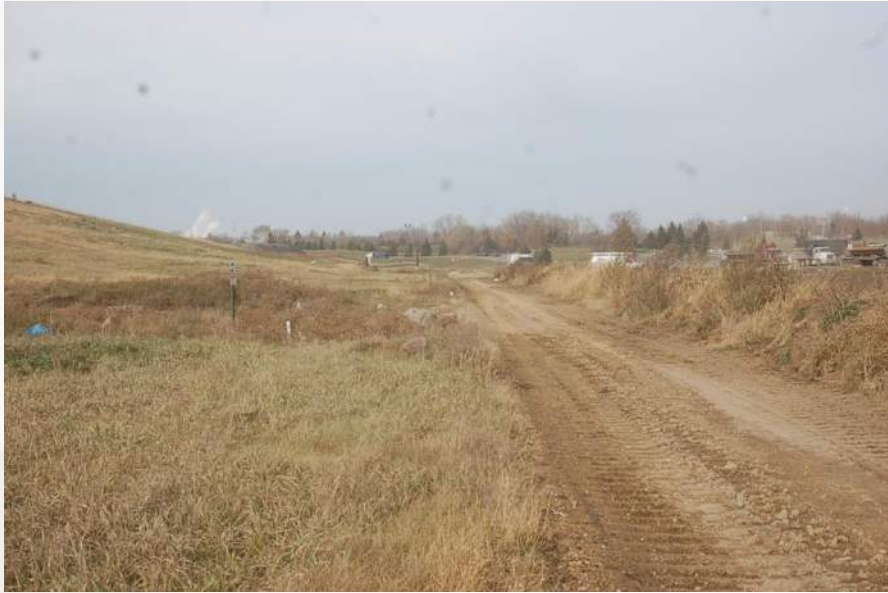
Photo 7 - Cell 3A North Perimeter Rd/LF Toe

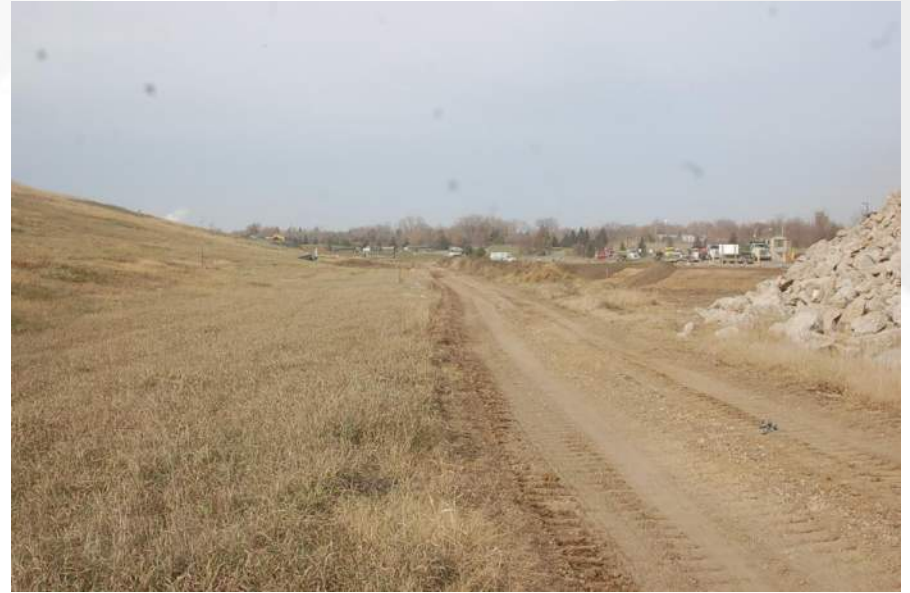
Photo 8 - Cell 3A North Perimeter Rd/LF Toe

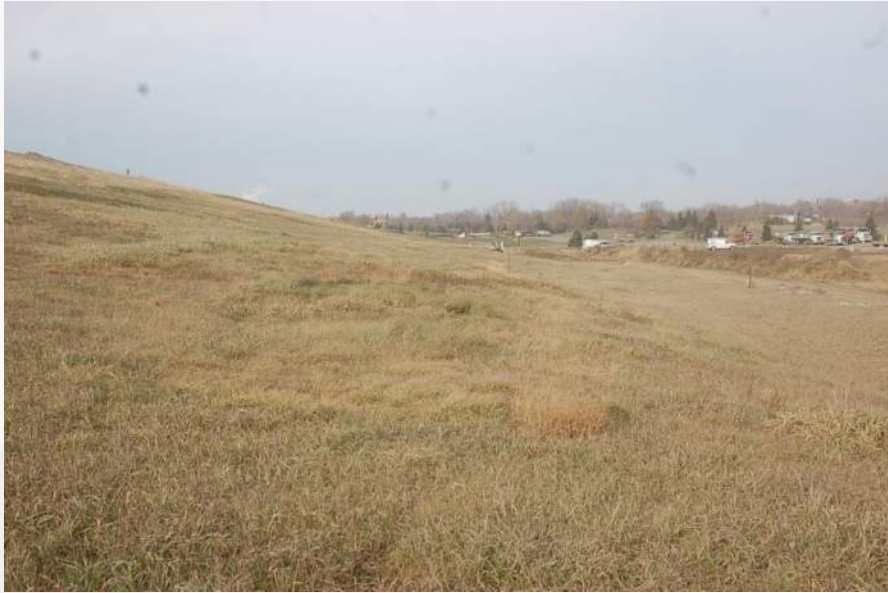
Photo 9 - Cell 3A North Landfill Face

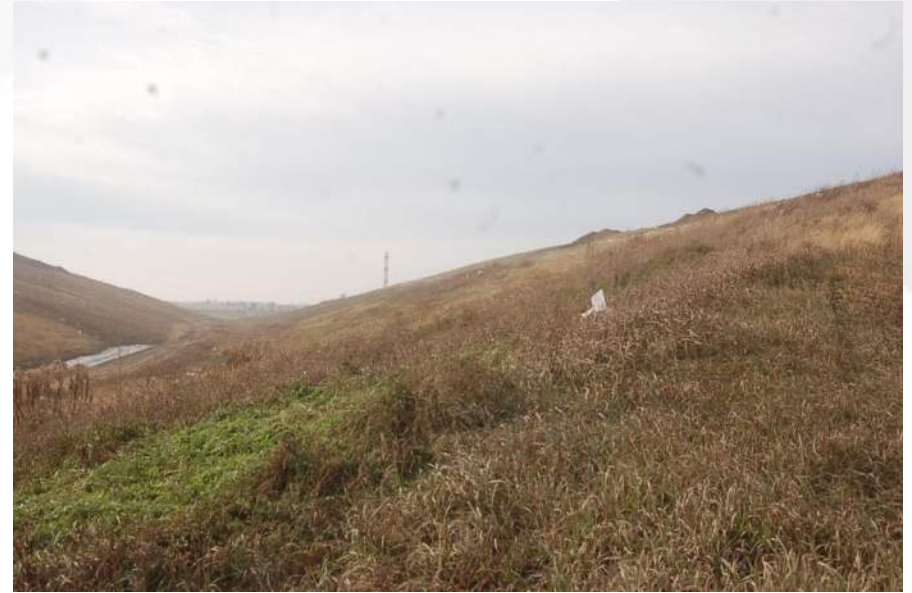
Photo 10 - Cell 3A East Landfill Face

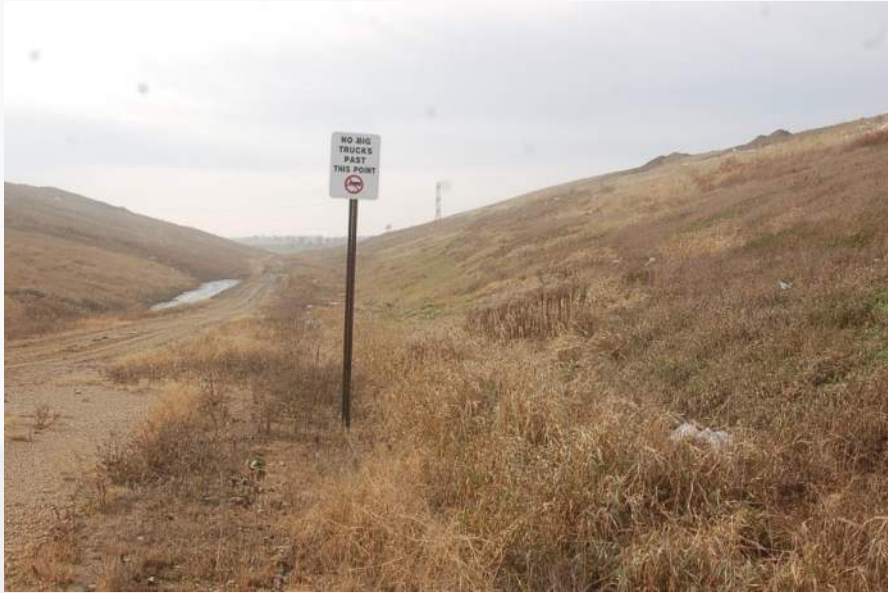
Photo 11 - Cell 3A East Perimeter Rd/LF Toe

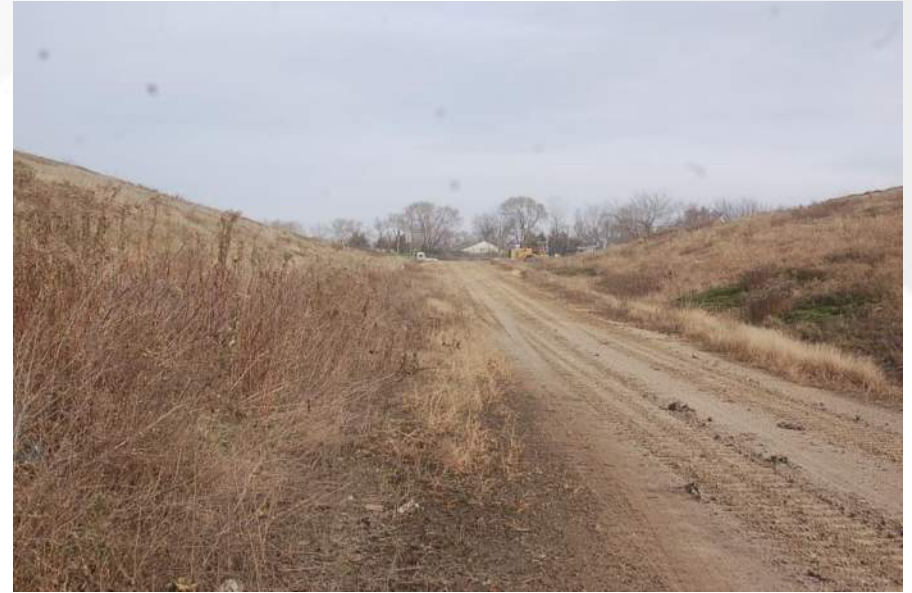
Photo 12 - Cell 3A East Perimeter Rd/LF Toe

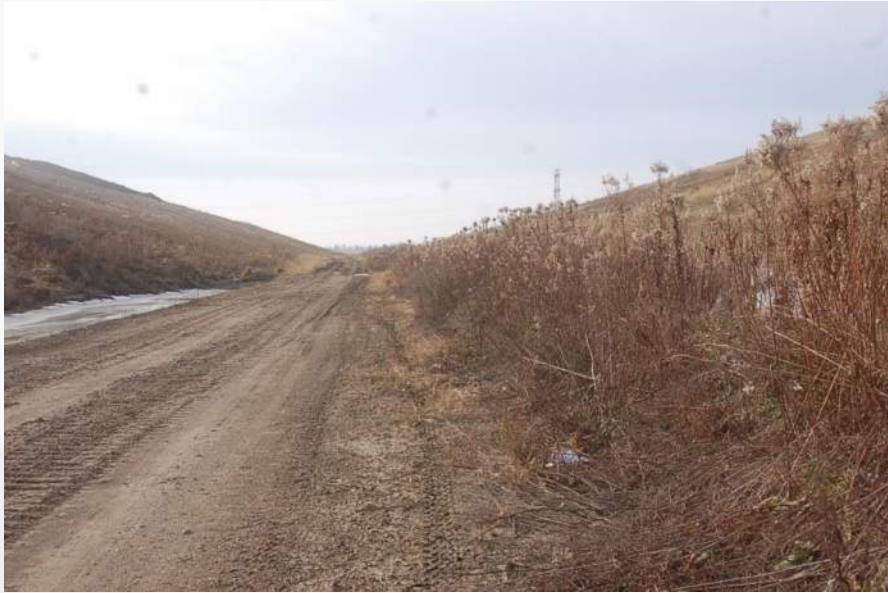
Photo 13 - Cell 3A East Perimeter Rd/LF Toe

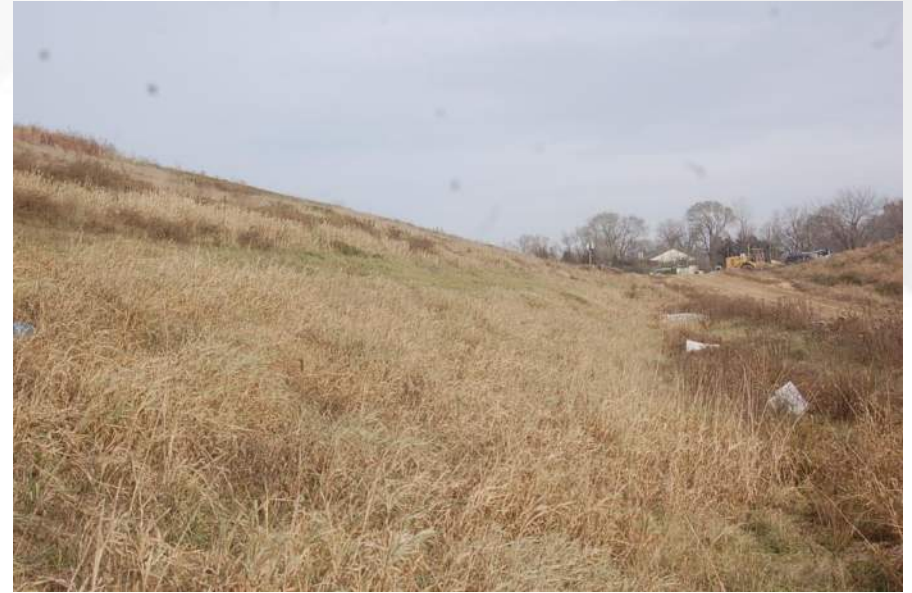
Photo 14 - Cell 3A East Landfill Face

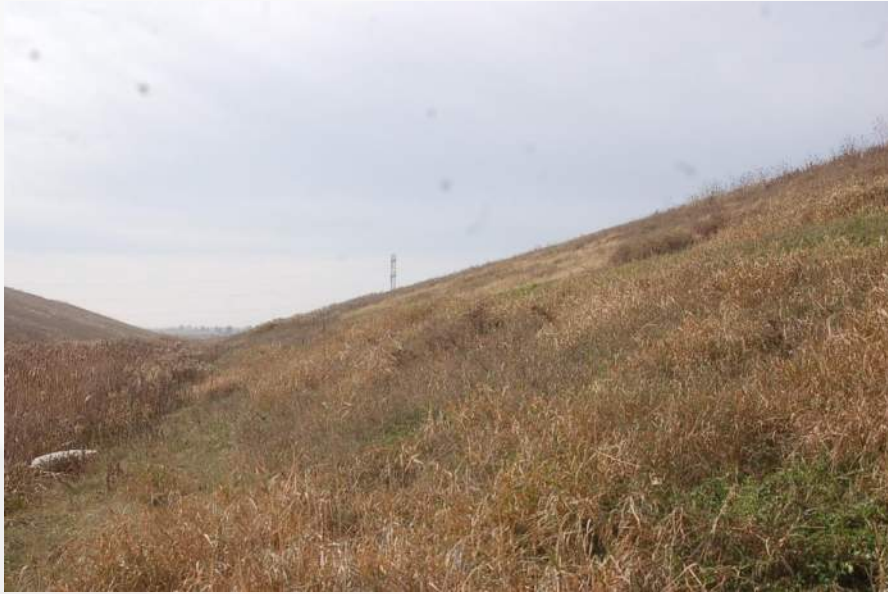
Photo 15 - Cell 3A East Landfill Face

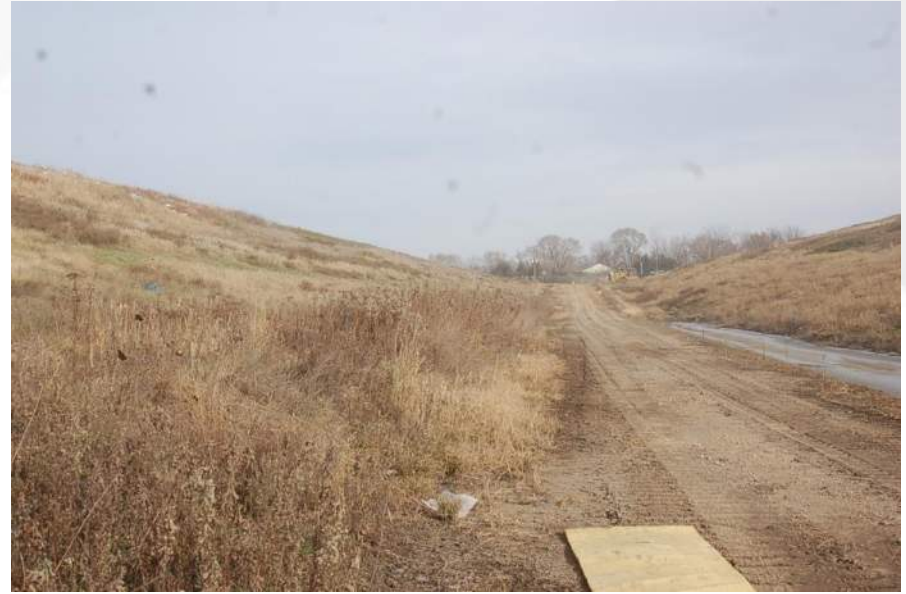
Photo 16 - Cell 3A East Perim RD/LF Toe

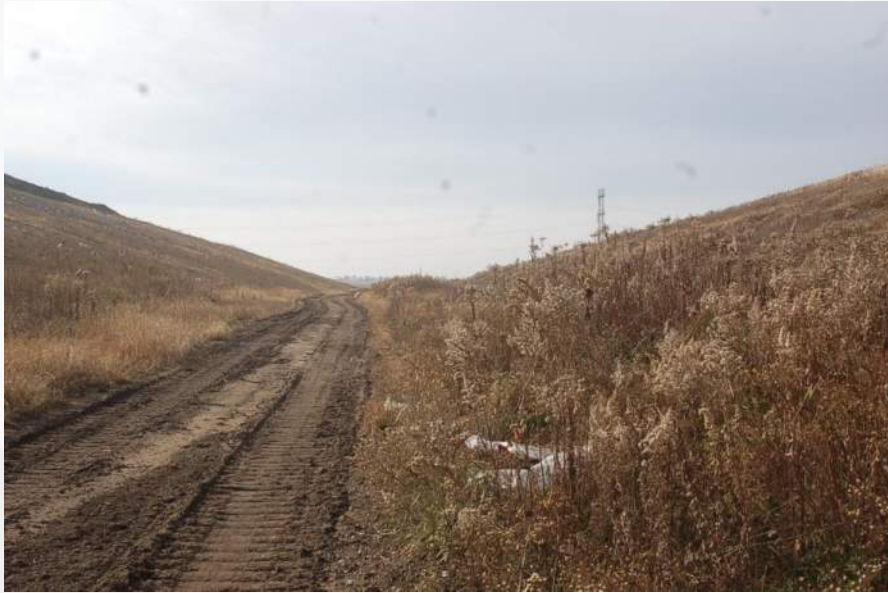
Photo 17 - Cell 3A East Perim RD/LF Toe

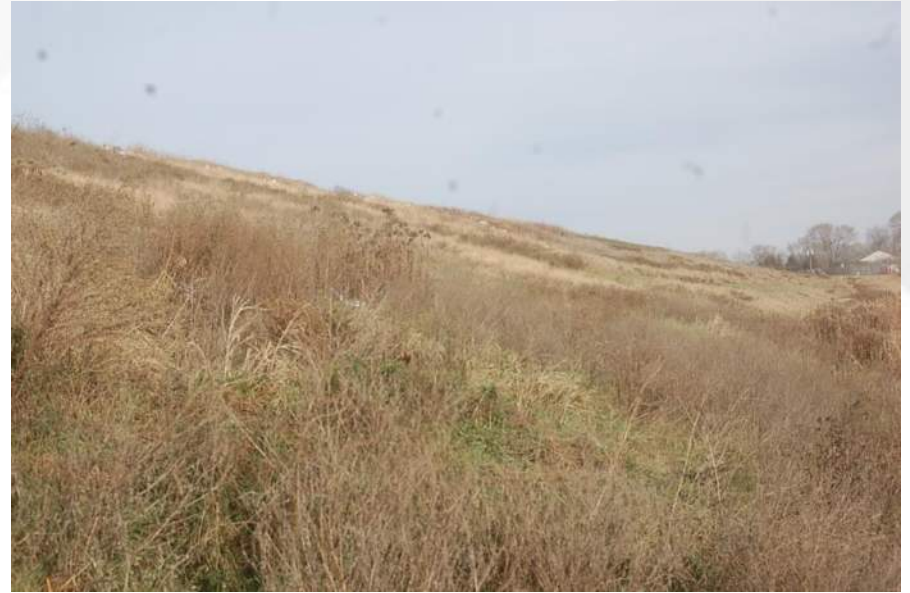
Photo 18 - Cell 3A East Landfill Face

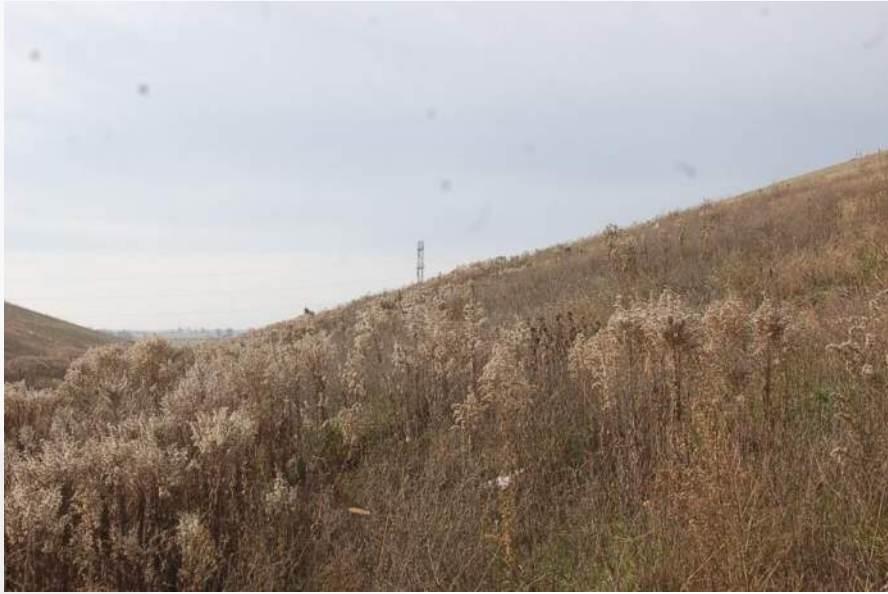
Photo 19 - Cell 3A East Landfill Face

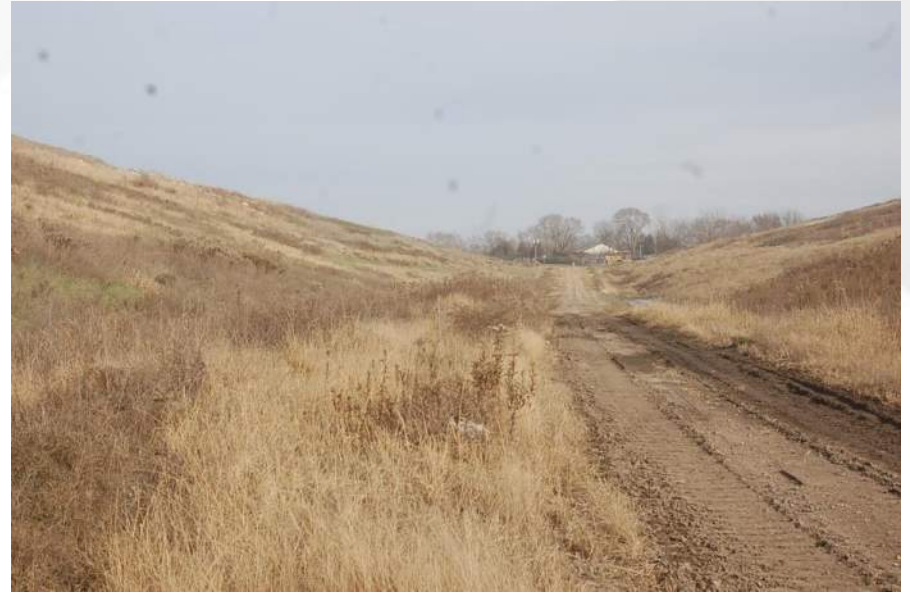
Photo 20 - Cell 3A Perim Rd/LF Toe

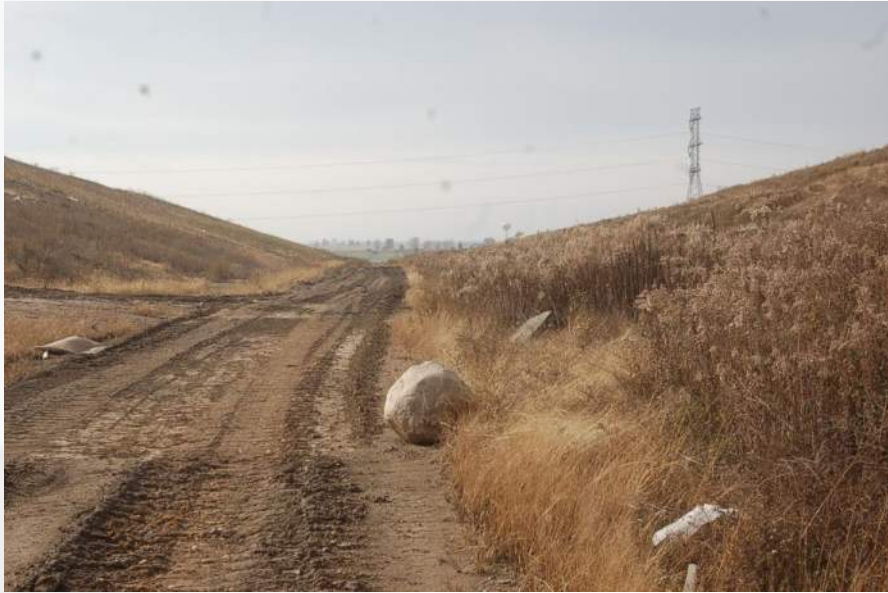
Photo 21 - Cell 3C East Perim RD/LF Toe

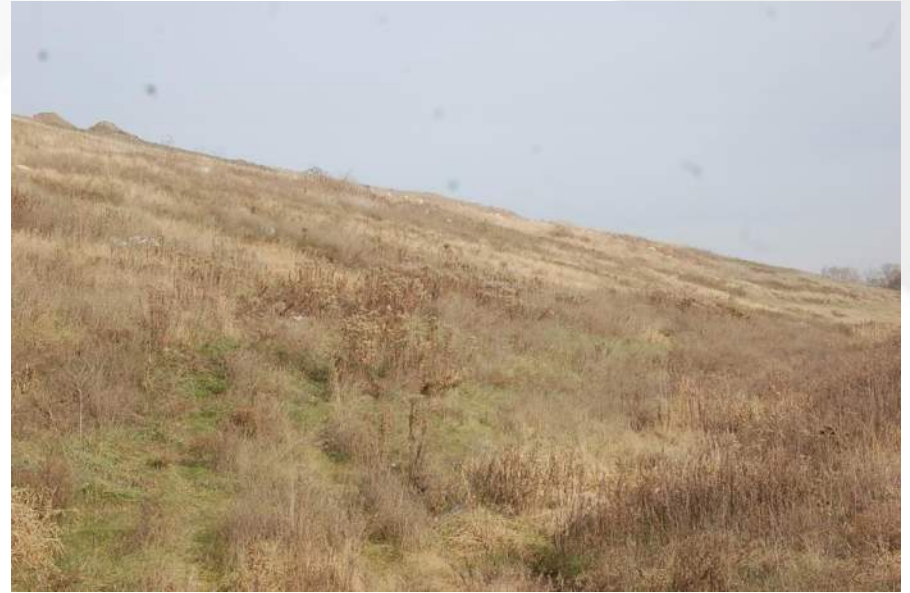
Photo 22 - Cell 3A East Landfill Face

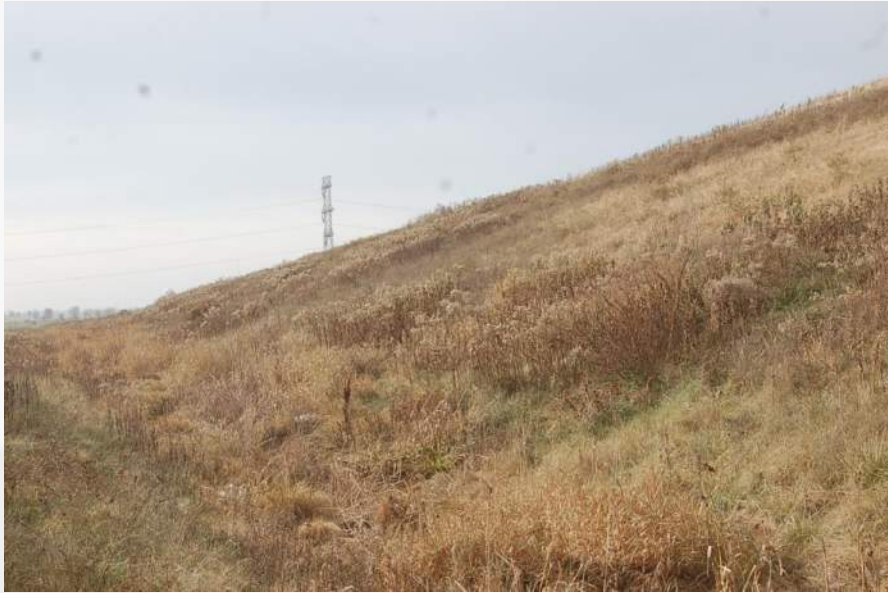
Photo 23 - Cell 3C East Landfill Face

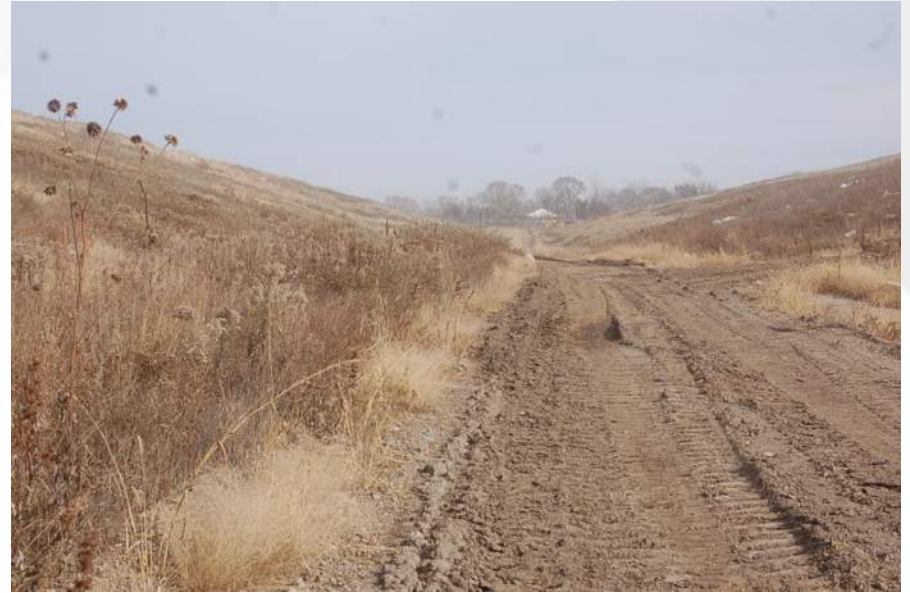
Photo 24 - Cell 3C East Perim RD/LF Toe

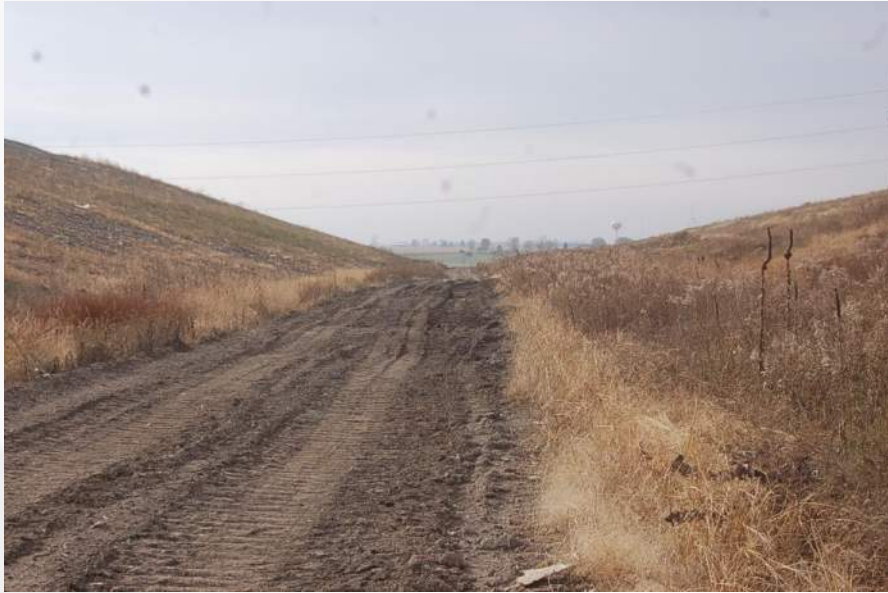
Photo 25 - Cell 3C East Perim RD/LF Toe

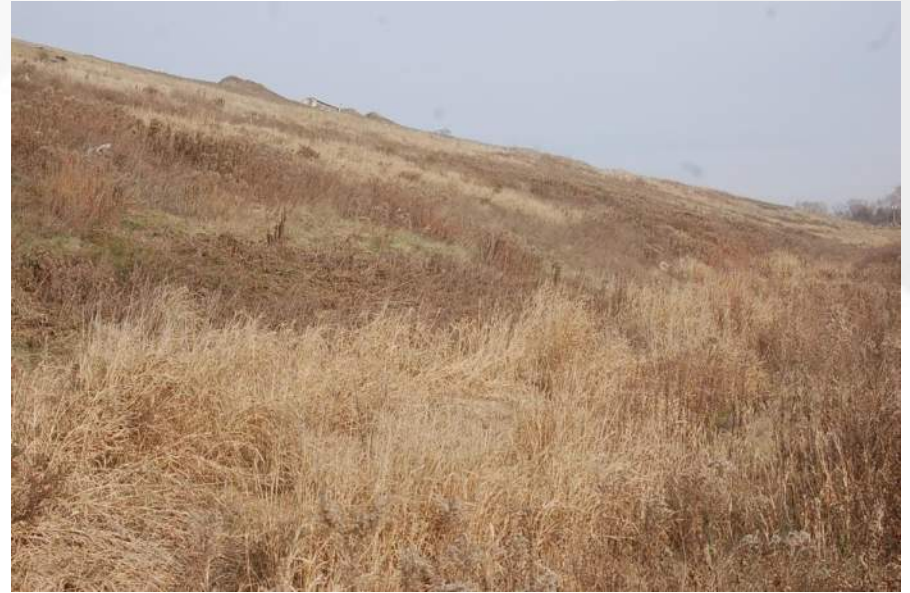
Photo 26 - Cell 3C East Landfill Face

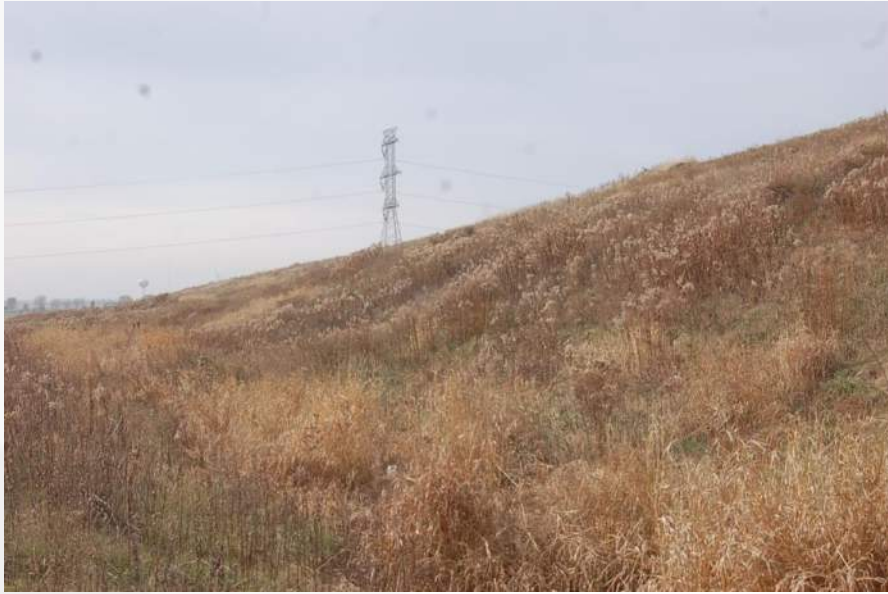
Photo 27 - Cell 3C East Landfill Face

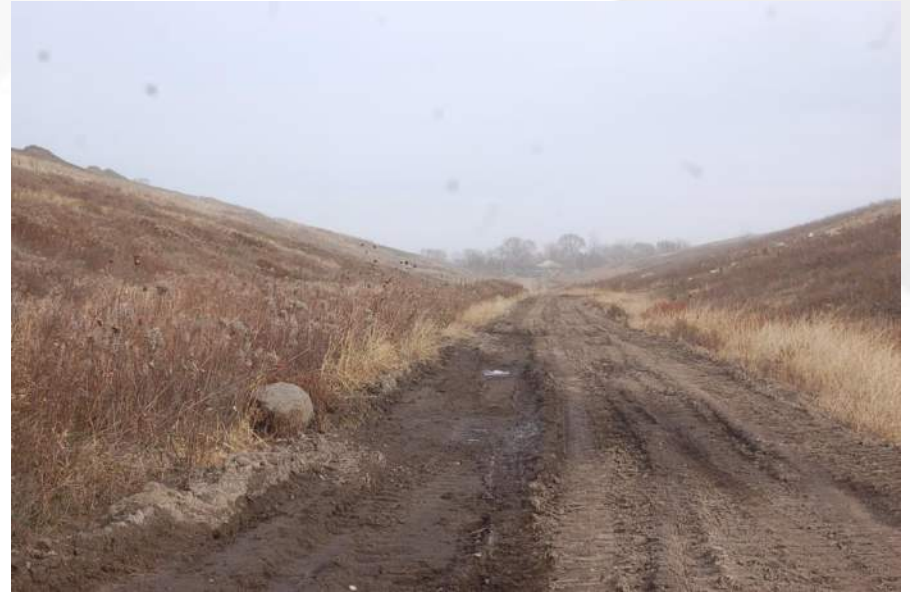
Photo 28 - Cell 3C East Perim RD/LF Toe

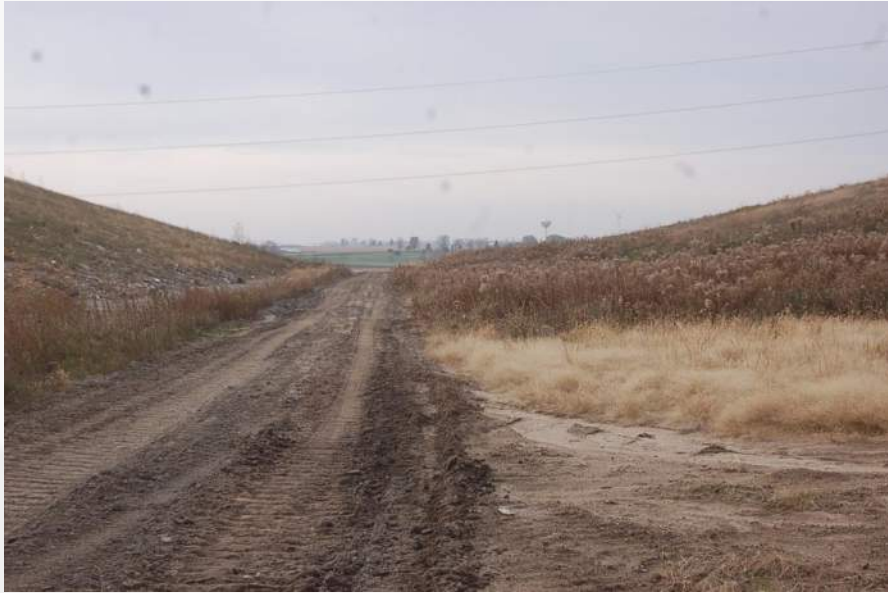
Photo 29 - Cell 2D East Perim Rd/LF Toe

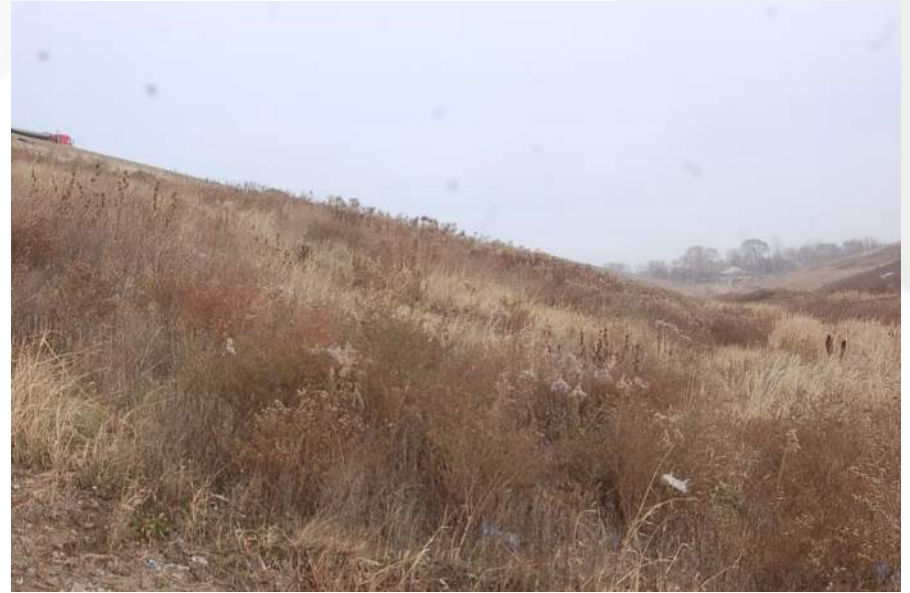
Photo 30 - Cell 3C East Landfill Face

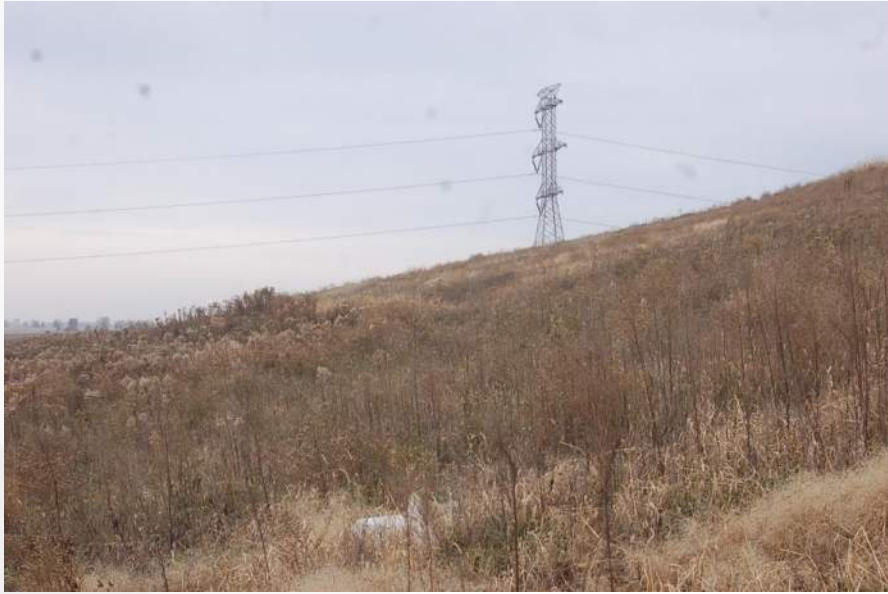
Photo 31 - Cell 2D East Landfill Face

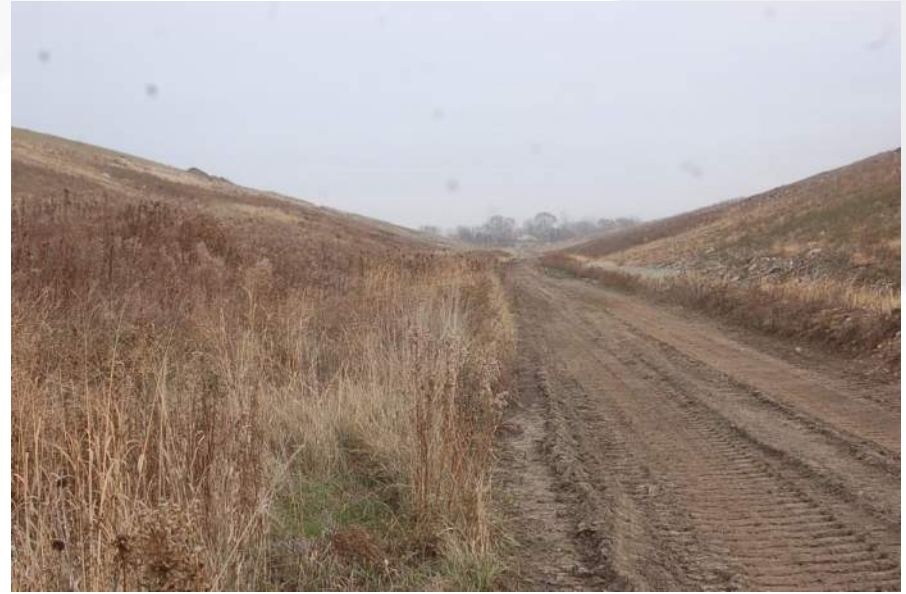
Photo 32 - Cell 2D East Perim Rd/LF Toe

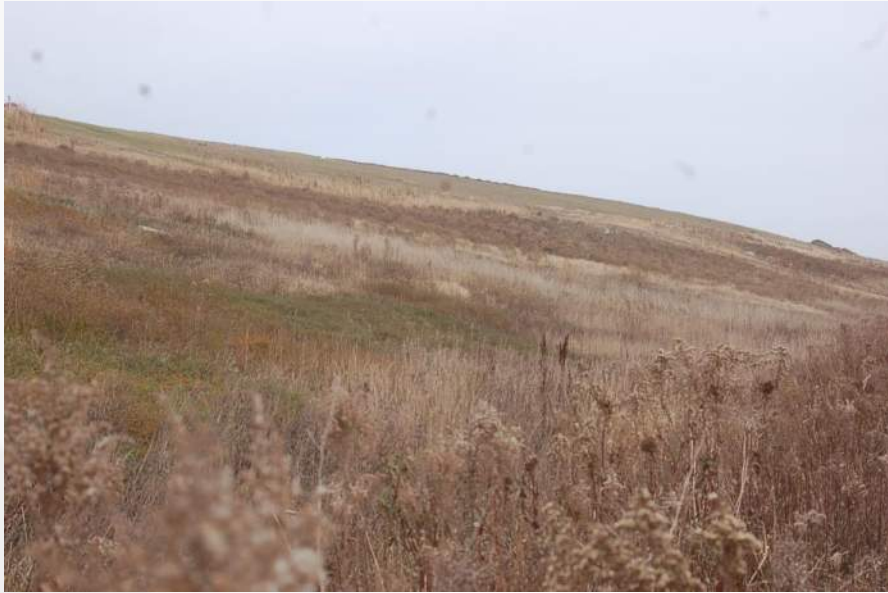
Photo 33 - Cell 2D East Landfill Face

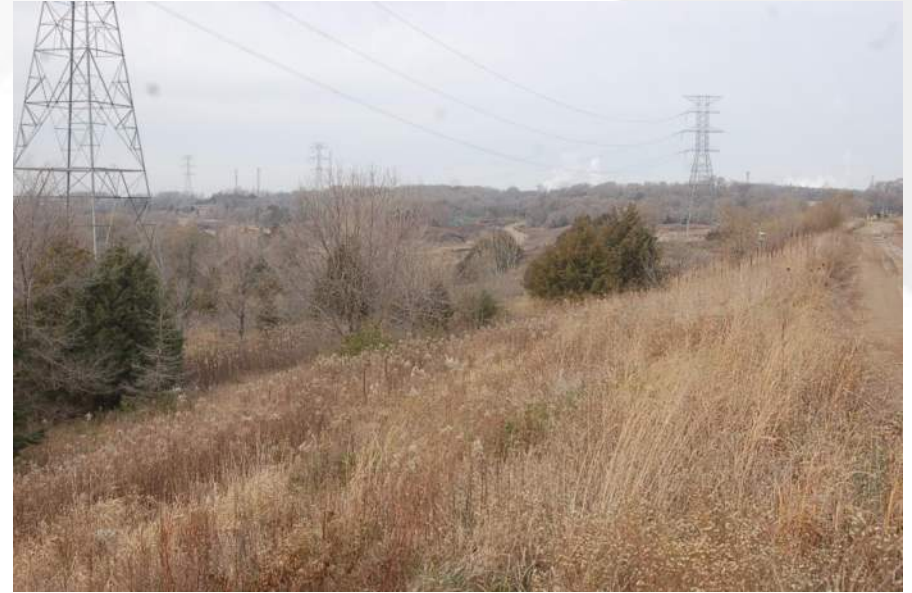
Photo 34 - Cell 2D South Perimeter Berm

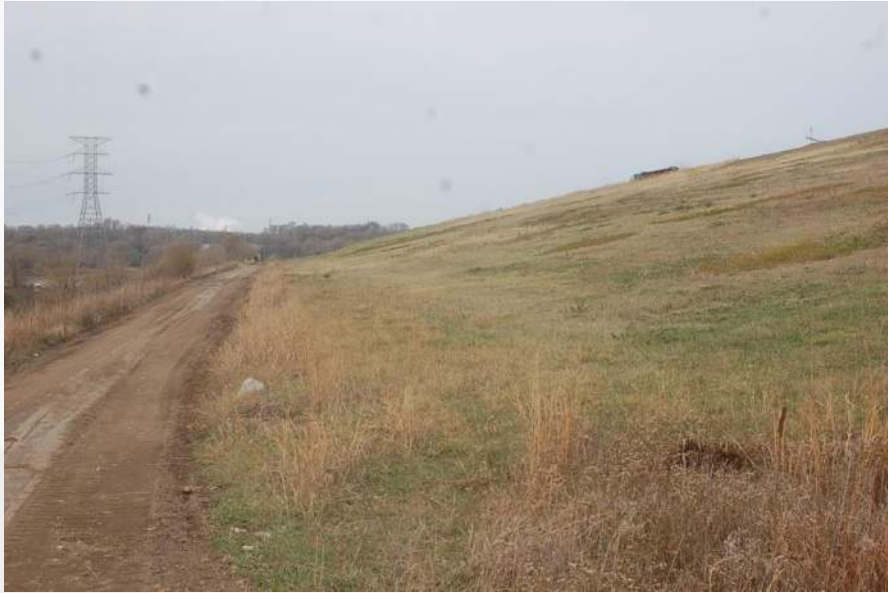
Photo 35 - Cell 2D South Perim Rd/LF Toe

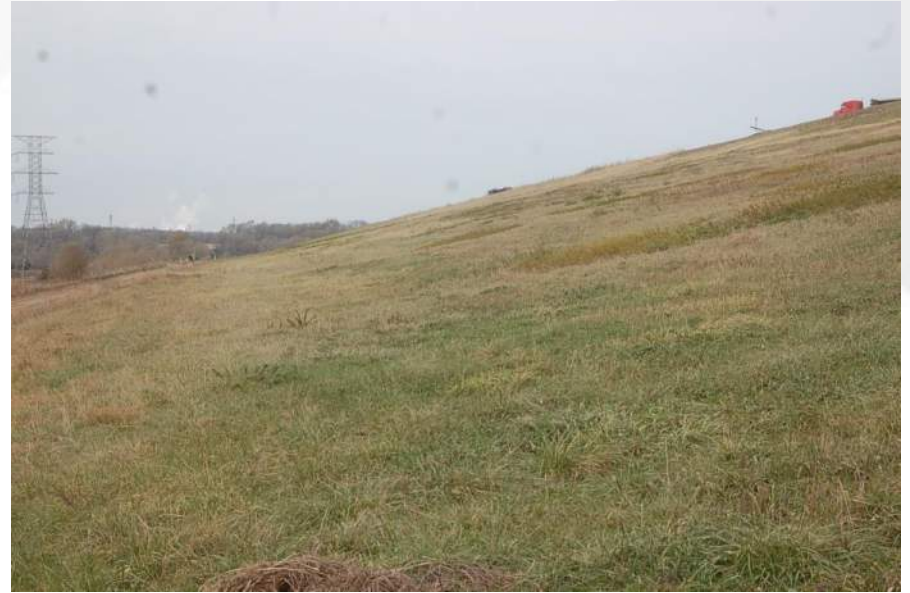
Photo 36 - Cell 2D South Landfill Face

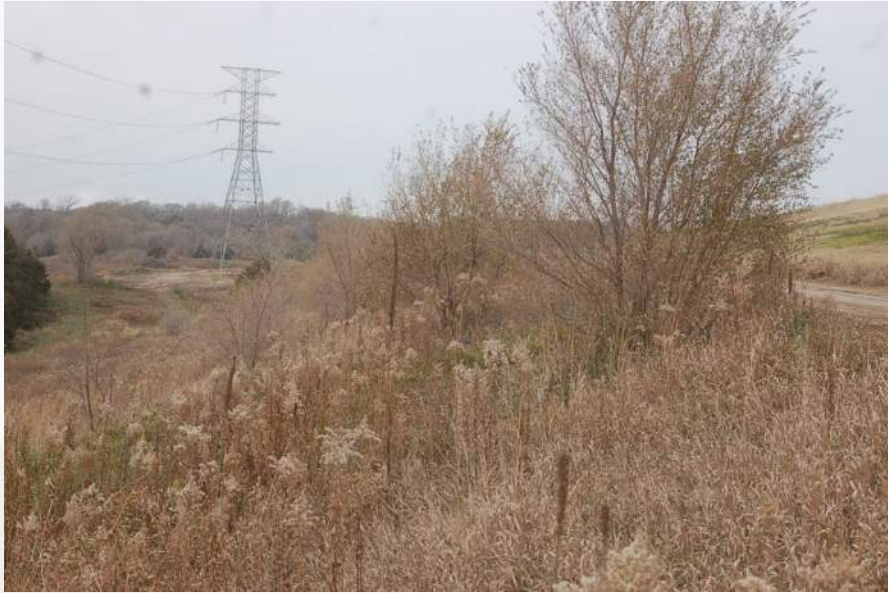
Photo 37 - Cell 2C South Perimeter Berm

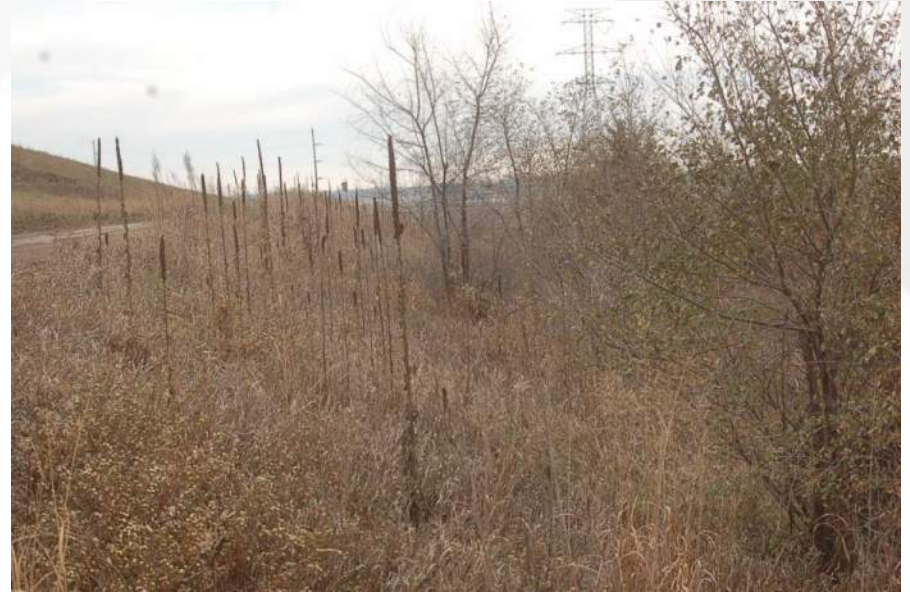
Photo 38 - Cell 2C/2D South Perimeter Berm

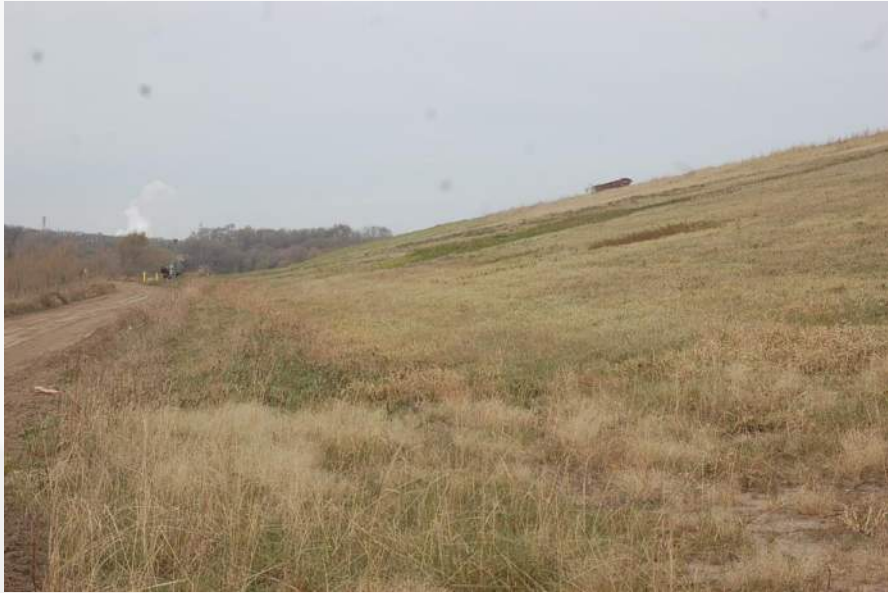
Photo 39 - Cell 2C South Landfill Face

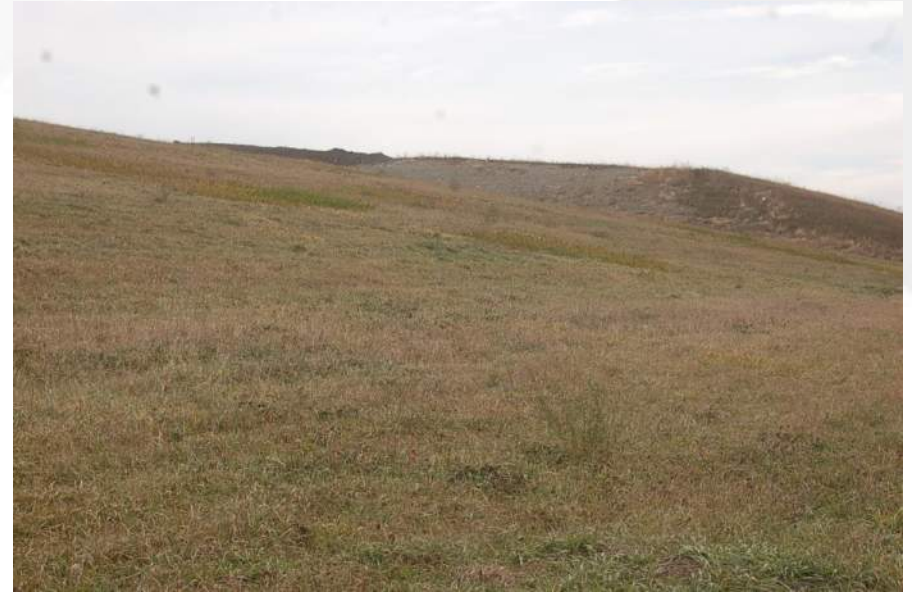
Photo 40 - Cell 2C/2D South Landfill Face

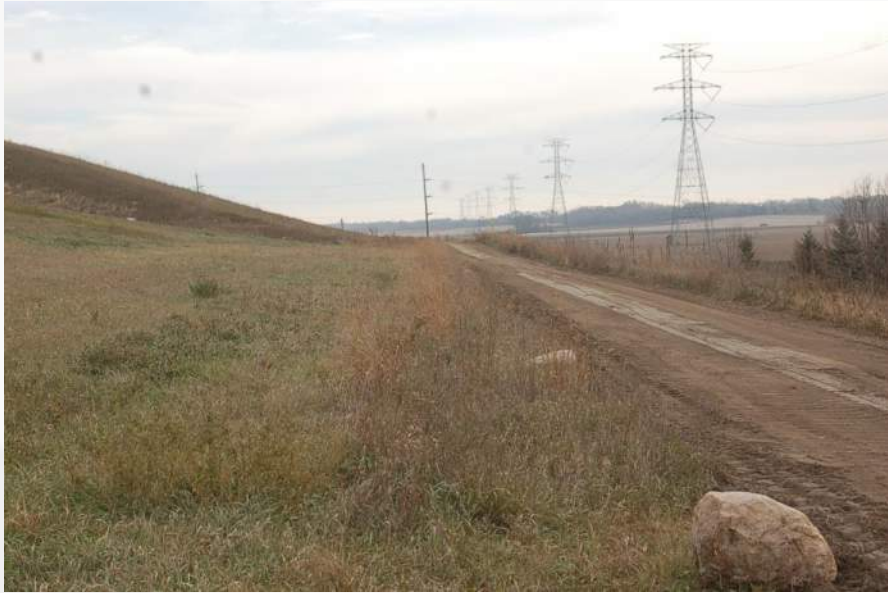
Photo 41 - Cell 2C/2D South Perim Rd/LF Toe

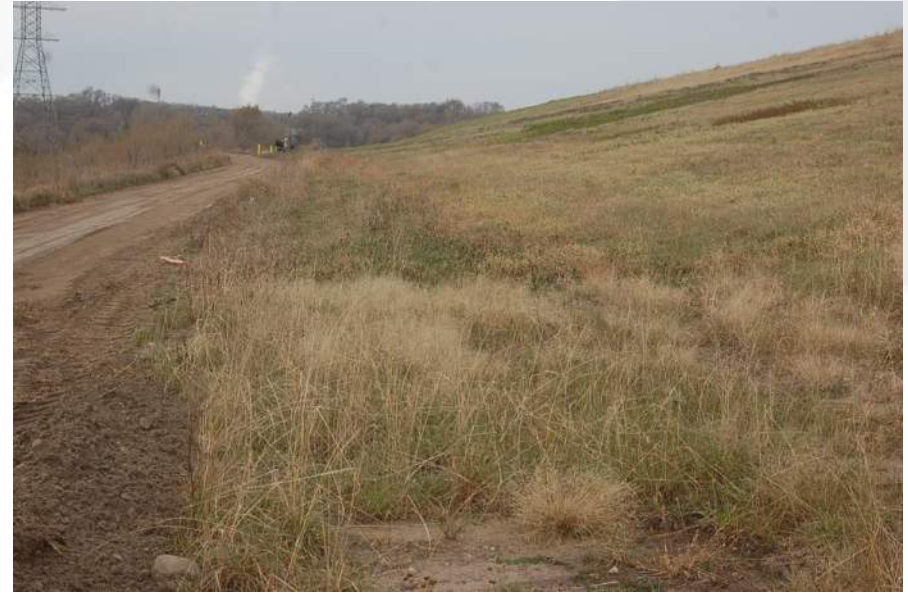
Photo 42 - Cell 2C East Perim Rd/LF Toe
