Technical Memo

To: Geoff Strack, SKB Environmental, Inc.
From: Dave Parenteau, PE (MN), Wenck Associates, Inc.
Date: January 9, 2018
Subject: Annual Inspection SKB Rosemount Industrial Waste Facility - Report of CCR Landfill Inspection
Wenck Project # B3053-0096

2018 Dike Integrity Inspection Report Photos SKB Rosemount Landfill

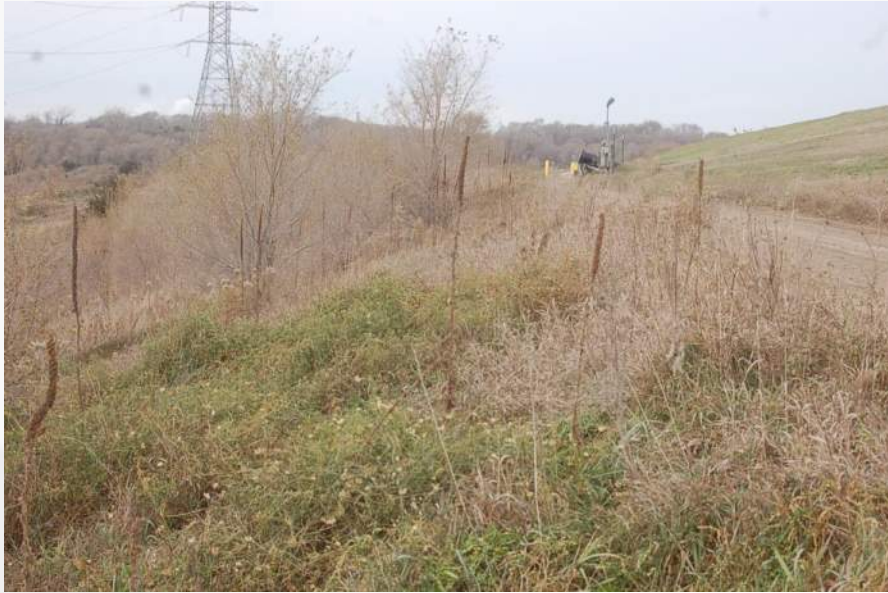
Photo 43 Cell 2C South Perimeter Berm

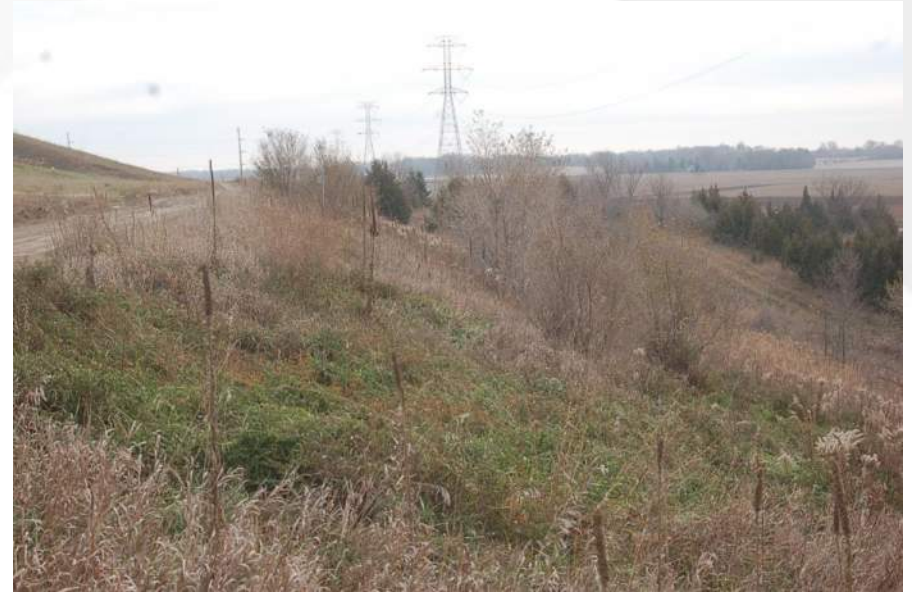
Photo 44 Cell 2C South Perimeter Berm

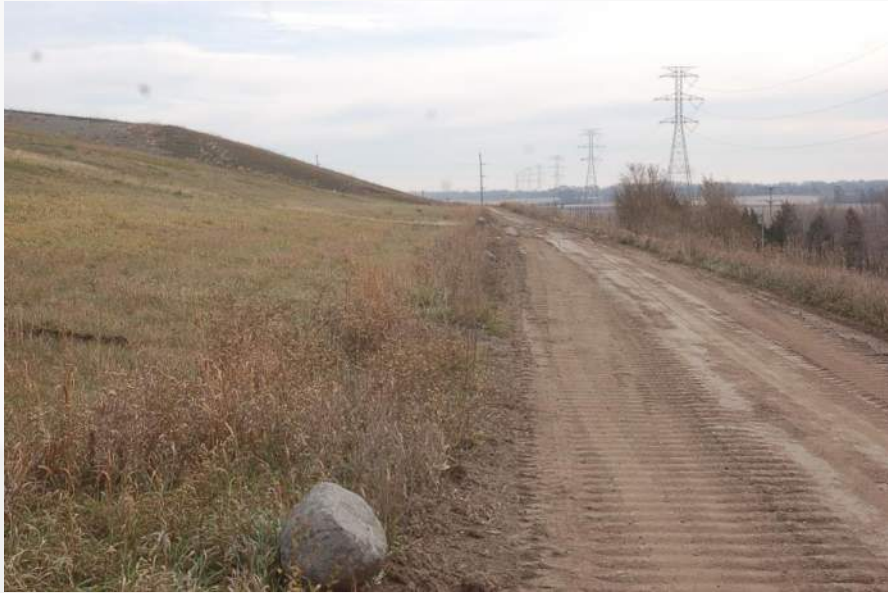
Photo 45 - Cell 2C South Perim Rd/LF Toe

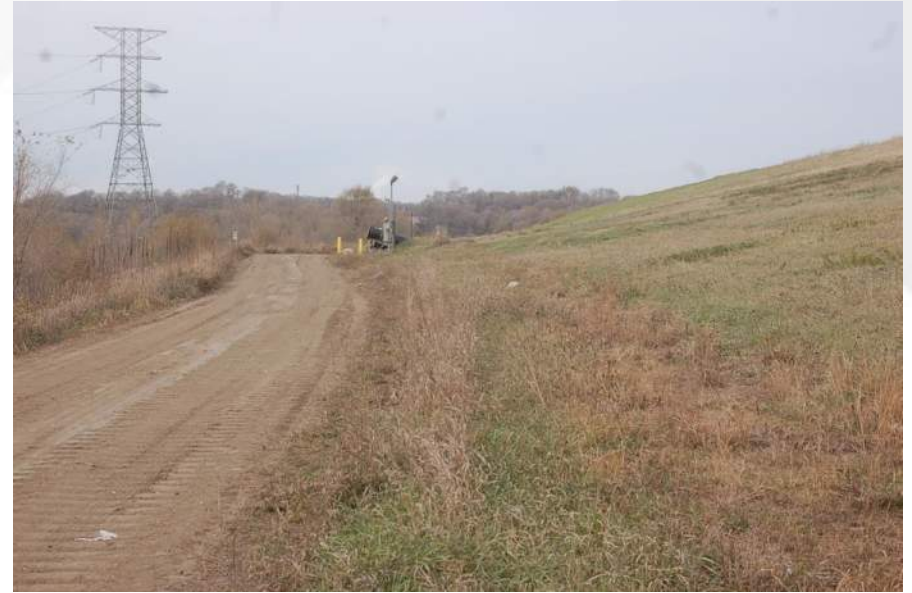
Photo 46 - Cell 2C South Perim Rd/LF Toe

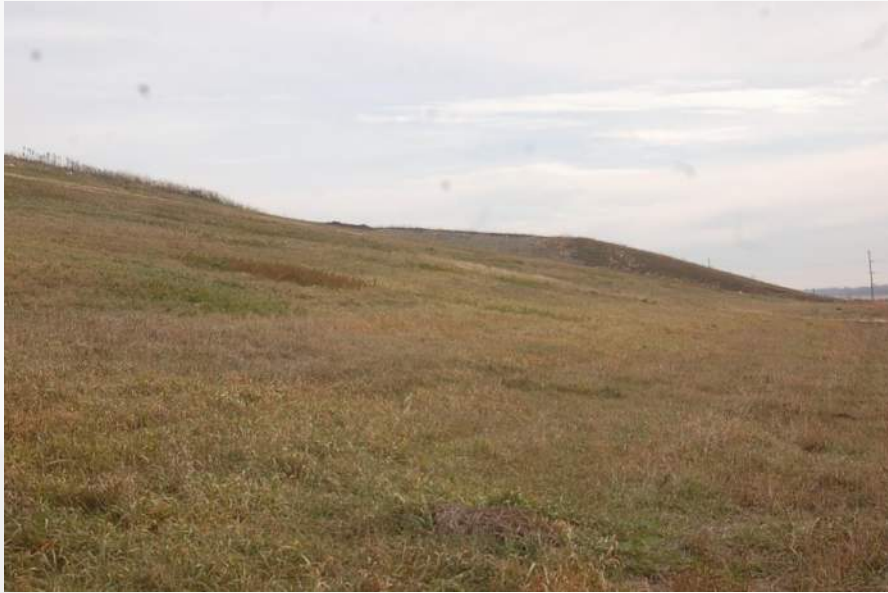
Photo 47 - Cell 2C South Landfill Face

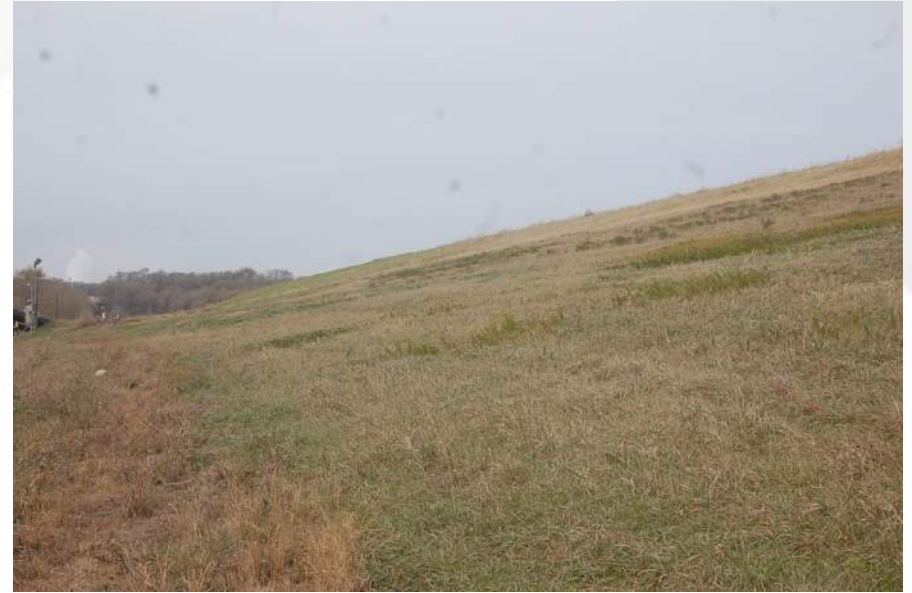
Photo 48 - Cell 2C South Landfill Face

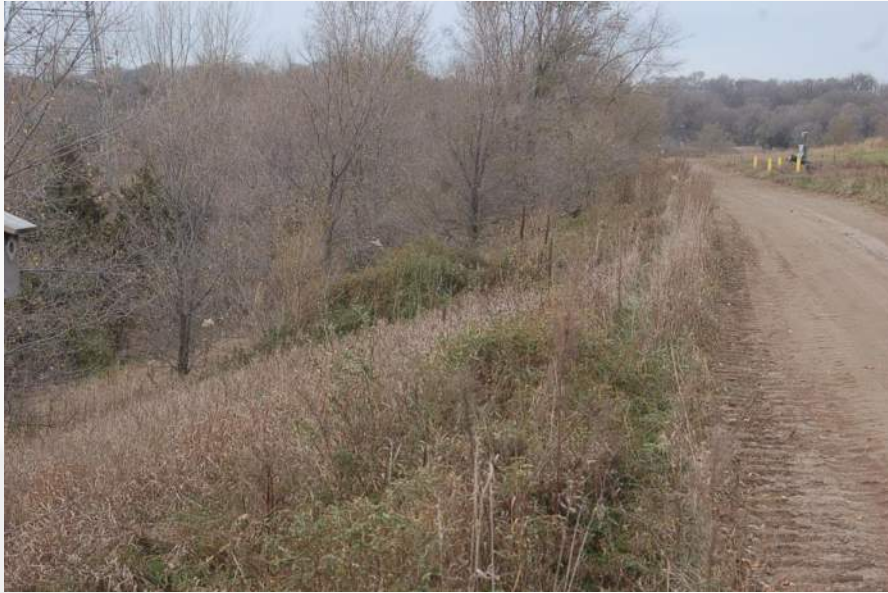
Photo 49 - Cell 2A/2B South Perimeter Berm

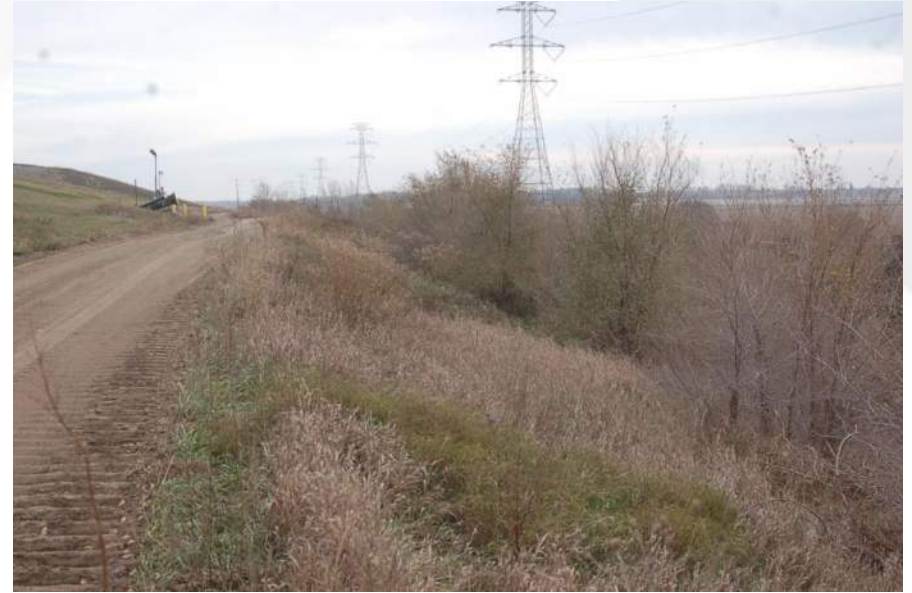
Photo 50 - Cell 2B/2C South Perimeter Berm

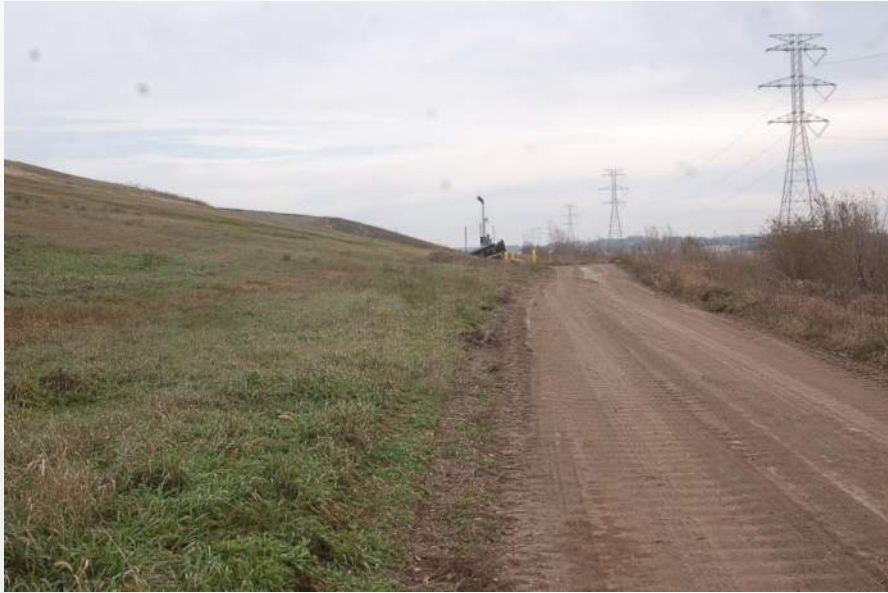
Photo 51 - Cell 2B/2C South Perim Rd/LF Toe

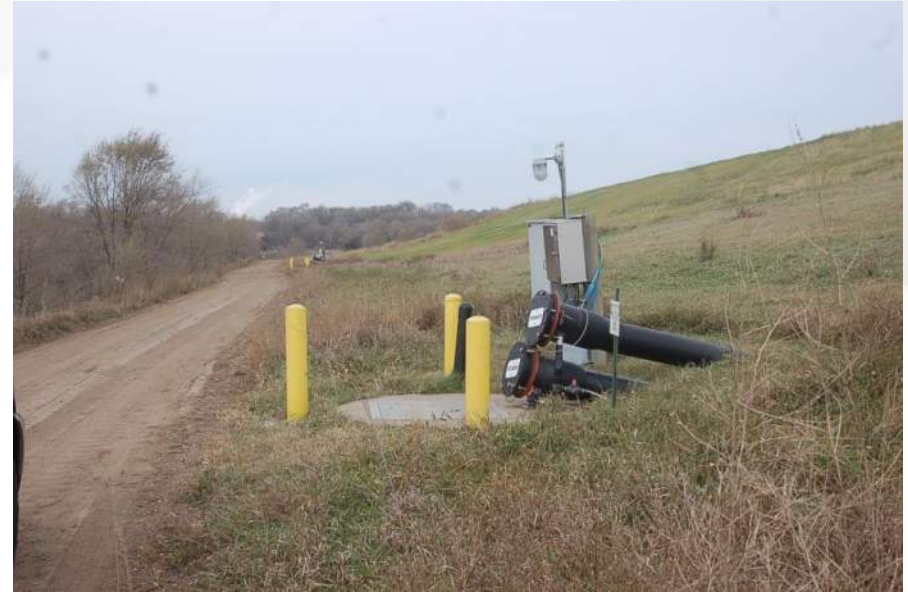
Photo 52 - Cell 2A/2B South Perim Rd/LF Toe

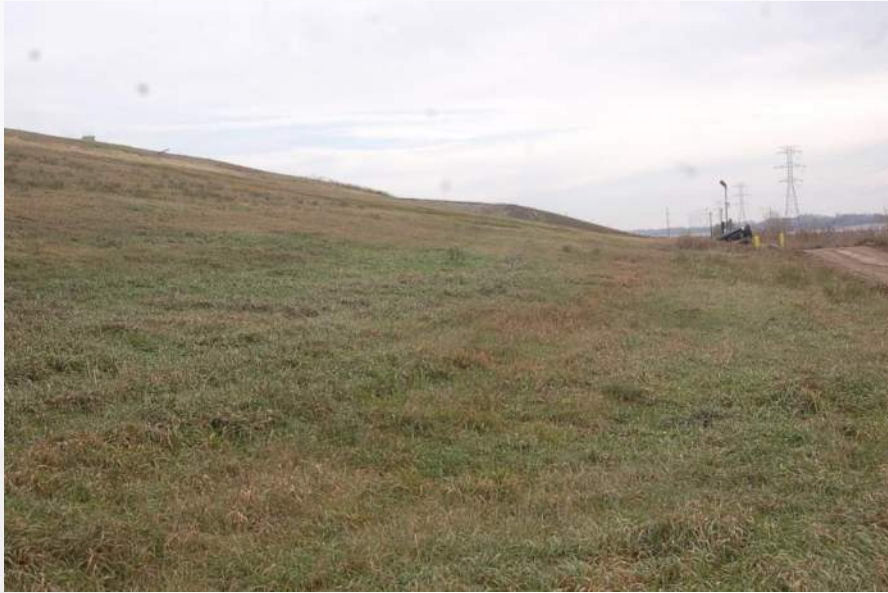
Photo 53 - Cell 2B/2C South Landfill Face

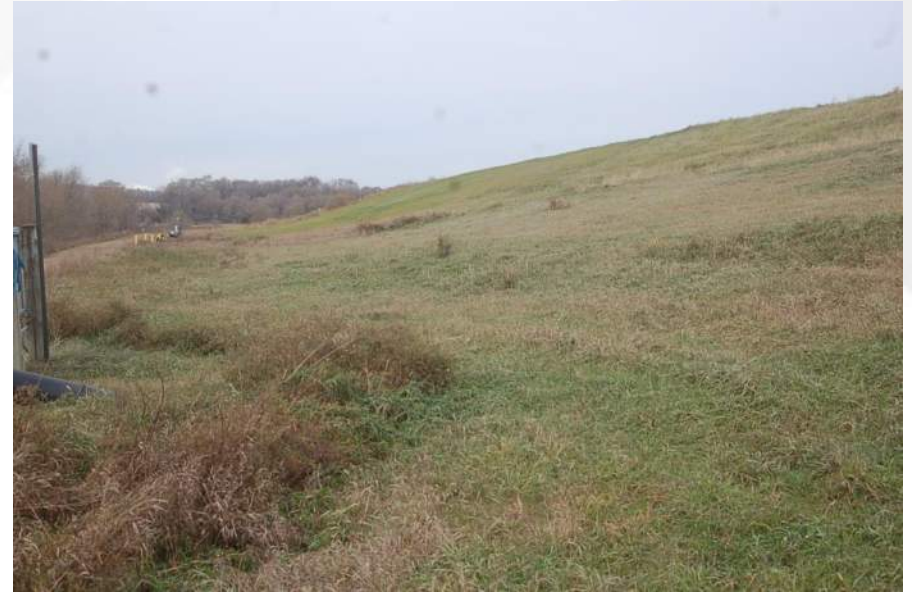
Photo 54 - Cell 2A/2B South Landfill Face

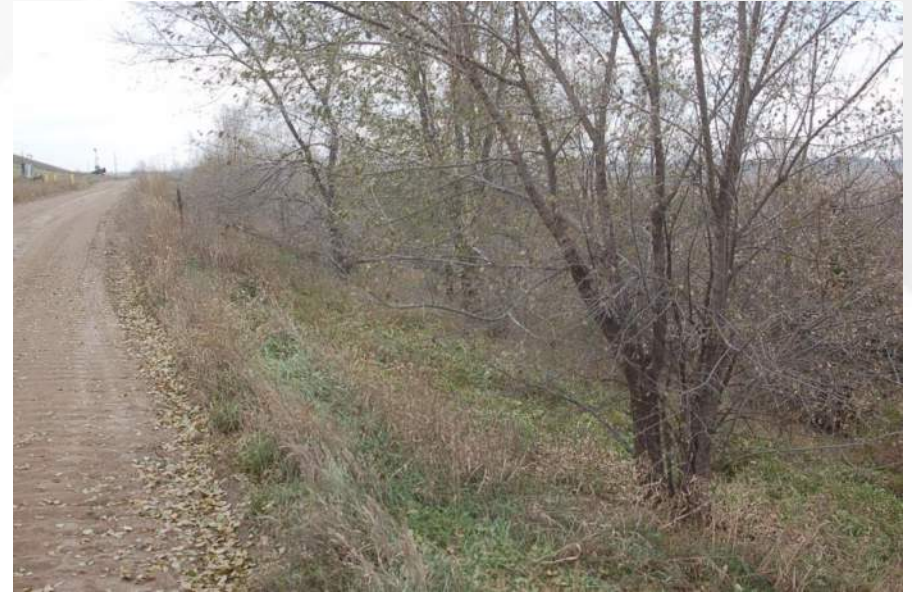
Photo 56 - Cell 2A South Perimeter Berm

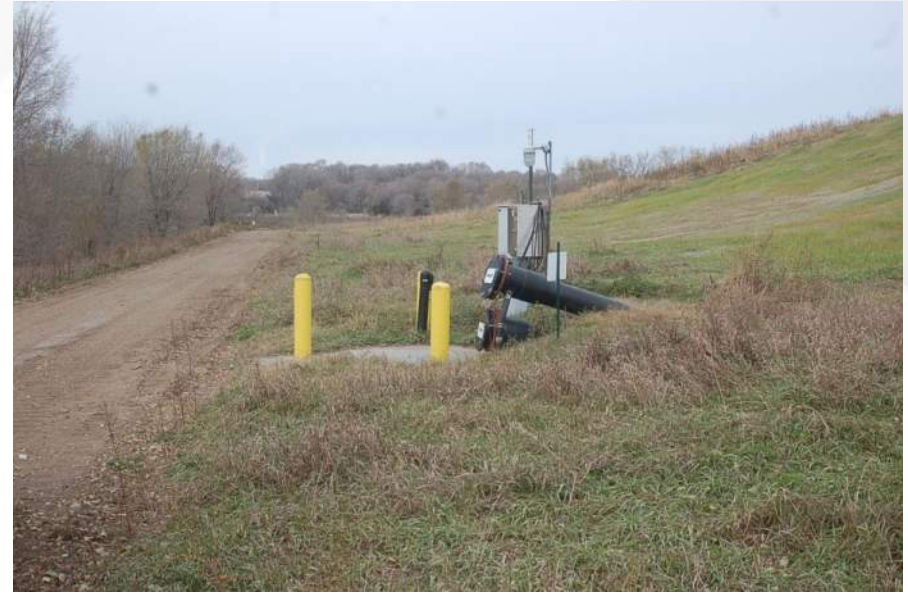
Photo 58 - Cell 2A South Perim Rd/LF Toe

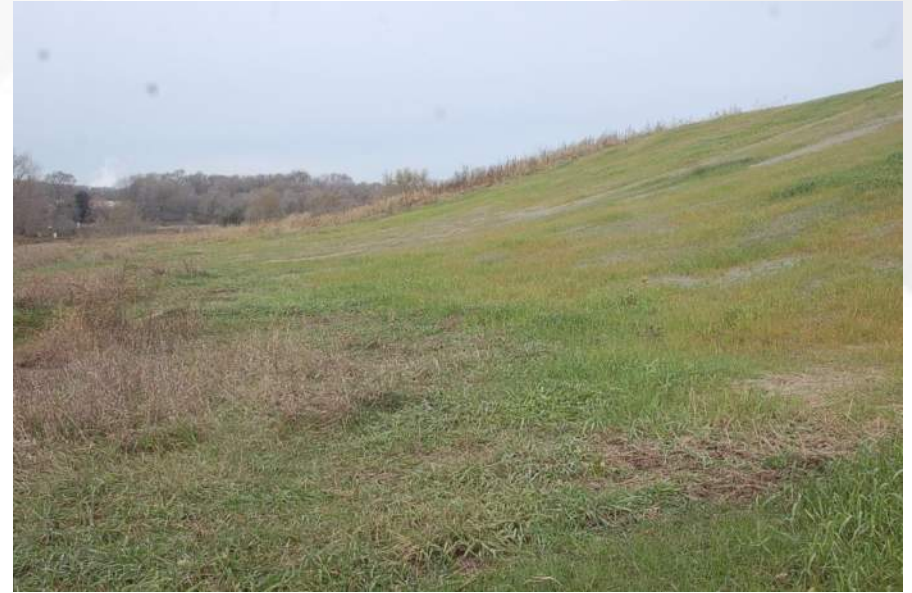
Photo 60 - Cell 2A South Landfill Face

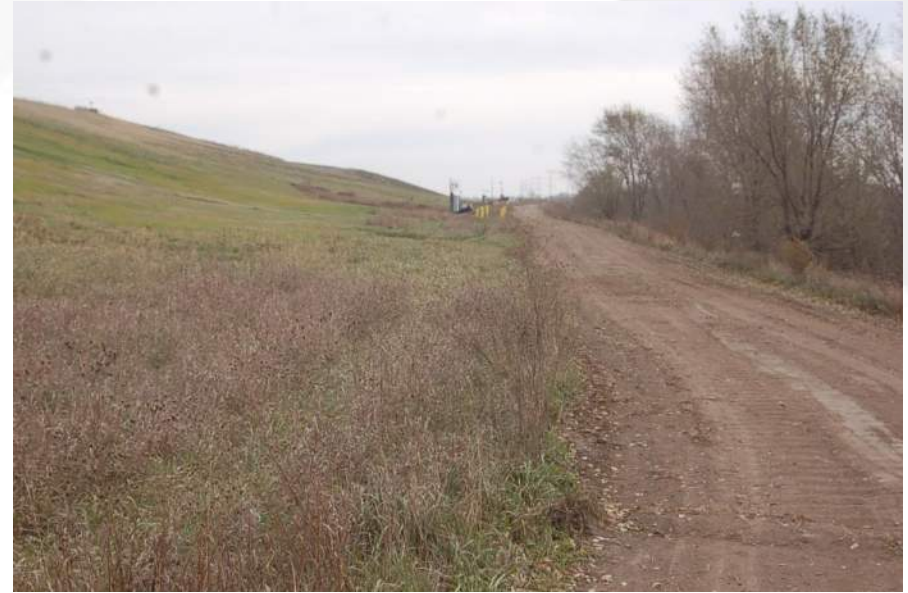
Photo 62 - Cell 2A South Perim Rd/LF Toe

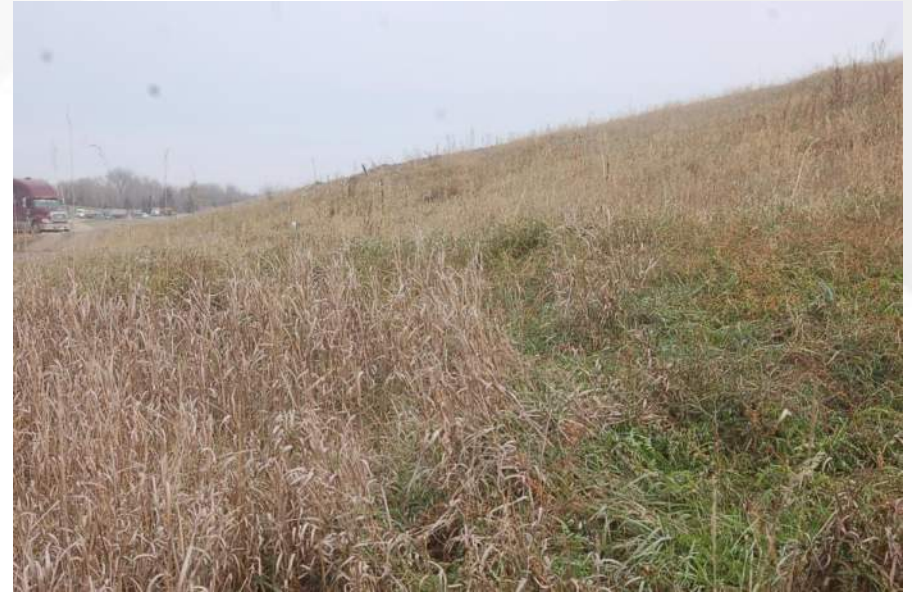
Photo 64 - Cell 2A West Landfill Face

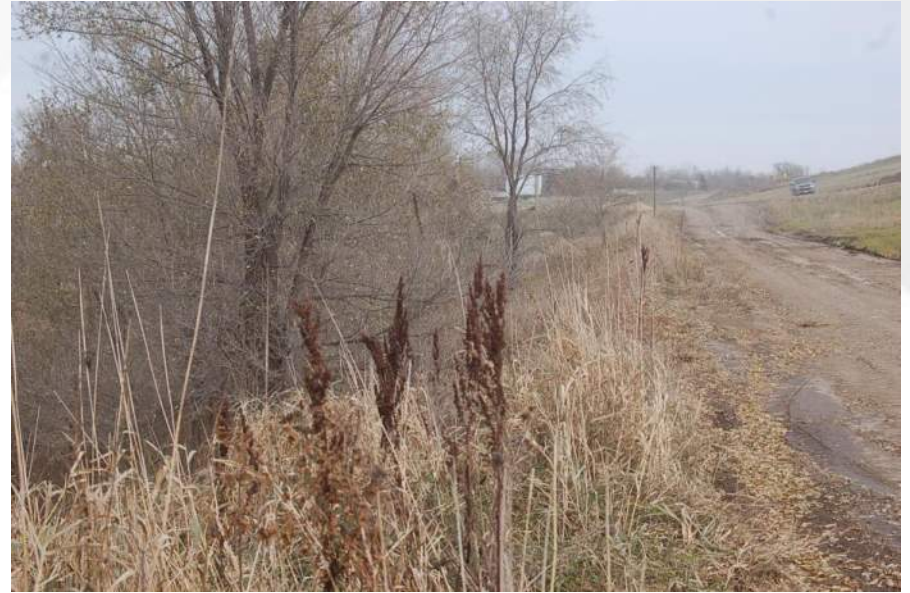
Photo 66 - Cell 2A West Perimeter Berm

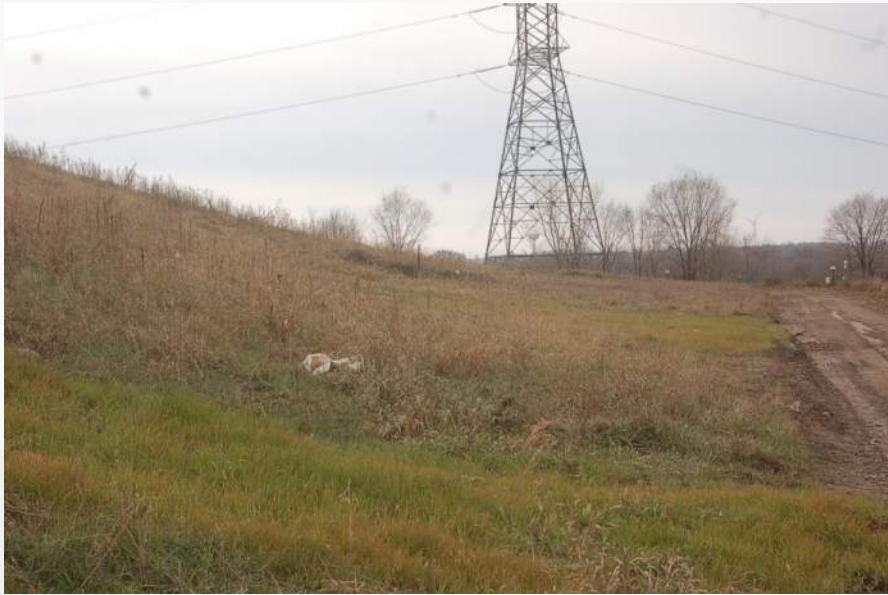
Photo 67- Cell 2A West Landfill Face

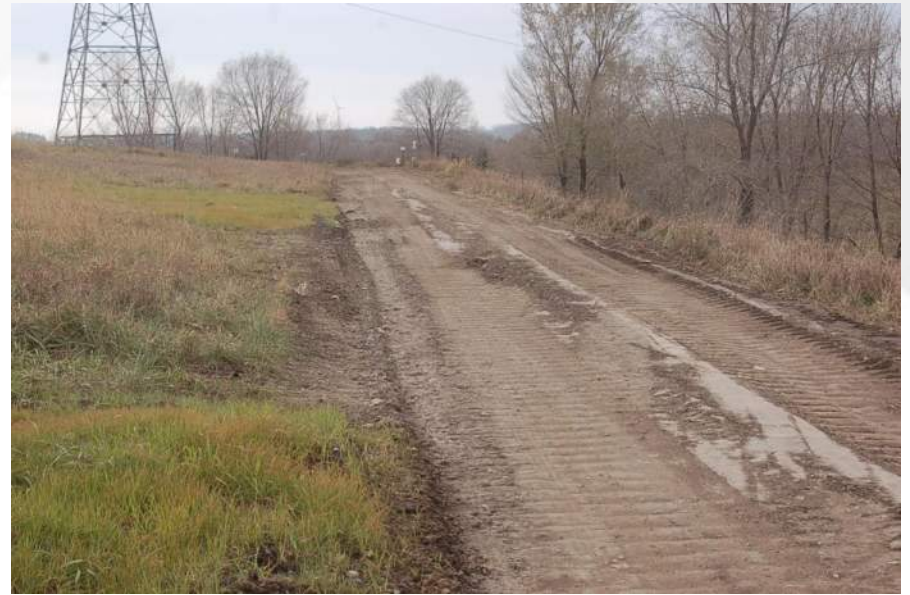
Photo 68 - Cell 2A West Perim RD/LF Toe

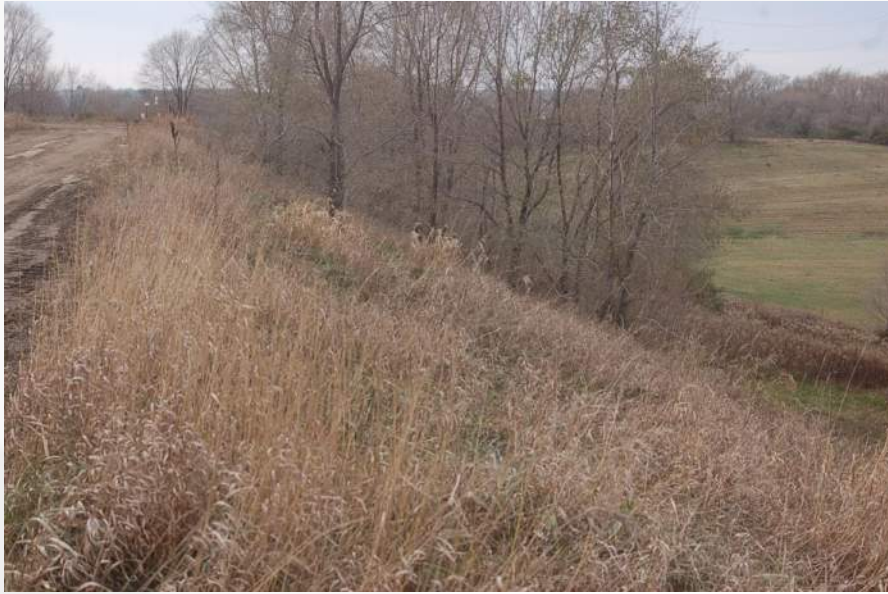
Photo 69 - Cell 2A West Perimeter Berm

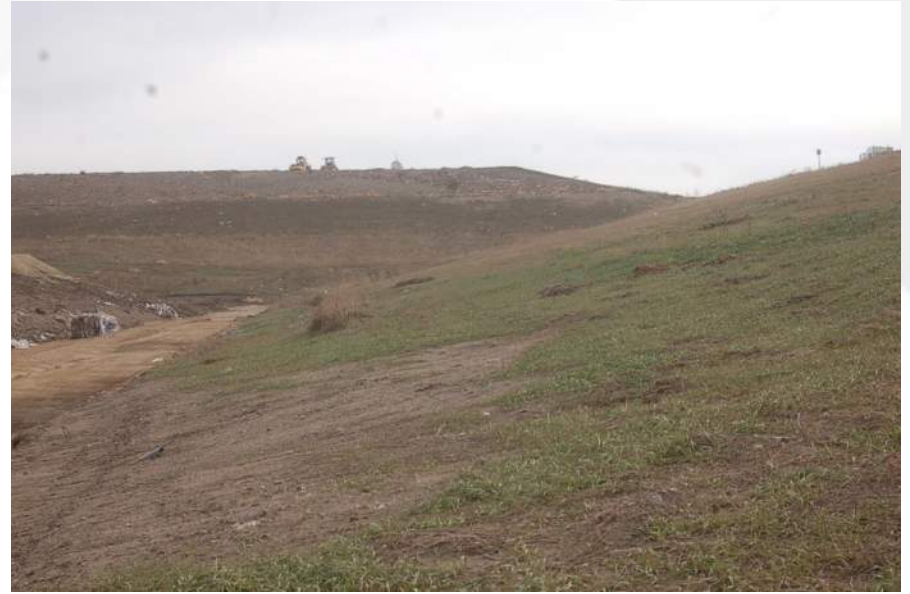
Photo 70 - Cell 2A North Landfill Face

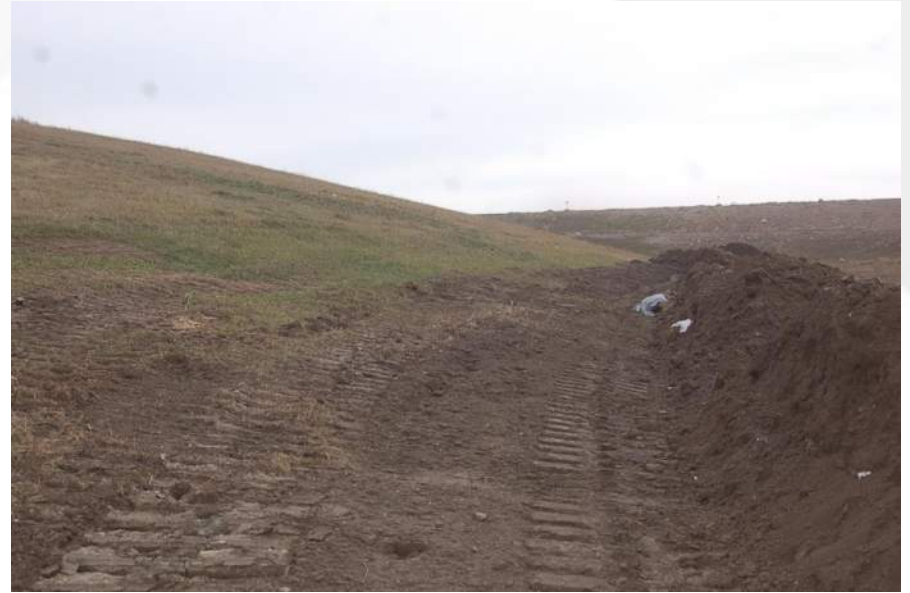
Photo 72 - Cell 1 South Landfill Face

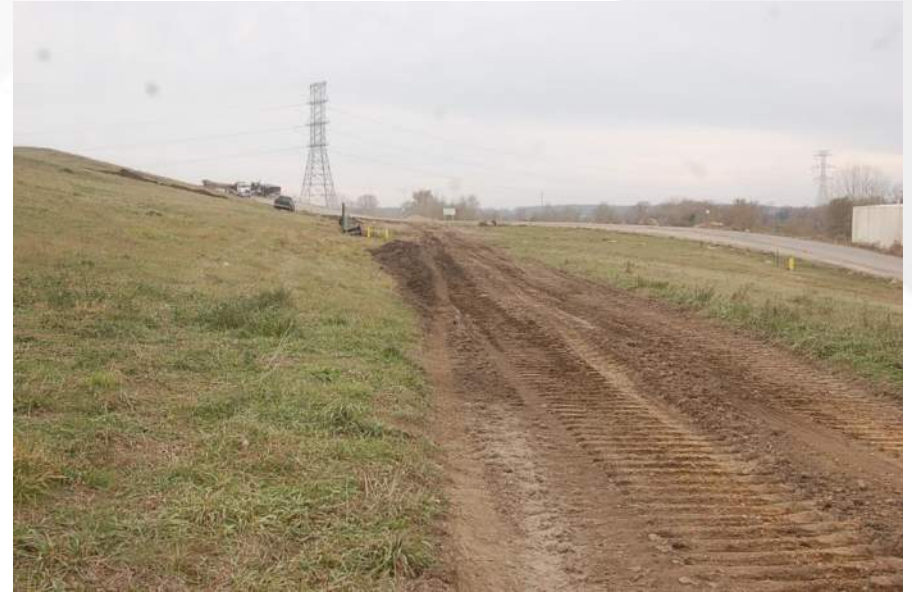
Photo 74 - Cell 1 West Perimeter Rd/LF Toe
