Technical Memo

Date: January 9, 2019

Subject: SKB Rosemount Industrial Waste Facility – 2018 Annual CCR Inspection
Wenck Project # B3053-0138

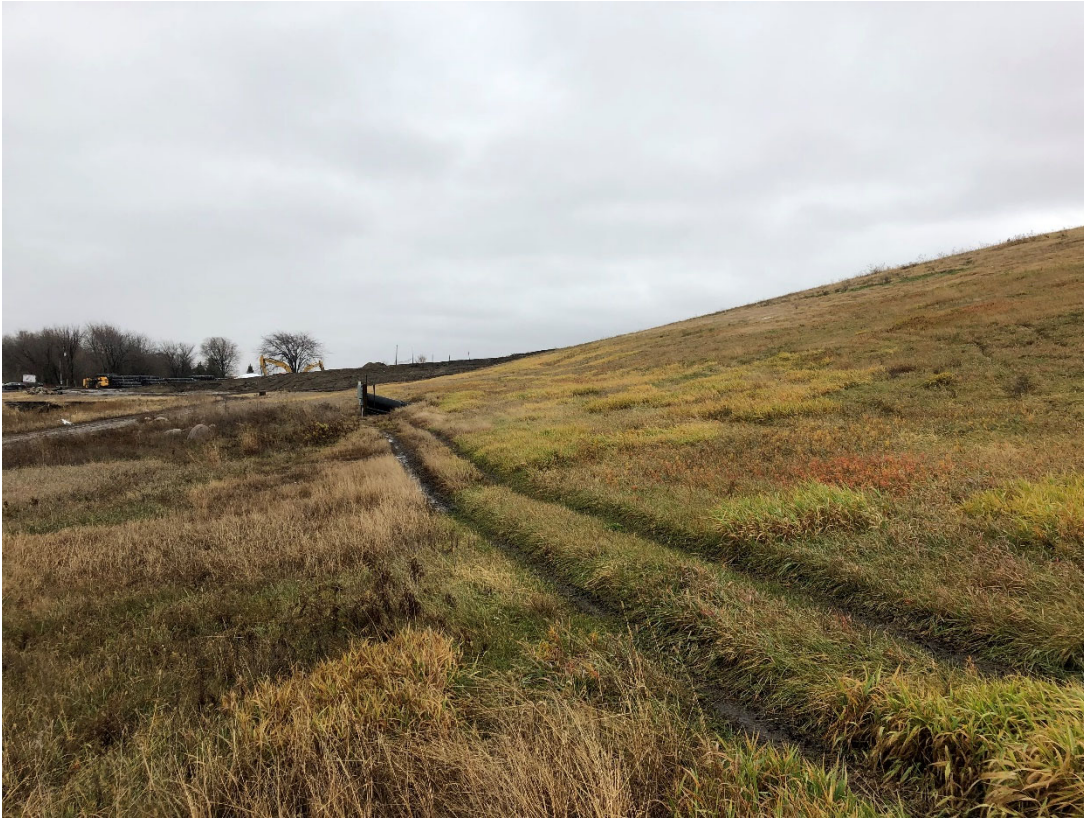
Photo 1: Location 1 – Looking Southeast, Cell 3A & 3B Waste Slope & Anchor Trench

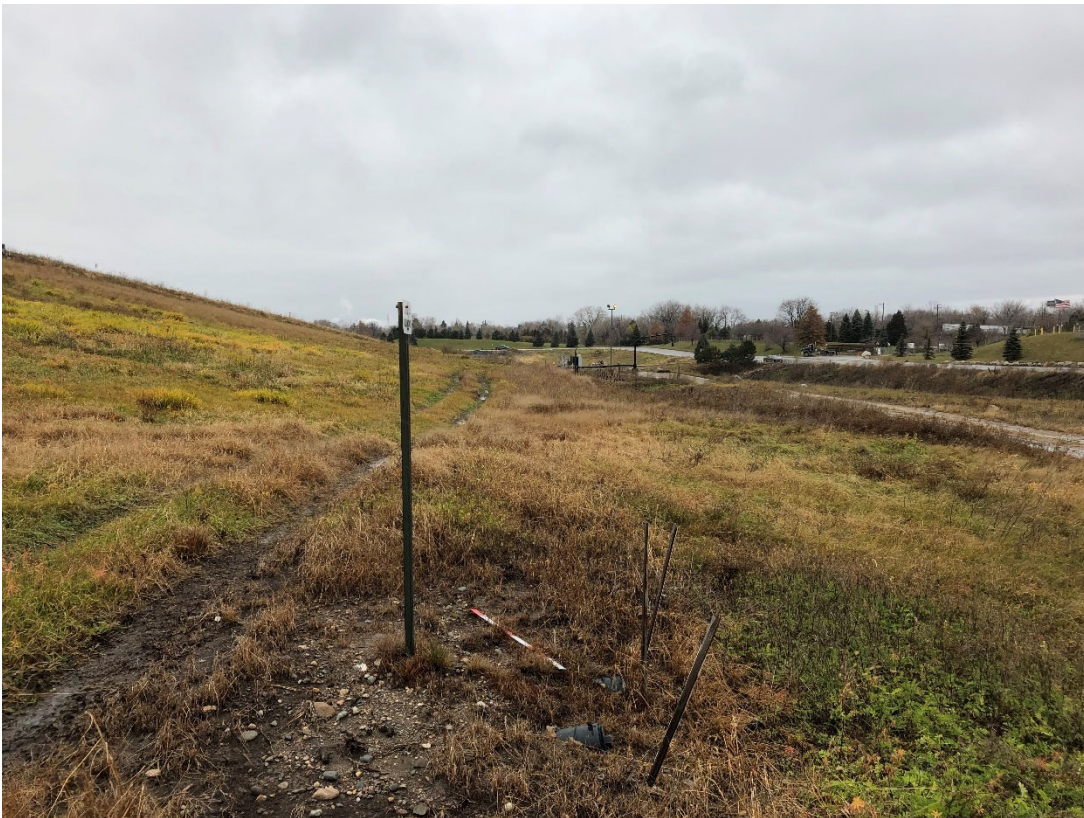
Photo 2: Location 1 – Looking Northwest, Cell 3 Berm

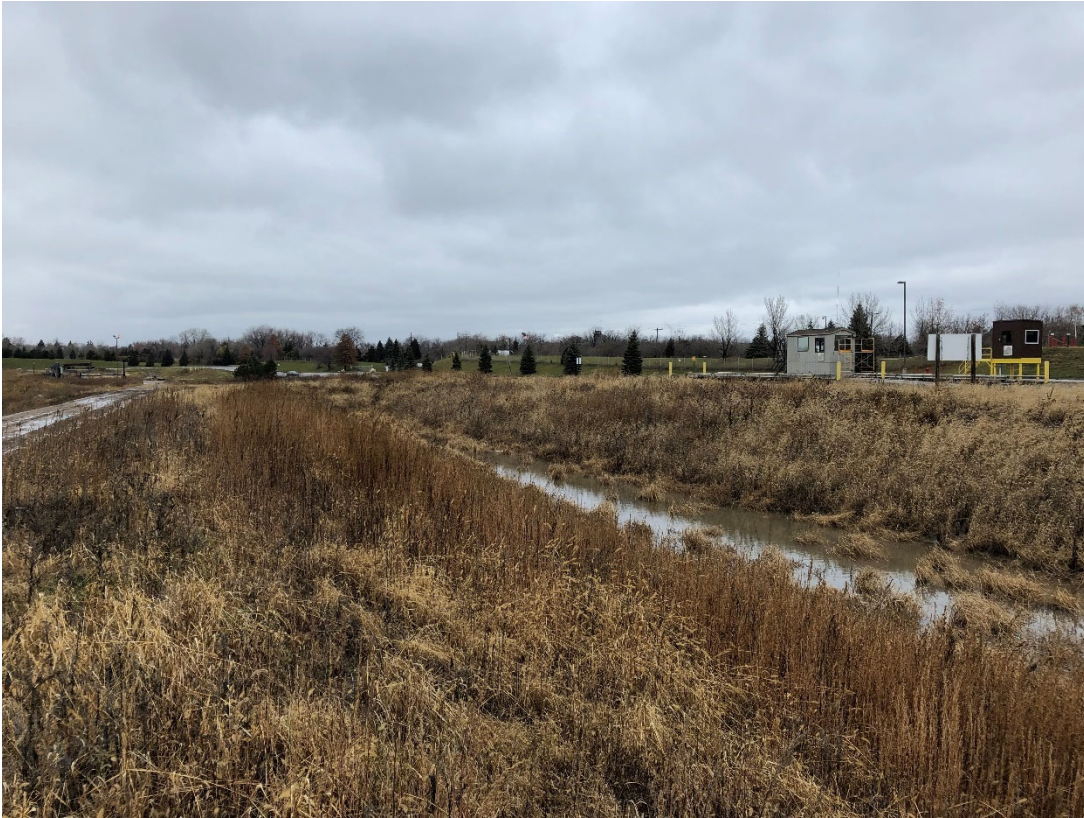
Photo 3: Location 2 – Looking Northwest, Cell 3 Berm & Stormwater Pond

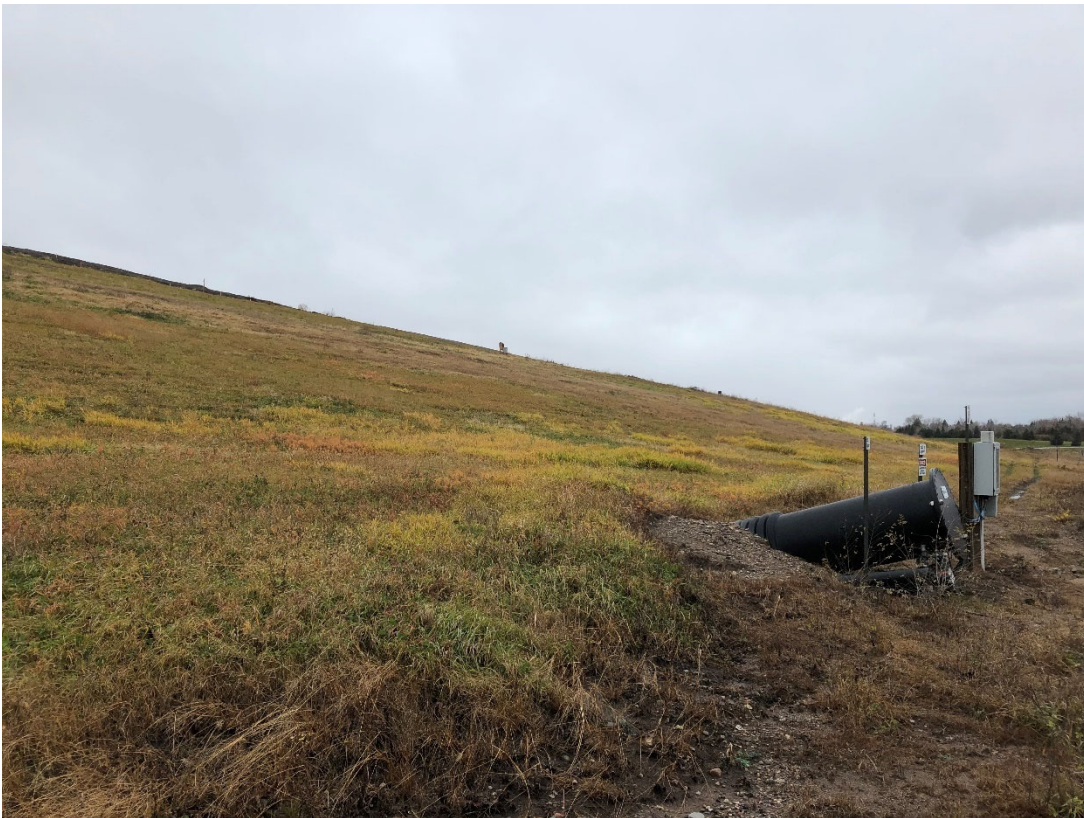
Photo 4: Location 2 – Looking Northwest, Cell 3 Anchor Trench and Waste Slope

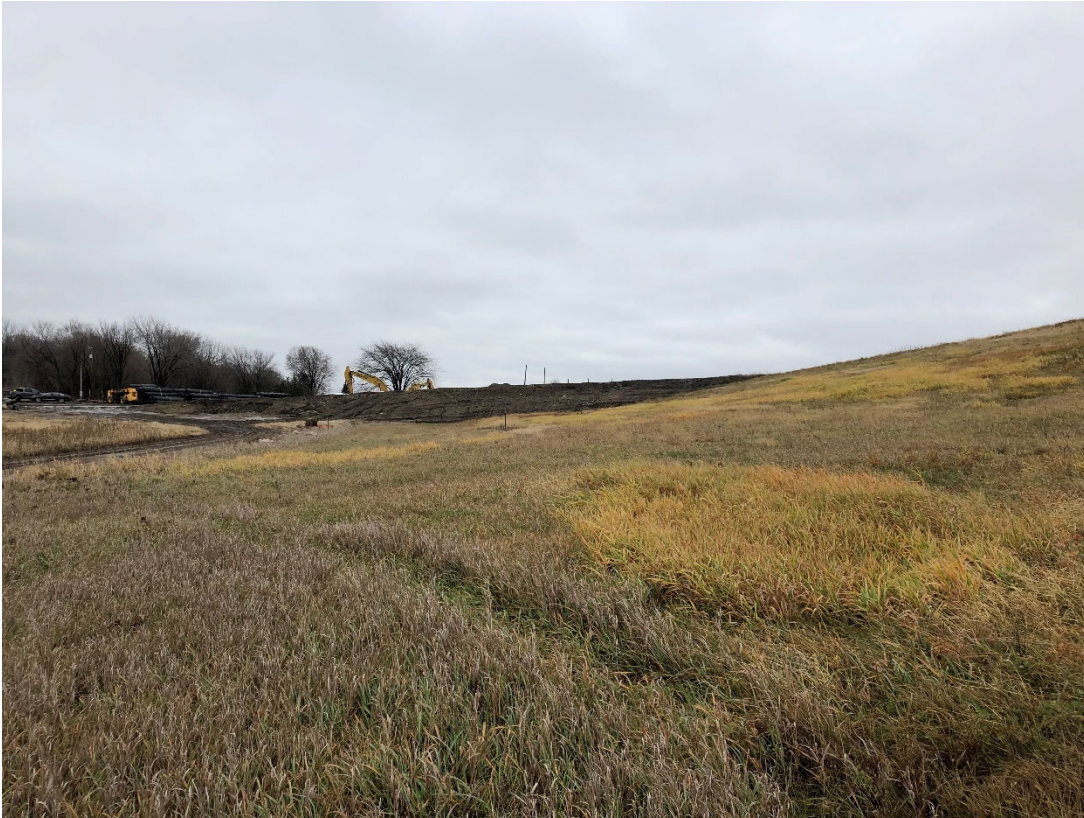
Photo 5: Location 2 – Looking Southeast, Phase 3A Anchor Trench and Northeastern Waste Slope

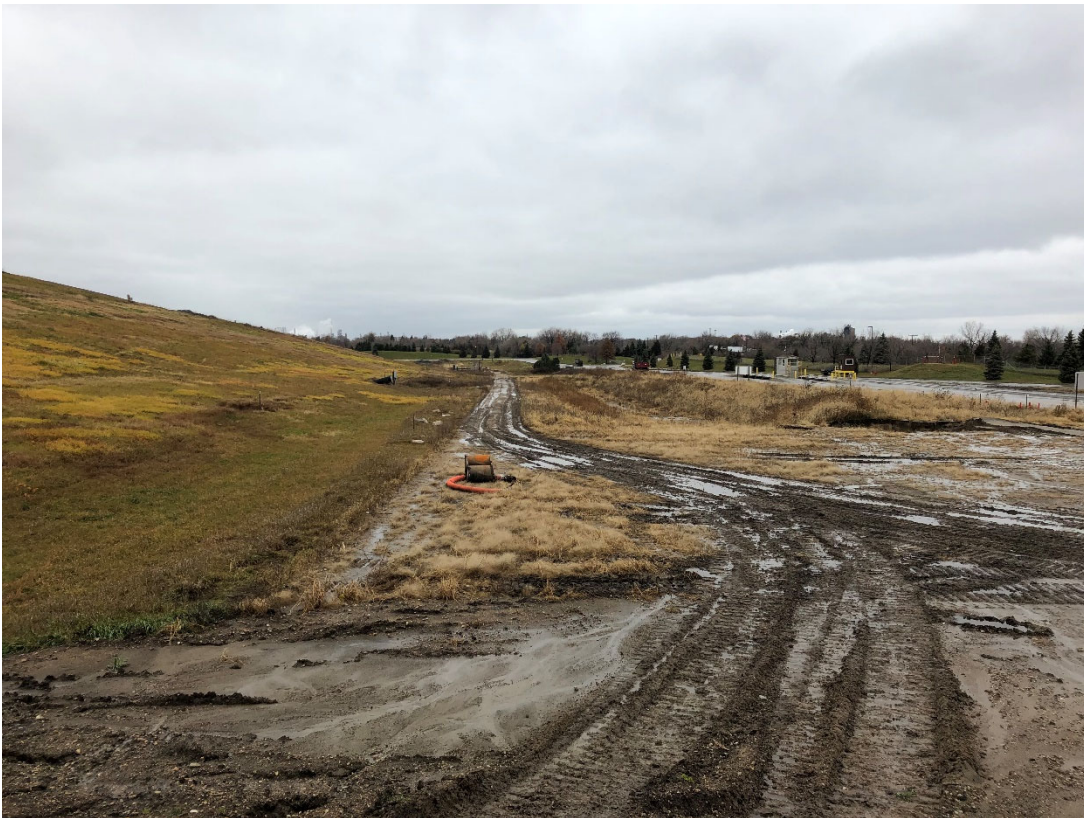
Photo 6: Location 3 – Looking Northwest, Phase 3A Anchor Trench and Northeastern Waste Slope

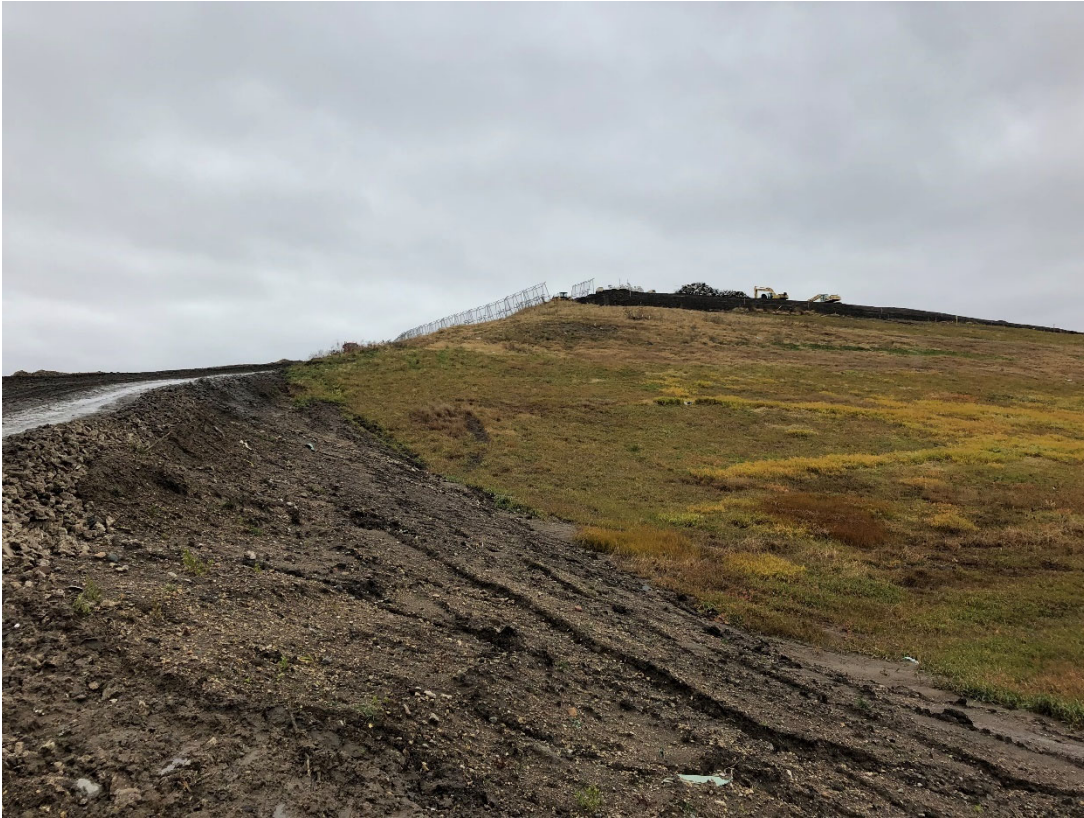
Photo 7: Location 3 – Looking West, Phase 3 East Corner & Interior Access Road

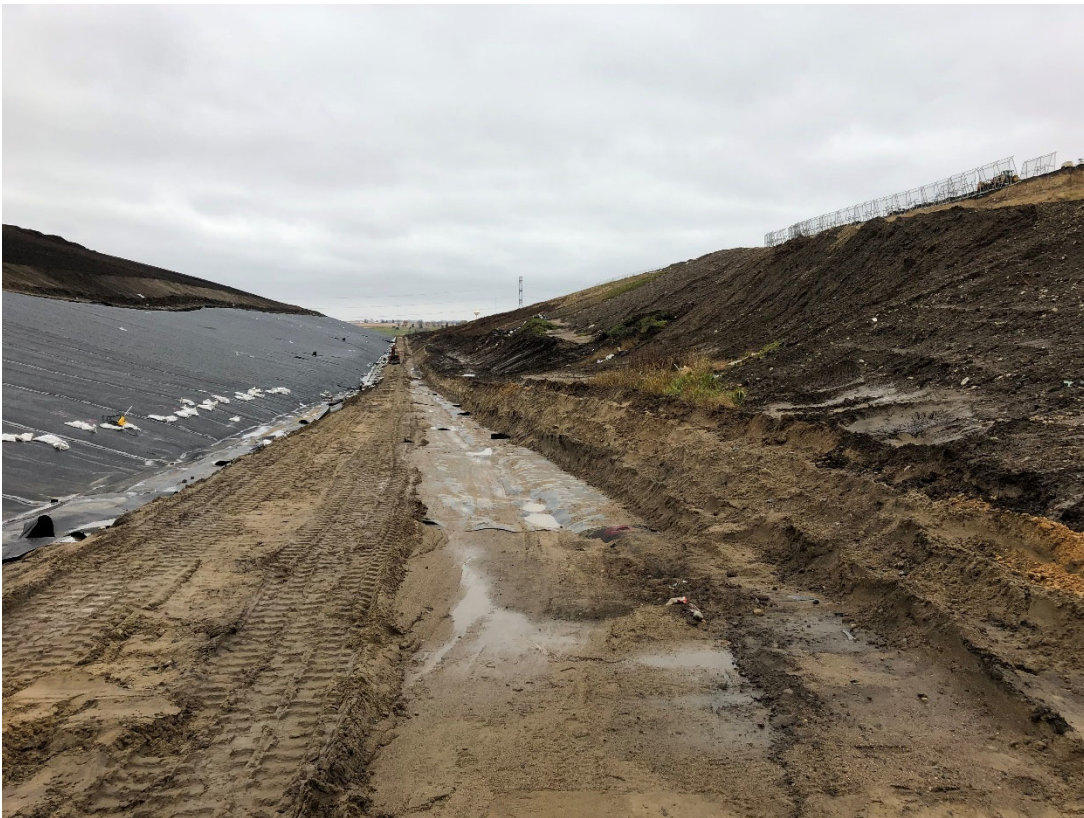
Photo 8: Location 3 – Looking Southwest, Southeastern Slope, Anchor Trench & New Liner Construction

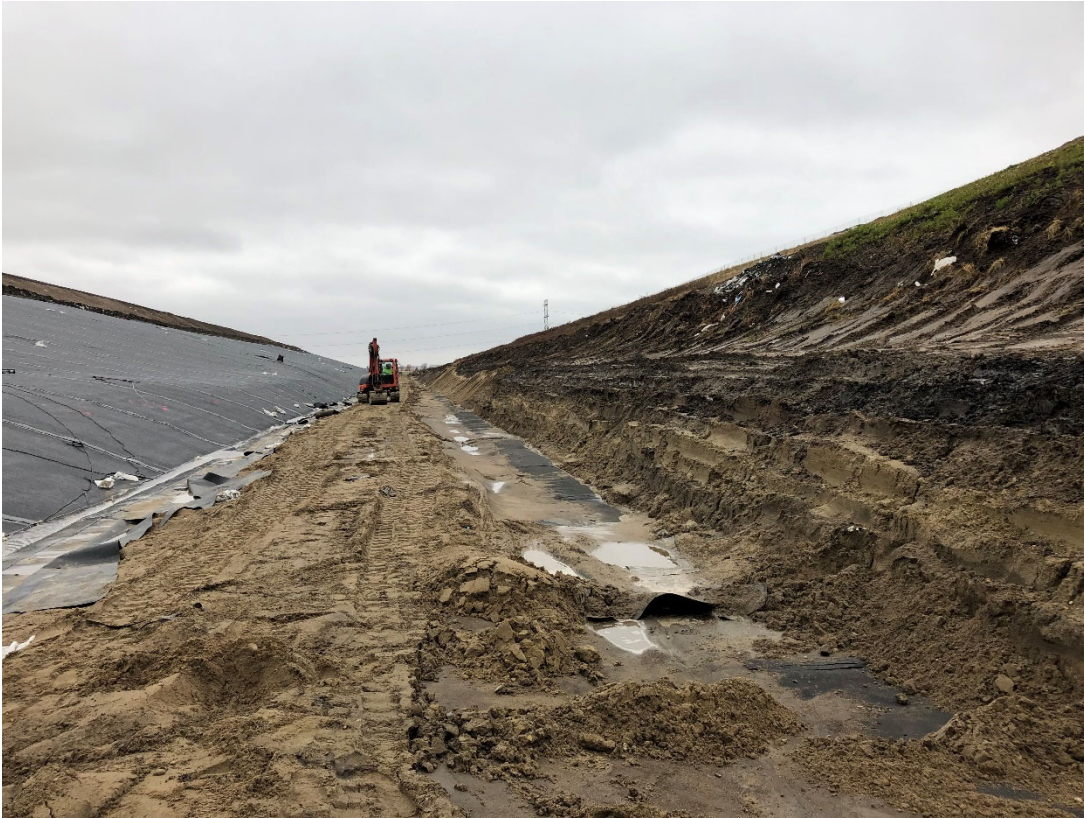
Photo 9: Location 4 – Looking Southwest, Southeastern Slope, Anchor Trench & New Liner Construction

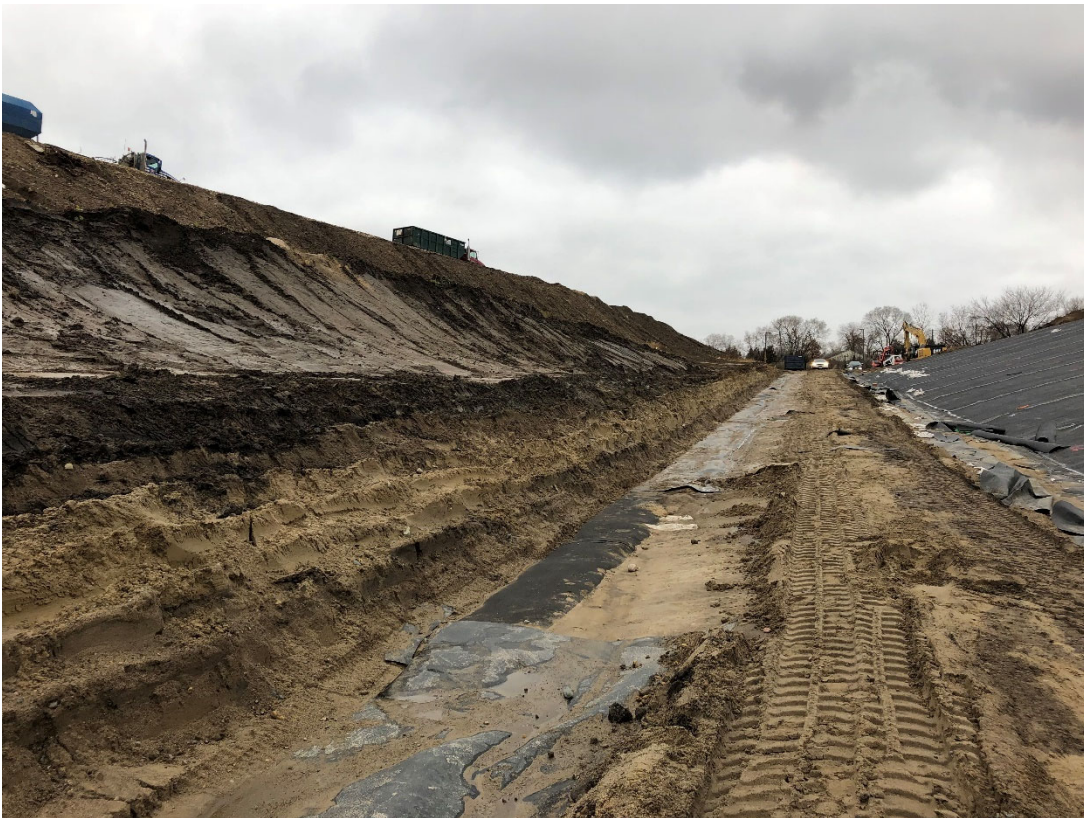
Photo 10: Location 4 – Looking Northeast, Southeastern Slope, Anchor Trench & New Liner Construction

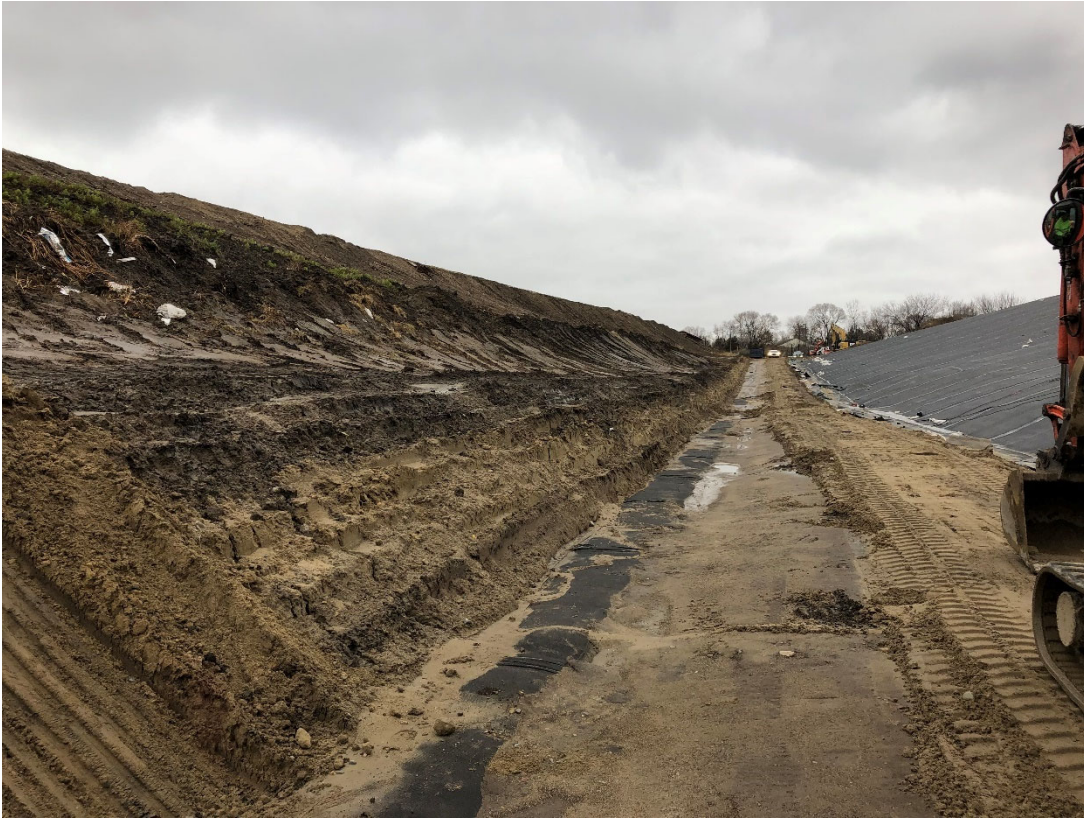
Photo 11: Location 5 – Looking Northeast, Southeastern Slope, Anchor Trench & New Liner Construction

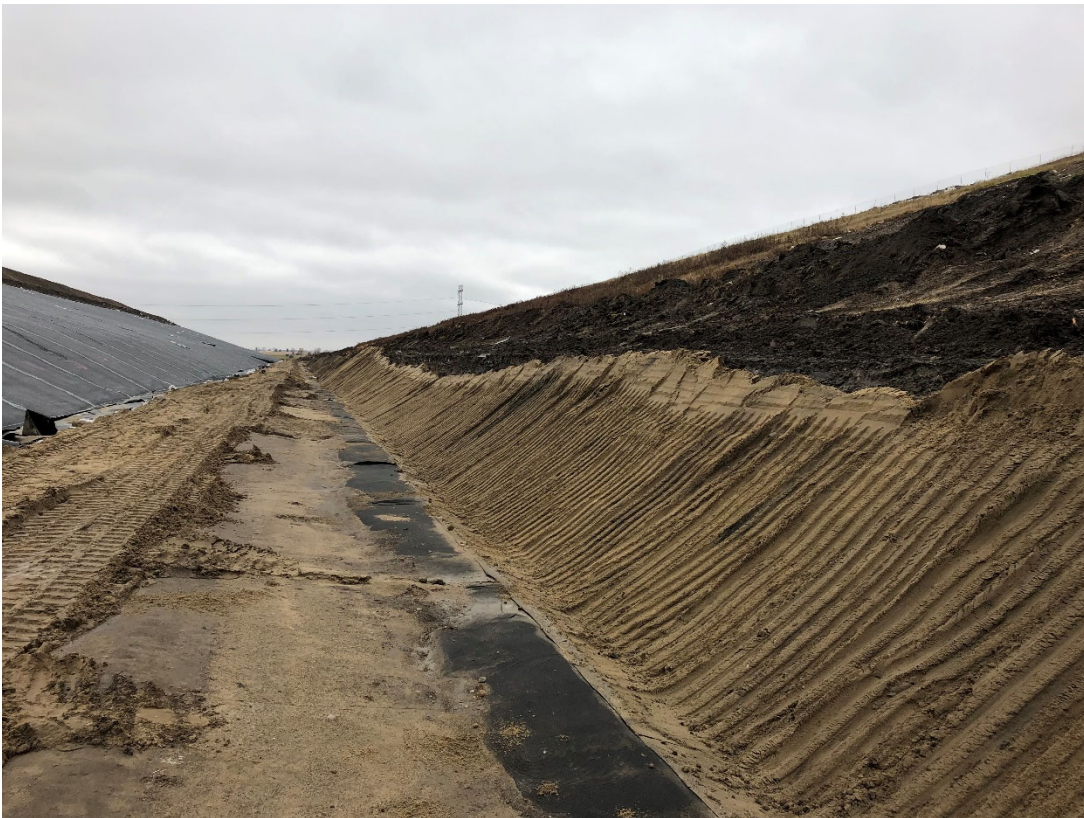
Photo 12: Location 5 – Looking Southwest, Southeastern Slope, Anchor Trench & New Liner Construction

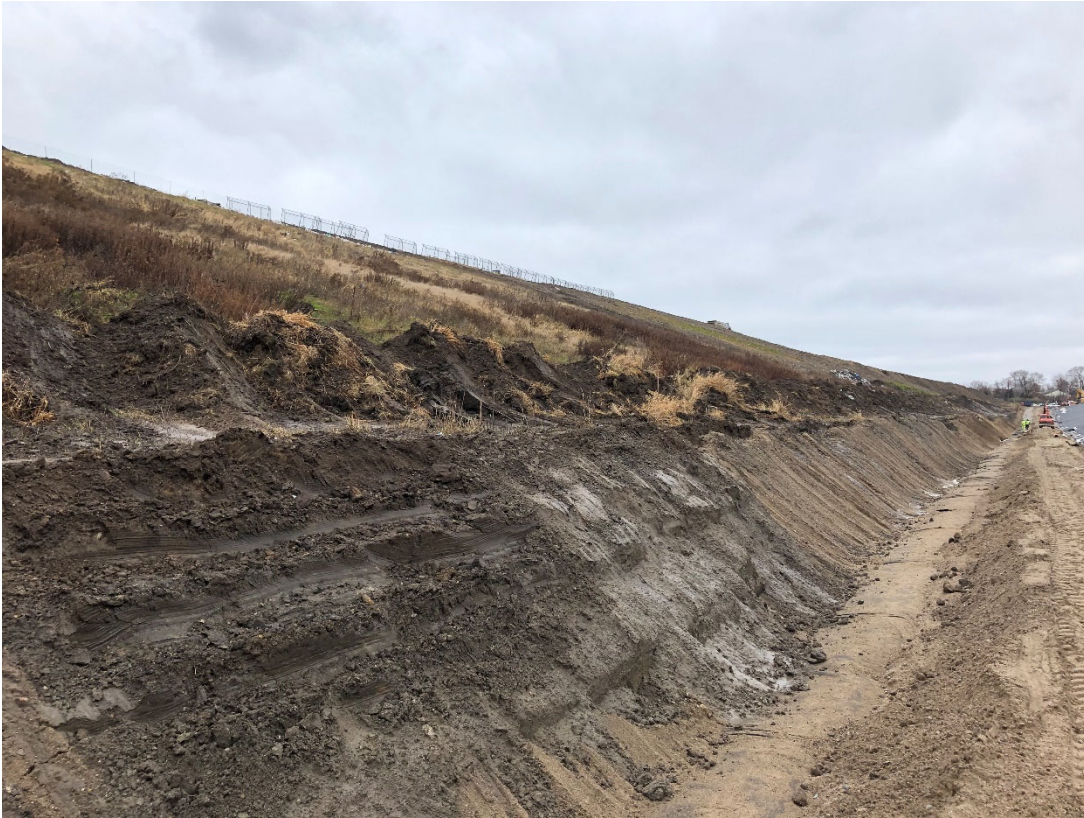
Photo 13: Location 6 – Looking Northeast, Southeastern Slope, Anchor Trench & New Liner Construction

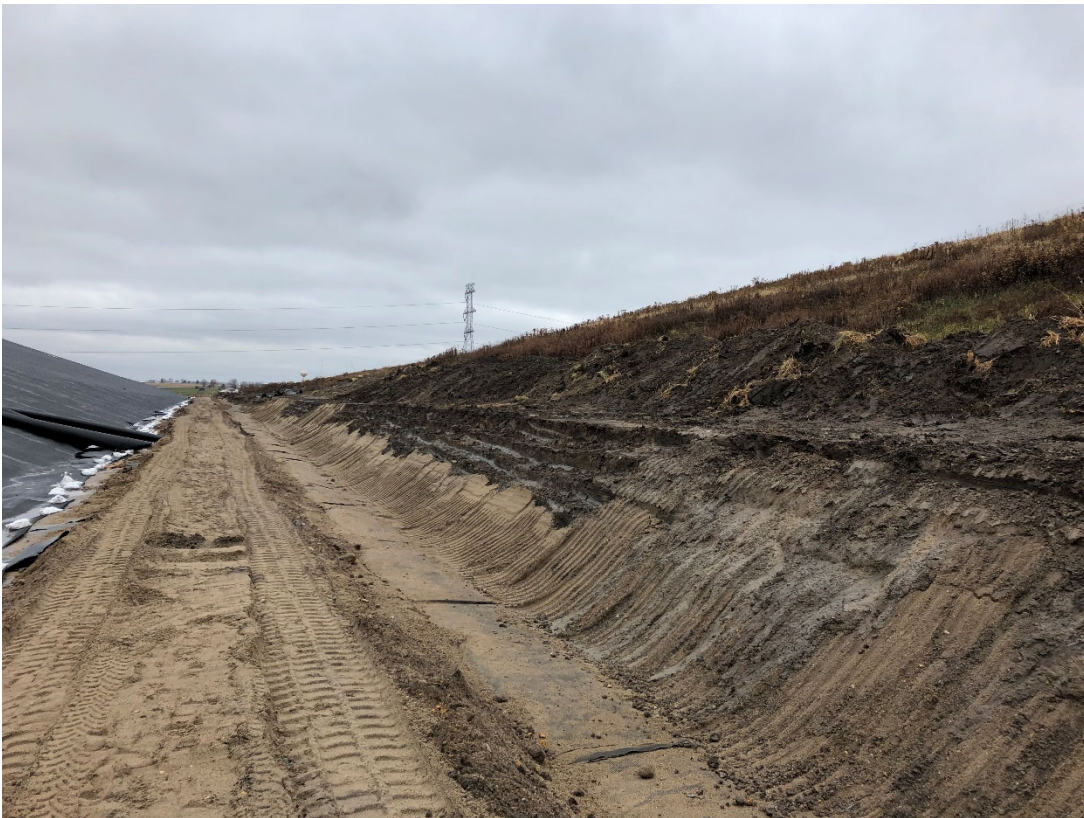
Photo 14: Location 6 – Looking Southwest, Southeastern Slope, Anchor Trench & New Liner Construction

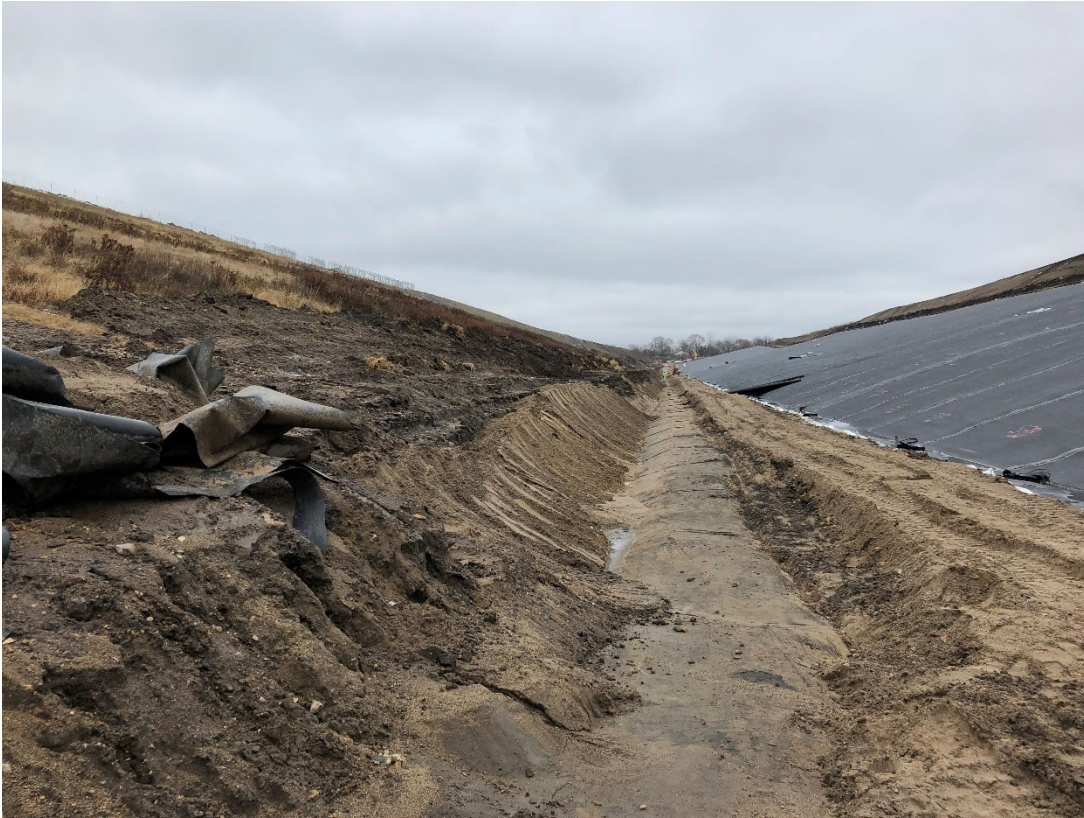
Photo 15: Location 8 – Looking Northeast, Southeastern Slope, Anchor Trench & New Liner Construction

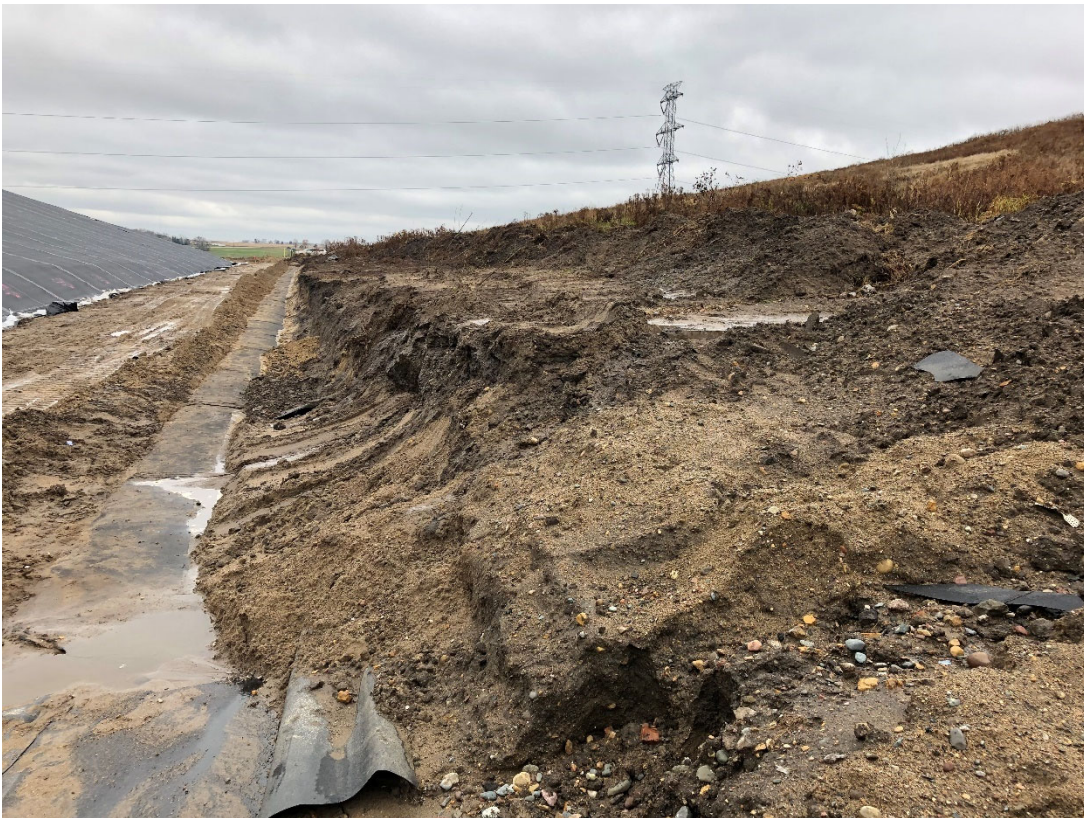
Photo 16: Location 8 – Looking Southwest, Southeastern Slope, Anchor Trench & New Liner Construction

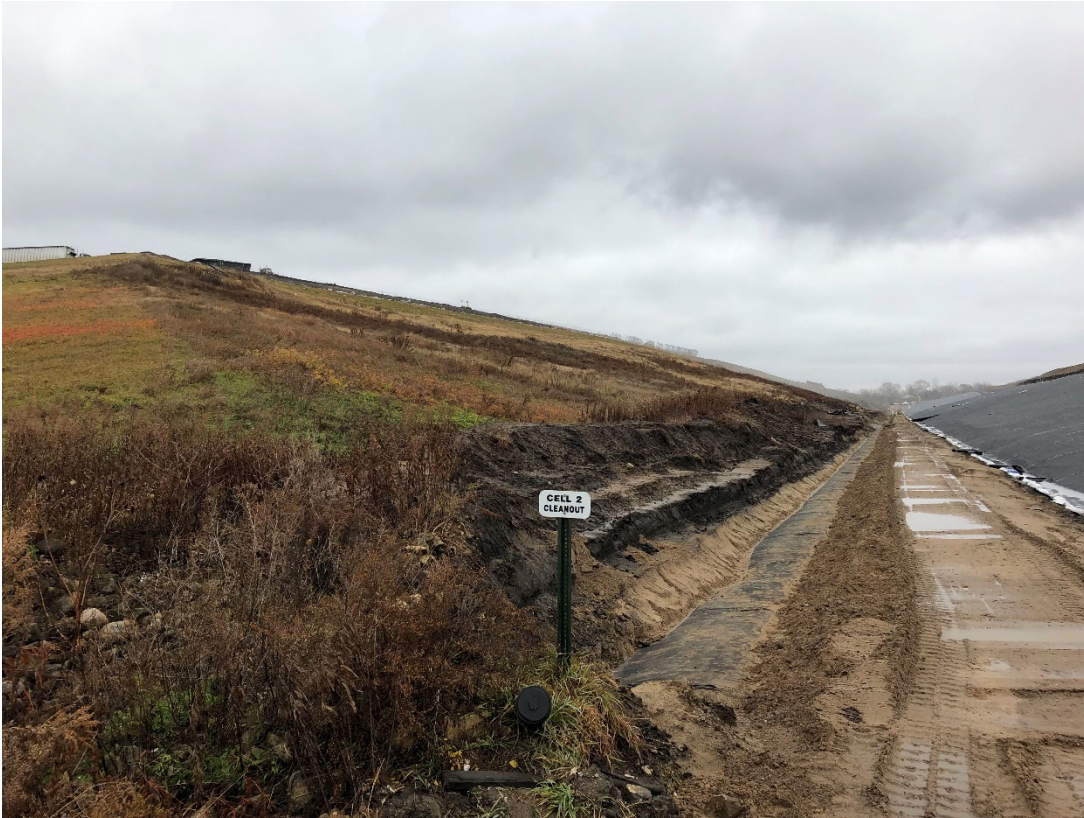
Photo 17: Location 9 – Looking Northeast, Southeastern Slope, Anchor Trench & New Liner Construction

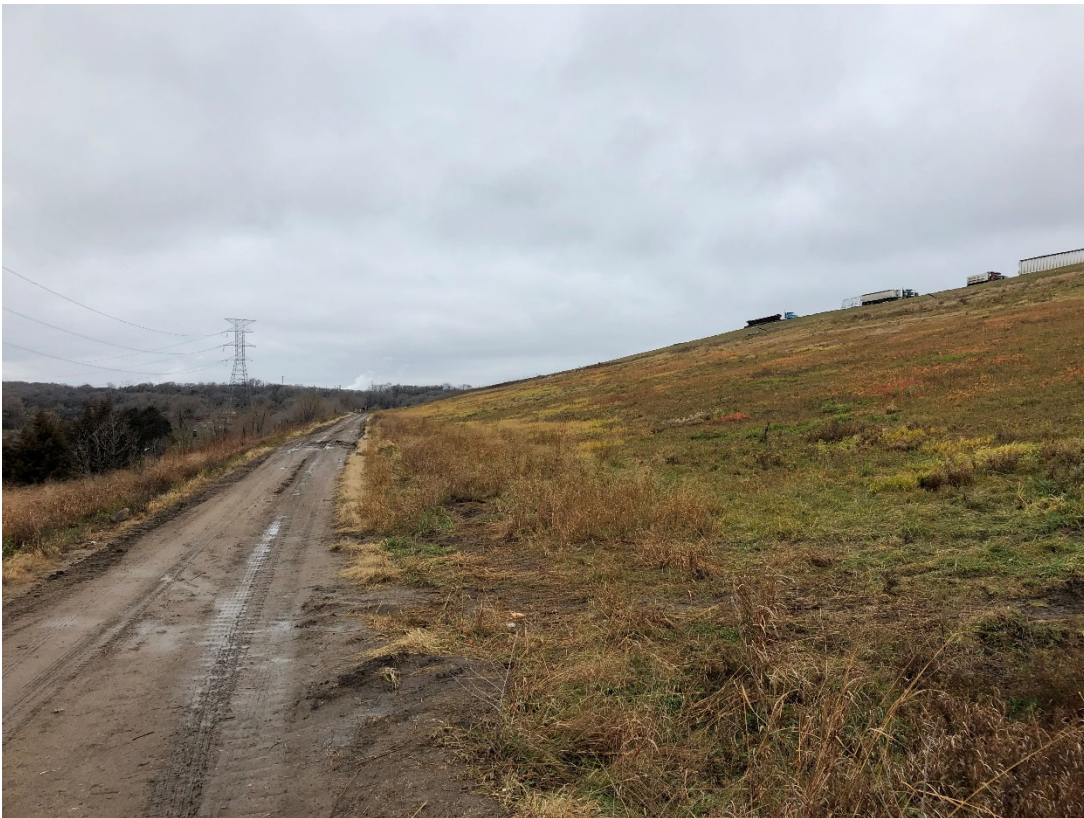
Photo 18: Location 9 – Looking Northwest, Cell 2D Southwestern Slope and Perimeter Road

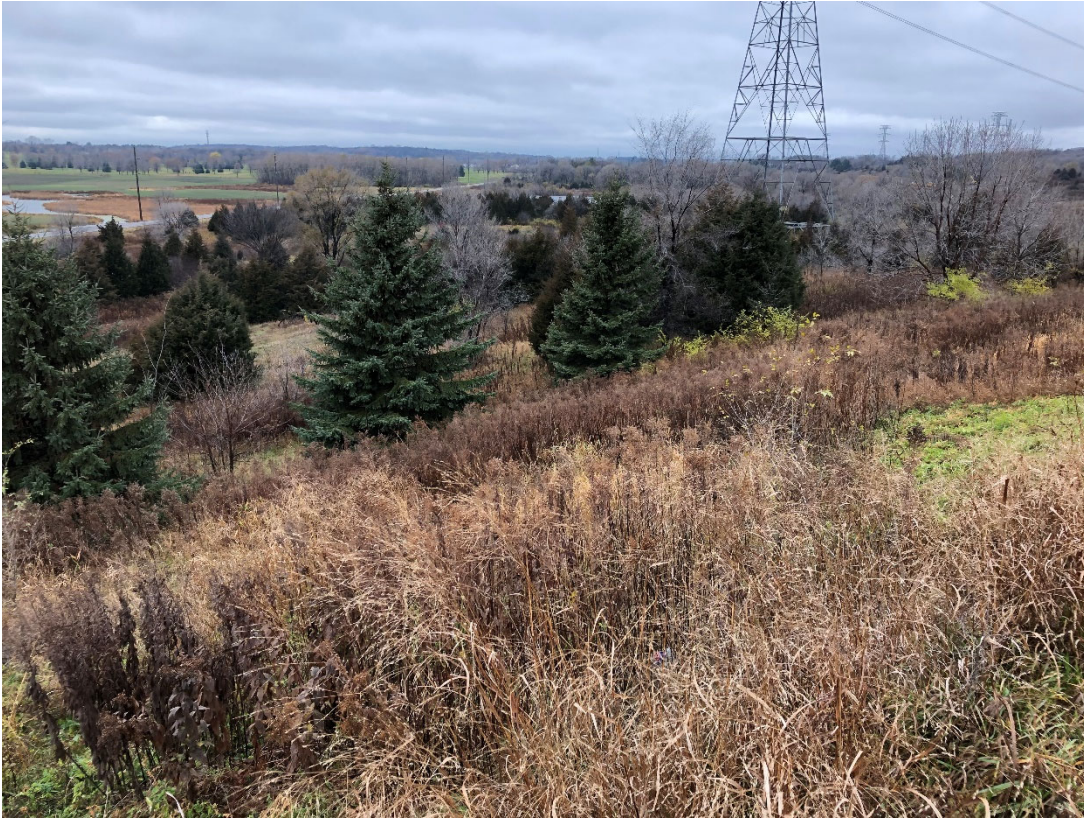
Photo 19: Location 9 – Looking North, Cell 2D Berm

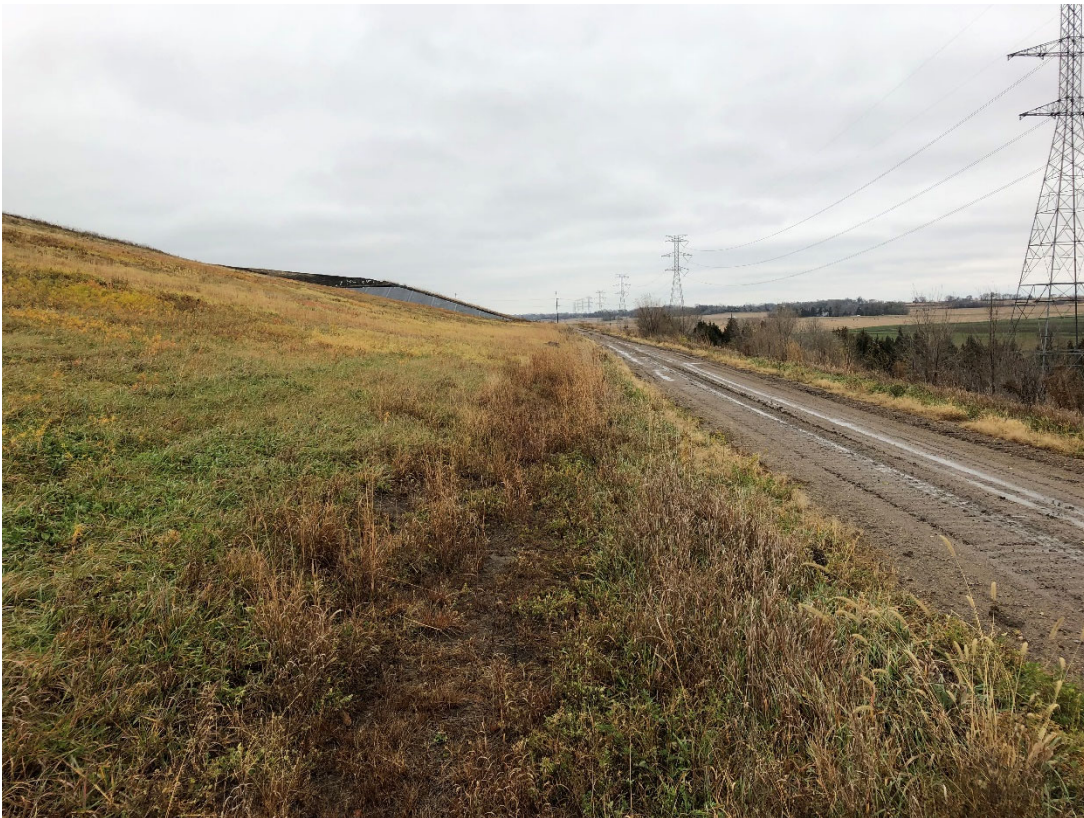
Photo 20: Location 10 – Looking Southeast, Cell 2D Southwestern Slope, Anchor Trench, and Road

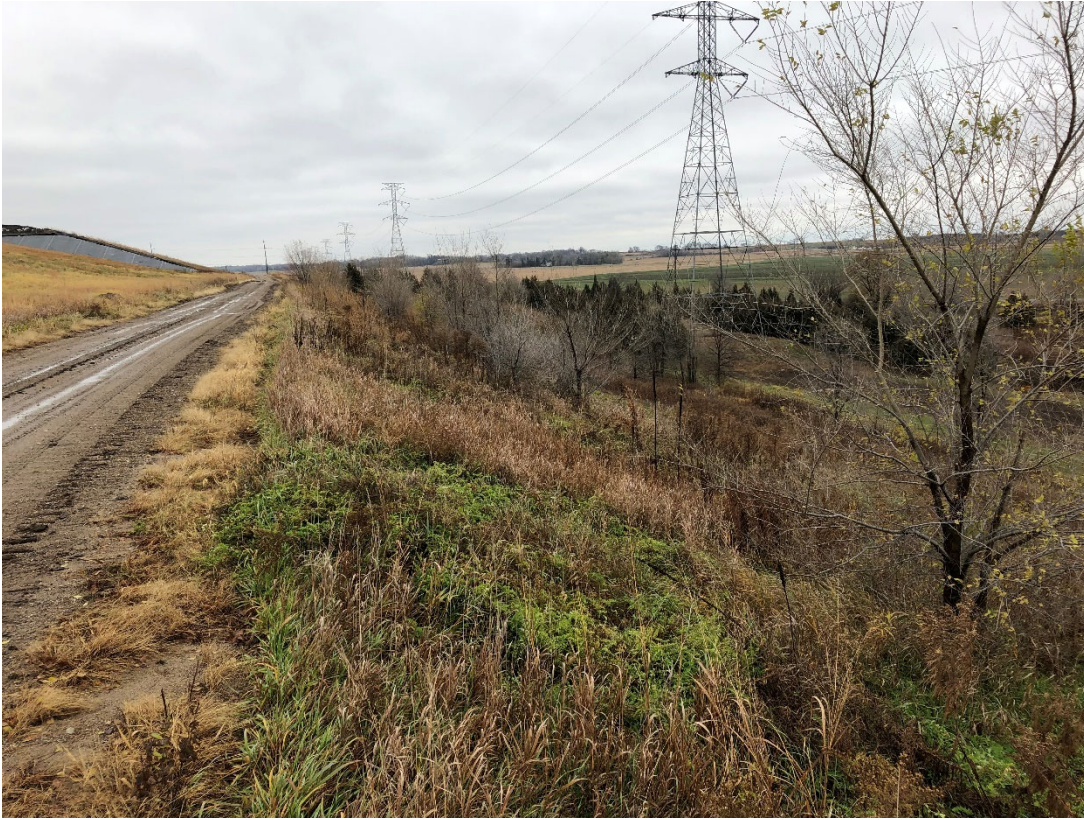
Photo 21: Location 10 – Looking Southeast, Cell 2D Berm

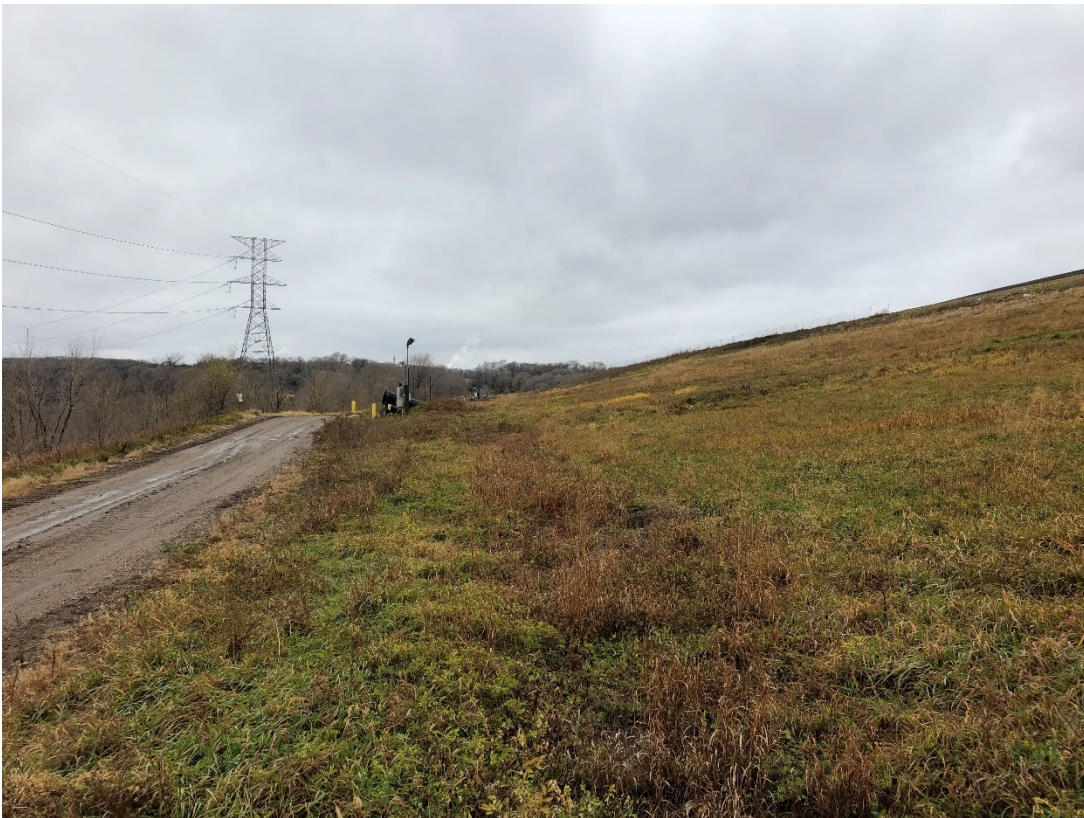
Photo 22: Location 10 – Looking Northwest, Cell 2C Southwestern Slope, Anchor Trench, and Road

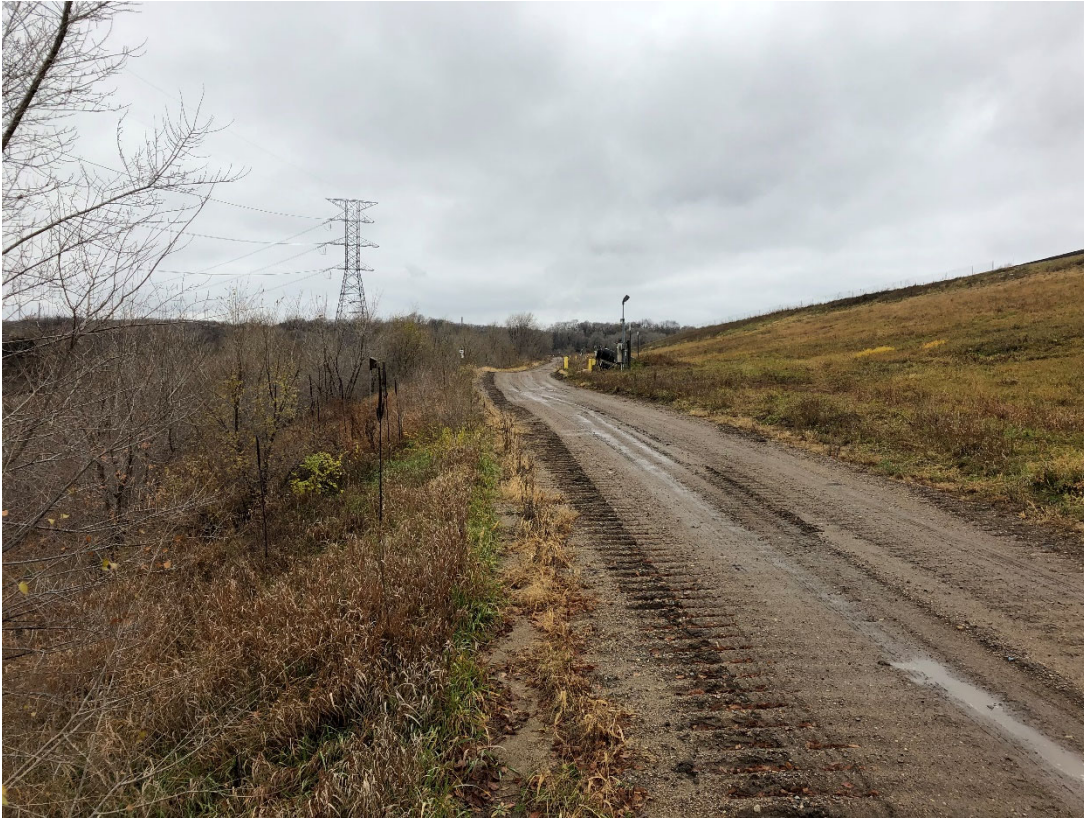
Photo 23: Location 10 – Looking Northwest, Cell 2C Cell 2C Southwestern Berm

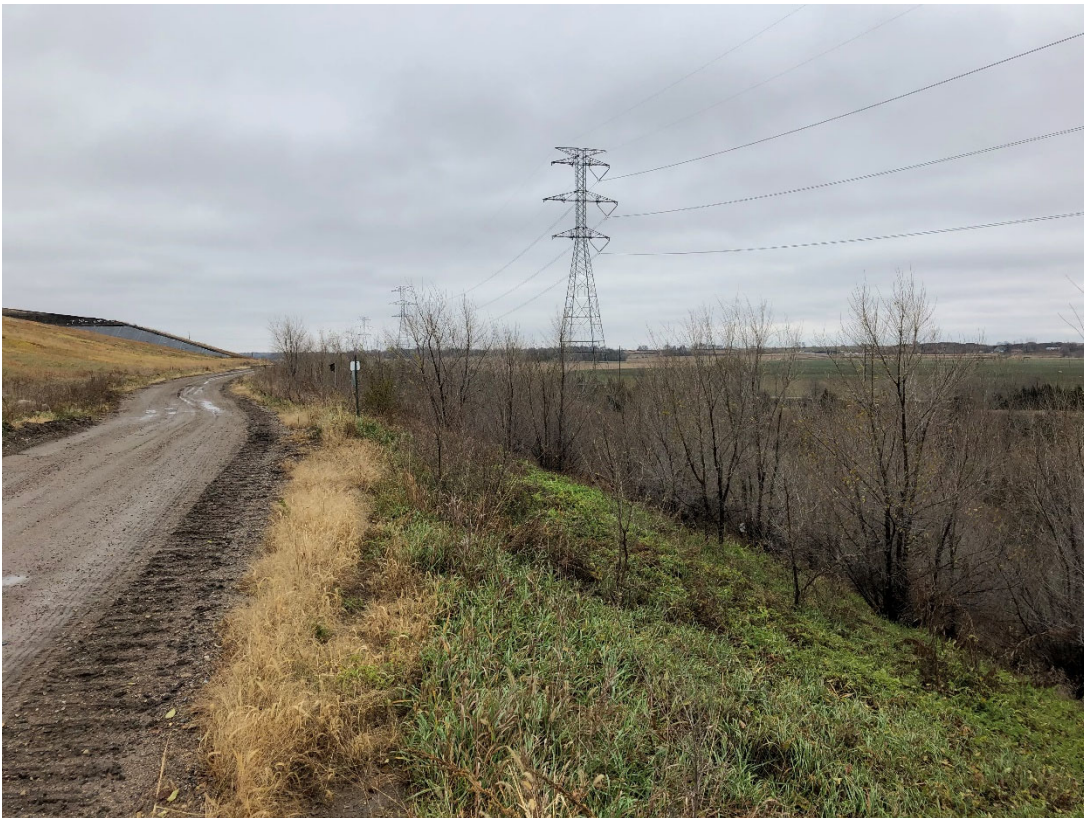
Photo 24: Location 11 – Looking Southwest, Cell 2C Southwestern Berm

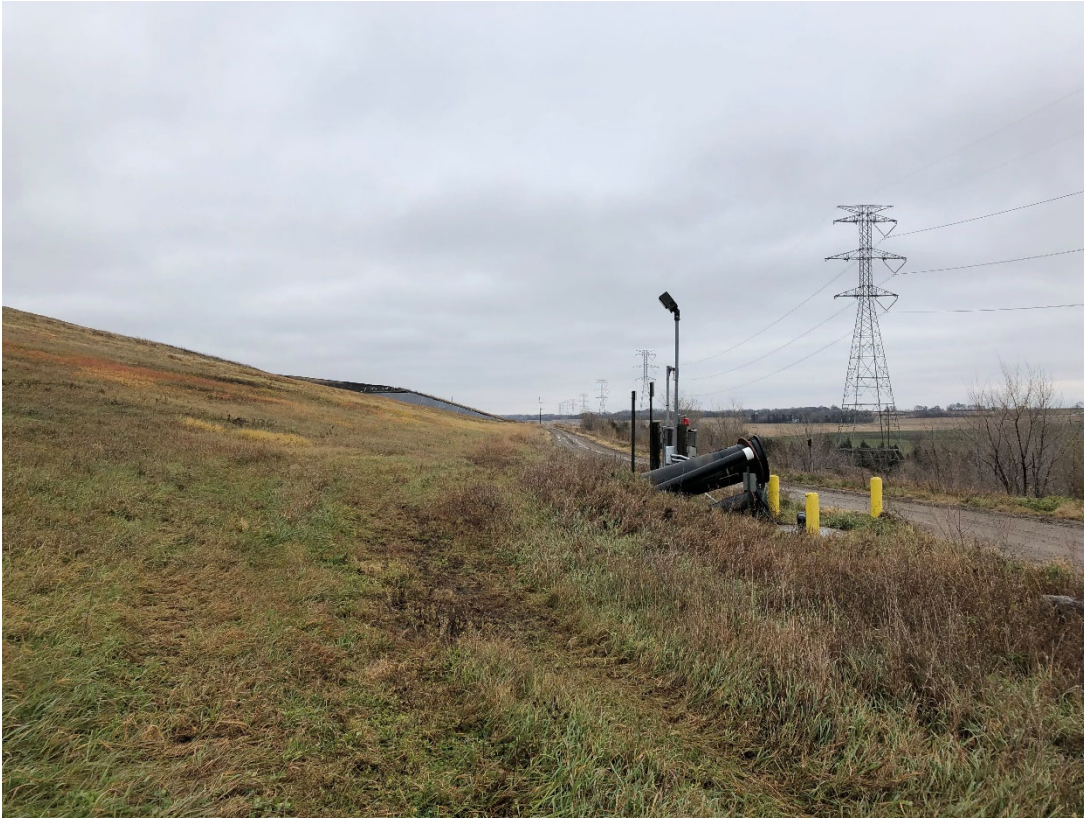
Photo 25: Location 11 – Looking Southwest, Cell 2C Southwestern Waste Slope and Anchor Trench
