Technical Memo

Date: January 9, 2019

Subject: SKB Rosemount Industrial Waste Facility – 2018 Annual CCR Inspection
Wenck Project # B3053-0138

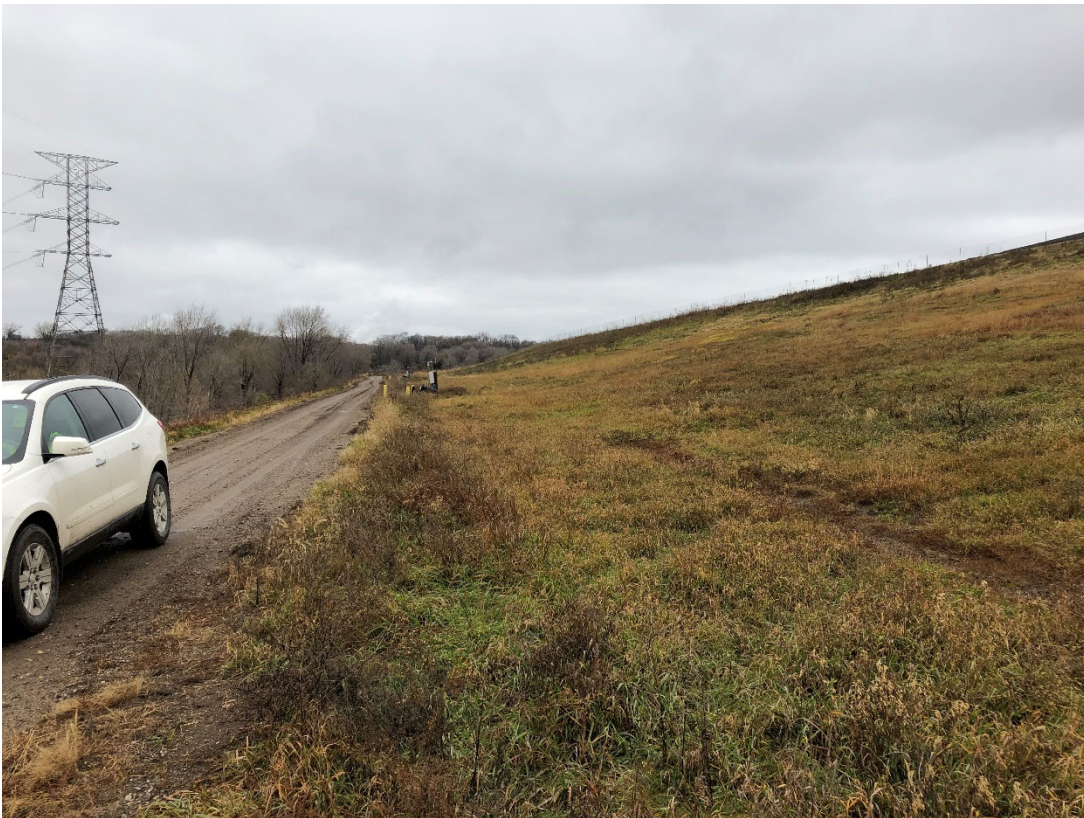
Photo 26: Location 11 – Looking Northwest, Cell 2C & 2B Southwestern Waste Slope and Anchor Trench

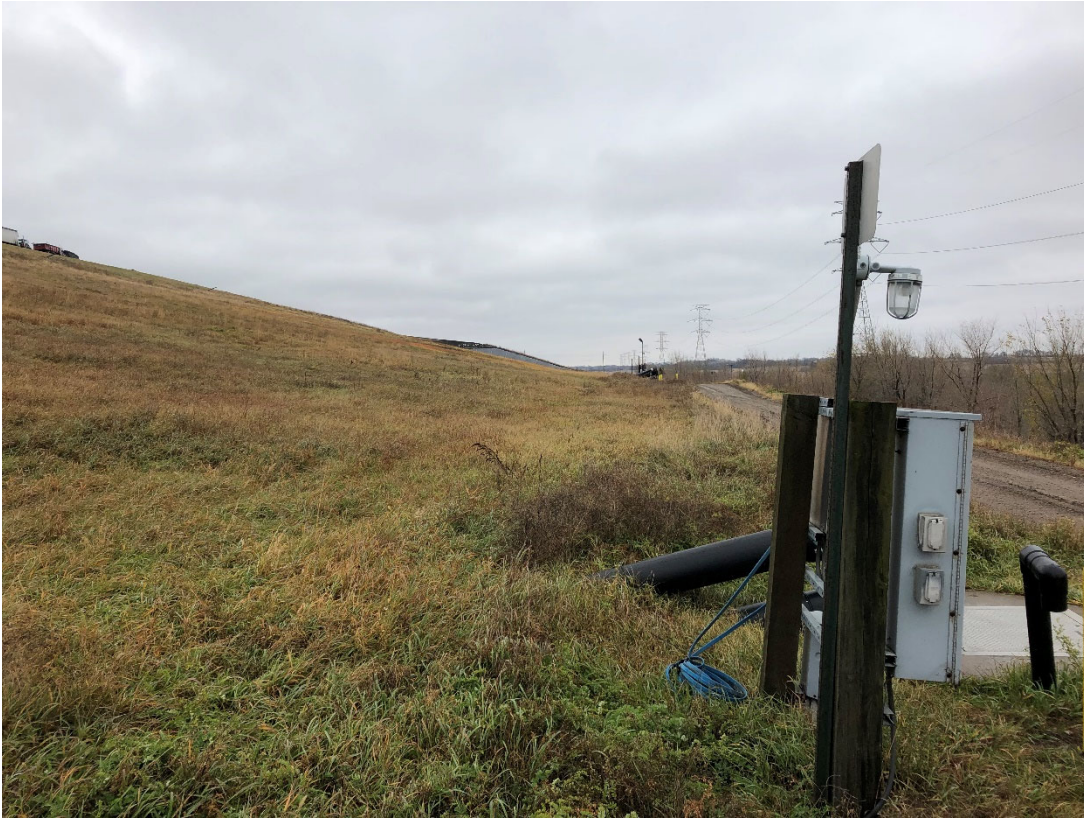
Photo 27: Location 12 – Looking Southeast, Cell 2C Southwestern Waste Slope and Anchor Trench

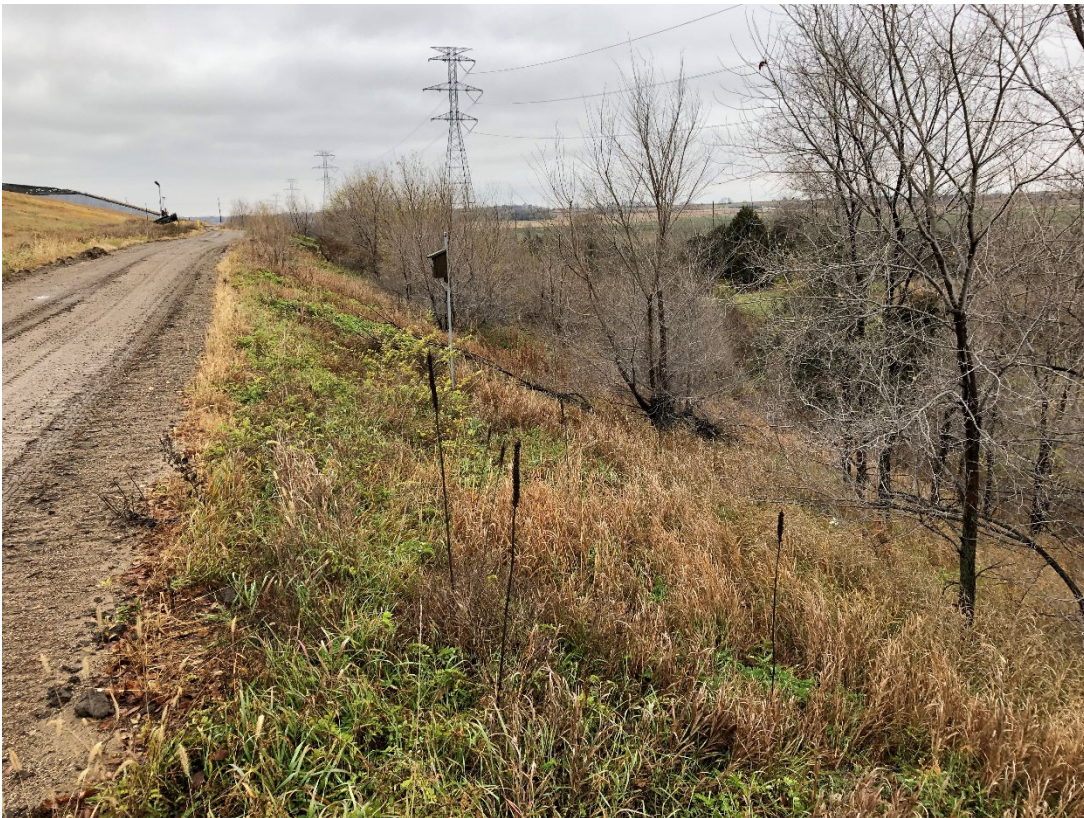
Photo 28: Location 12 – Looking Southeast, Cell 2C Southwestern Berm

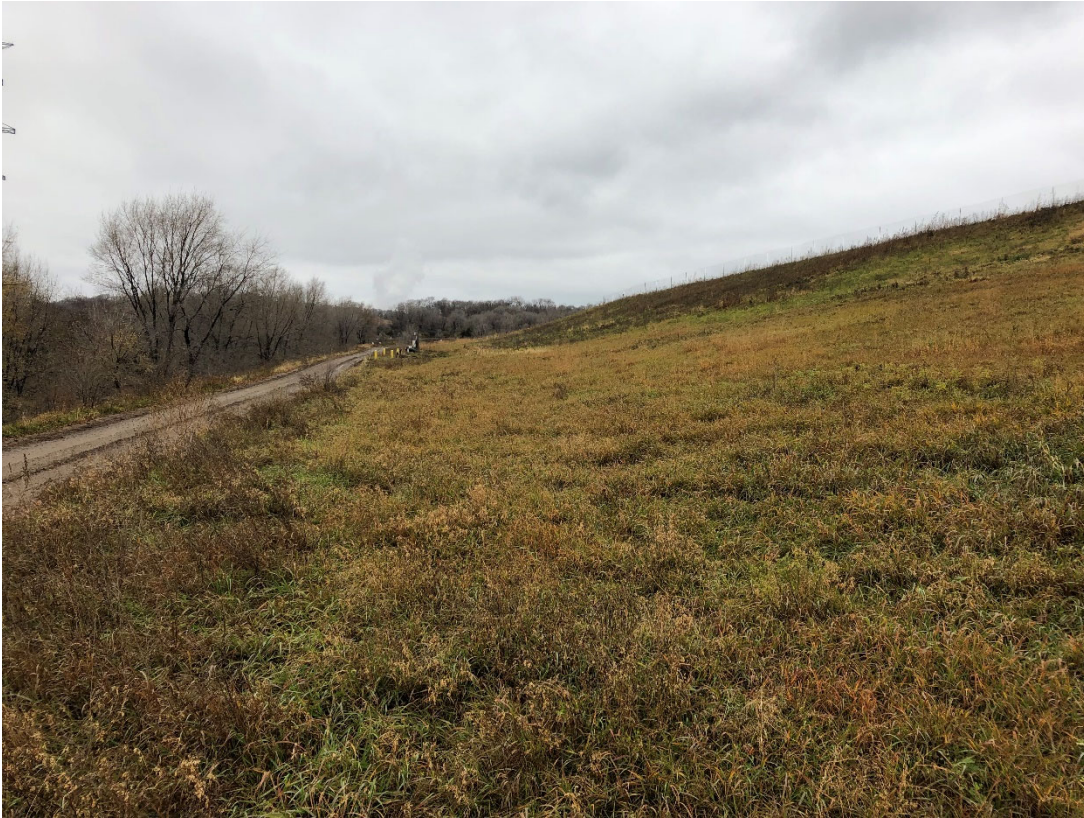
Photo 29: Location 12 – Looking Northwest, Cell 2B Southwestern Waste Slope and Anchor Trench

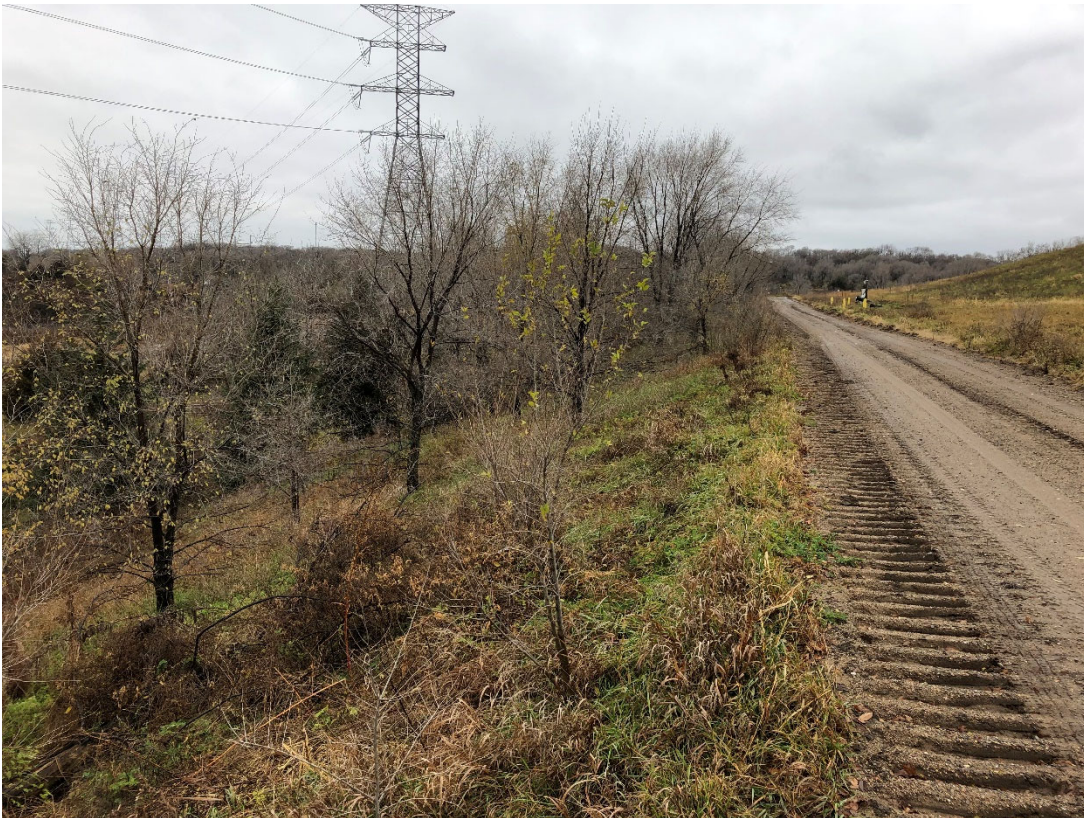
Photo 30: Location 12 – Looking Northwest, Cell 2B Southwestern Berm

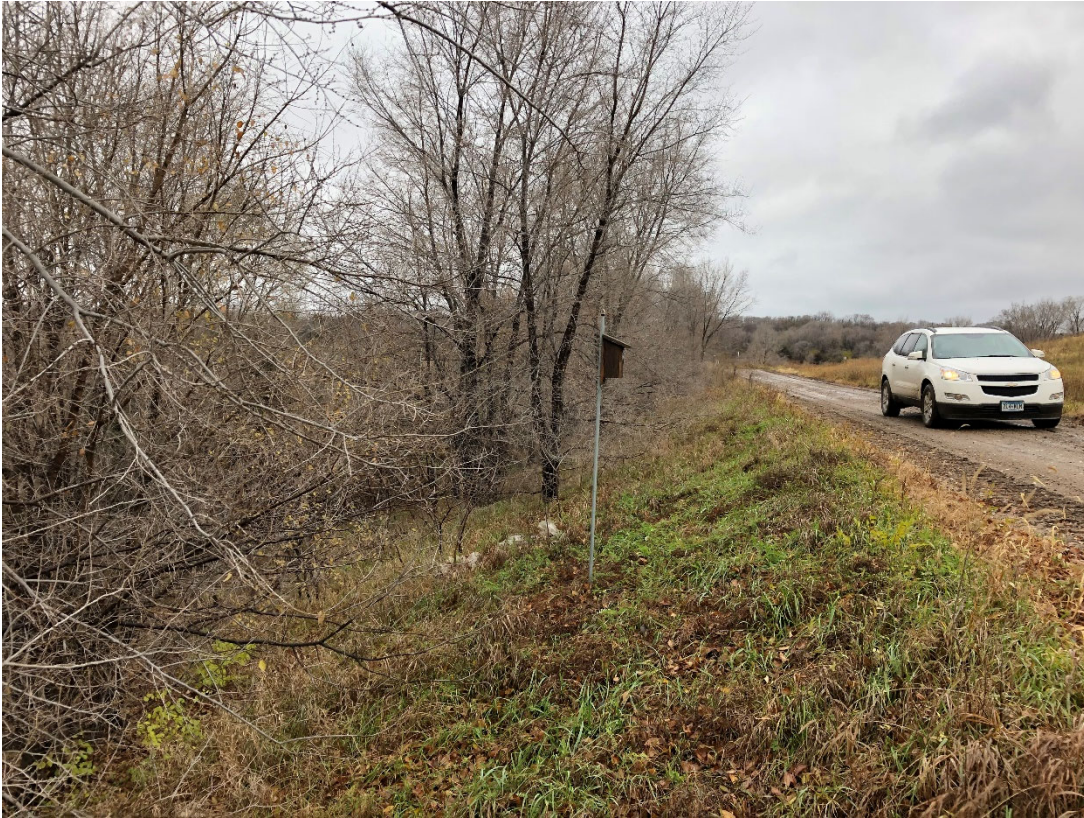
Photo 31: Location 13 – Looking Northwest, Cell 2A Southwestern Berm

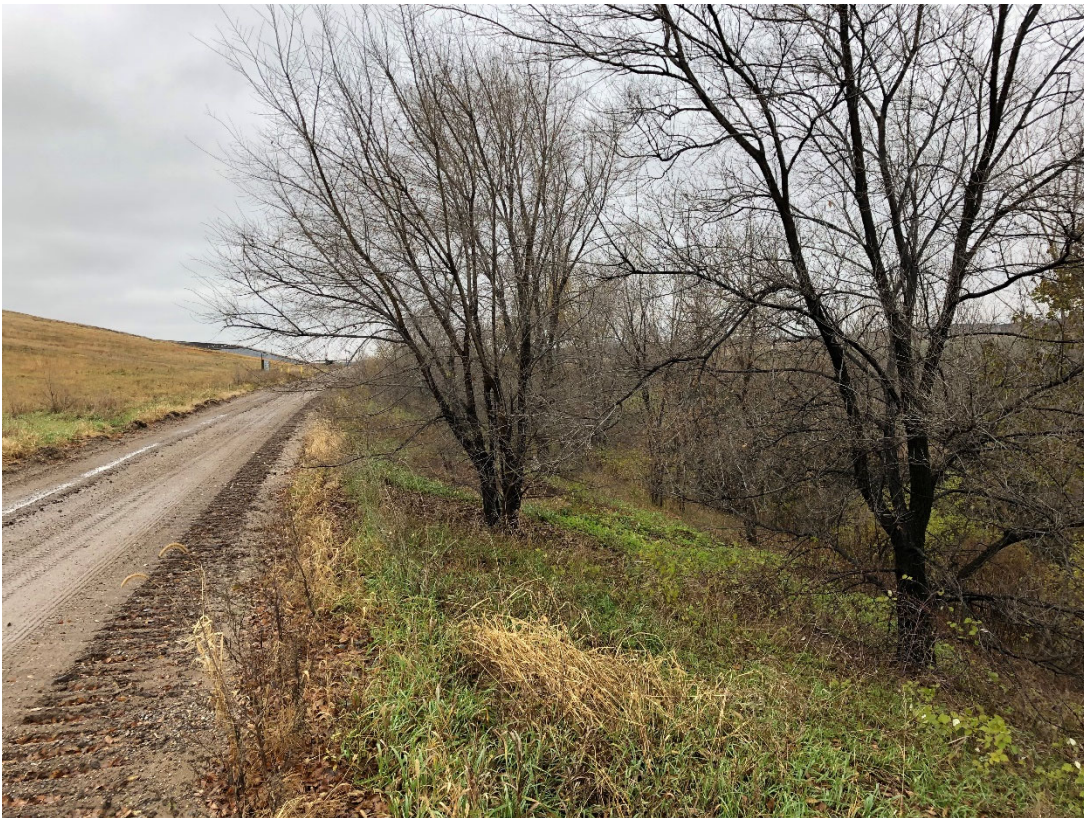
Photo 32: Location 13 – Looking Southeast, Cell 2B Southwestern Berm

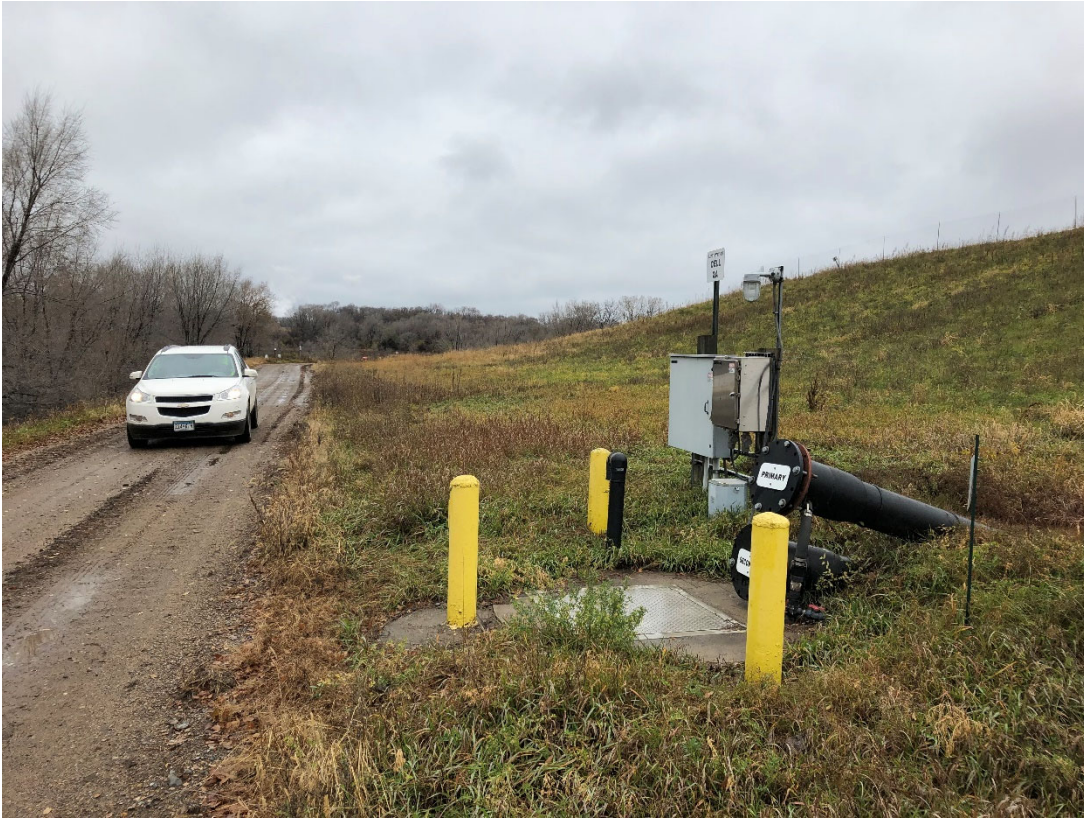
Photo 33: Location 13 – Looking Northwest, Cell 2A Southwestern Waste Slope and Perimeter Road

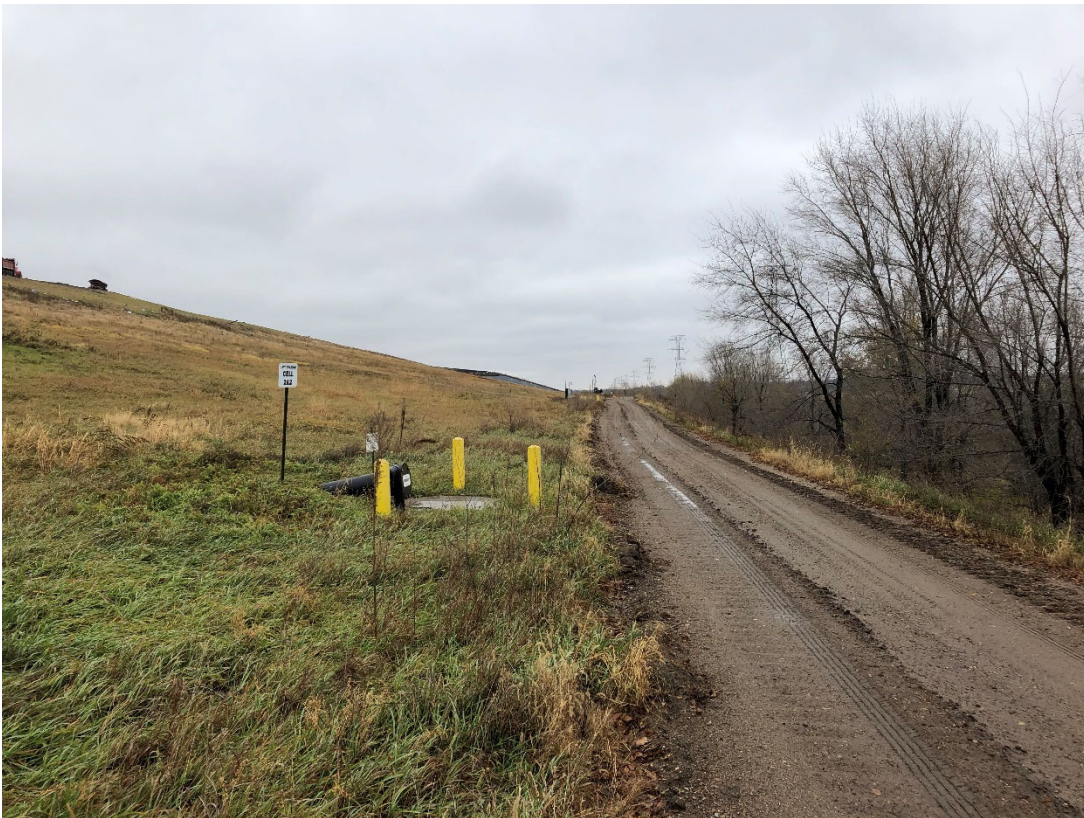
Photo 34: Location 13 – Looking Southeast, Cell 2B Southwestern Waste Slope and Perimeter Road

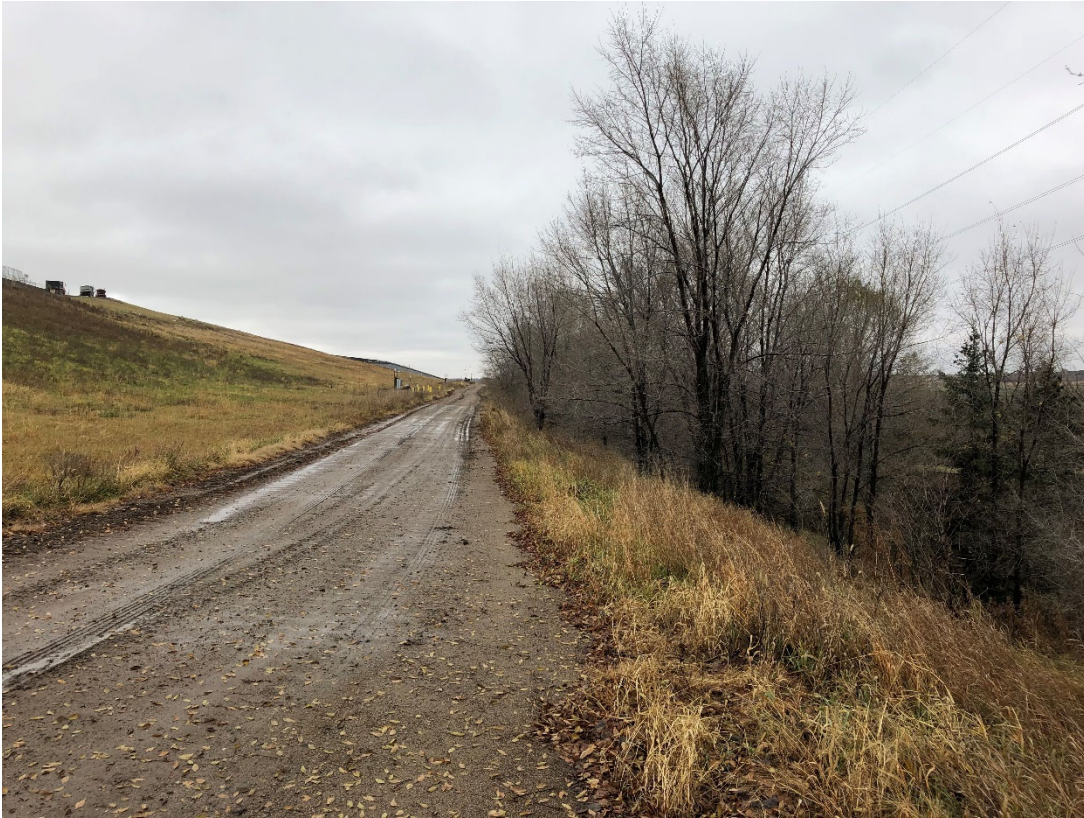
Photo 35: Location 14 – Looking Southeast, Cell 2A Southwestern Berm

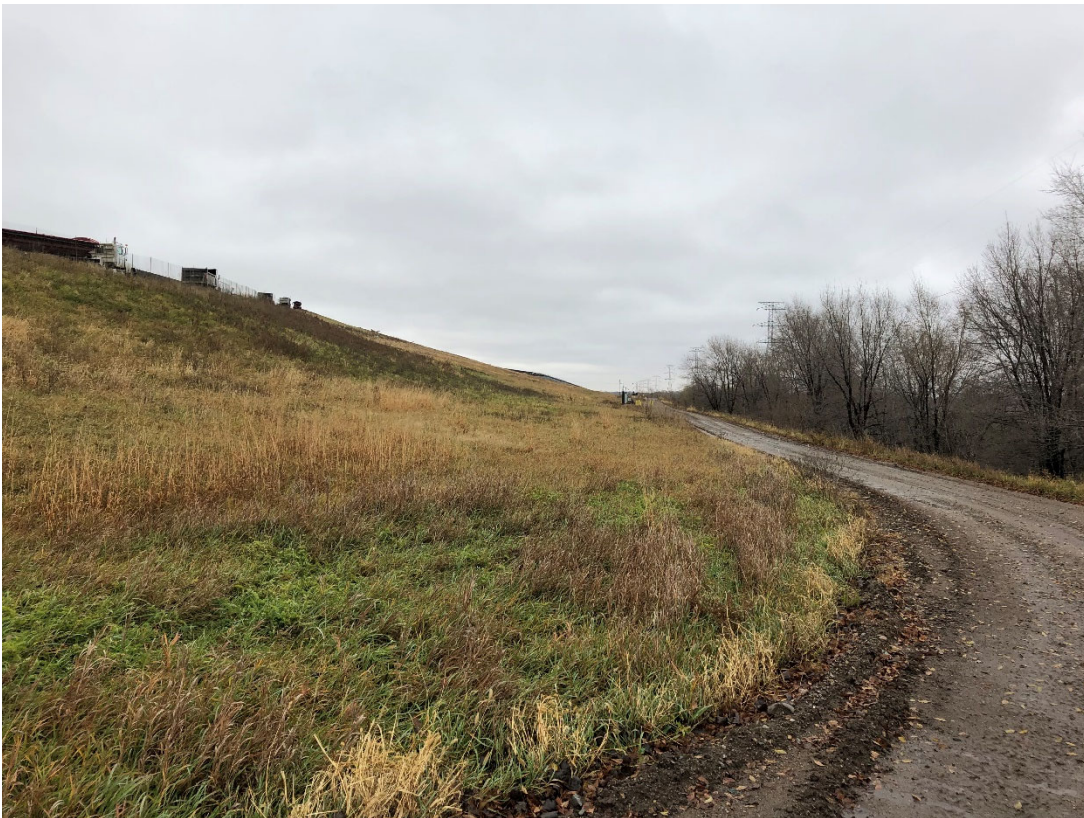
Photo 36: Location 14 – Looking Southeast, Cell 2A Southwestern Waste Slope

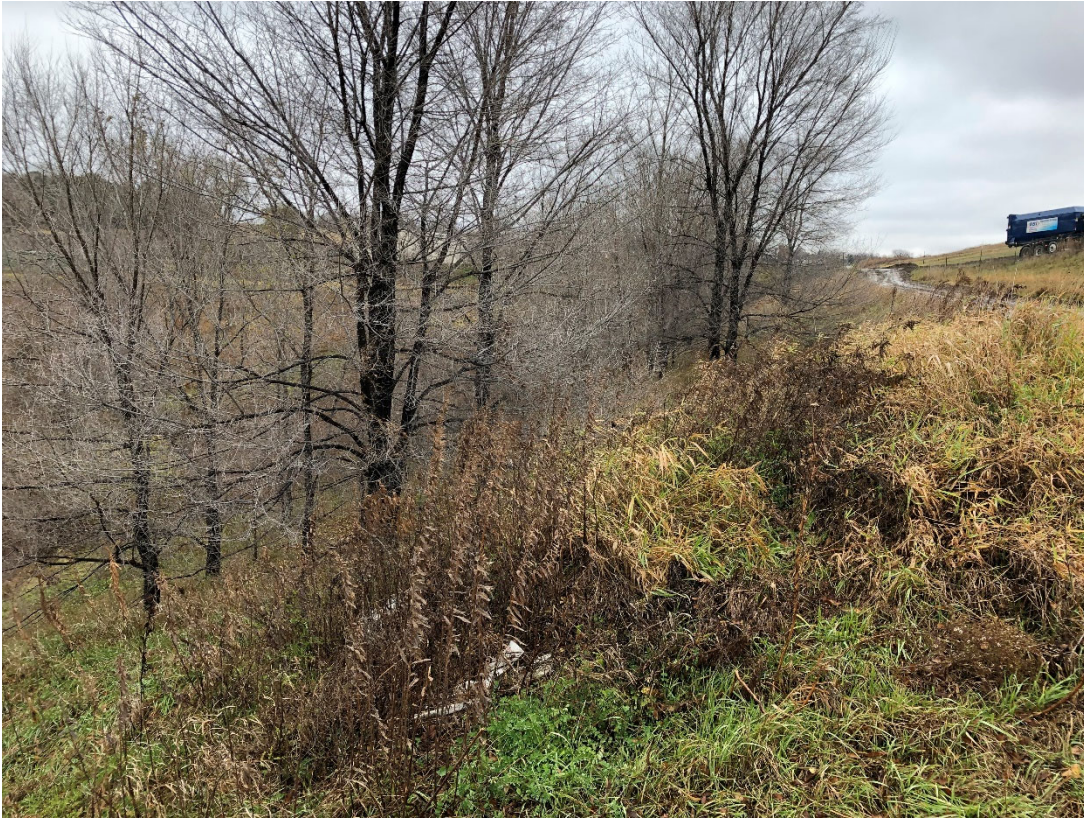
Photo 37: Location 14 – Looking Northeast, Cell 2A Northwestern Berm

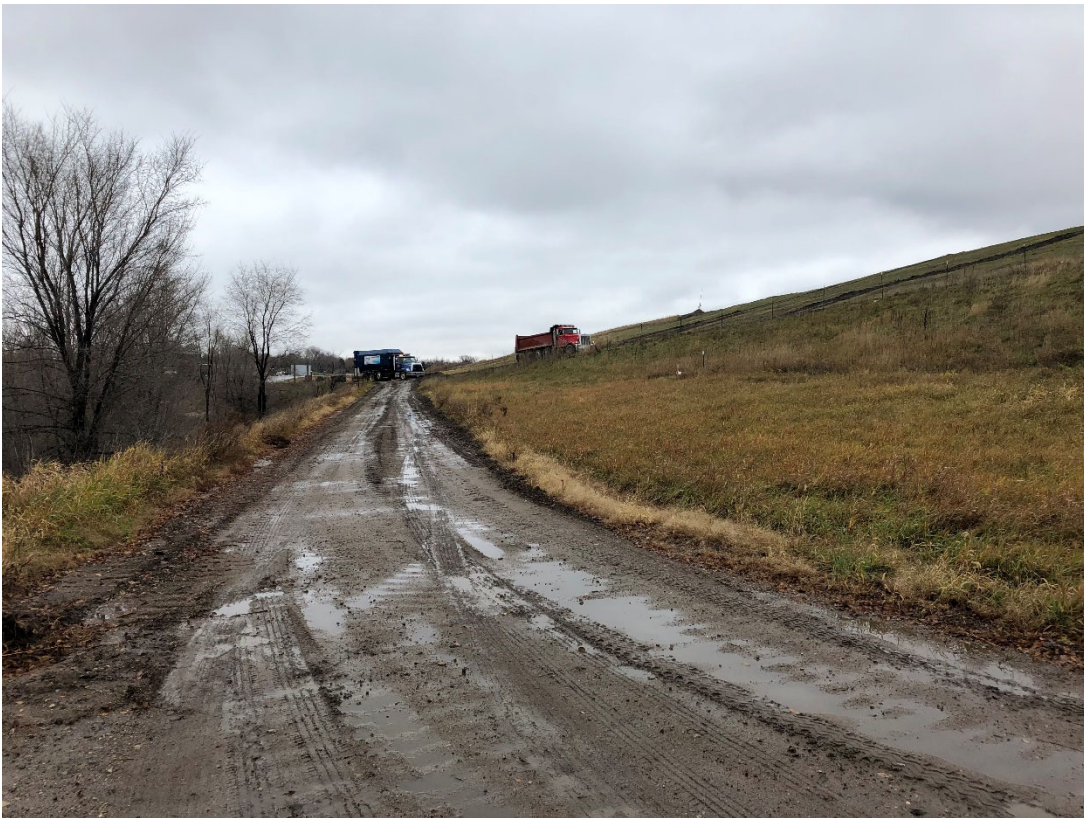
Photo 38: Location 14 – Looking Northeast, Cell 2A Northwestern Perimeter Road and Anchor Trench

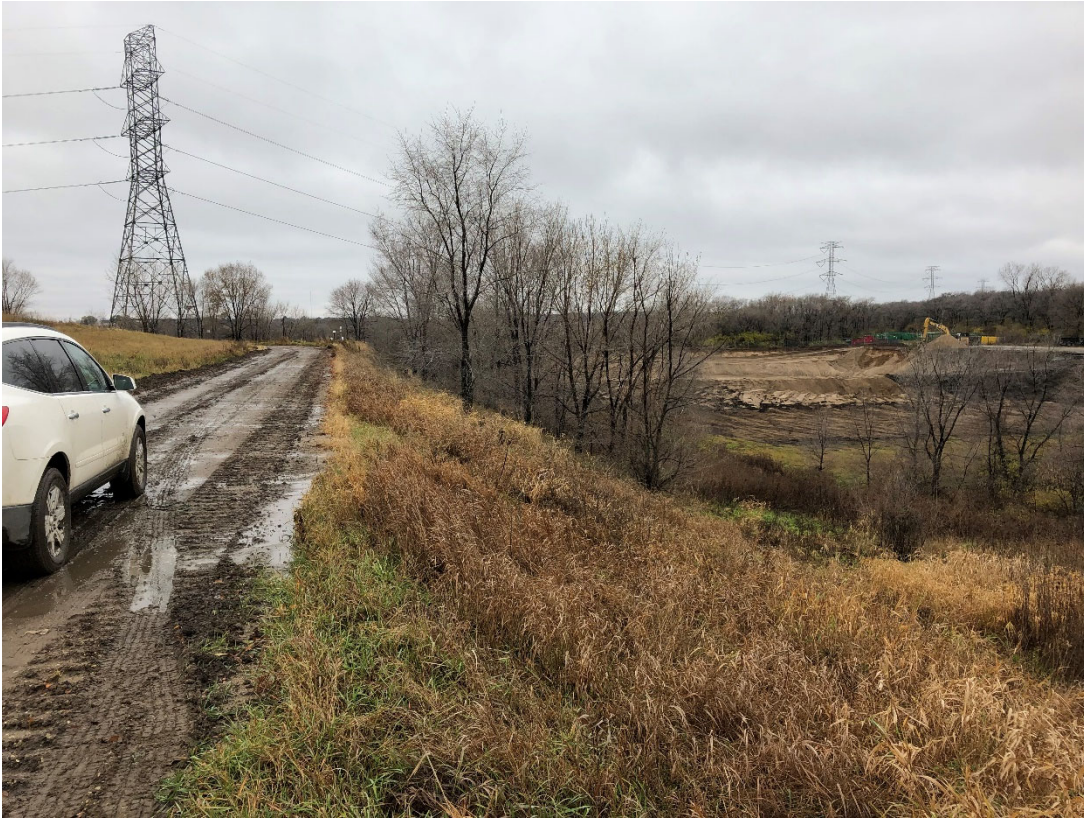
Photo 39: Location 15 – Looking Southwest, Cell 2A Northwestern Berm

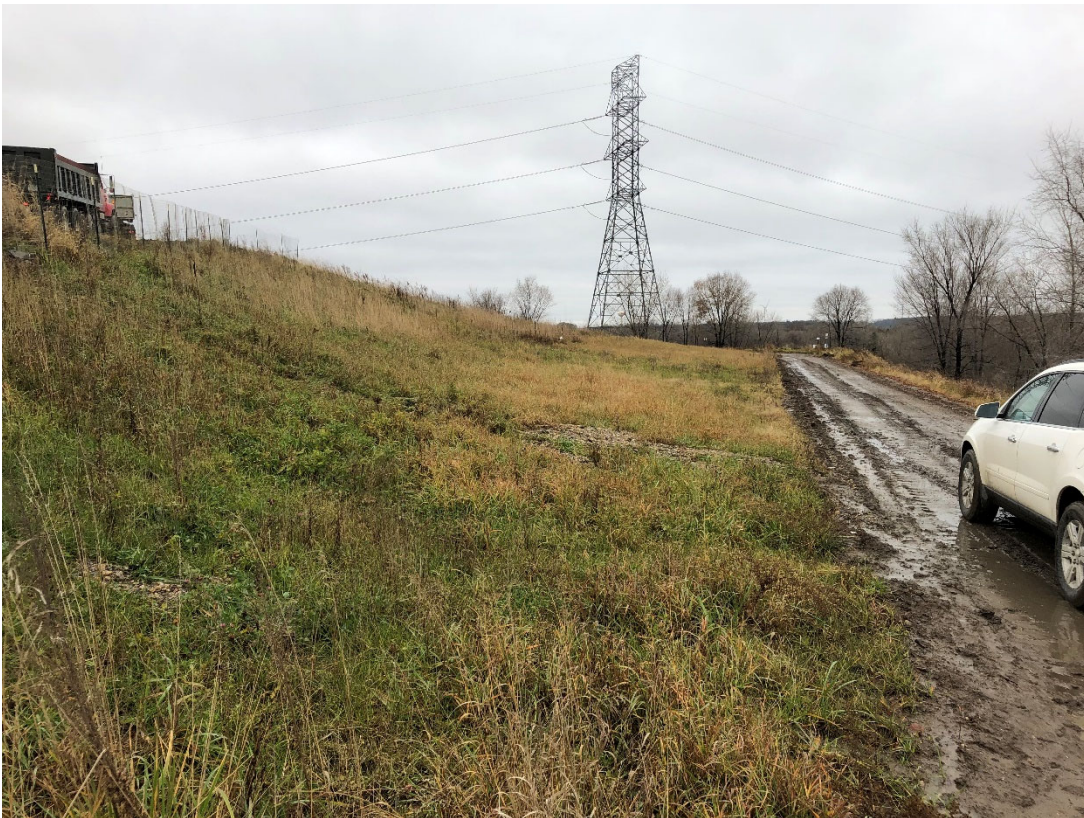
Photo 40: Location 15 – Looking Southwest, Cell 2A Northwest Waste Slope and Anchor Trench

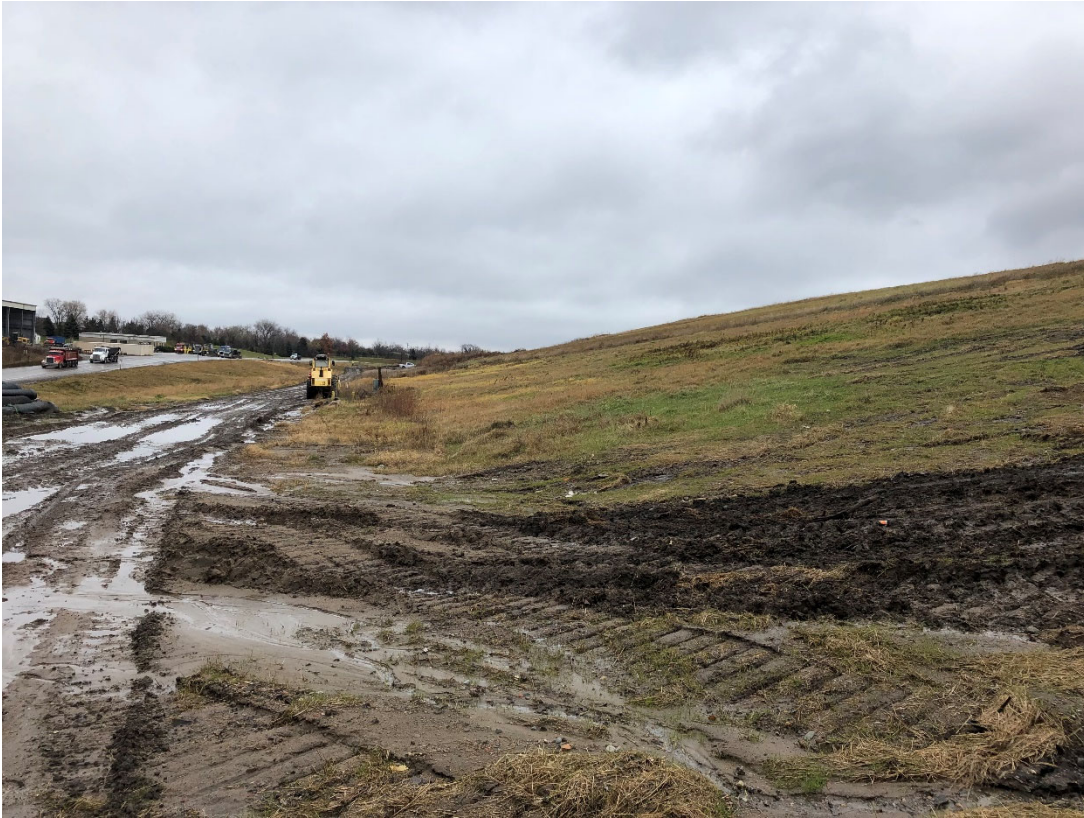
Photo 41: Location 15 – Looking Northeast, Cell 1 Northwestern Waste Slope

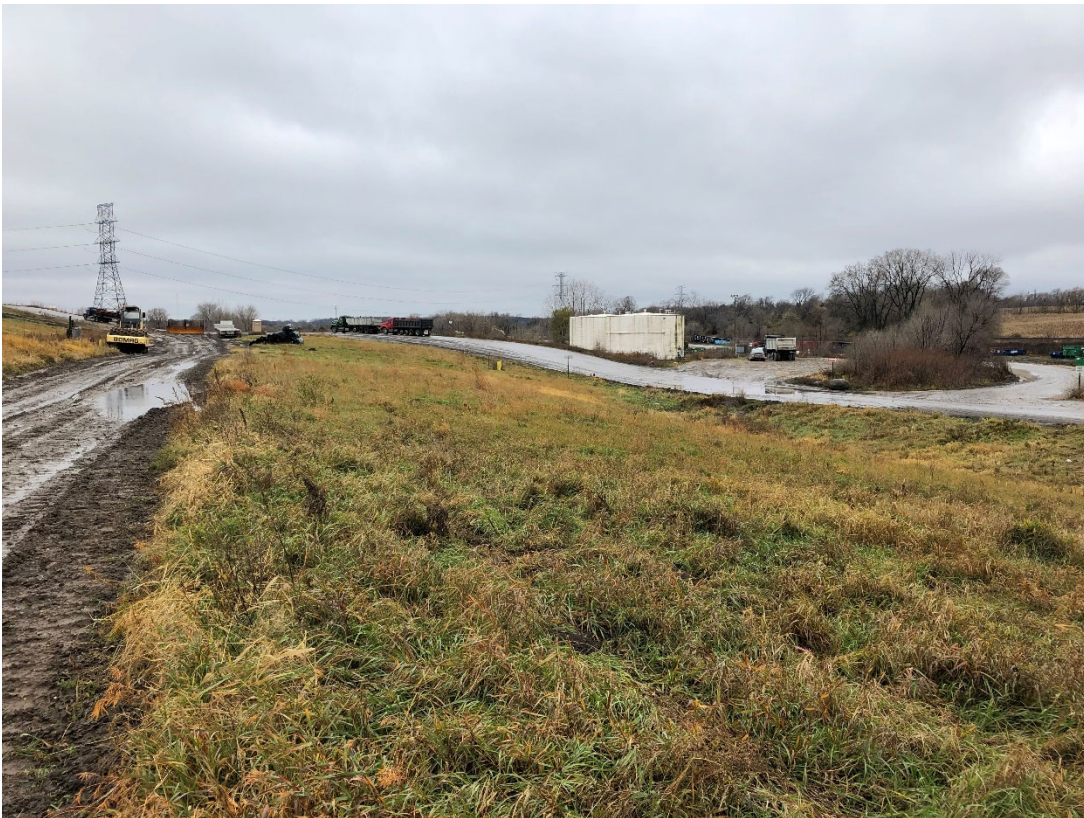
Photo 42: Location 17 – Looking Southwest, Cell 1 Northwestern Berm

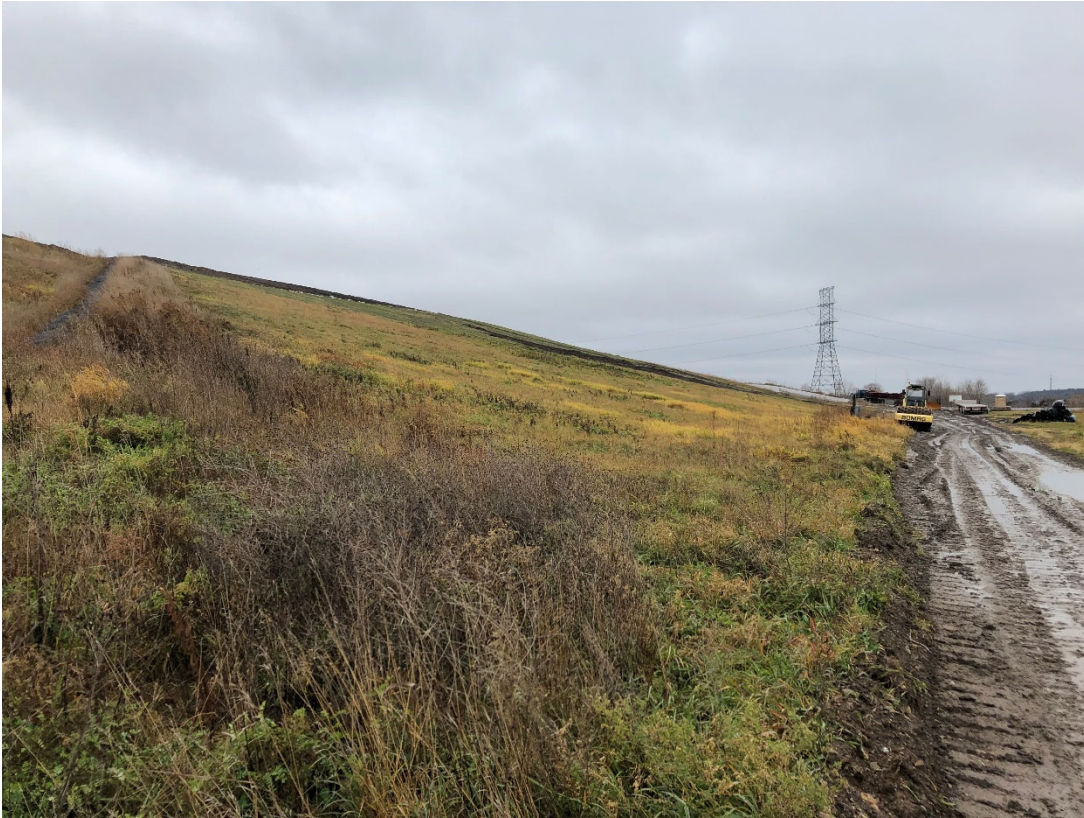
Photo 43: Location 17 – Looking South, Cell 1 Limit of Industrial Waste (CCR)
