Technical Memo

To: Geoff Strack, P.E., Waste Connections
From: Brad Sullivan, P.E., Wenck Associates, Inc.
Date: January 9, 2020
Subject: SKB Rosemount Industrial Waste Facility
2019 Annual CCR Inspection Report
Wenck Project #B3053-0180

PROJECT TITLE
2019 CCR INSPECTION REPORT

SKB ROSEMOUNT LANDFILL
ROSEMOUNT, MINNESOTA

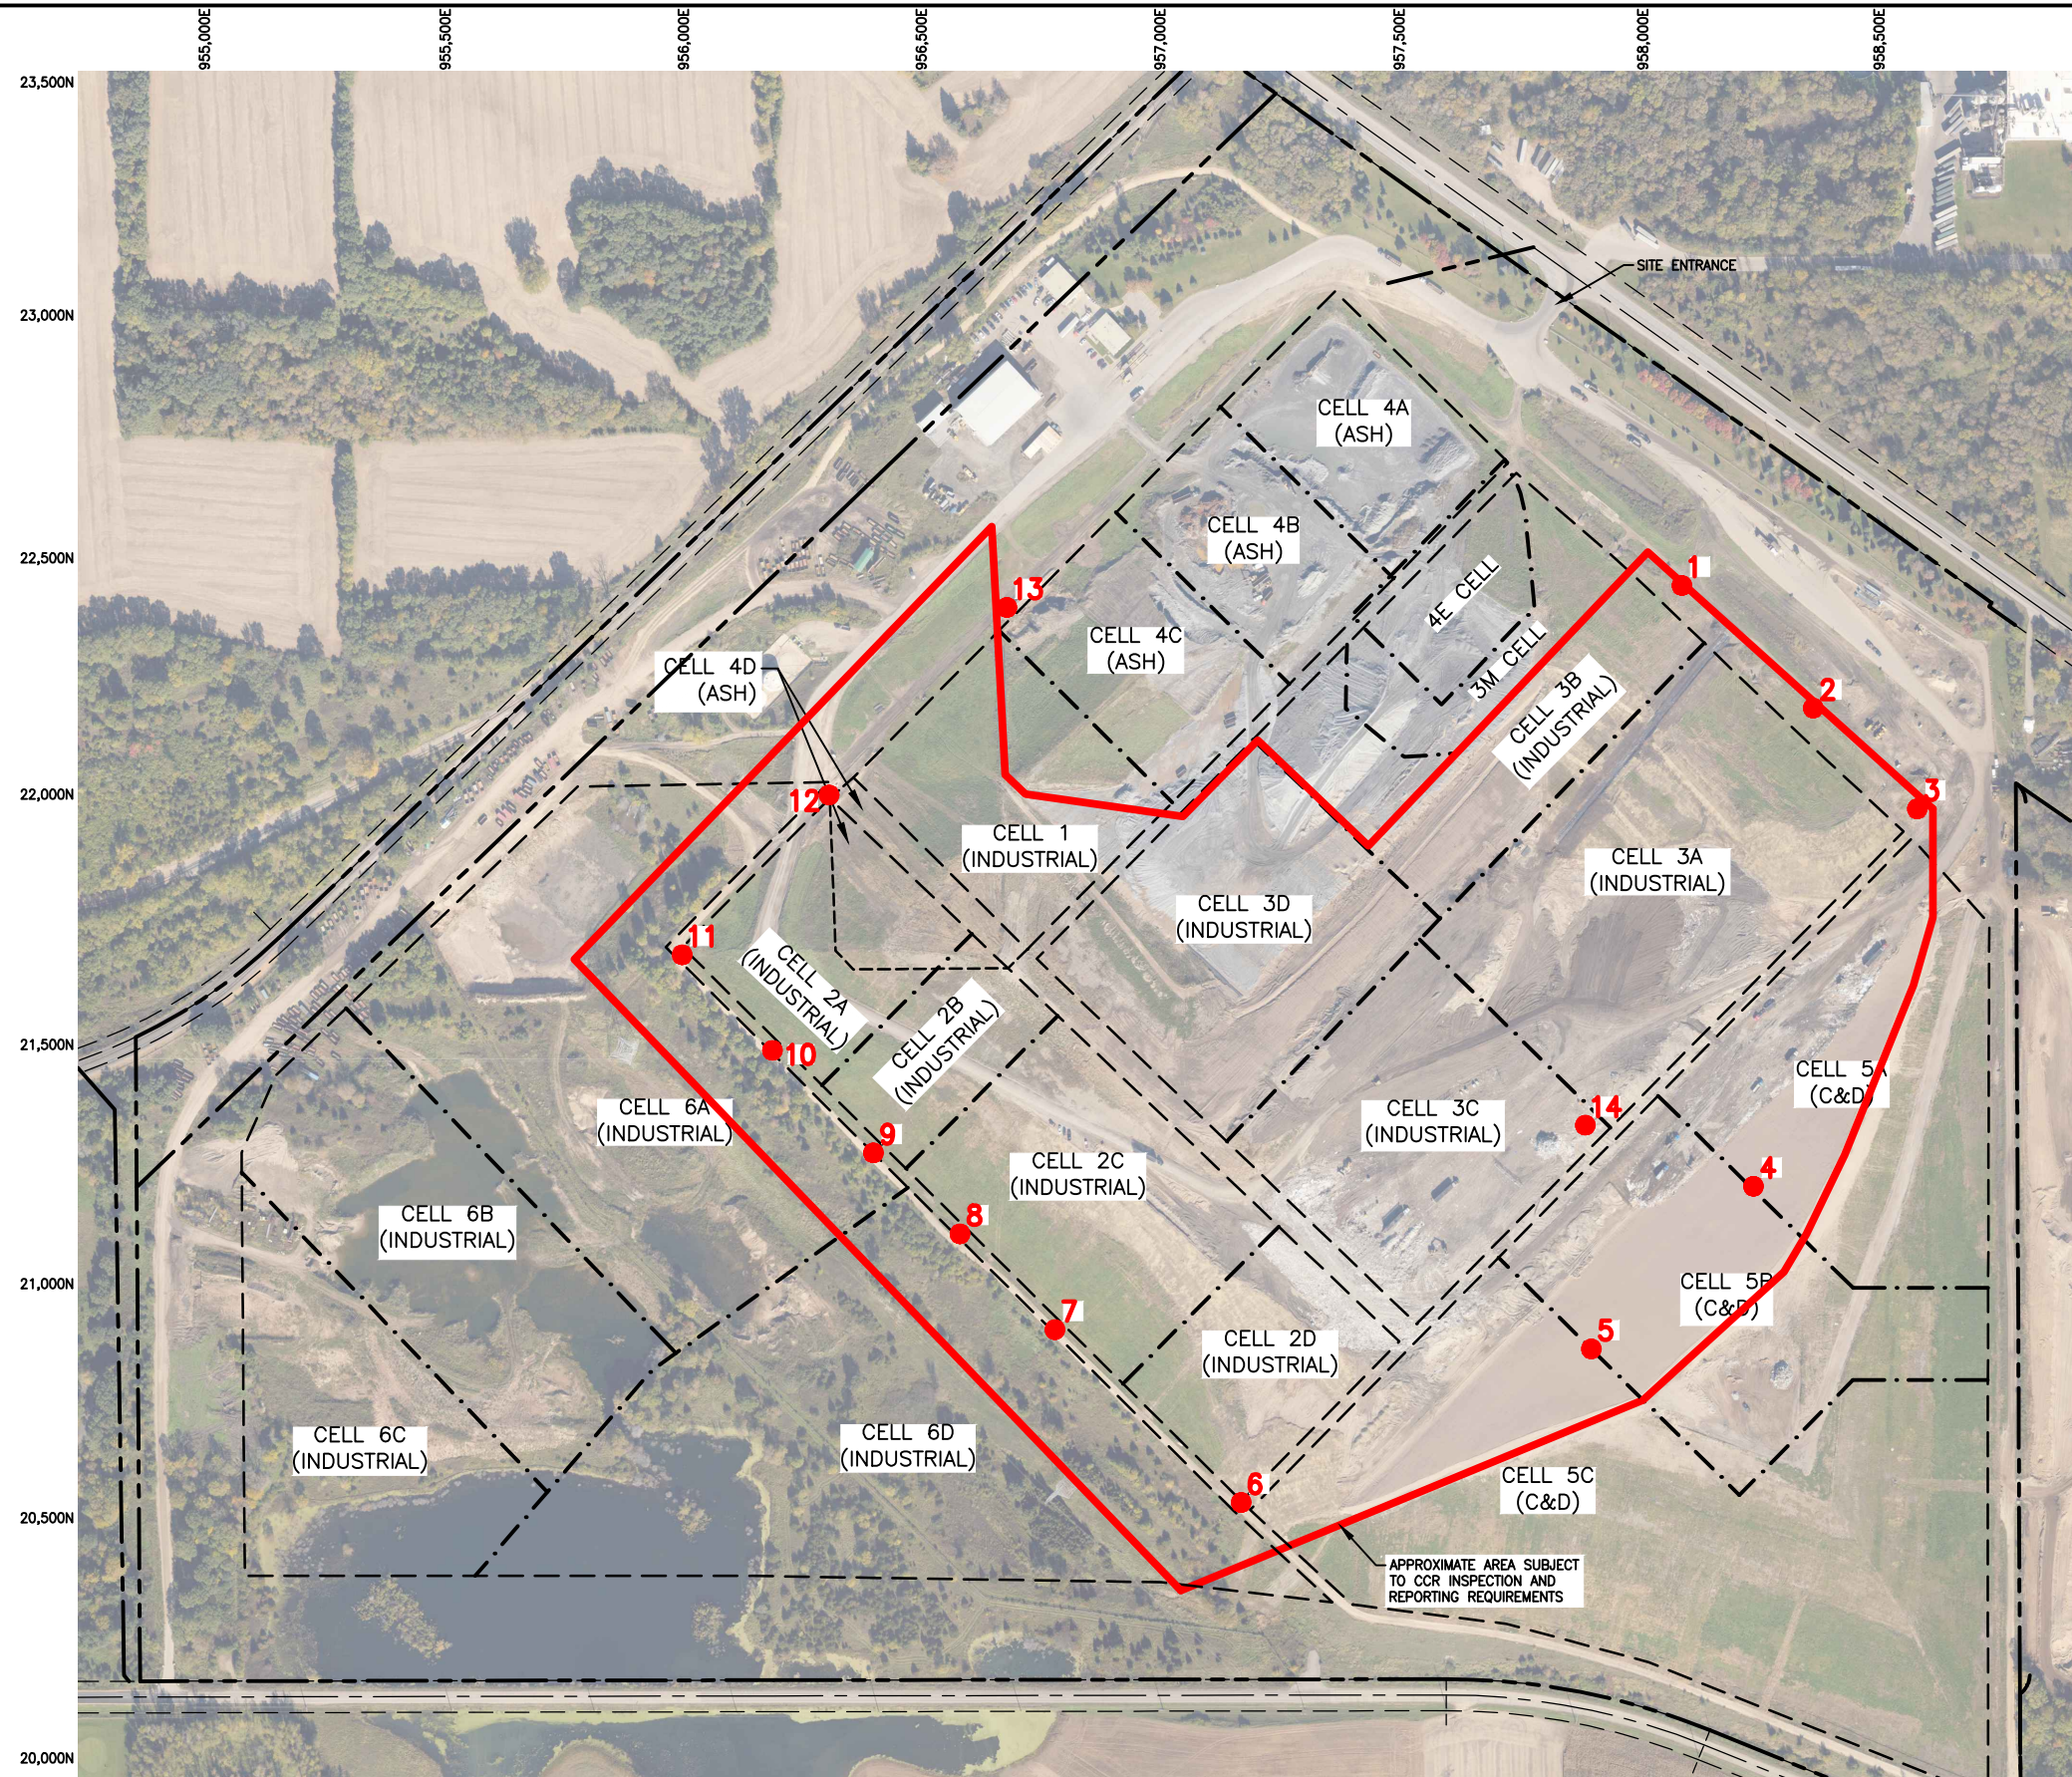
DWN BY BWS	CHK'D TJS	APP'D BWS	DWG DATE JAN. 2020
PROJECT NO. 3053-0180	SHEET NO. FIGURE 1	SCALE AS NOTED	REV NO. 0

Photos of the landfill embankments and waste slopes were taken during the inspection. Figure 1 presents the photo locations, and Attachment 1 contains a photo log from the inspections.

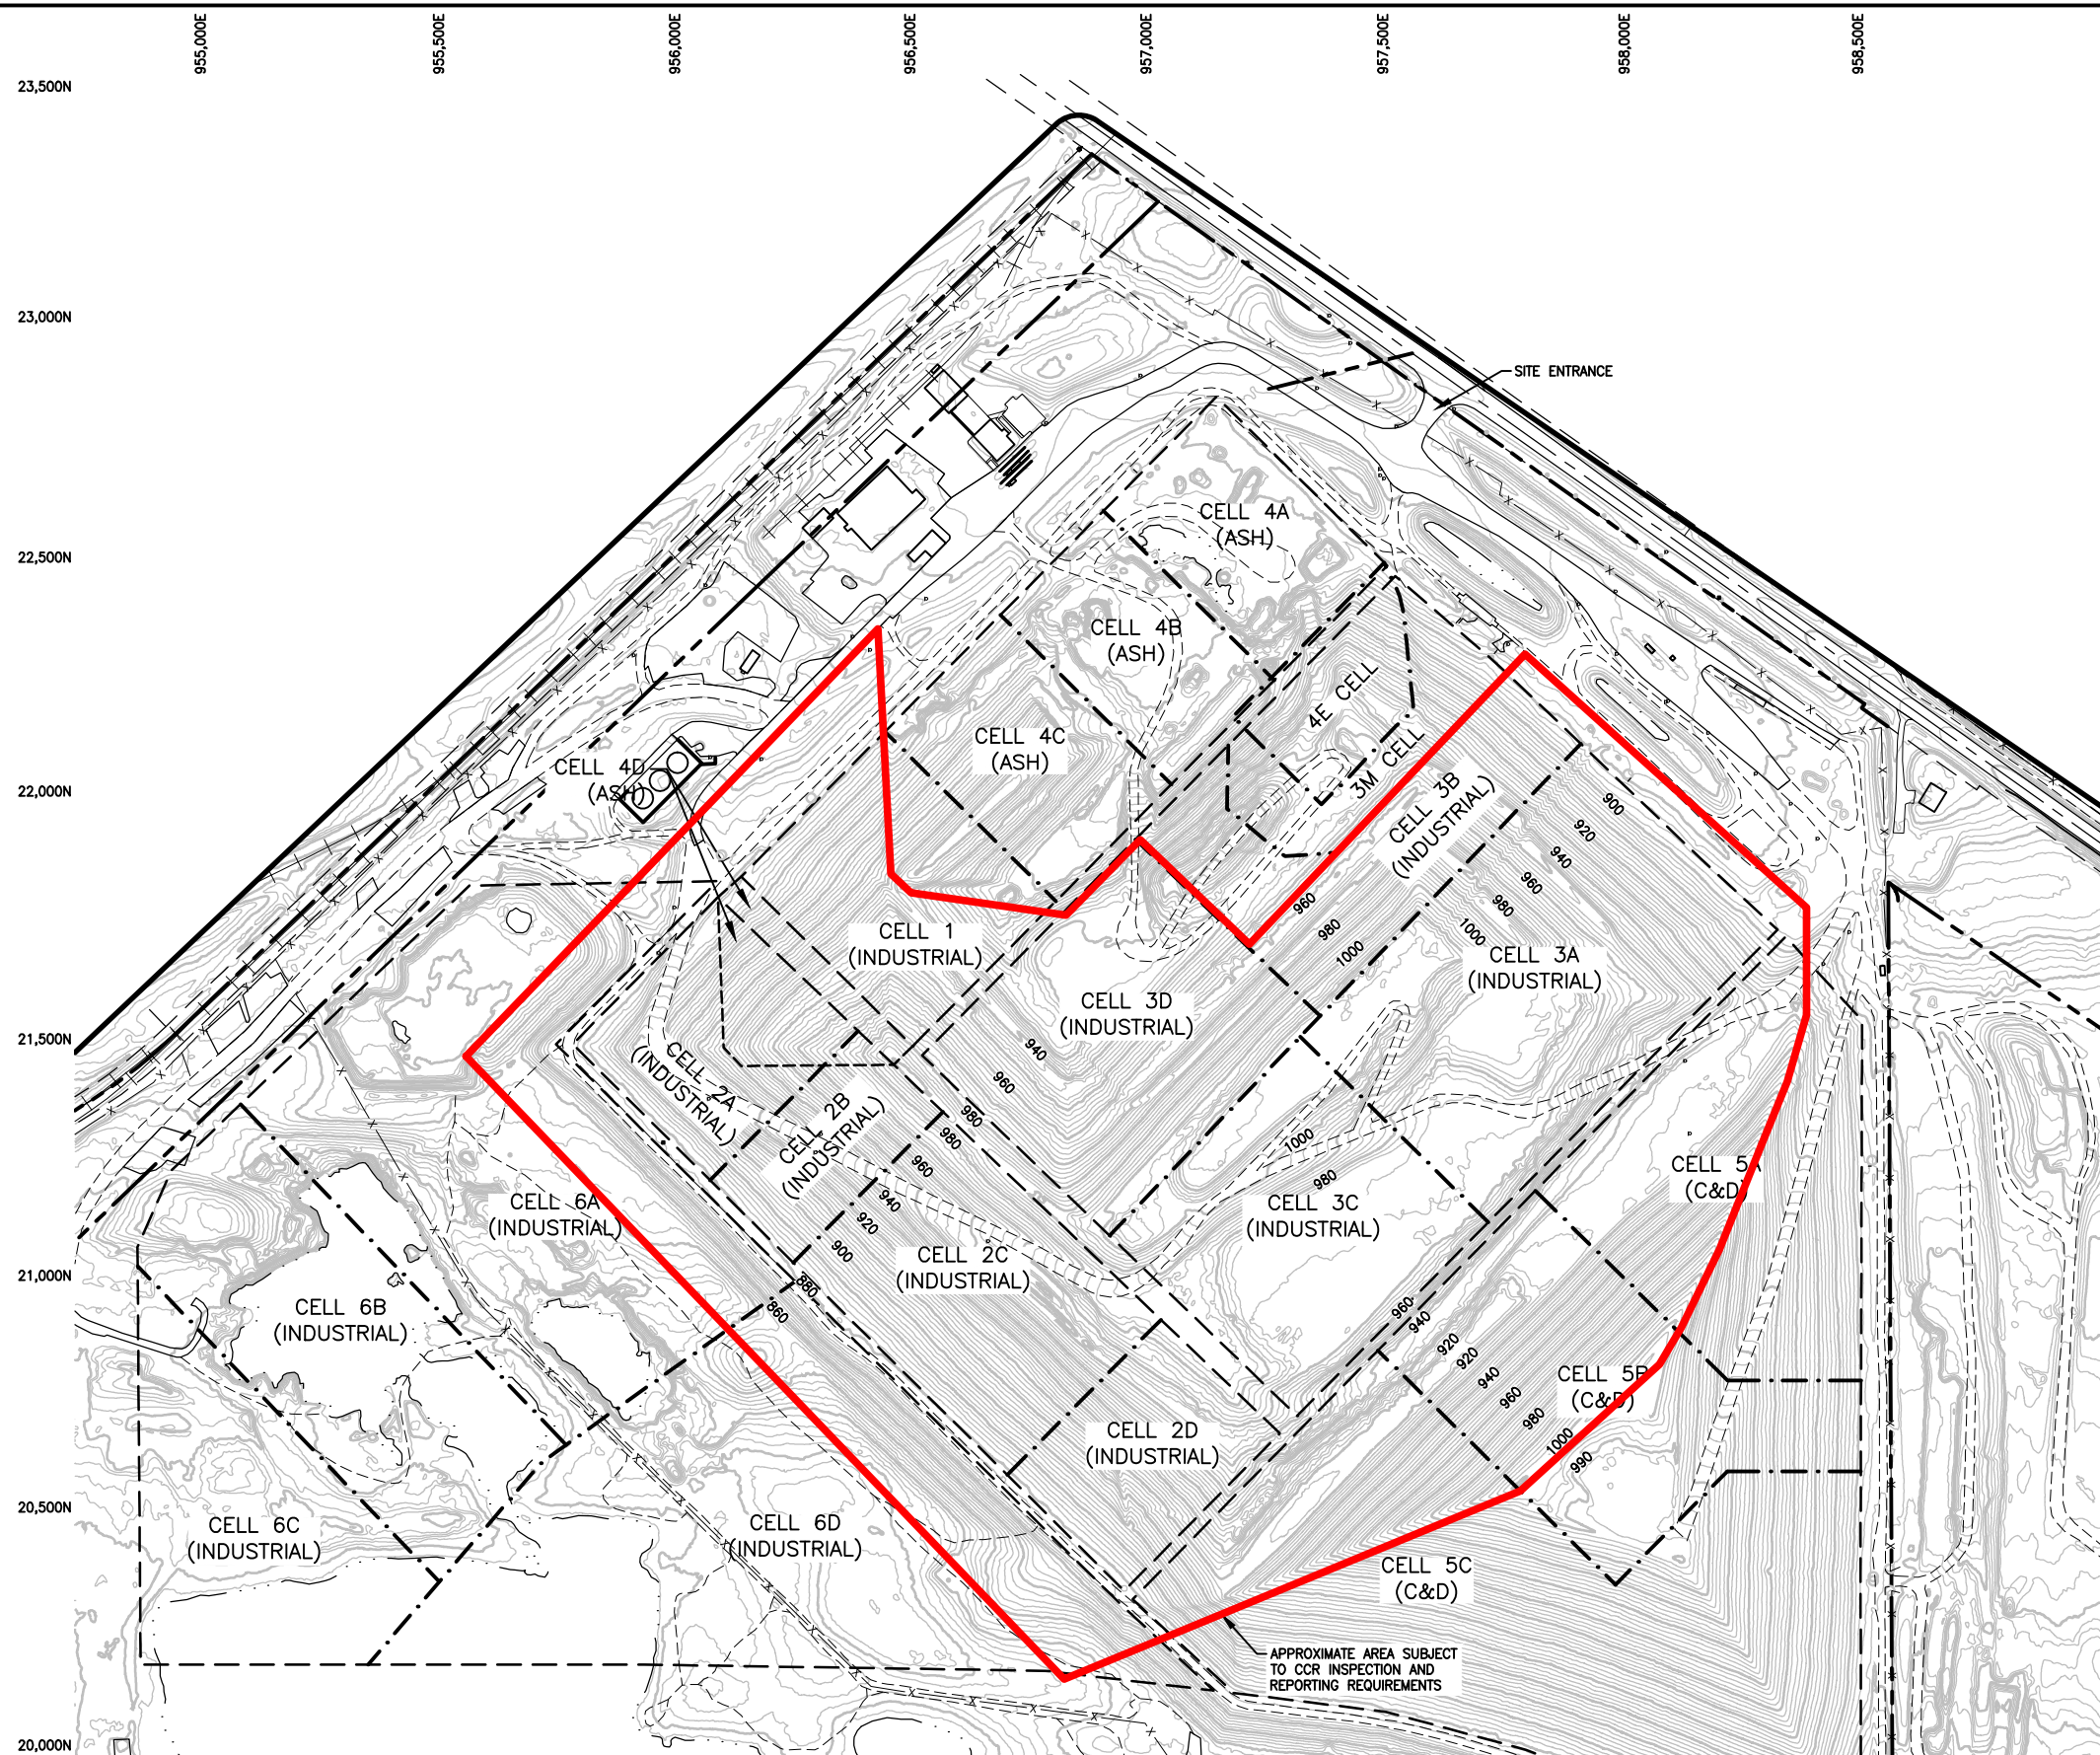
SHEET TITLE			
SITE MAP			
DWN BY	CHK'D	APP'D	DWG DATE
BWS	TJS	BWS	JAN. 2020
PROJECT NO.		SCALE	
3053-0180		AS NOTED	
SHEET NO.		REV NO.	
FIGURE 2		0

The annual aerial photogrammetry survey was performed on October 17, 2019 which the estimated in-place volume is based on. A comparison of the 2019 and 2018 aerial surveys confirm that the embankment and slope topography is substantially unchanged with no significant movement. The 2019 aerial survey is included as Figure 2.

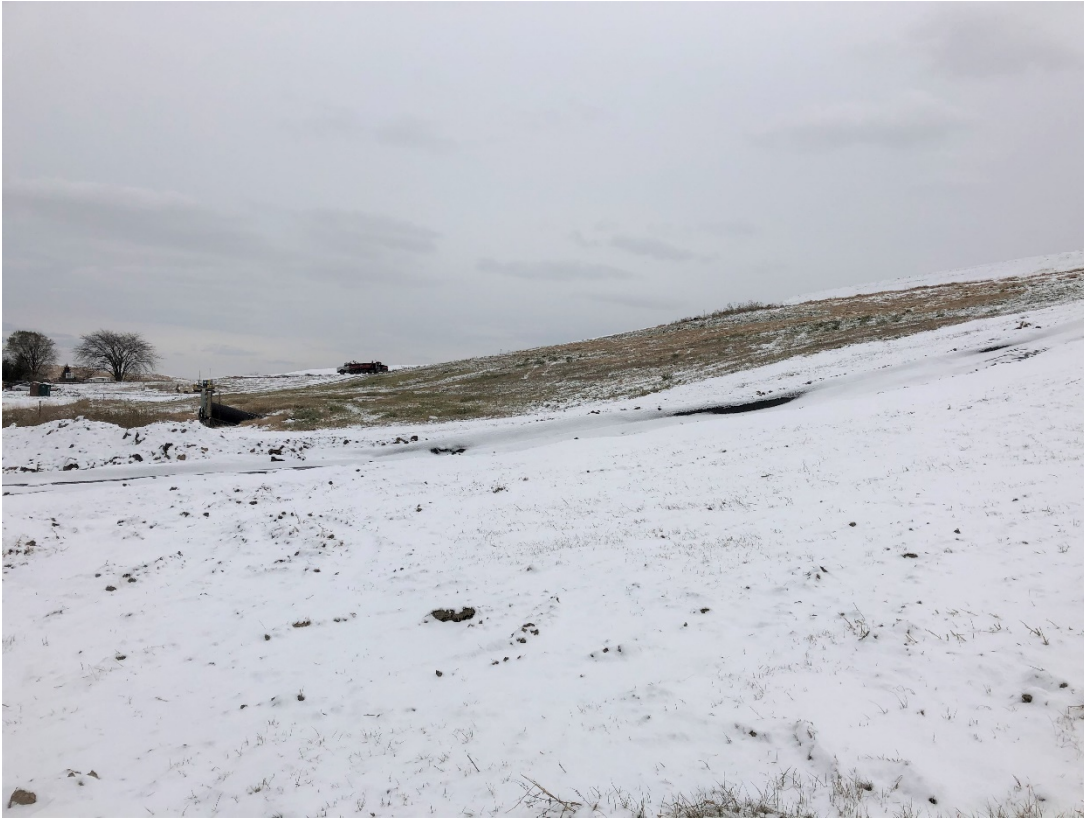
Photo 1: Location 1 – Looking Southeast, Cell 3A & 3B Waste Slope & Anchor Trench

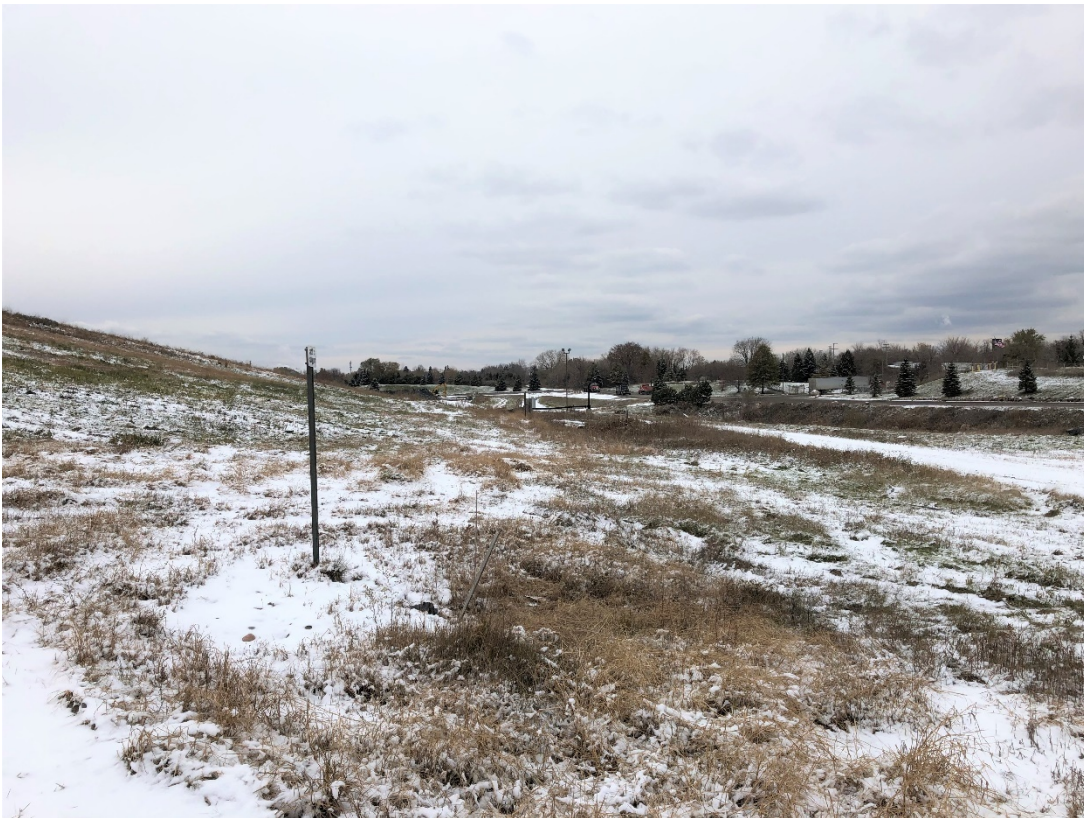
Photo 2: Location 1 – Looking Northwest, Cell 3 Berm

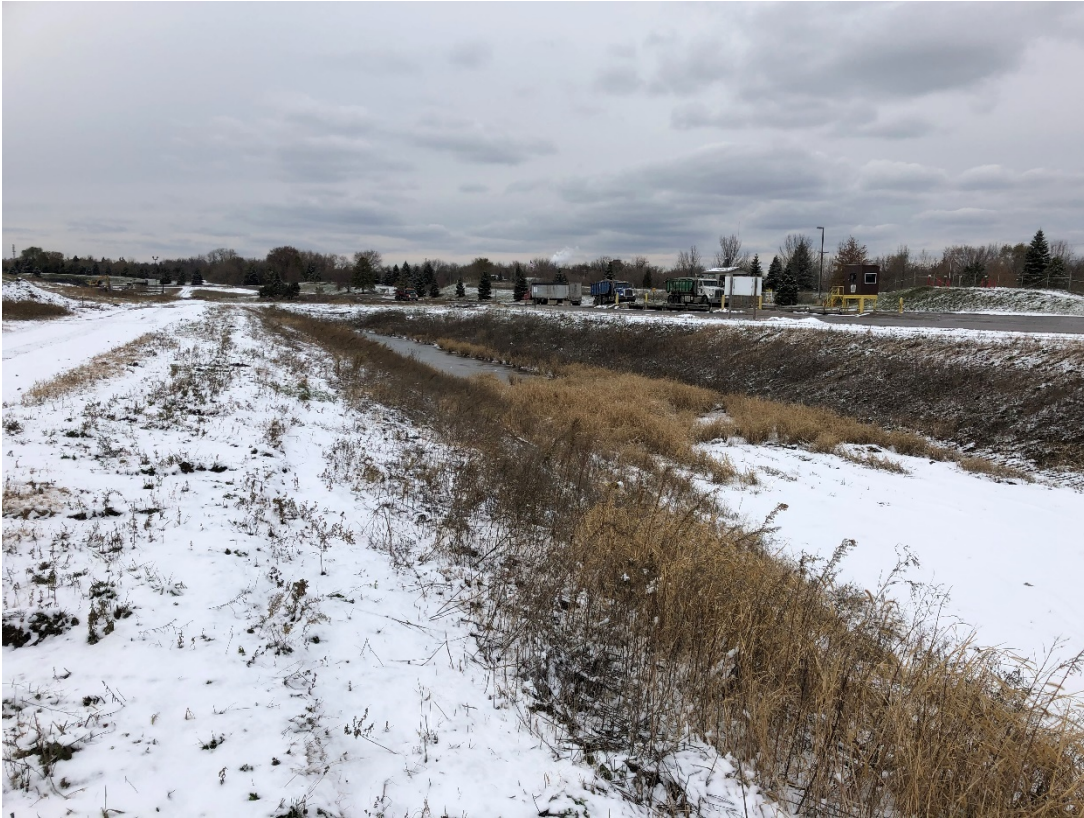
Photo 3: Location 2 – Looking Northwest, Cell 3 Berm & Stormwater Pond

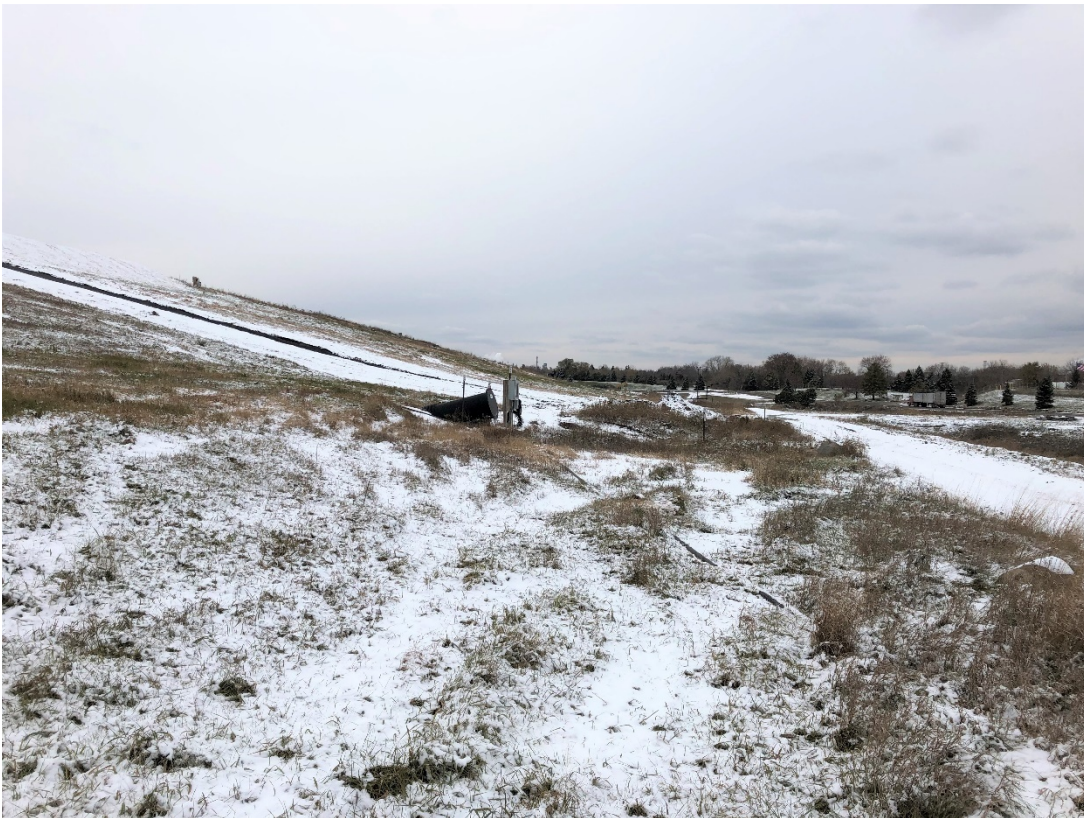
Photo 4: Location 2 – Looking Northwest, Cell 3 Anchor Trench and Waste Slope

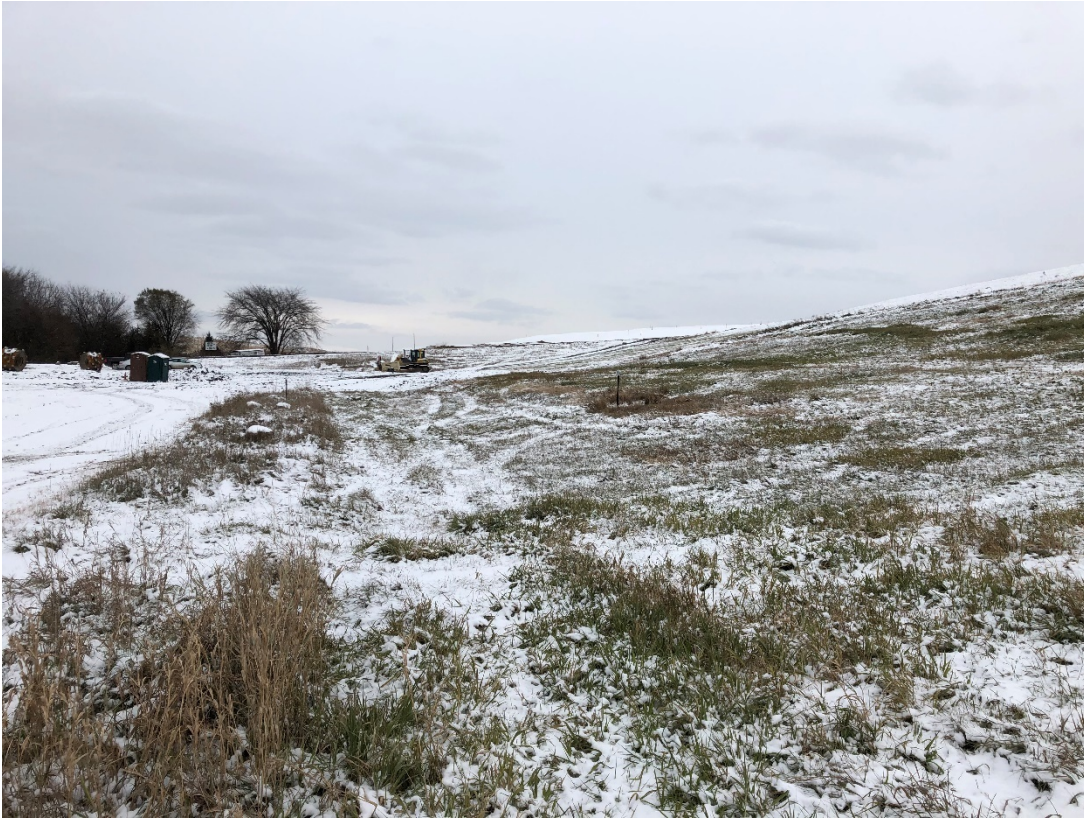
Photo 5: Location 2 – Looking Southeast, Phase 3A Anchor Trench and Northeastern Waste Slope

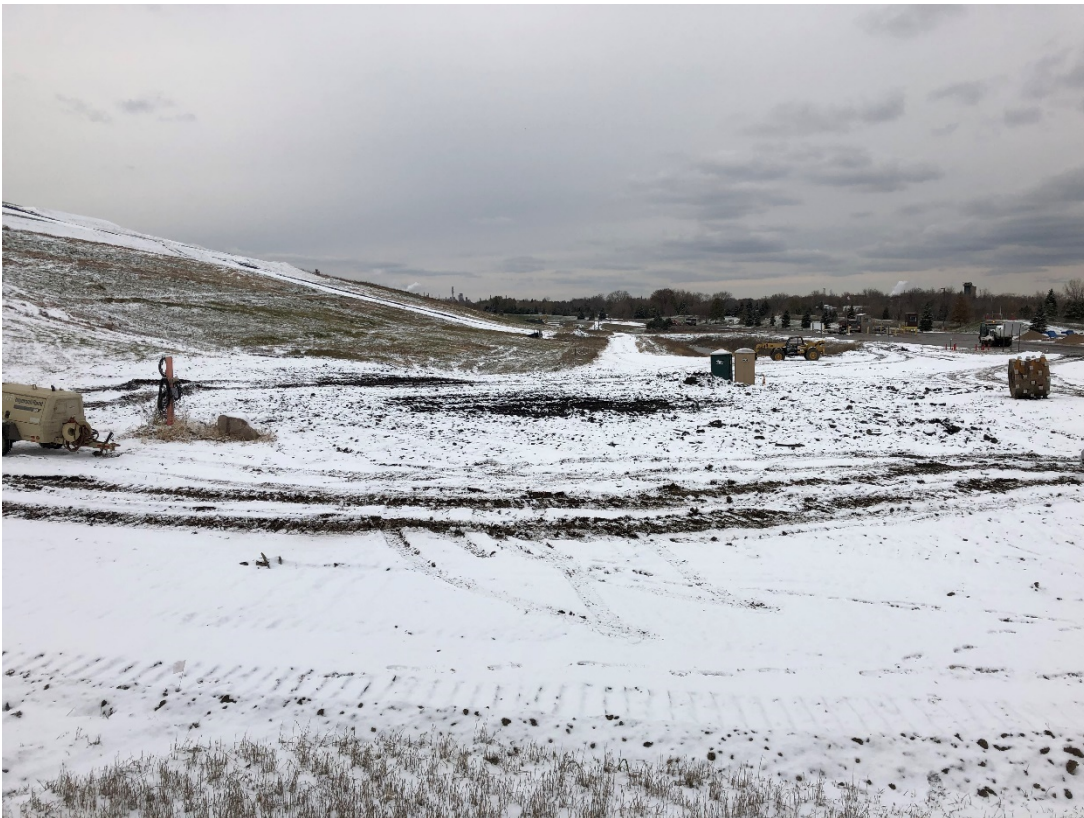
Photo 6: Location 3 – Looking Northwest, Phase 3A Anchor Trench and Northeastern Waste Slope

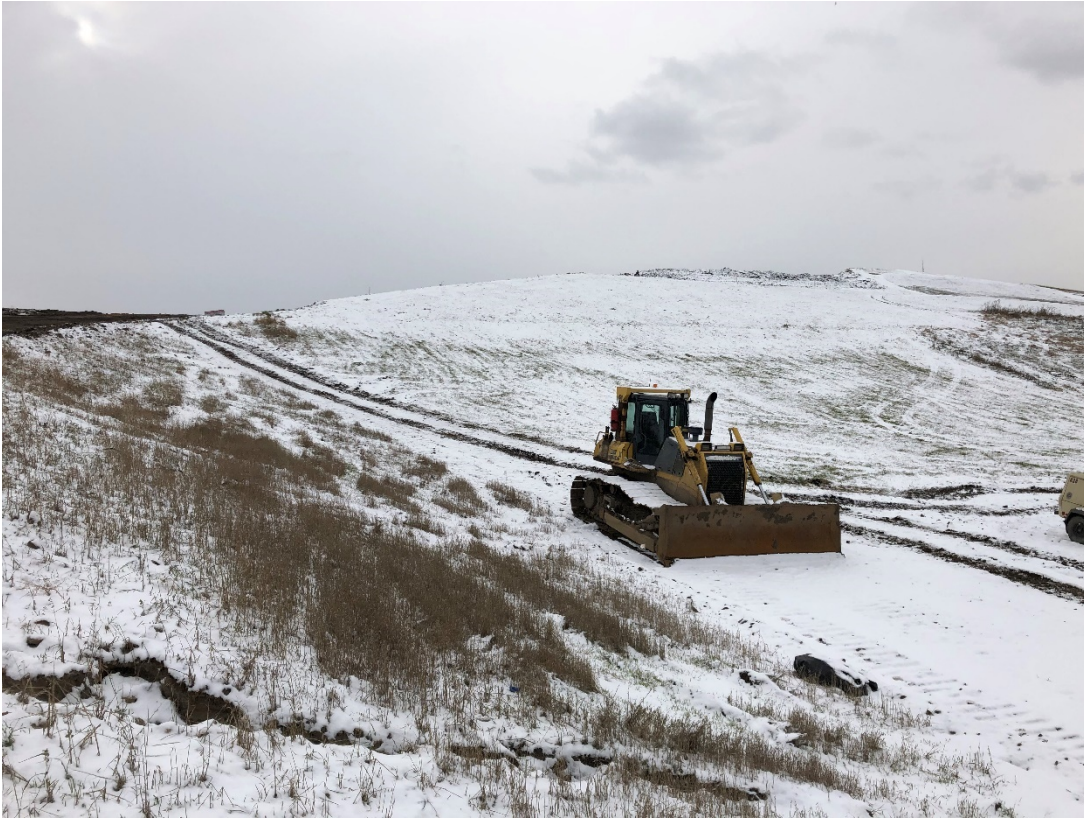
Photo 7: Location 3 – Looking West, Phase 3 East Corner & Interior Access Road

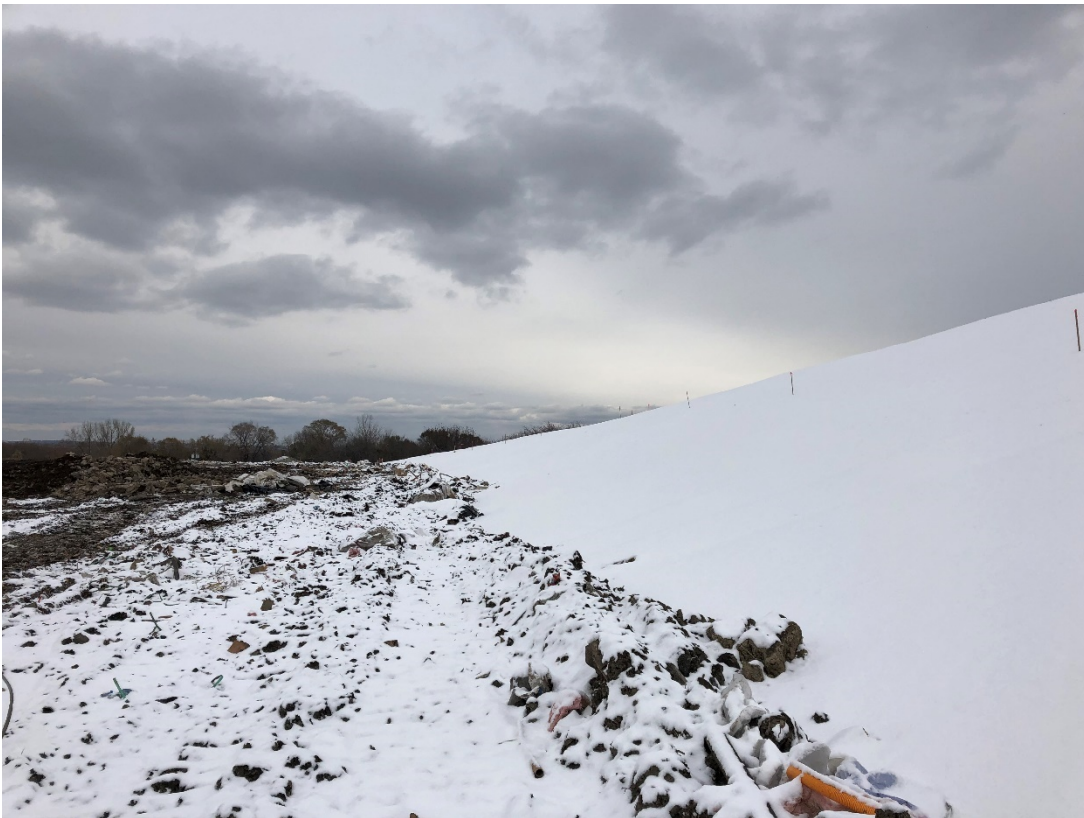
Photo 8: Location 4 – Looking Northeast, Phase 3F Liner Limit

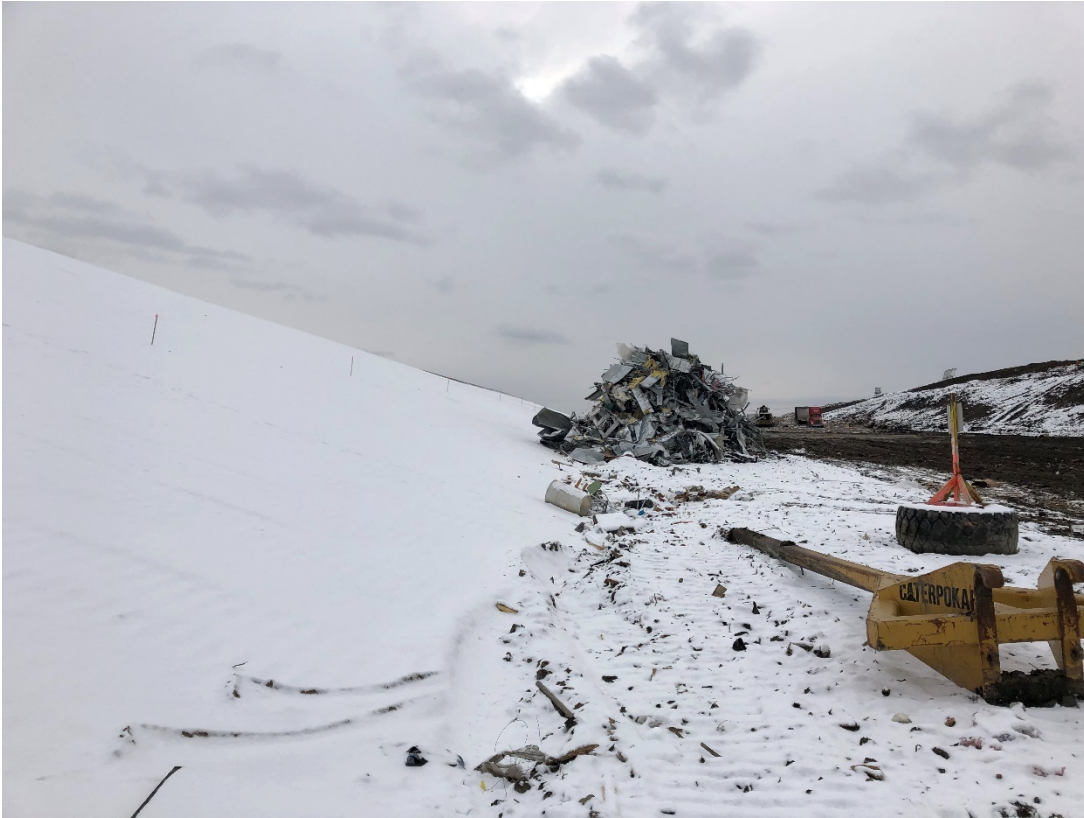
Photo 9: Location 4 – Looking Southwest, Phase 3F Liner Limit

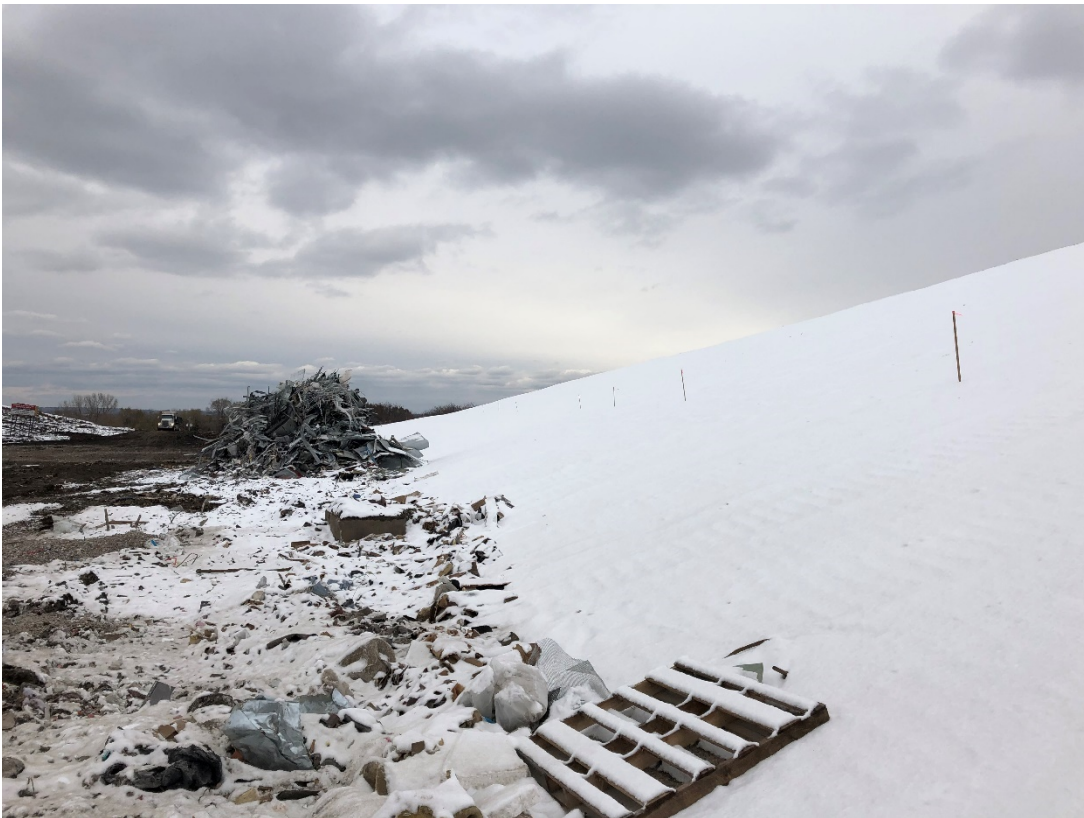
Photo 10: Location 5 – Looking Southwest, Phase 3F Liner Limit

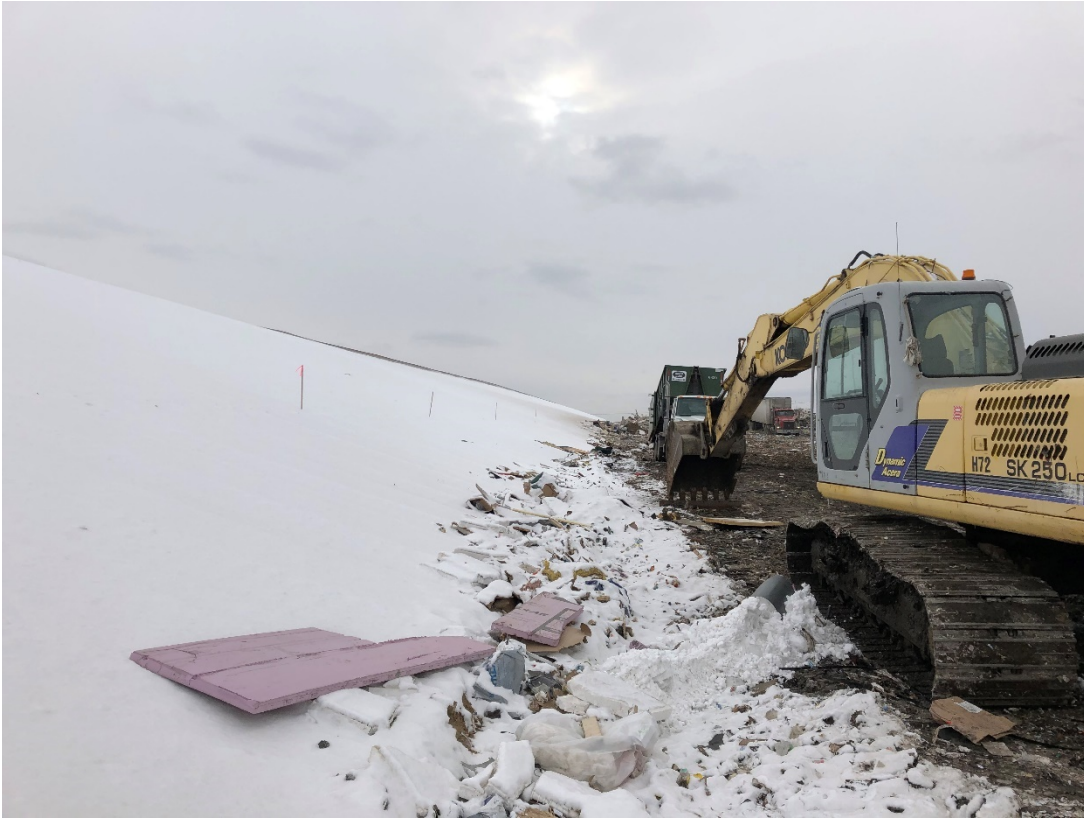
Photo 11: Location 5 – Looking Southwest, Phase 3F Liner Limit

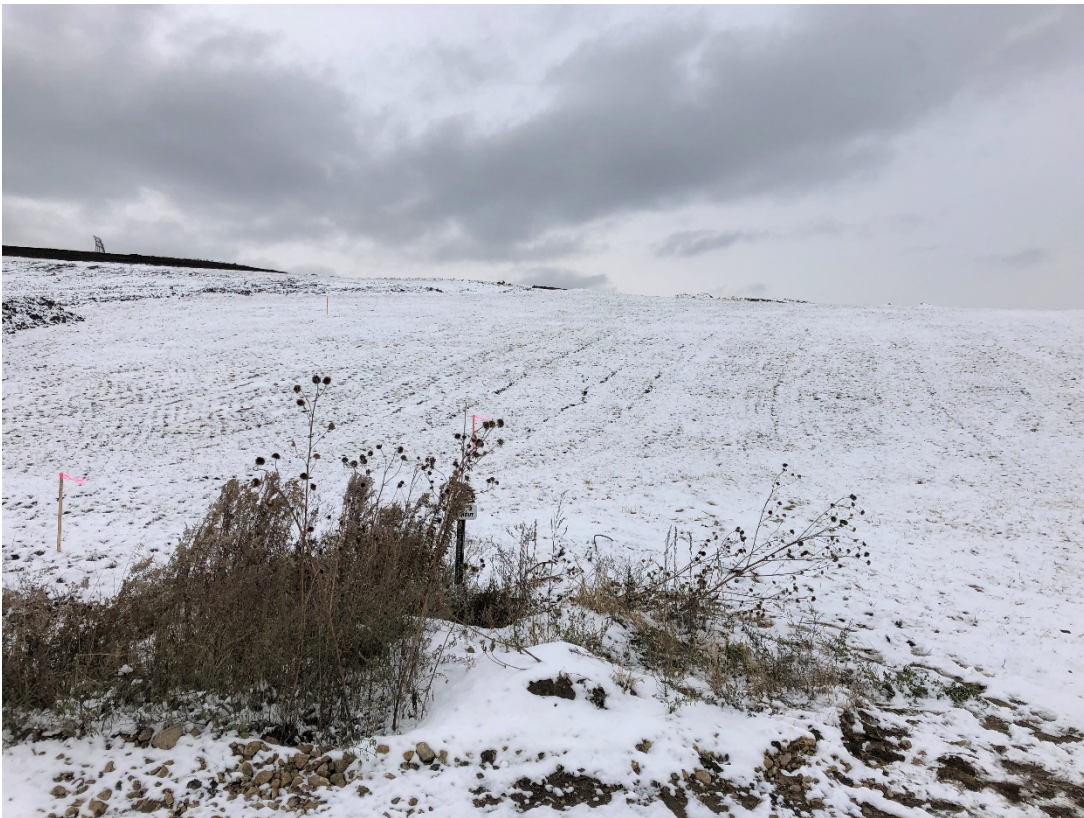
Photo 12: Location 6 – Looking Northeast, Southeastern Slope, Anchor Trench & New Liner Construction

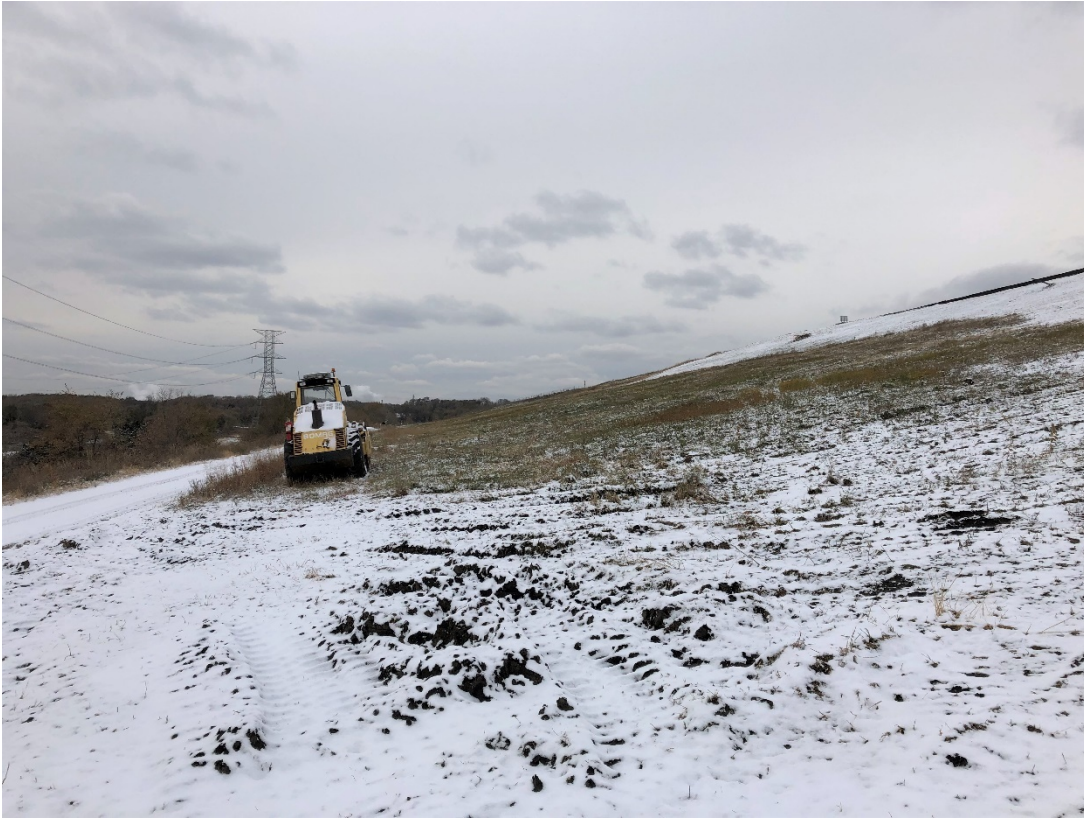
Photo 13: Location 6 – Looking Northwest, Cell 2D Southwestern Slope and Perimeter Road

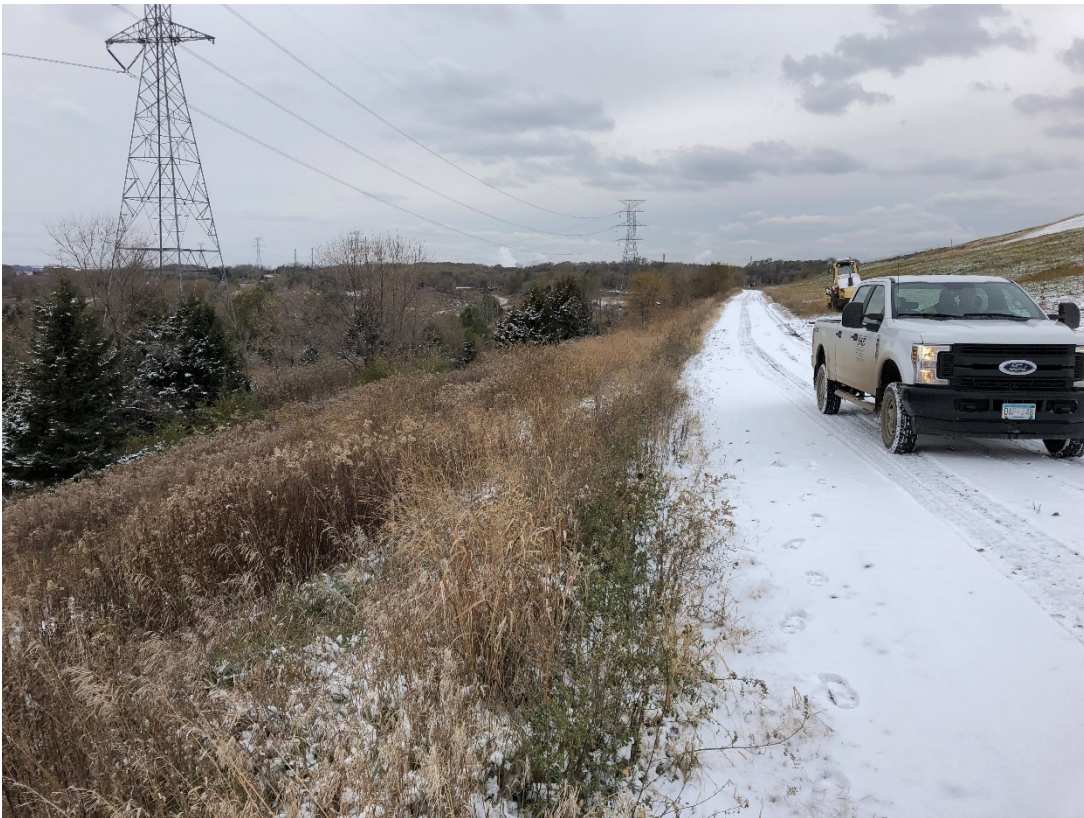
Photo 14: Location 6 – Looking North, Cell 2D Berm

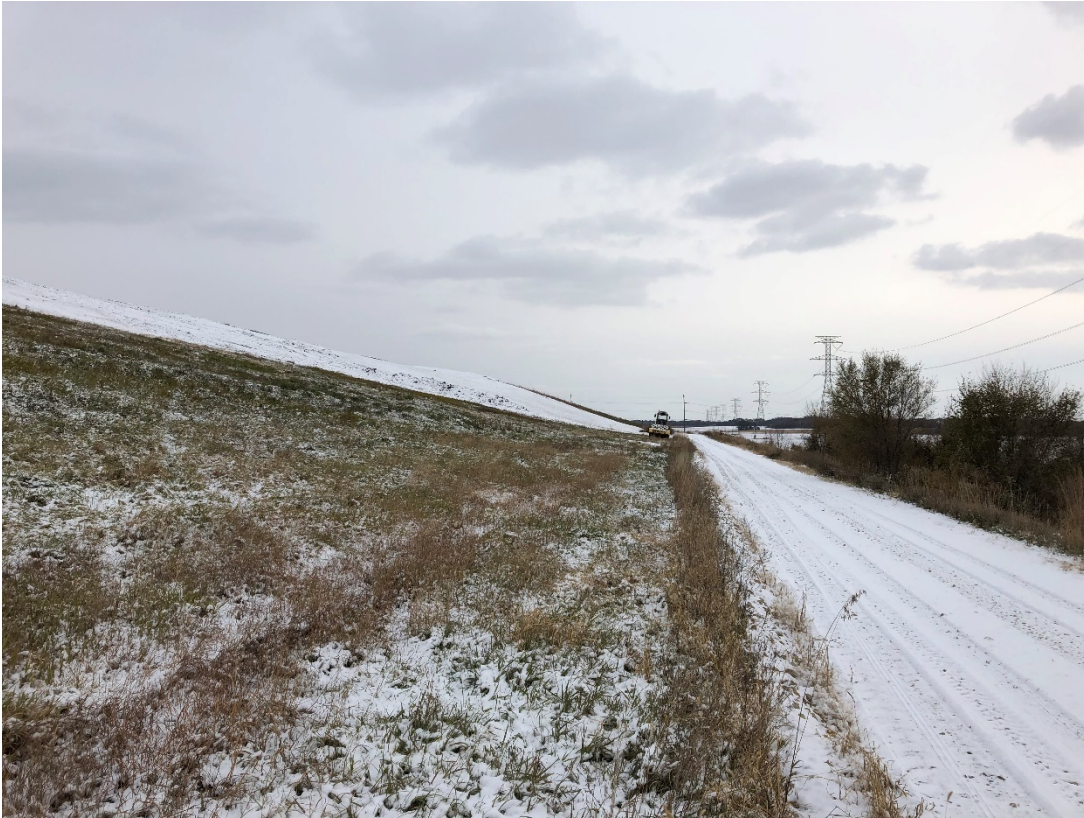
Photo 15: Location 7 – Looking Southeast, Cell 2D Southwestern Slope, Anchor Trench, and Road

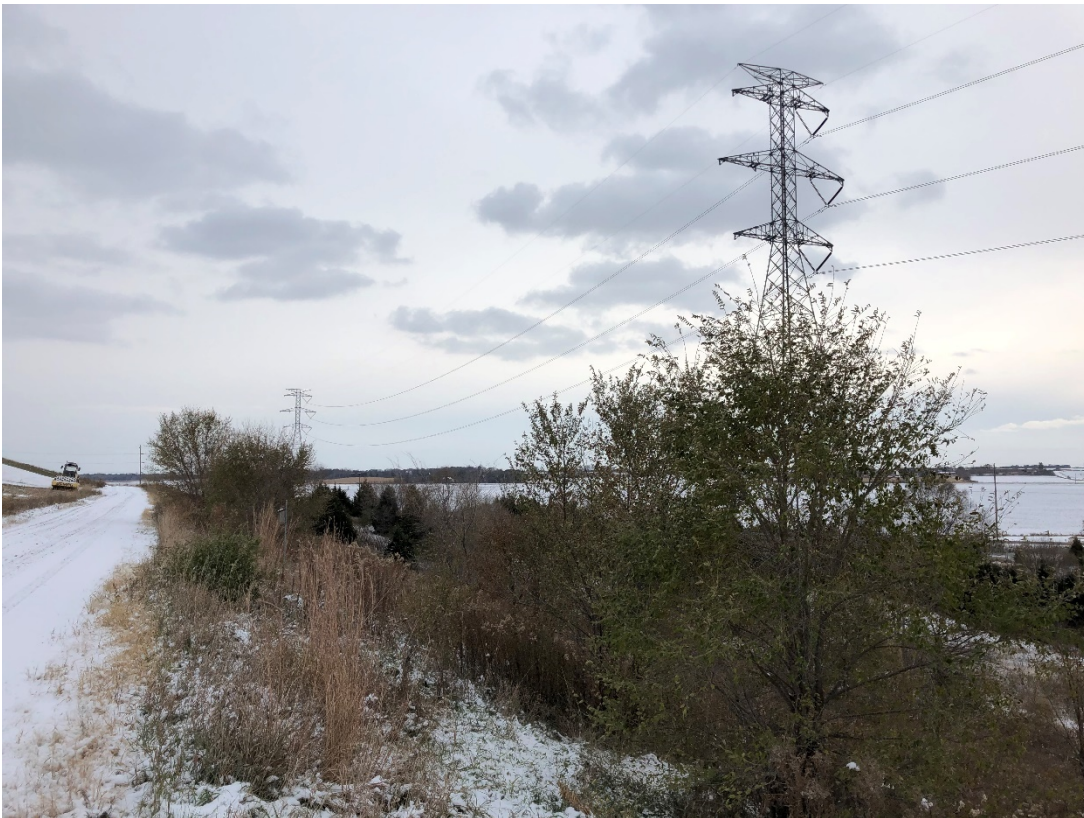
Photo 16: Location 7 – Looking Southeast, Cell 2D Berm

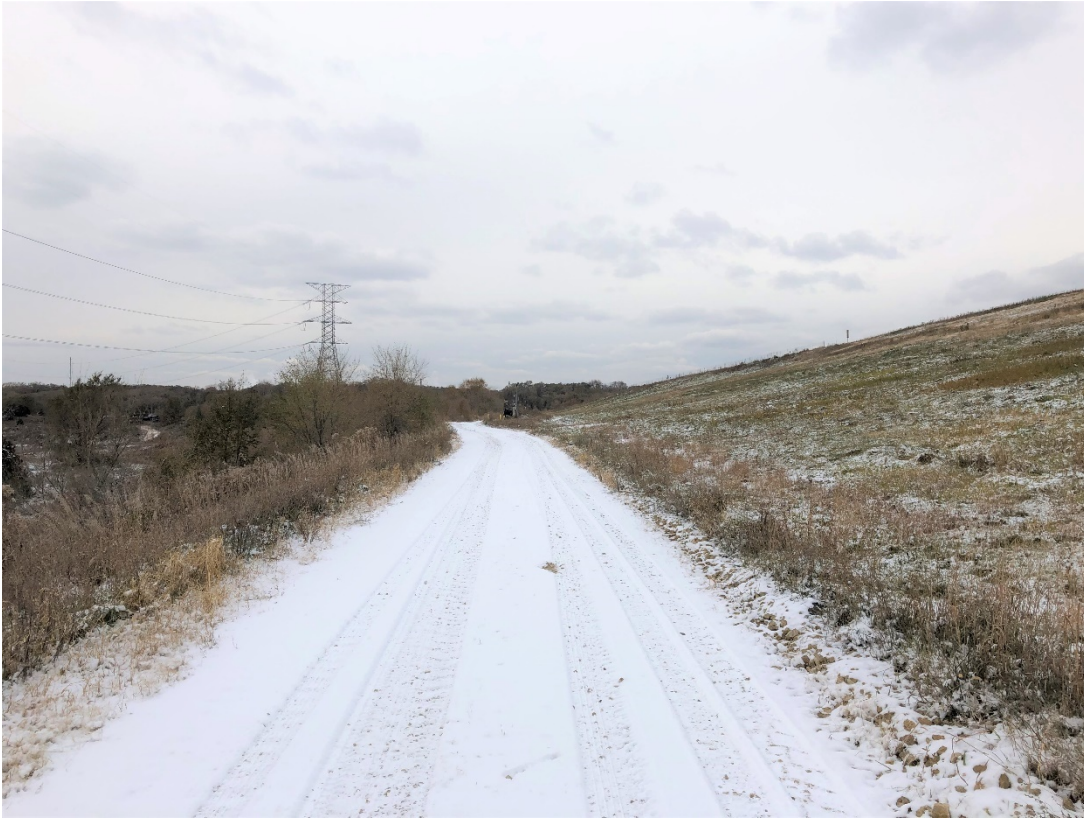
Photo 17: Location 7 – Looking Northwest, Cell 2C Southwestern Slope, Anchor Trench, and Road
