Technical Memo

To: Geoff Strack, P.E., Waste Connections
From: Brad Sullivan, P.E., Wenck Associates, Inc.
Date: January 9, 2020
Subject: SKB Rosemount Industrial Waste Facility
2019 Annual CCR Inspection Report
Wenck Project #B3053-0180

PROJECT TITLE
2019 CCR INSPECTION REPORT

SKB ROSEMOUNT LANDFILL
ROSEMOUNT, MINNESOTA

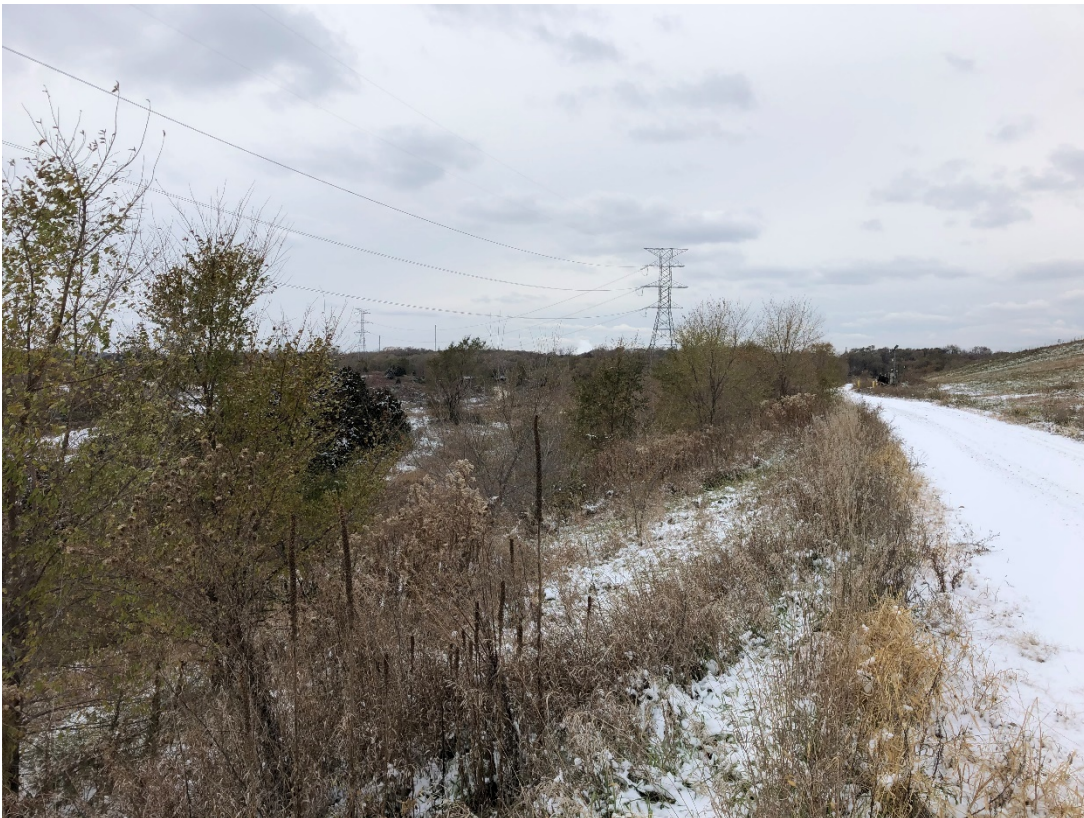
Photo 18: Location 7 – Looking Northwest, Cell 2C Cell 2C Southwestern Berm

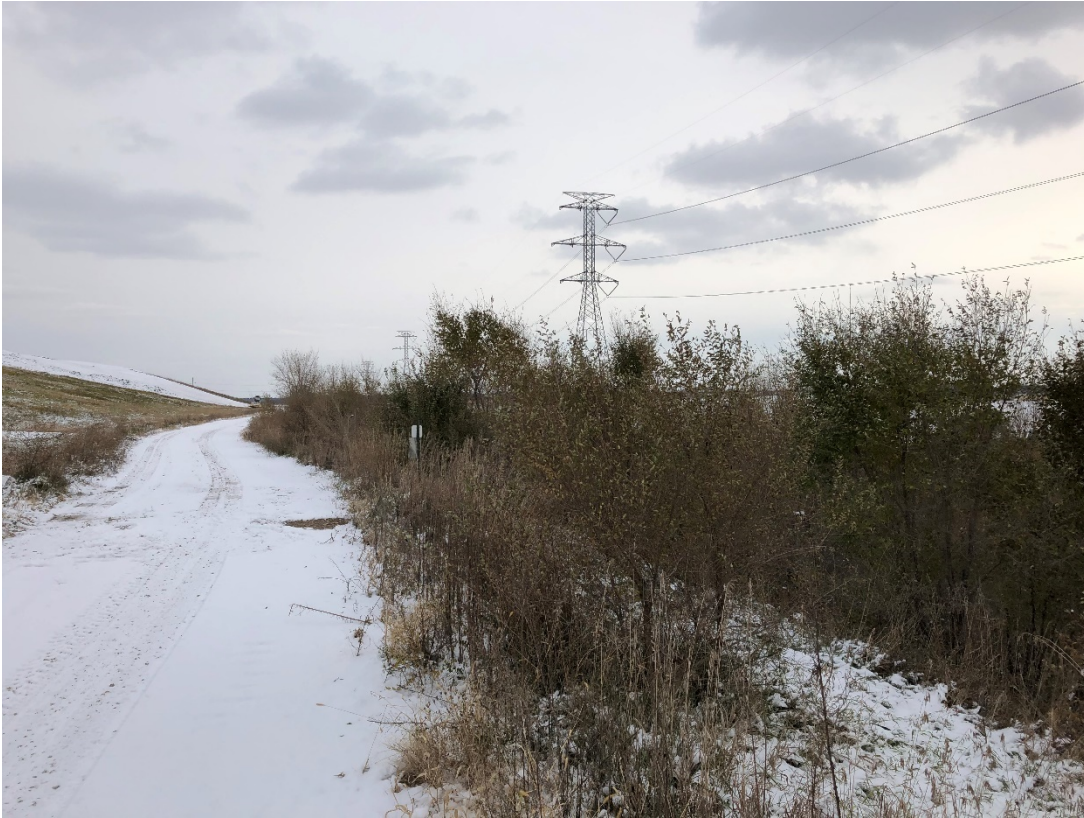
Photo 19: Location 8 – Looking Southwest, Cell 2C Southwestern Berm

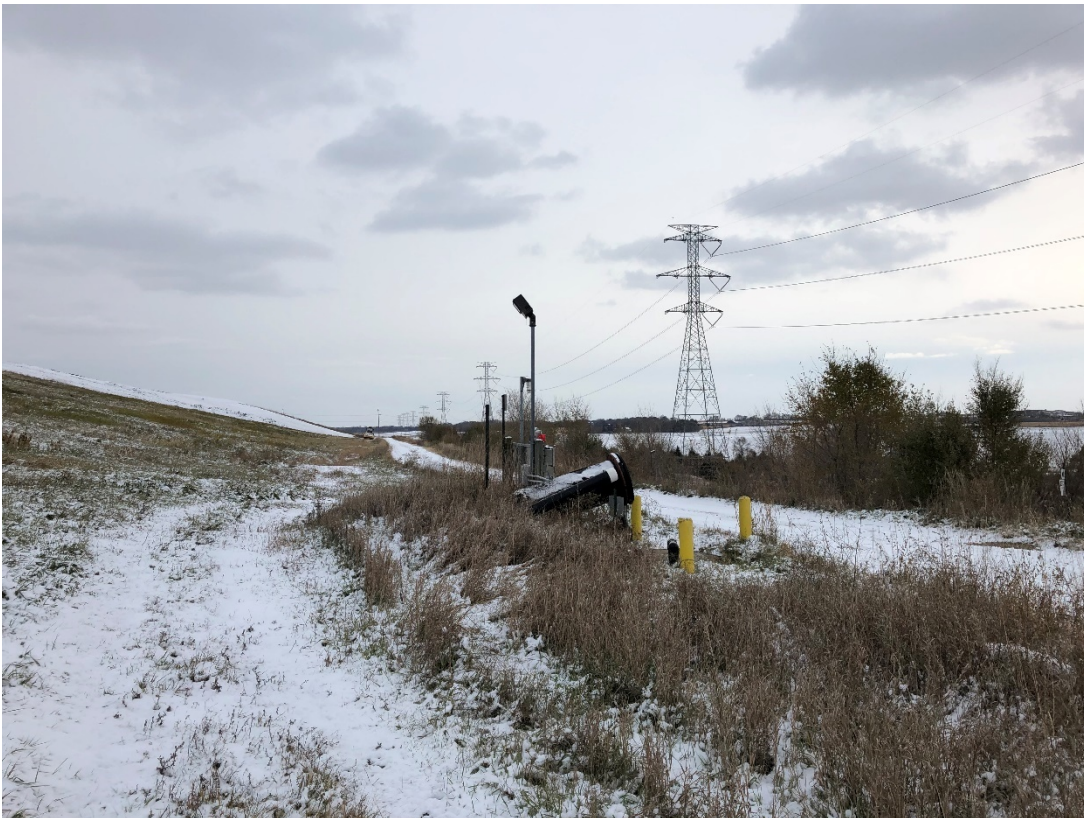
Photo 20: Location 8 – Looking Southwest, Cell 2C Southwestern Waste Slope and Anchor Trench

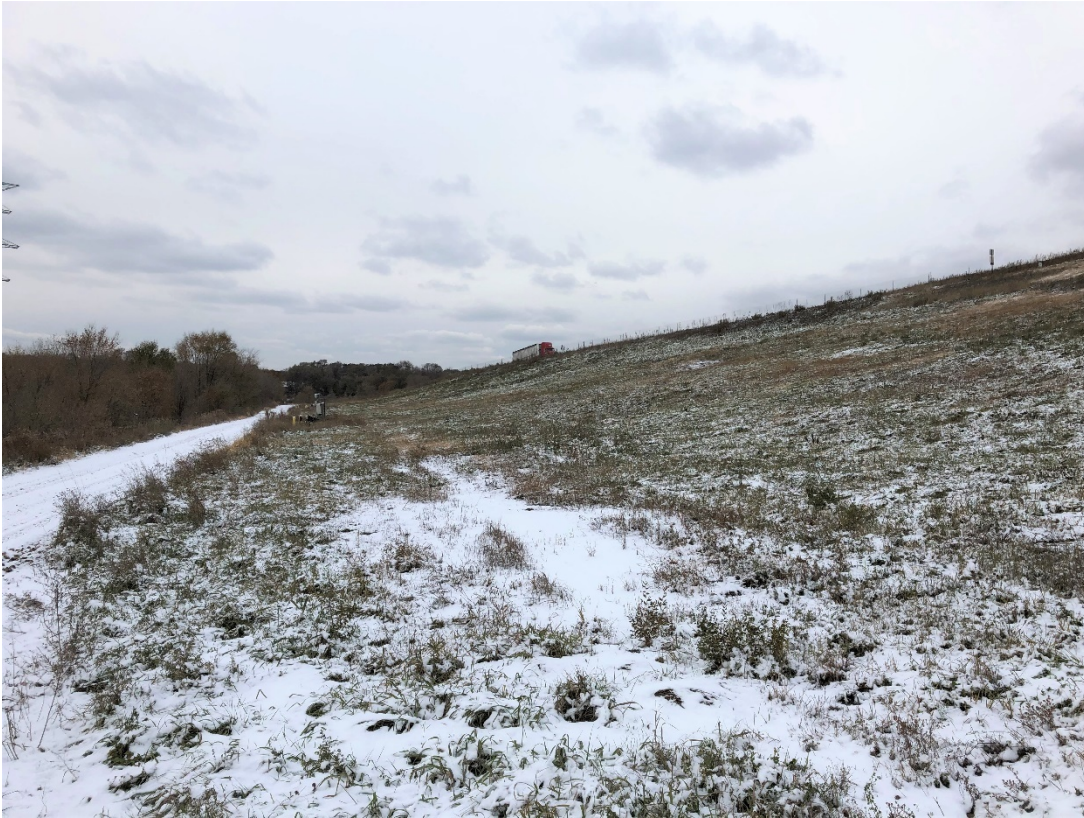
Photo 21: Location 8 – Looking Northwest, Cell 2C & 2B Southwestern Waste Slope and Anchor Trench

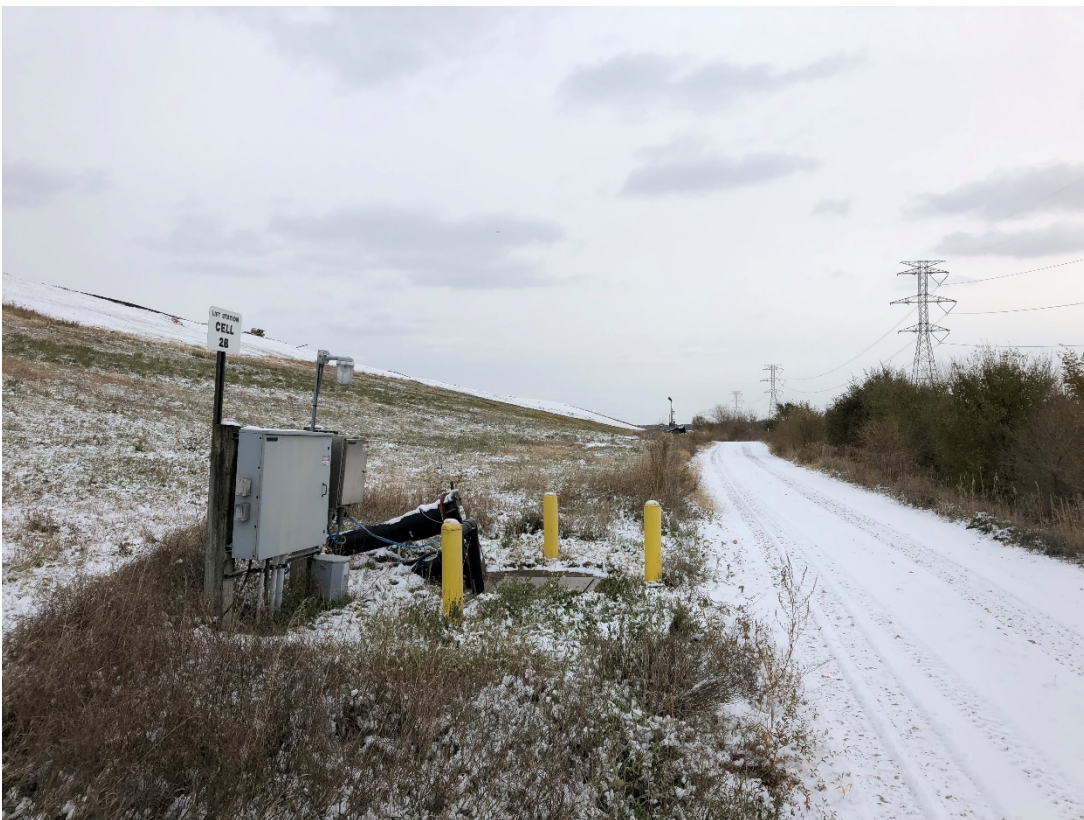
Photo 22: Location 9 – Looking Southeast, Cell 2C Southwestern Waste Slope and Anchor Trench

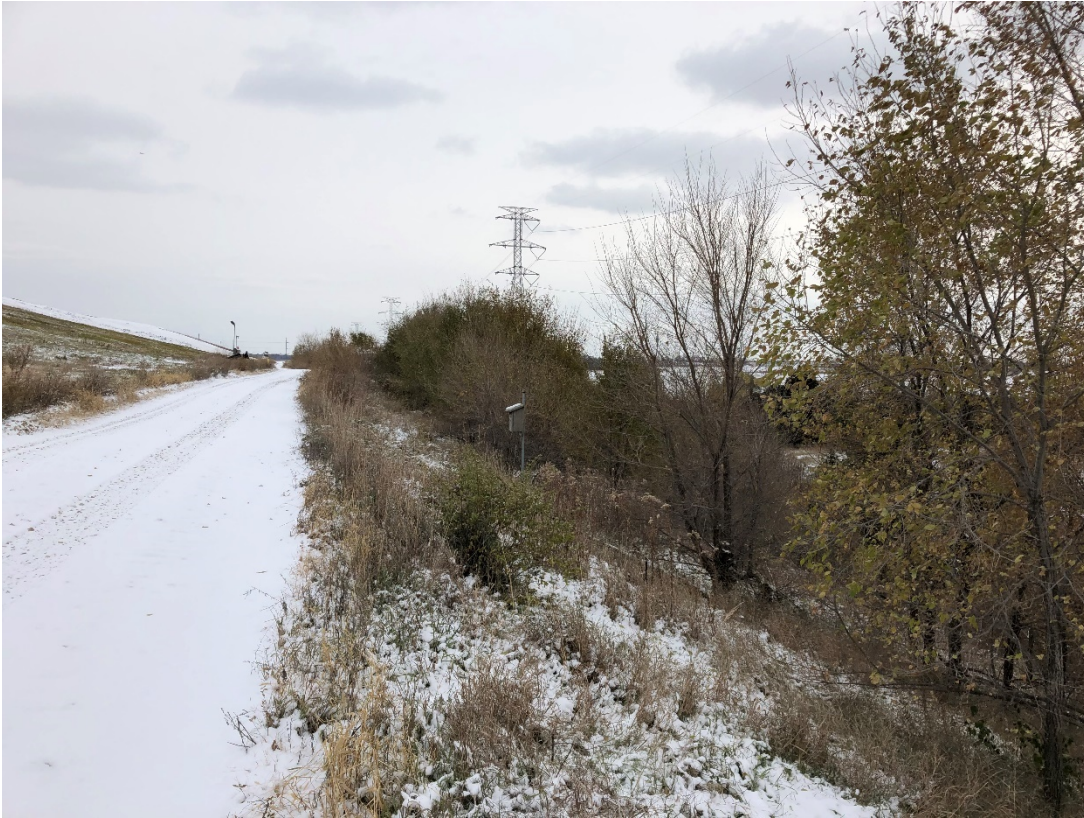
Photo 23: Location 9 – Looking Southeast, Cell 2C Southwestern Berm

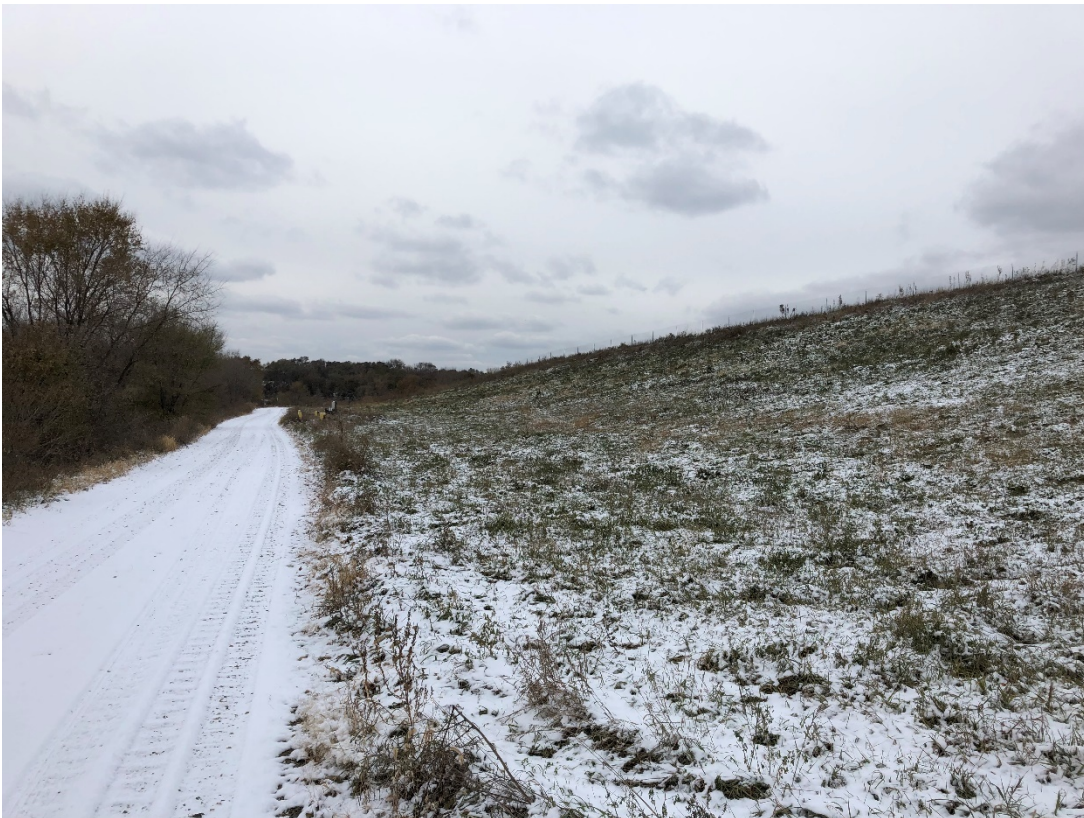
Photo 24: Location 9 – Looking Northwest, Cell 2B Southwestern Waste Slope and Anchor Trench

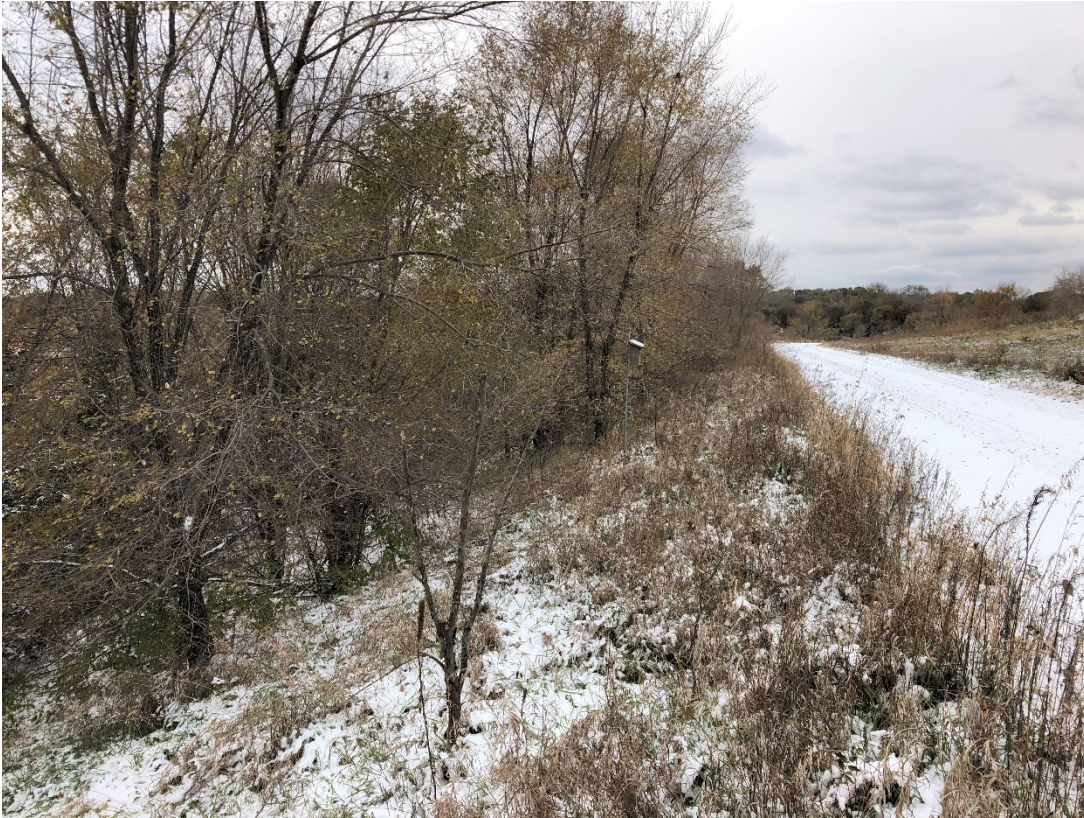
Photo 25: Location 9 – Looking Northwest, Cell 2B Southwestern Berm

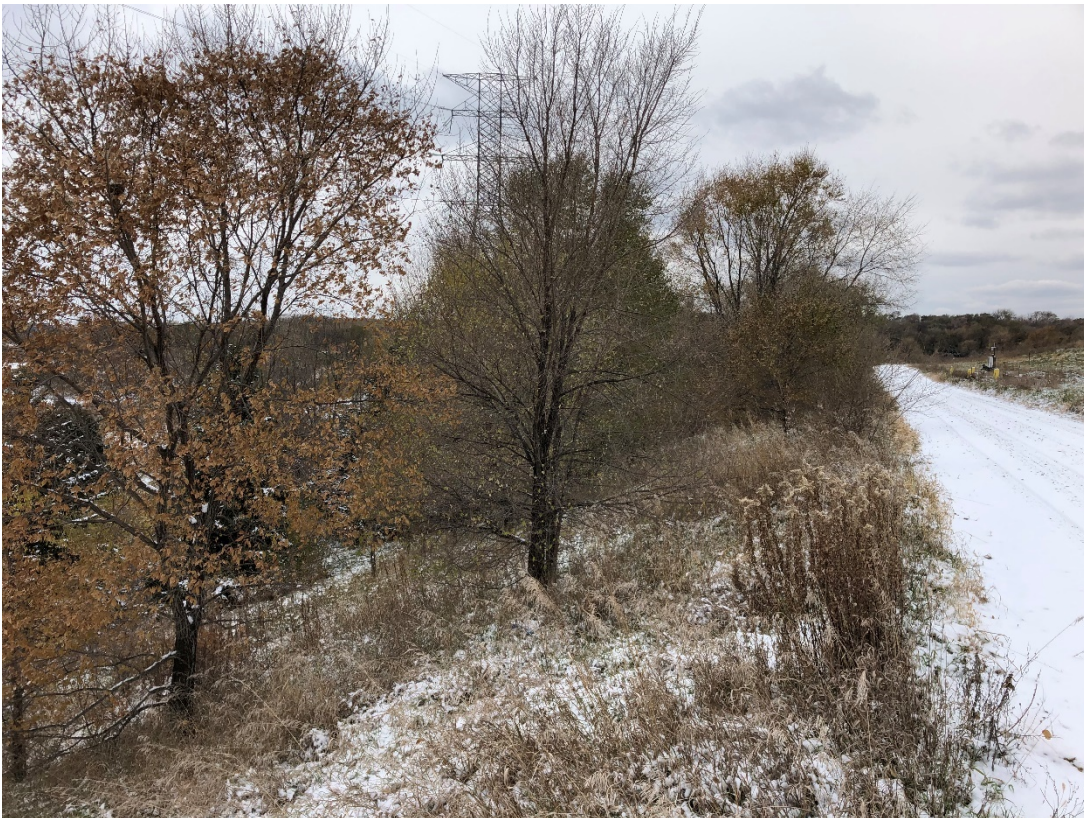
Photo 26: Location 10 – Looking Northwest, Cell 2A Southwestern Berm

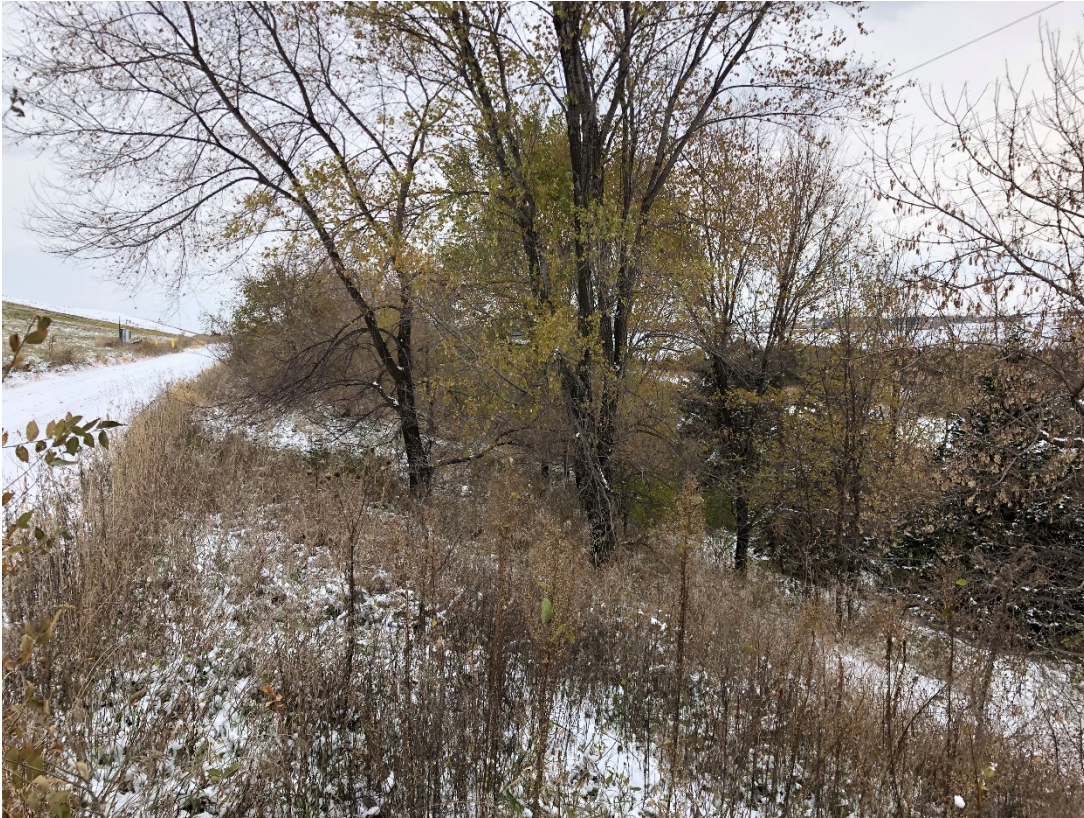
Photo 27: Location 10 – Looking Southeast, Cell 2B Southwestern Berm

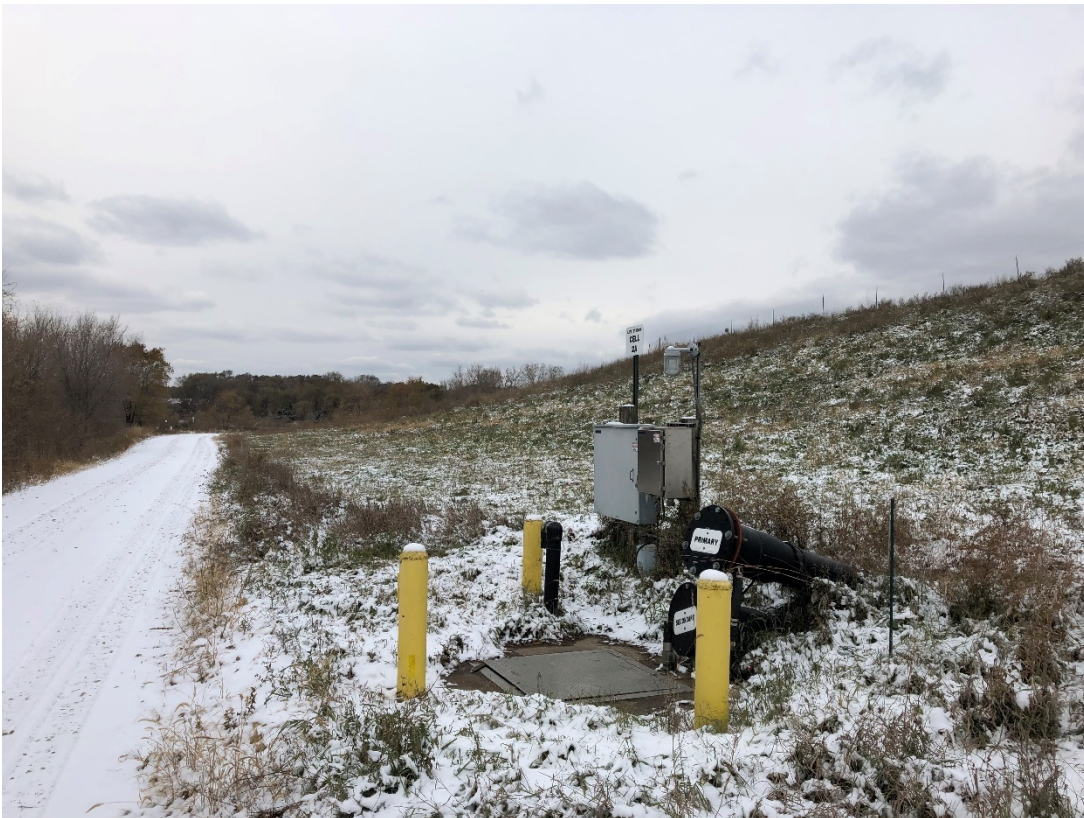
Photo 28: Location 10 – Looking Northwest, Cell 2A Southwestern Waste Slope and Perimeter Road

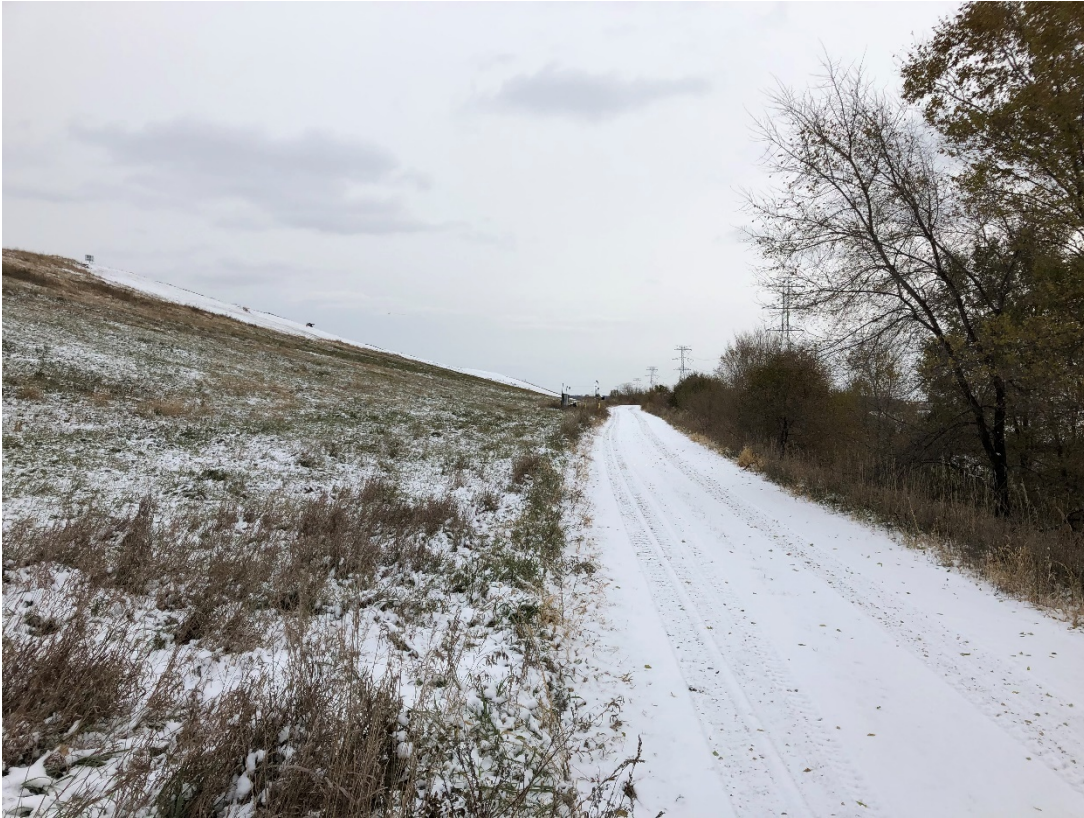
Photo 29: Location 10 – Looking Southeast, Cell 2B Southwestern Waste Slope and Perimeter Road

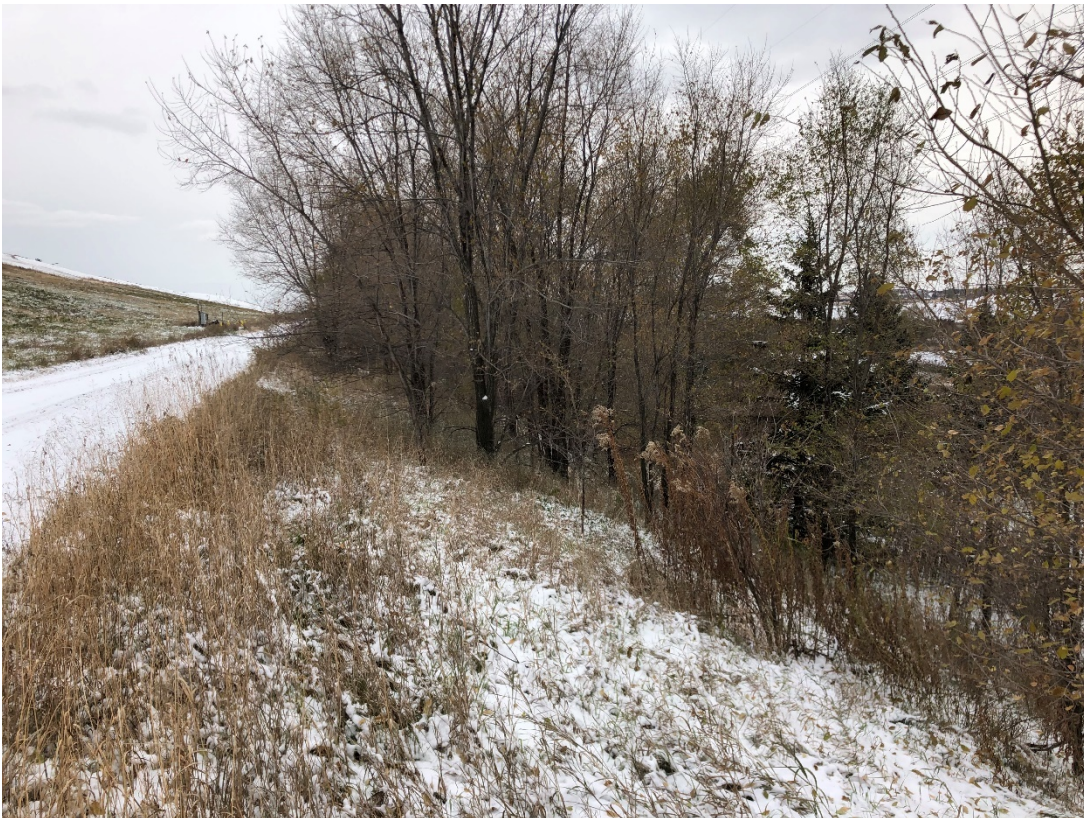
Photo 30: Location 11 – Looking Southeast, Cell 2A Southwestern Berm

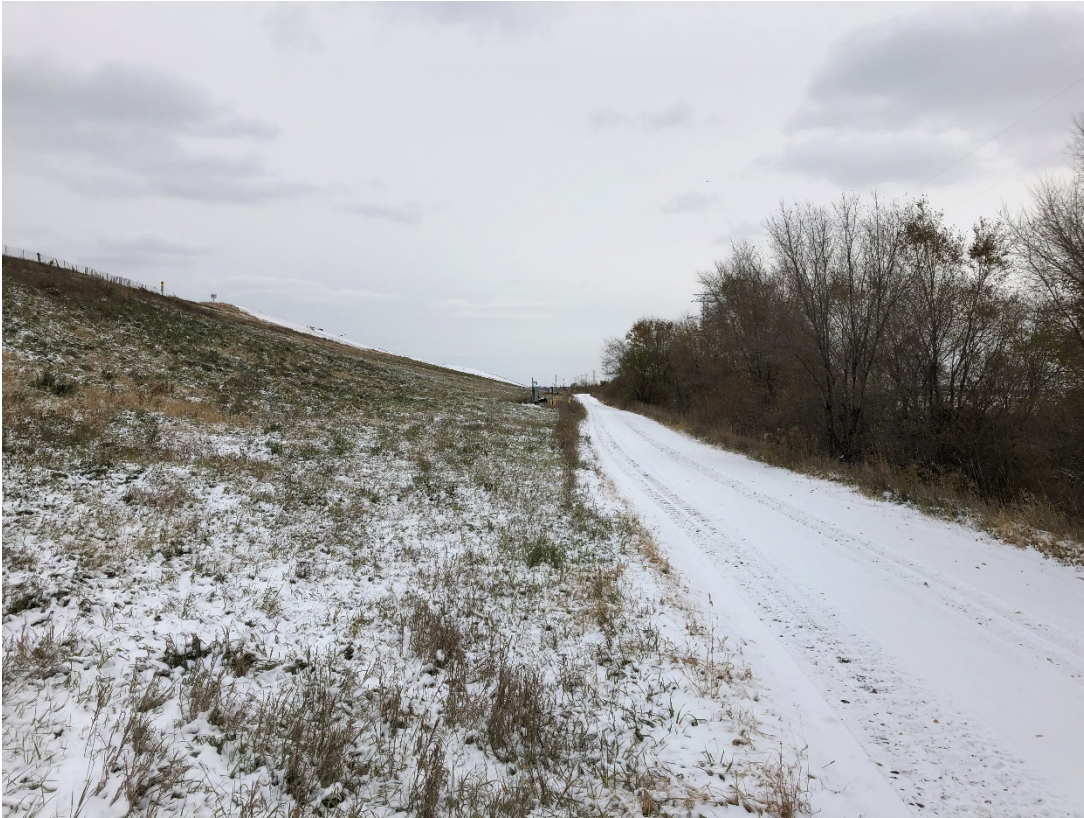
Photo 31: Location 11 – Looking Southeast, Cell 2A Southwestern Waste Slope

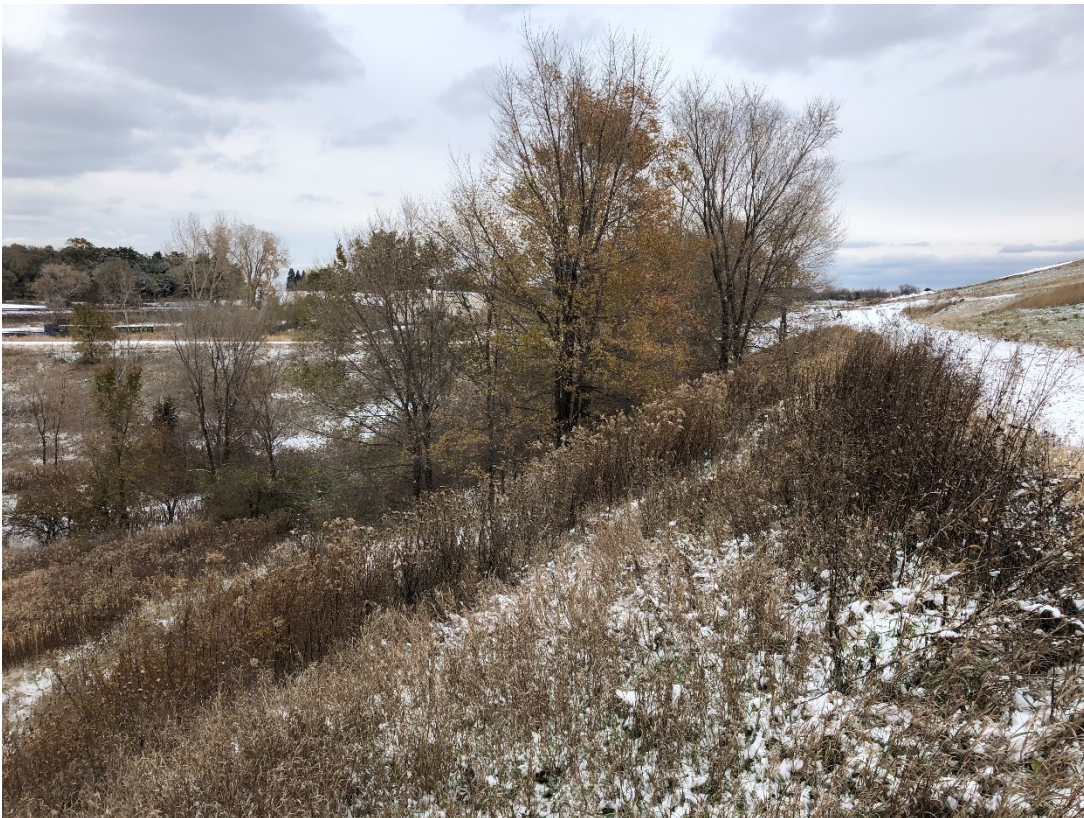
Photo 32: Location 11 – Looking Northeast, Cell 2A Northwestern Berm

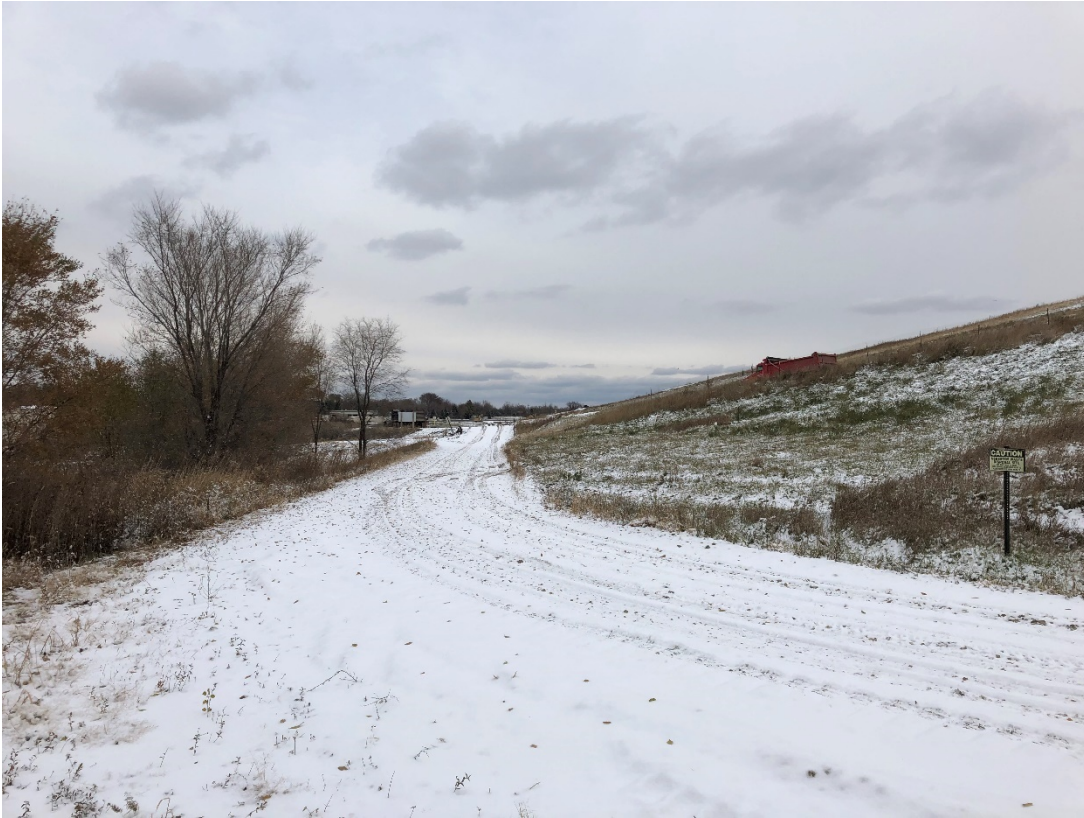
Photo 33: Location 11 – Looking Northeast, Cell 2A Northwestern Perimeter Road and Anchor Trench

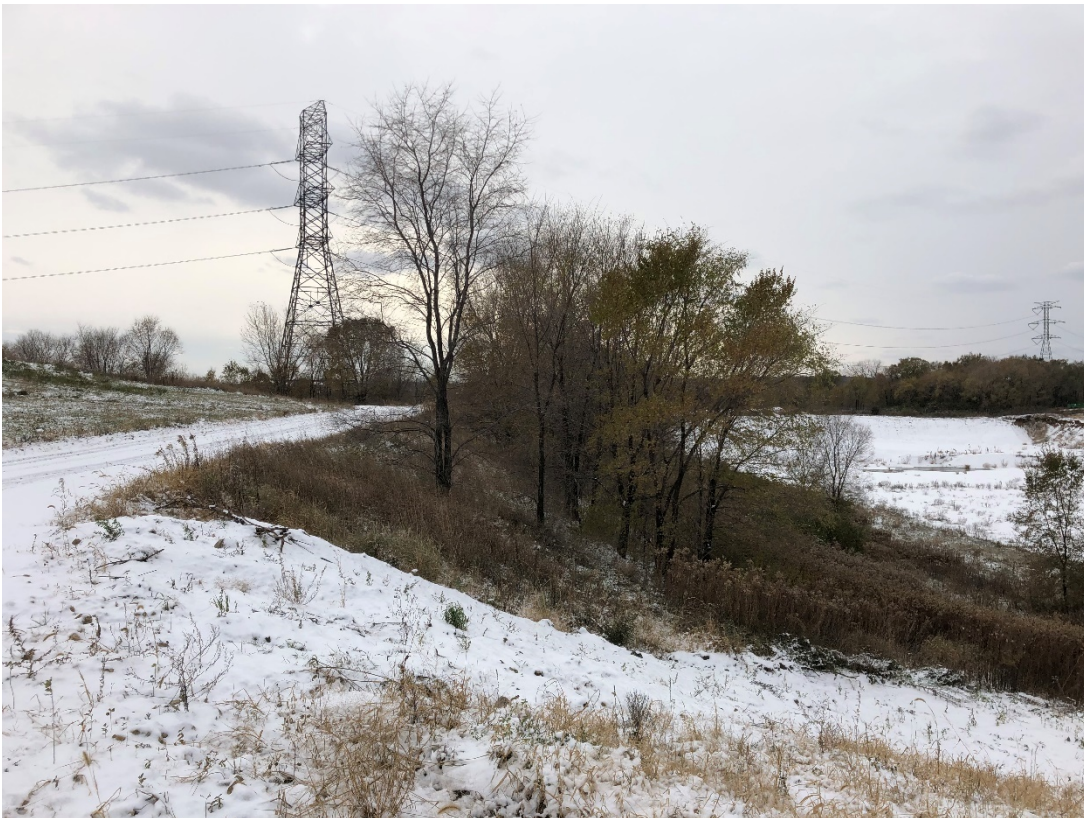
Photo 34: Location 12 – Looking Southwest, Cell 2A Northwestern Berm

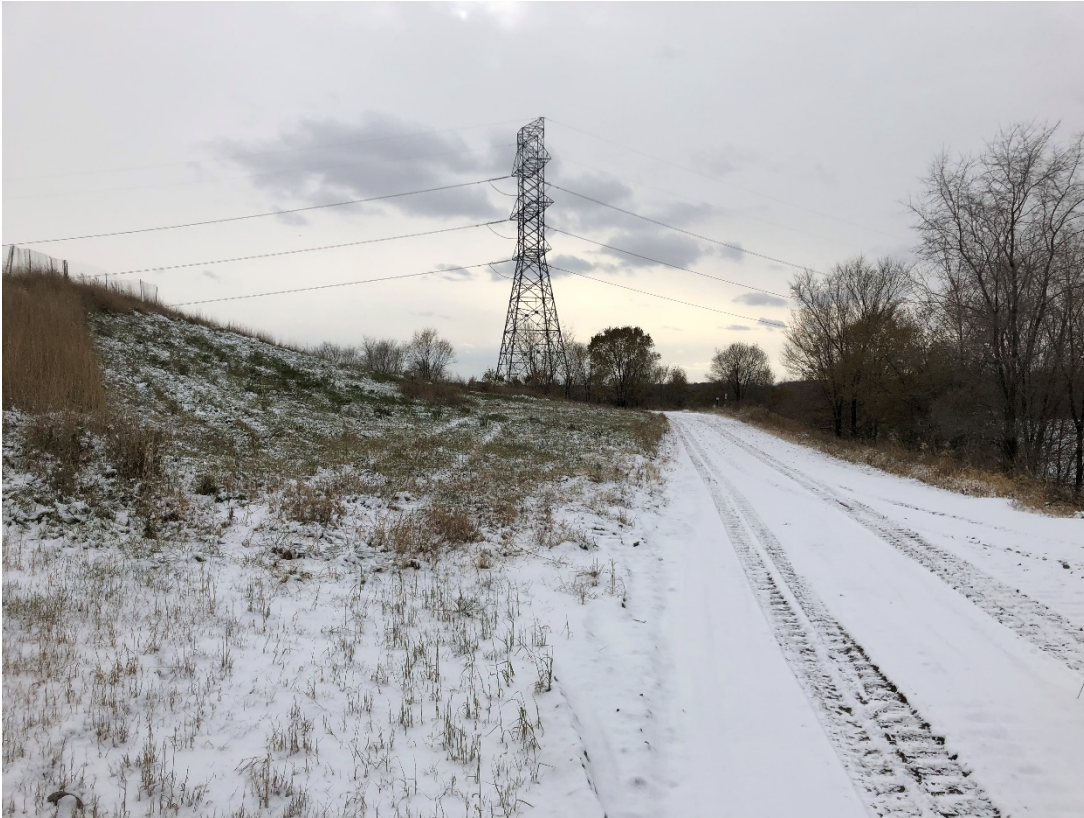
Photo 35: Location 12 – Looking Southwest, Cell 2A Northwester Waste Slope and Anchor Trench

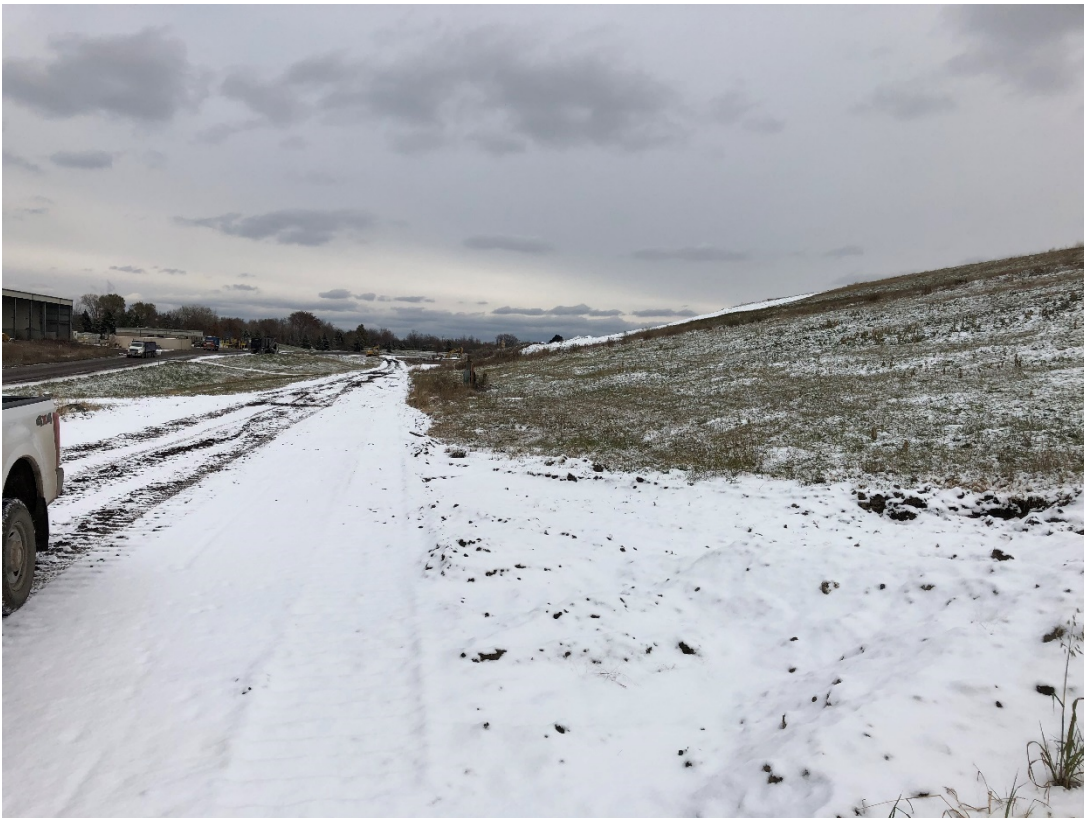
Photo 36: Location 12 – Looking Northeast, Cell 1 Northwestern Waste Slope

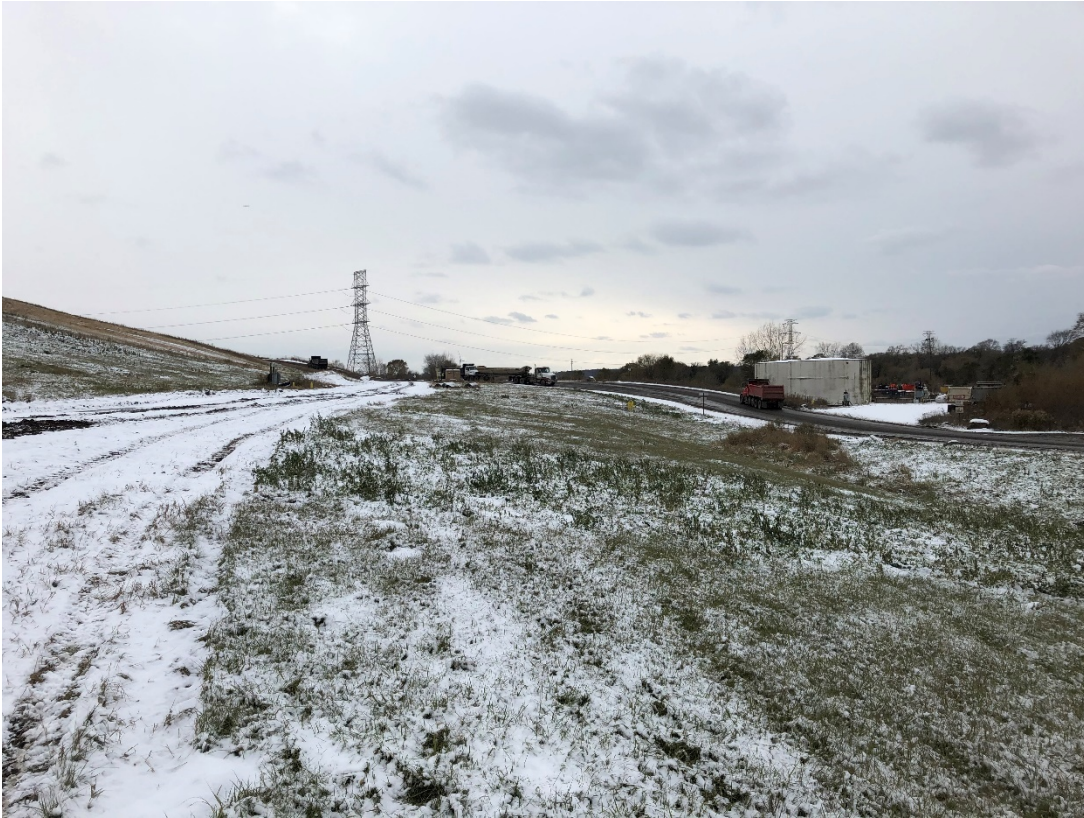
Photo 37: Location 13 – Looking Southwest, Cell 1 Northwestern Berm

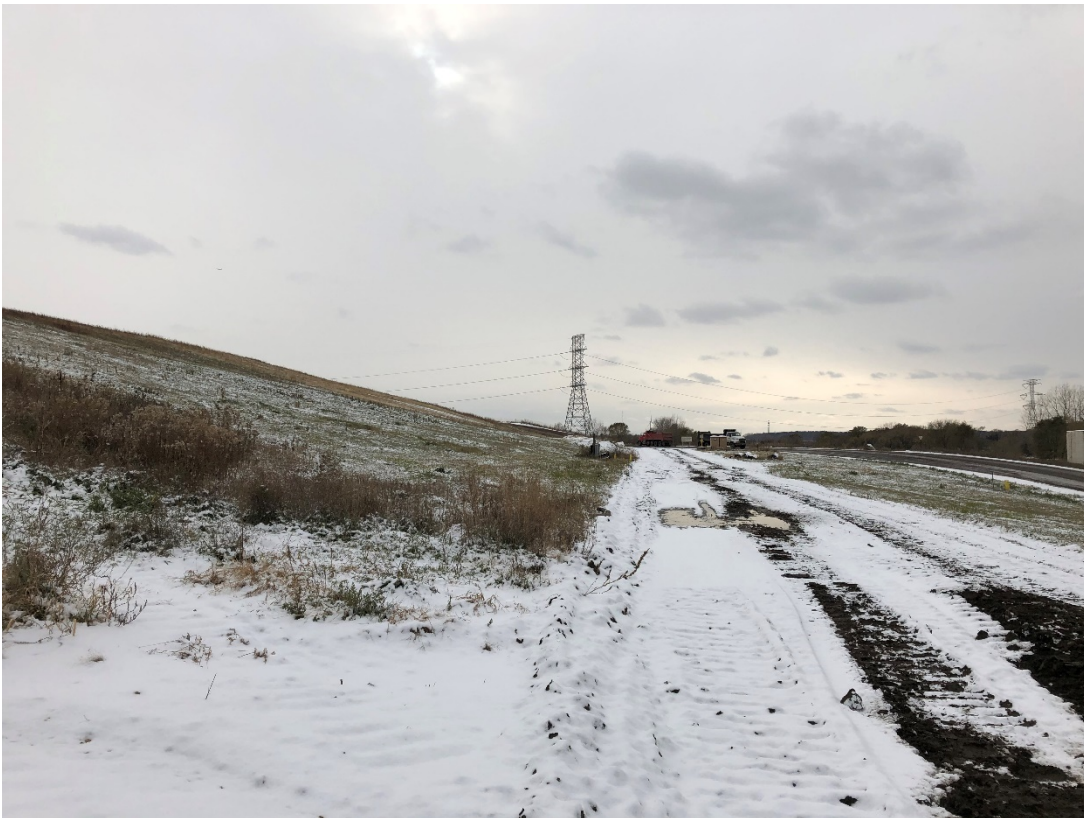
Photo 38: Location 13 – Looking South, Cell 1 Limit of Industrial Waste (CCR)

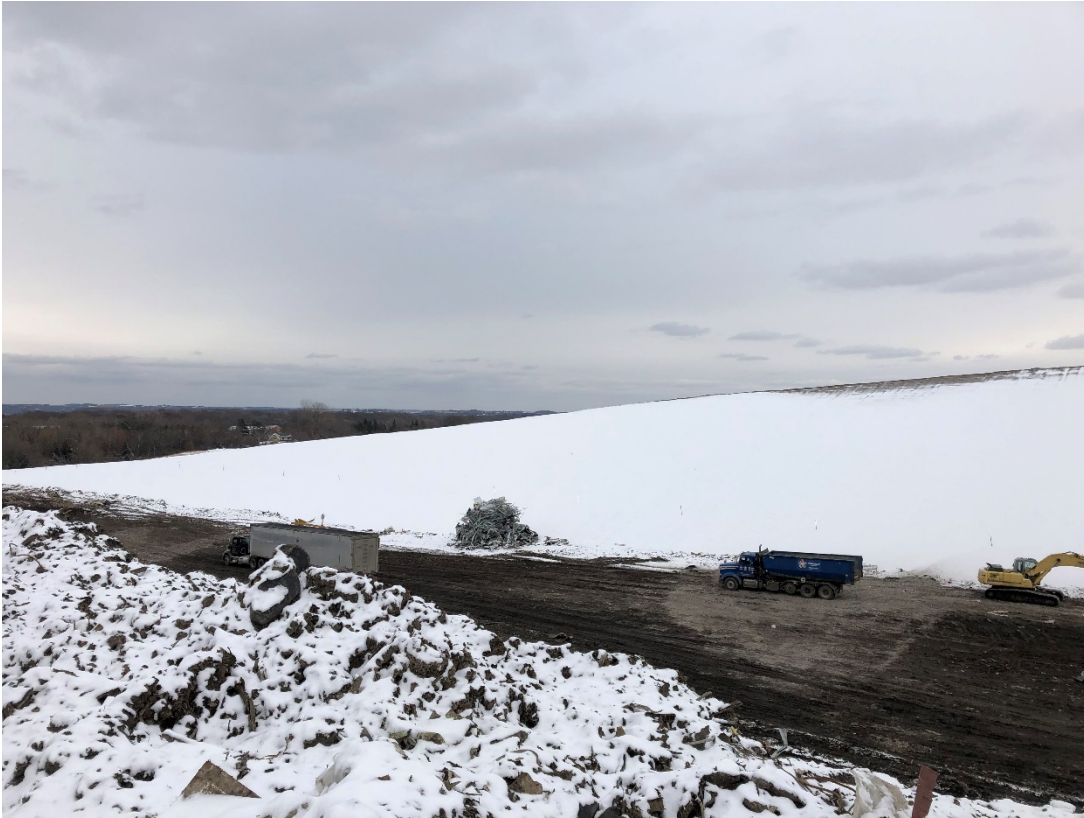
Photo 39: Location 14 – Looking East, Cell 3F Industrial Waste (CCR) Valley Fill Over C&D Disposal Area

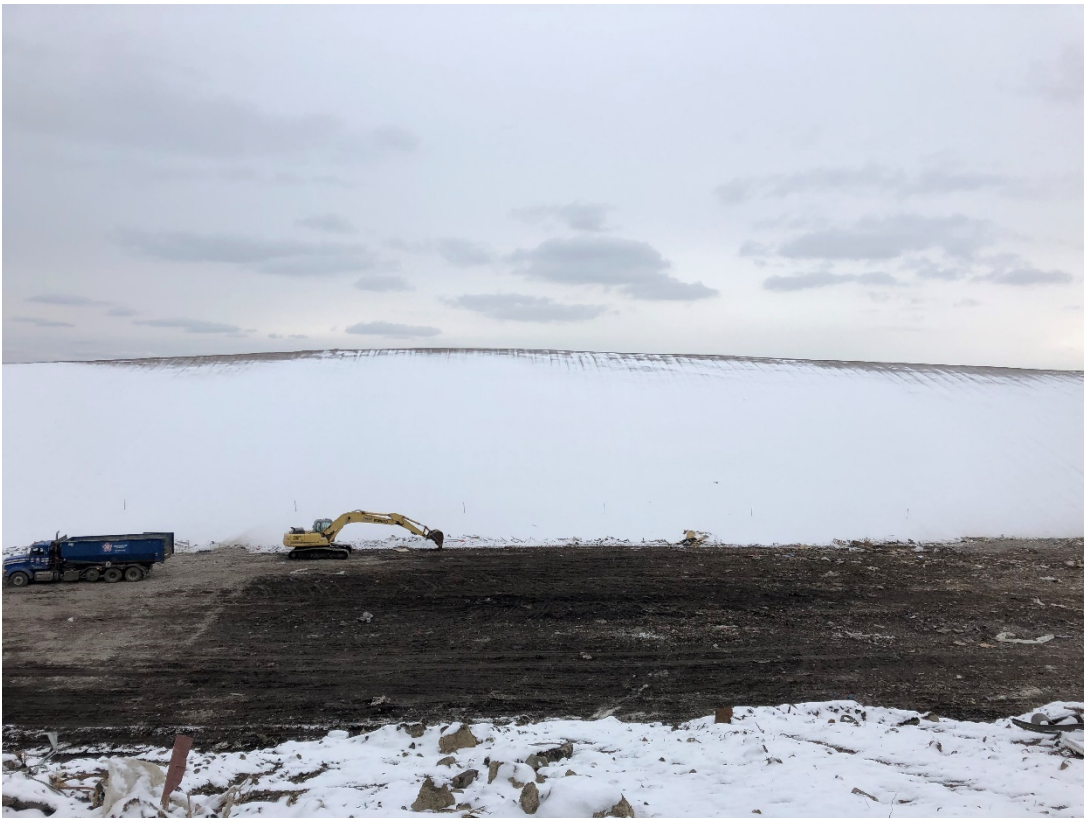
Photo 40: Location 14 – Looking Southeast, Cell 3F Industrial Waste Valley Fill Over C&D Disposal Area

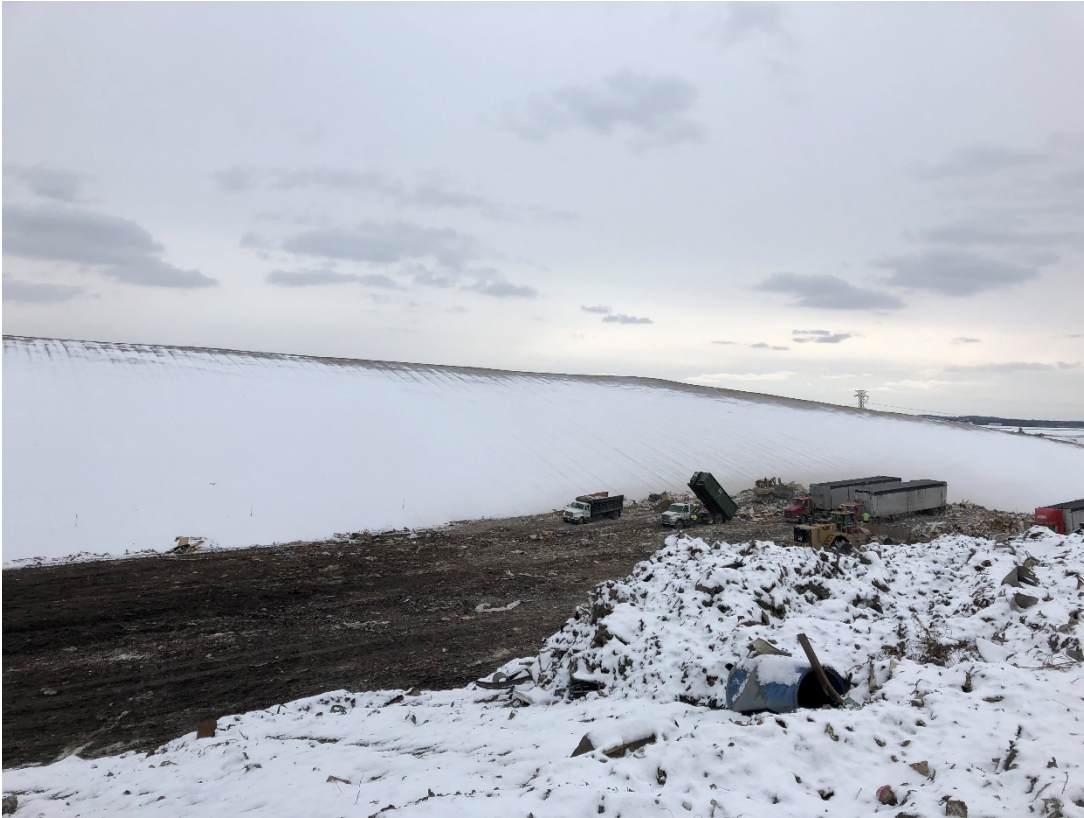
Photo 41: Location 14 – Looking South, Cell 3F Industrial Waste (CCR) Valley Fill Over C&D Disposal Area
