To:	Geoff Strack, PE, Waste Connections	From:	Bradley W Sullivan, PE, Stantec Consulting Services Inc.
File:	Project #B3053-20-518	Date:	January 9, 2021

**Reference: SKB Rosemount Industrial Waste Facility 2020 Annual CCR Inspection Report****Purpose**

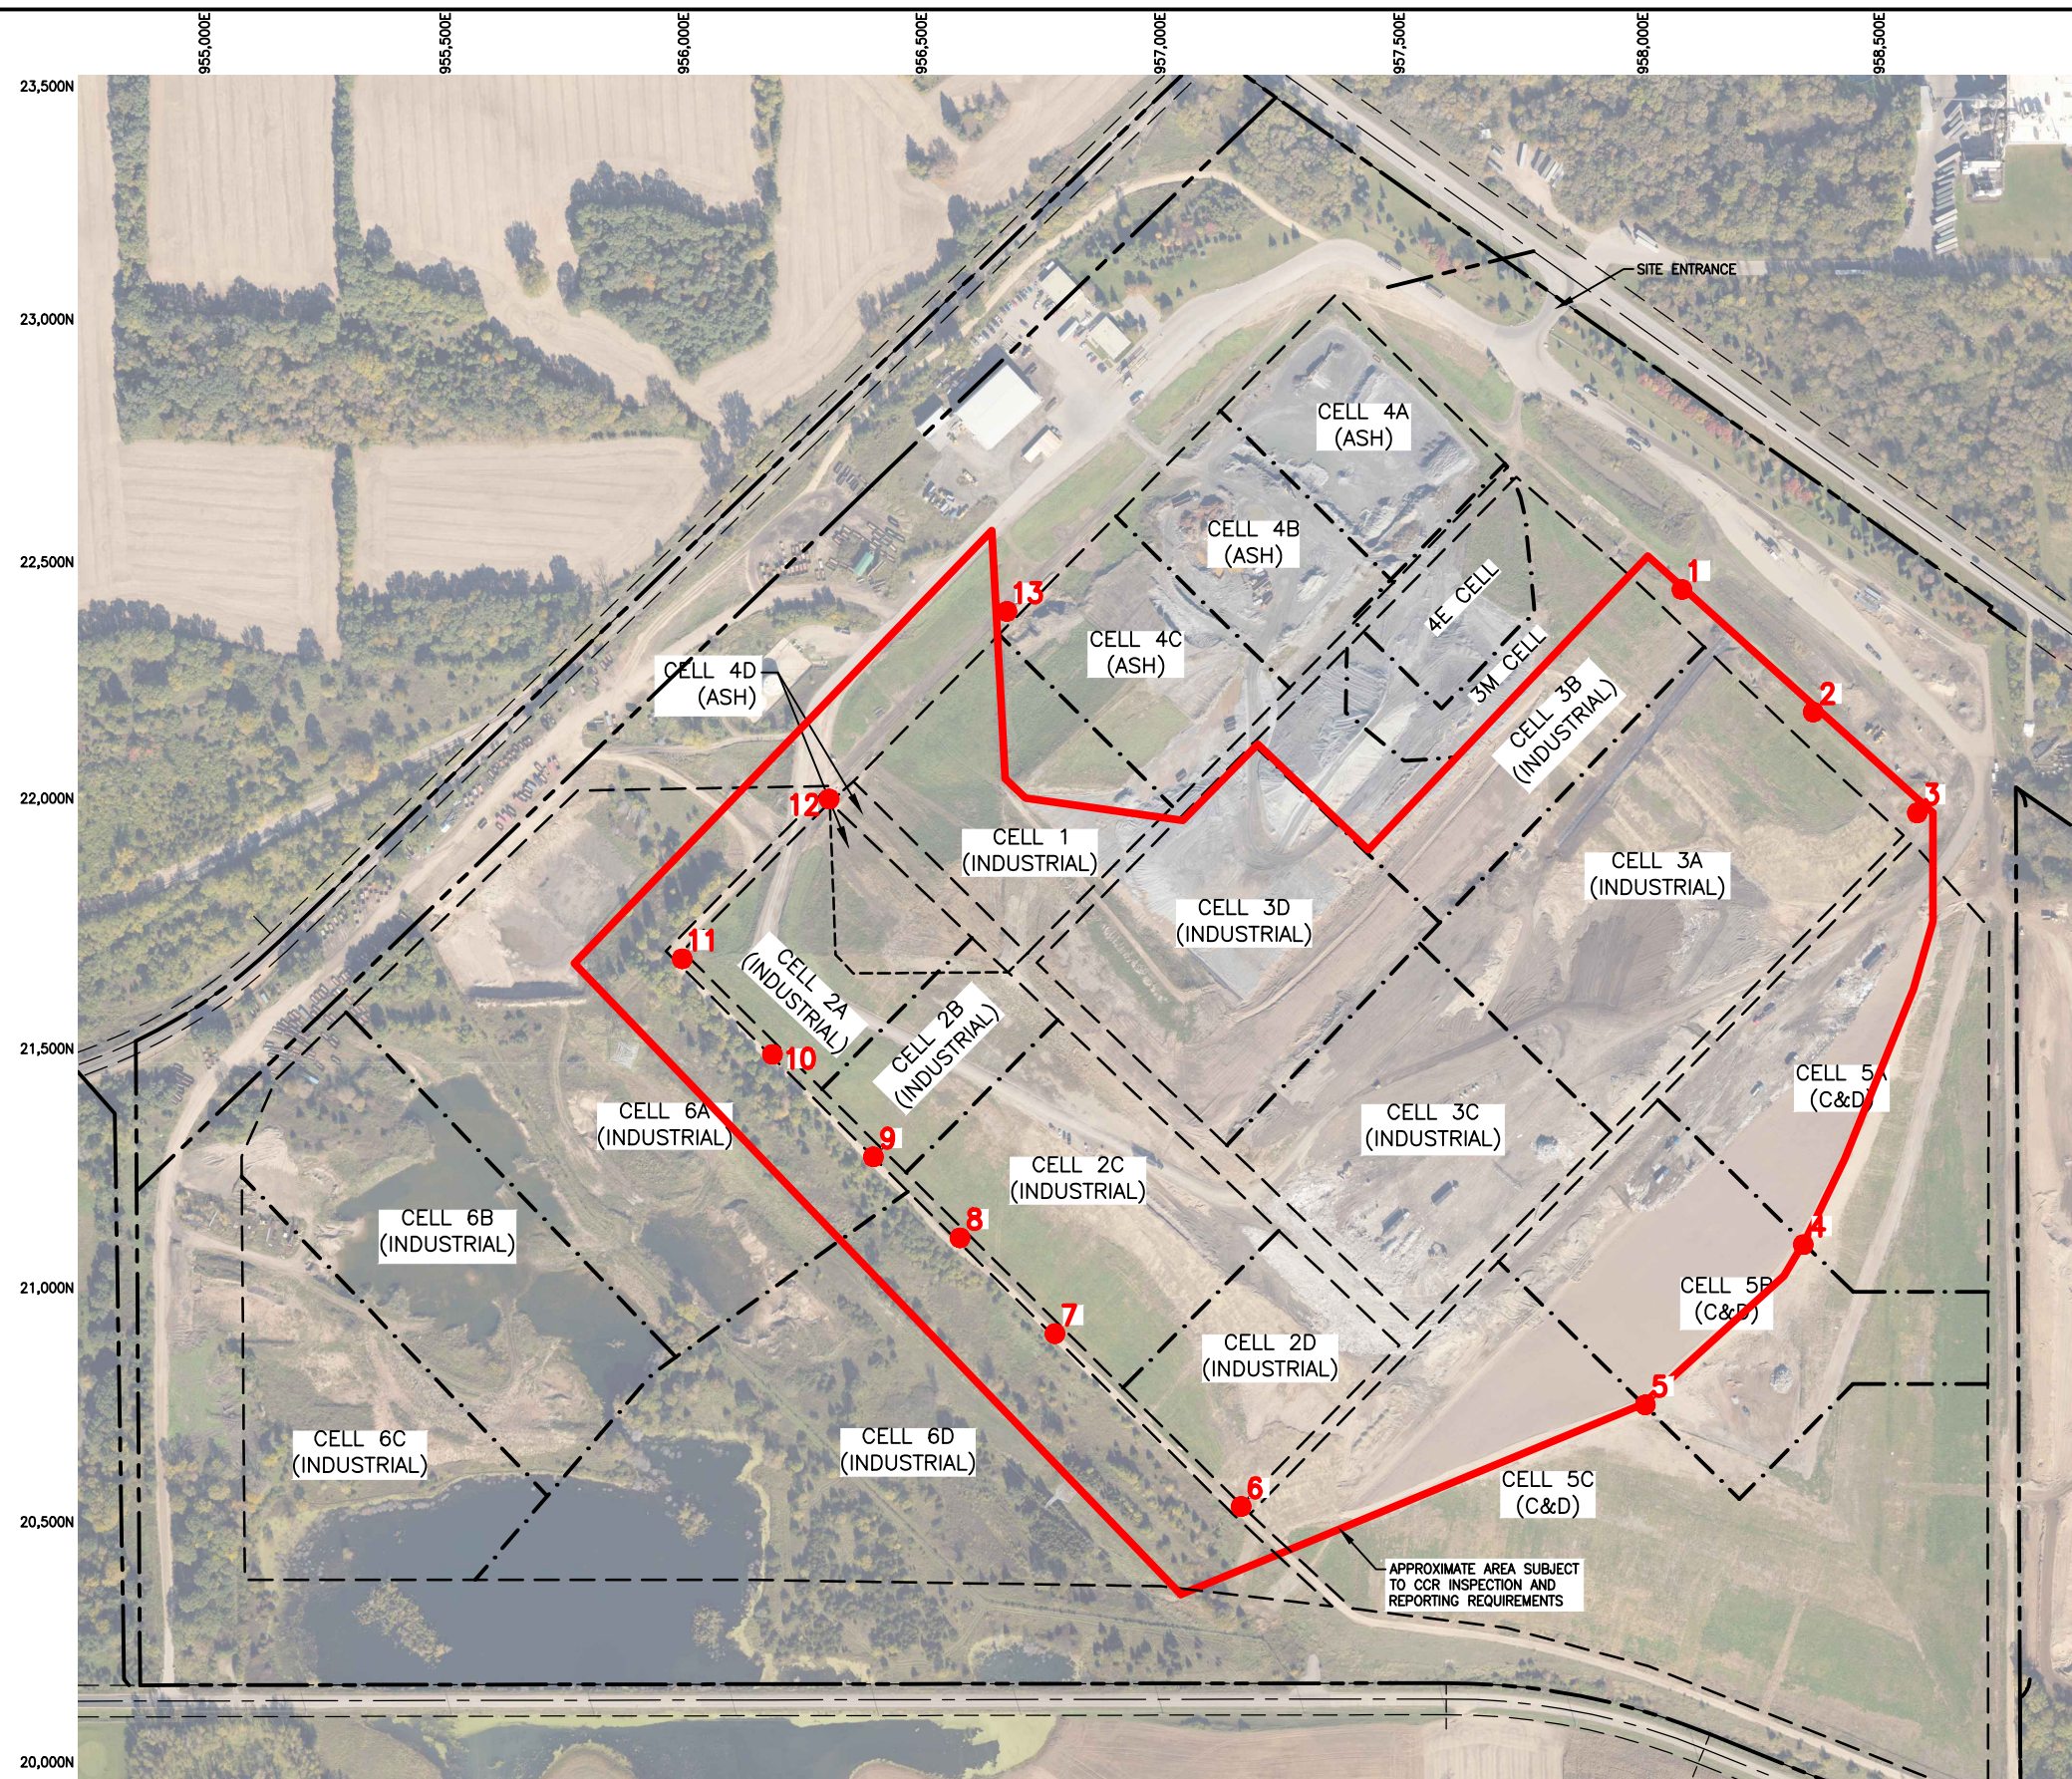
SHEET TITLE PHOTO LOCATIONS			
DWN BY JJT	CHK'D TJS	APP'D BWS	DWG DATE JAN. 2021
PROJECT NO. 3053-20-518	SHEET NO. FIGURE 1	SCALE AS NOTED	REV NO. 0

Photos of the landfill embankments and waste slopes were taken during the inspection. Figure 1 presents the photo locations, and Attachment 1 contains a photo log from the inspections.

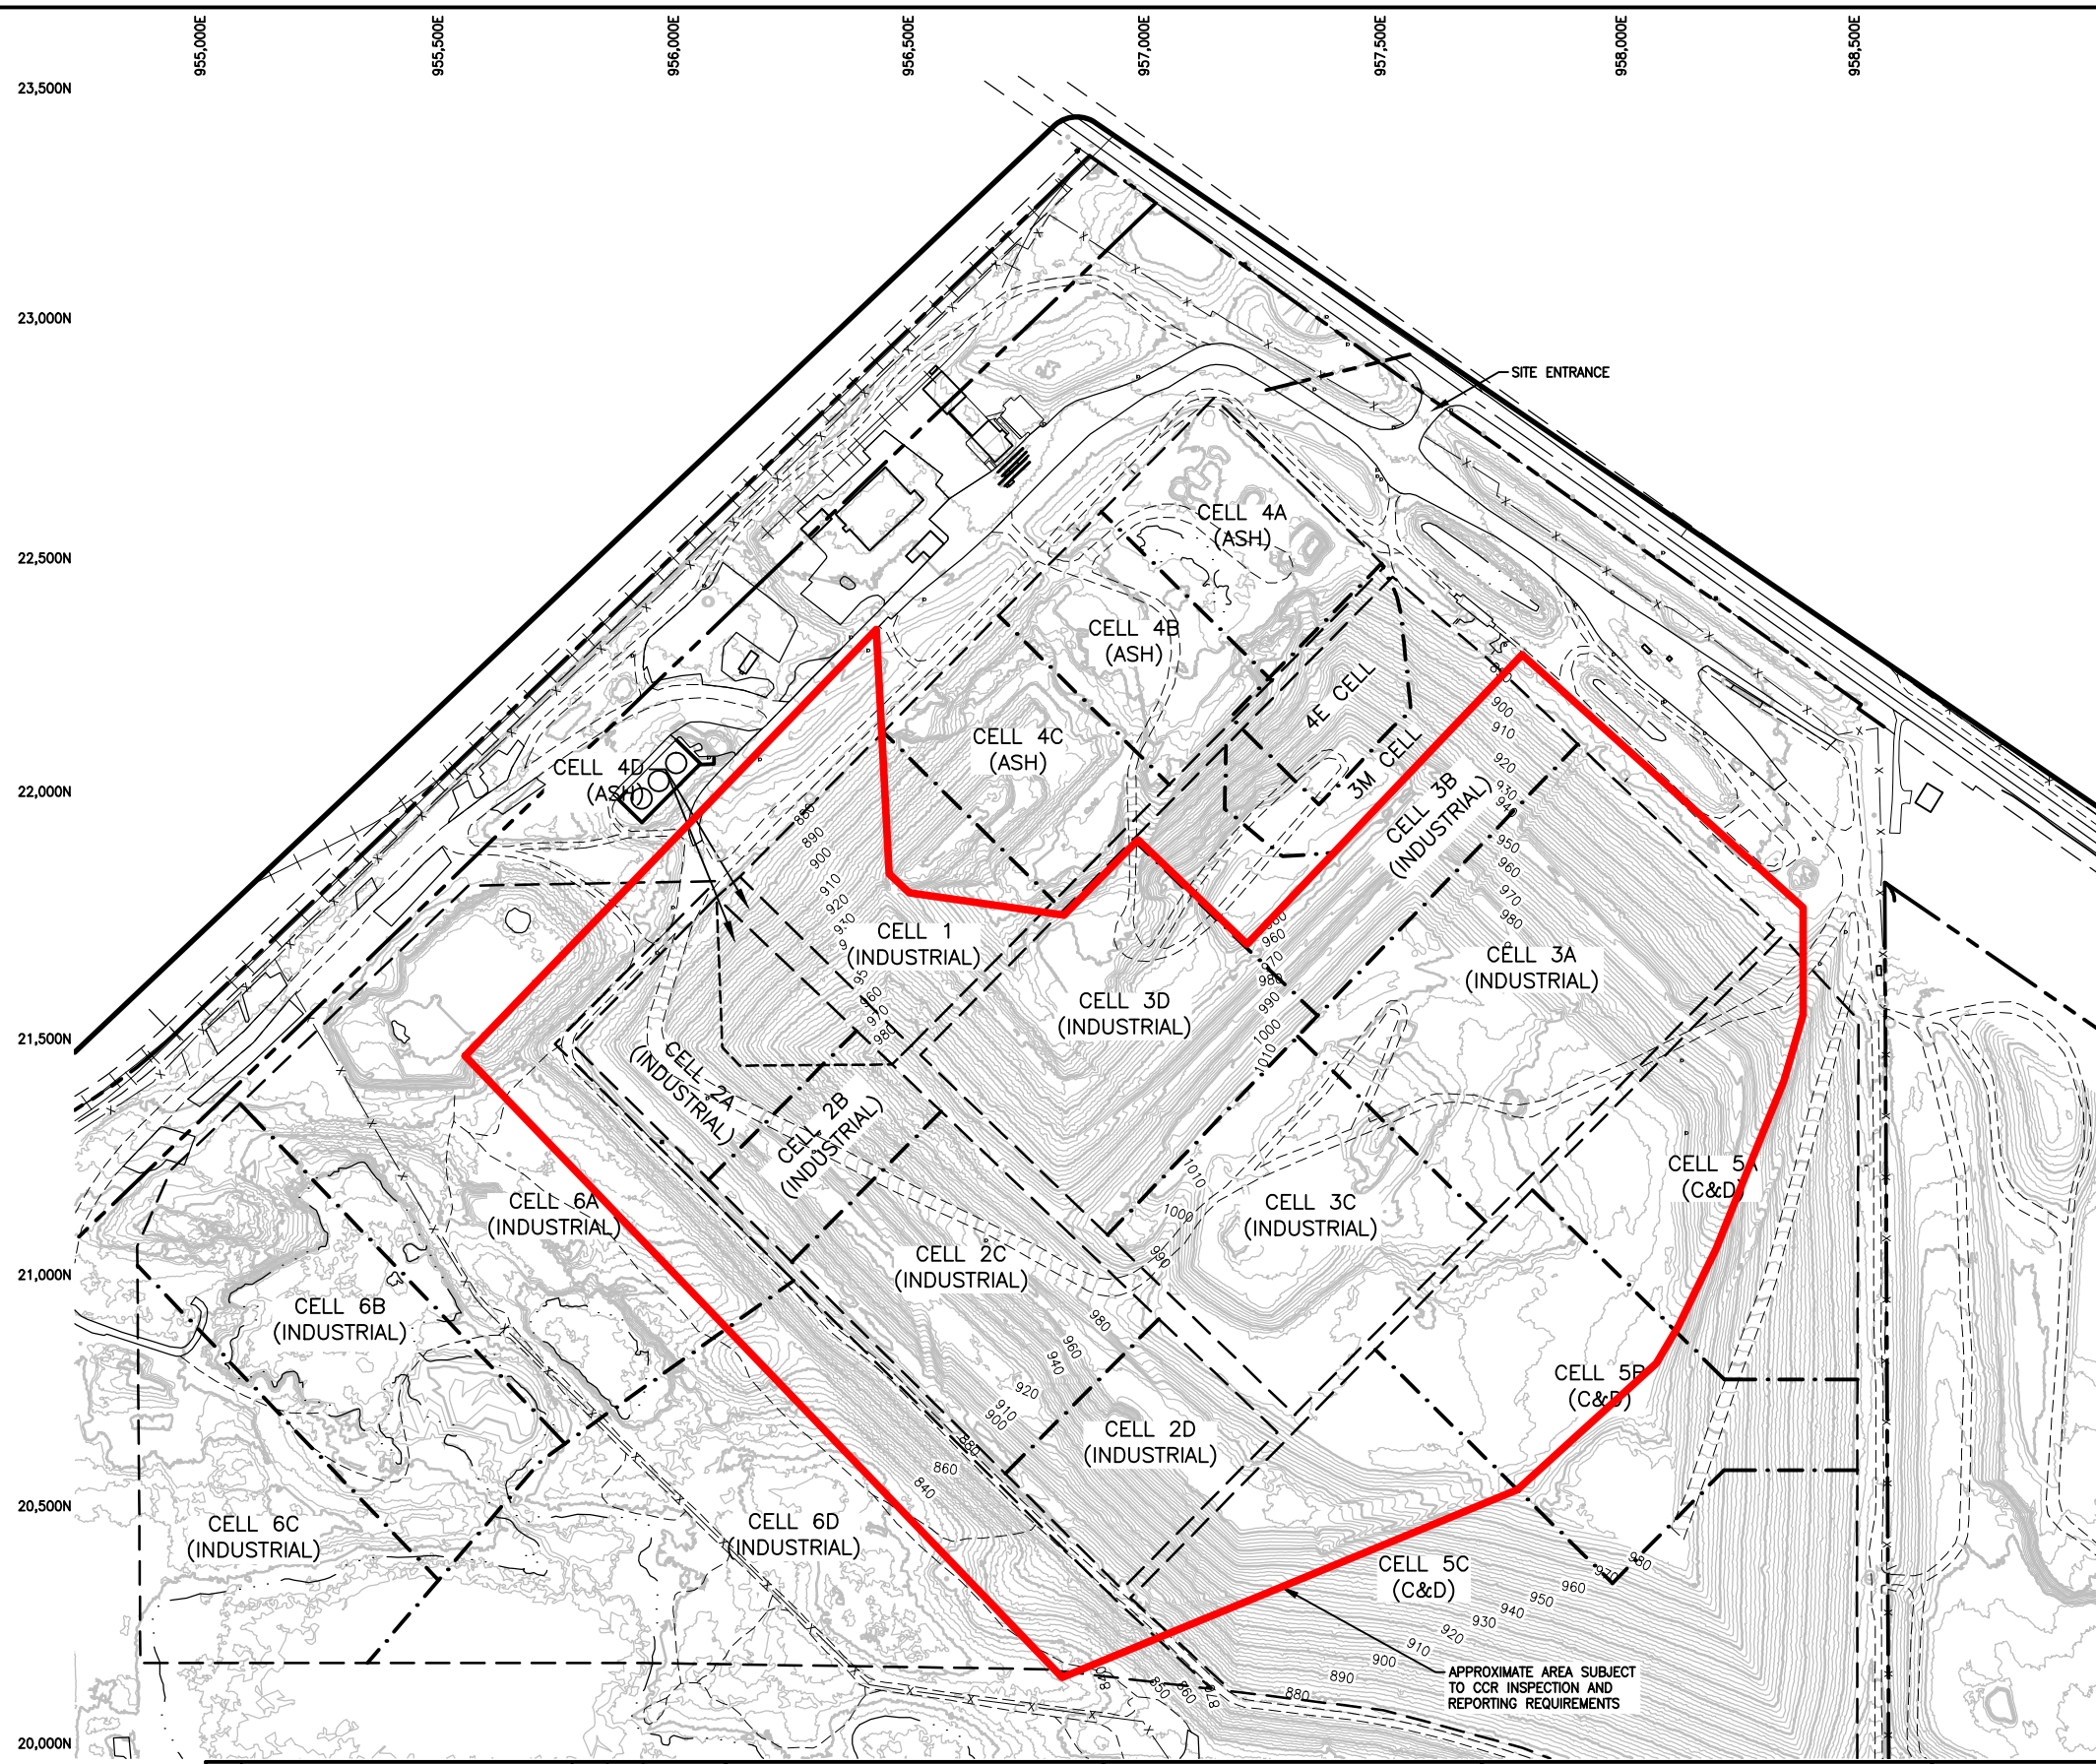
SHEET TITLE <b>SITE MAP</b>			
DWN BY JJT	CHK'D TJS	APP'D BWS	DWG DATE JAN. 2021
PROJECT NO. 3053-20-518	SHEET NO. FIGURE 2	SCALE AS NOTED	REV NO. 0

The annual aerial photogrammetry survey was performed on October 30, 2020 which the estimated in-place volume is based on. A comparison of the 2020 and 2019 aerial surveys confirm that the embankment and slope topography is substantially unchanged with no significant movement. The 2020 aerial survey is included as Figure 2.

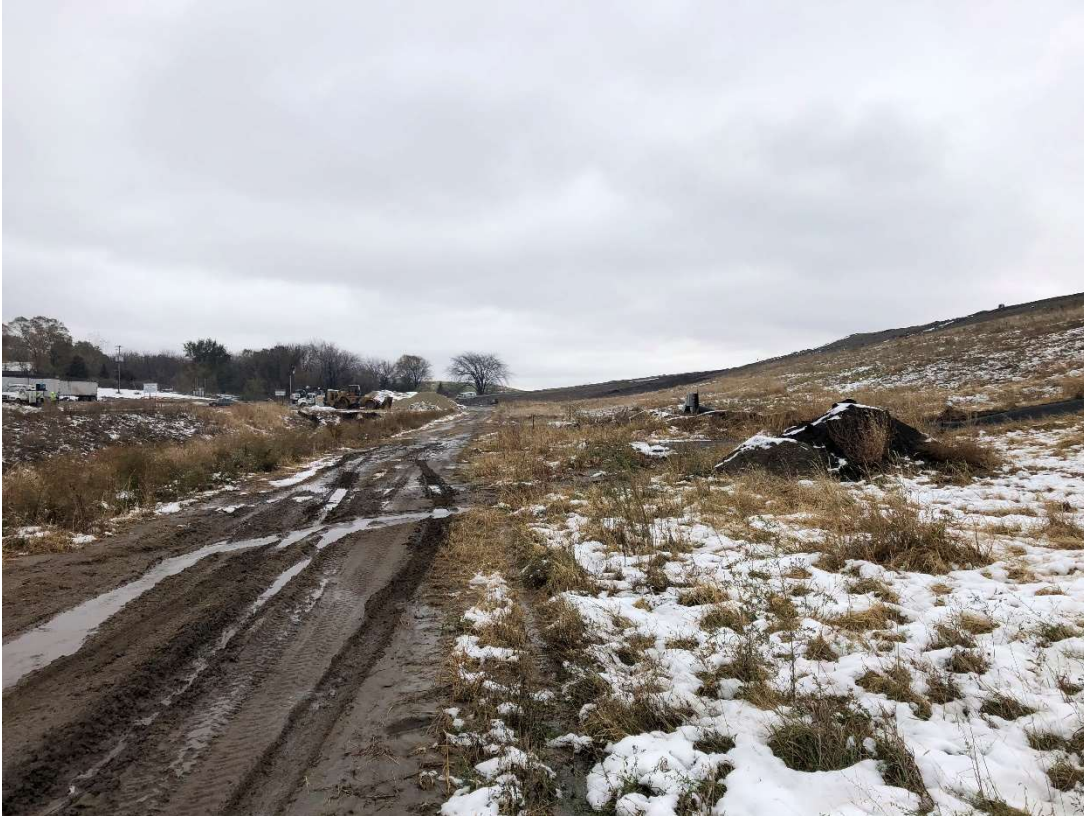
Location 1 – Looking Southeast, Cell 3A & 3B Waste Slope & Anchor Trench

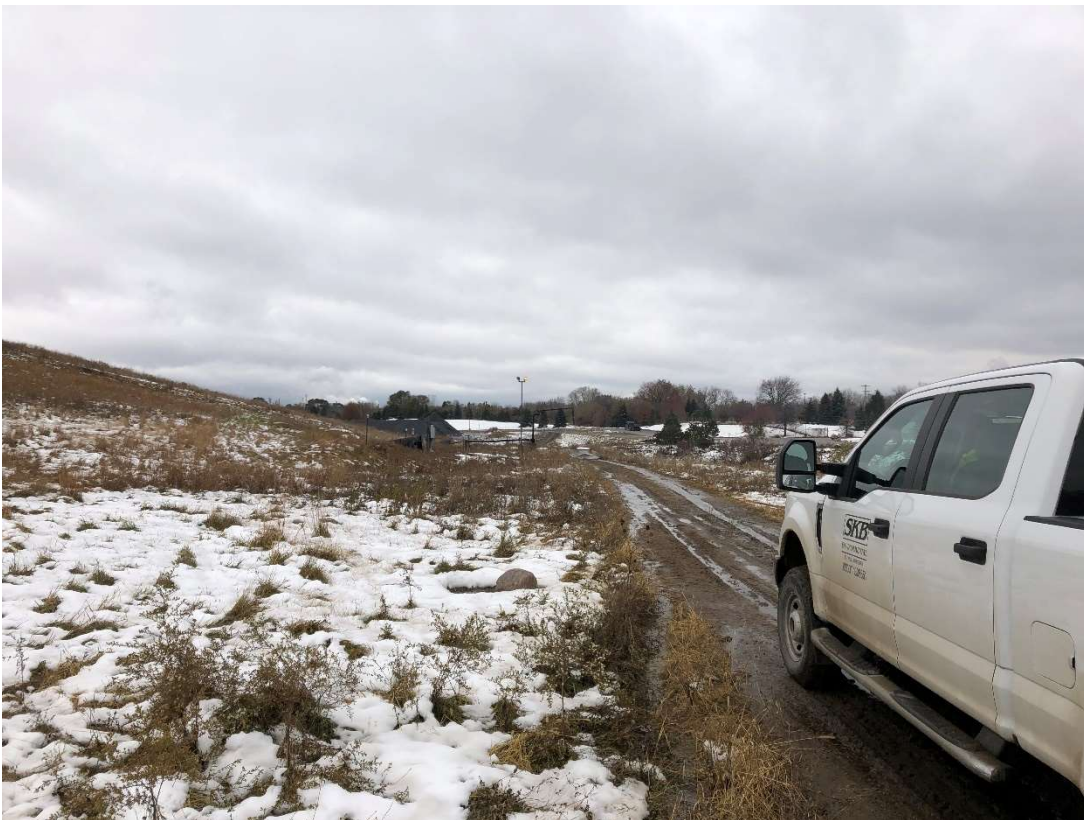
Location 1 – Looking Northwest, Cell 3 Berm

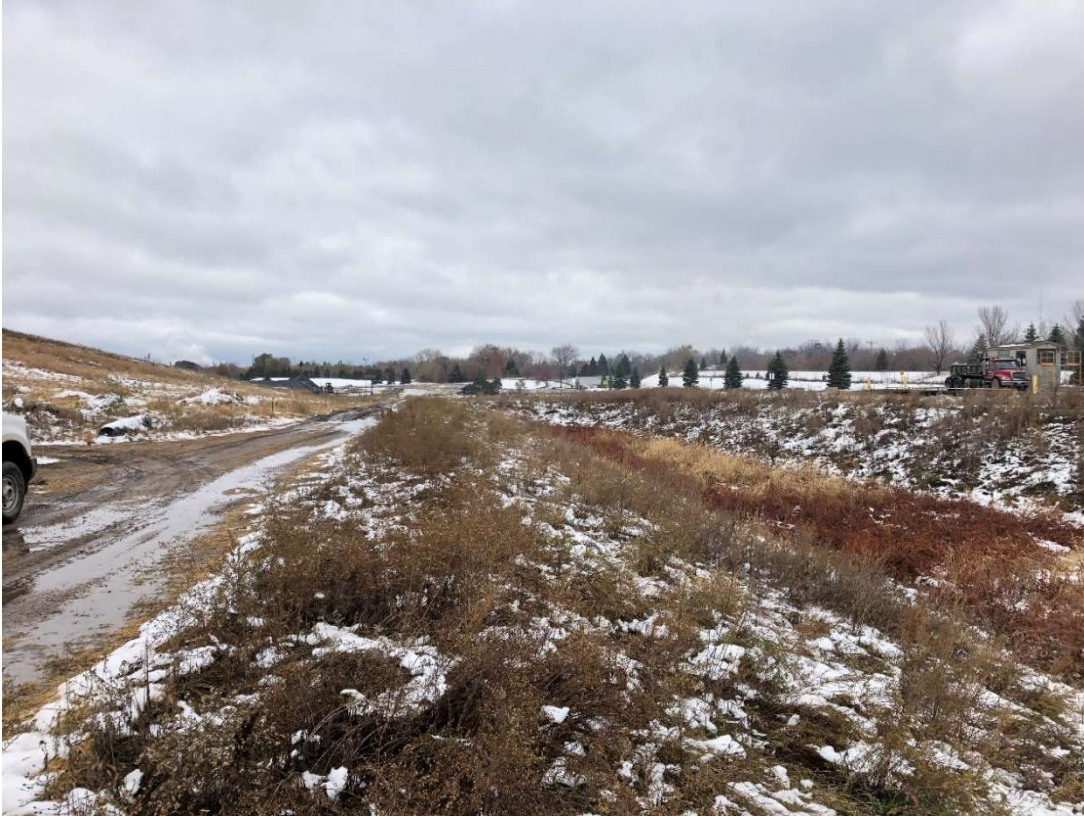
Location 2 – Looking Northwest, Cell 3 Berm & Stormwater Pond

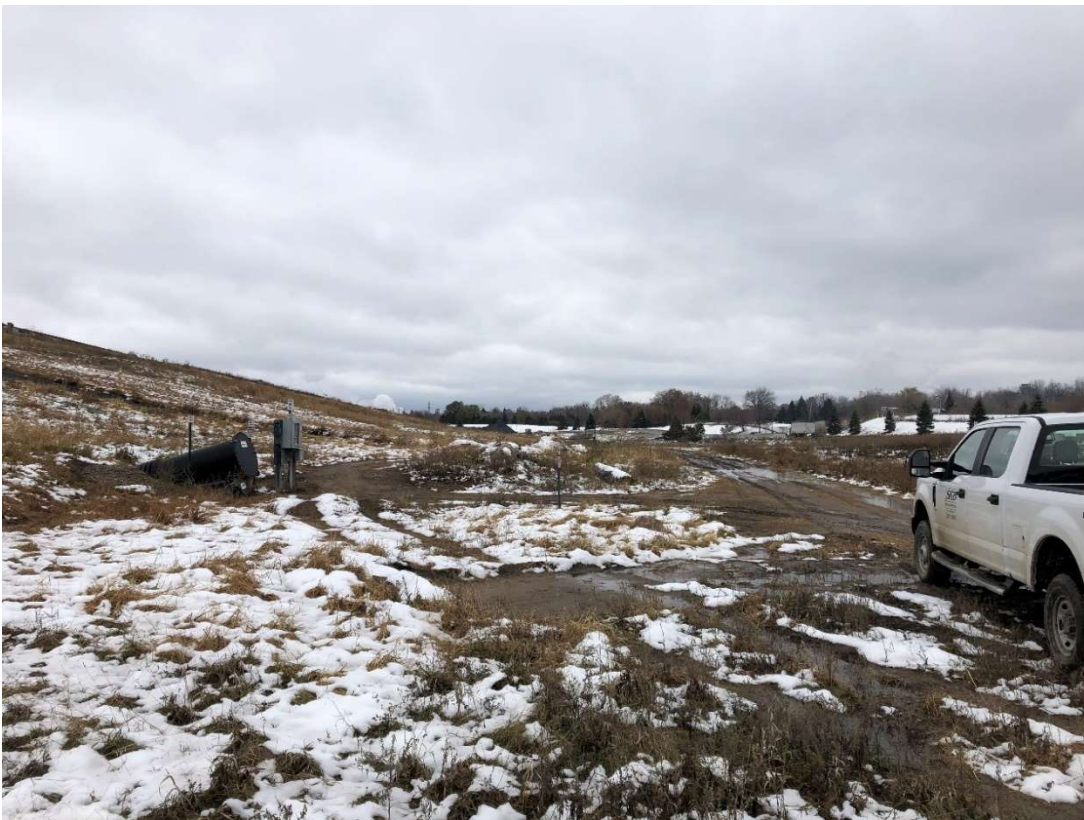
Location 2 – Looking Northwest, Cell 3 Anchor Trench and Waste Slope

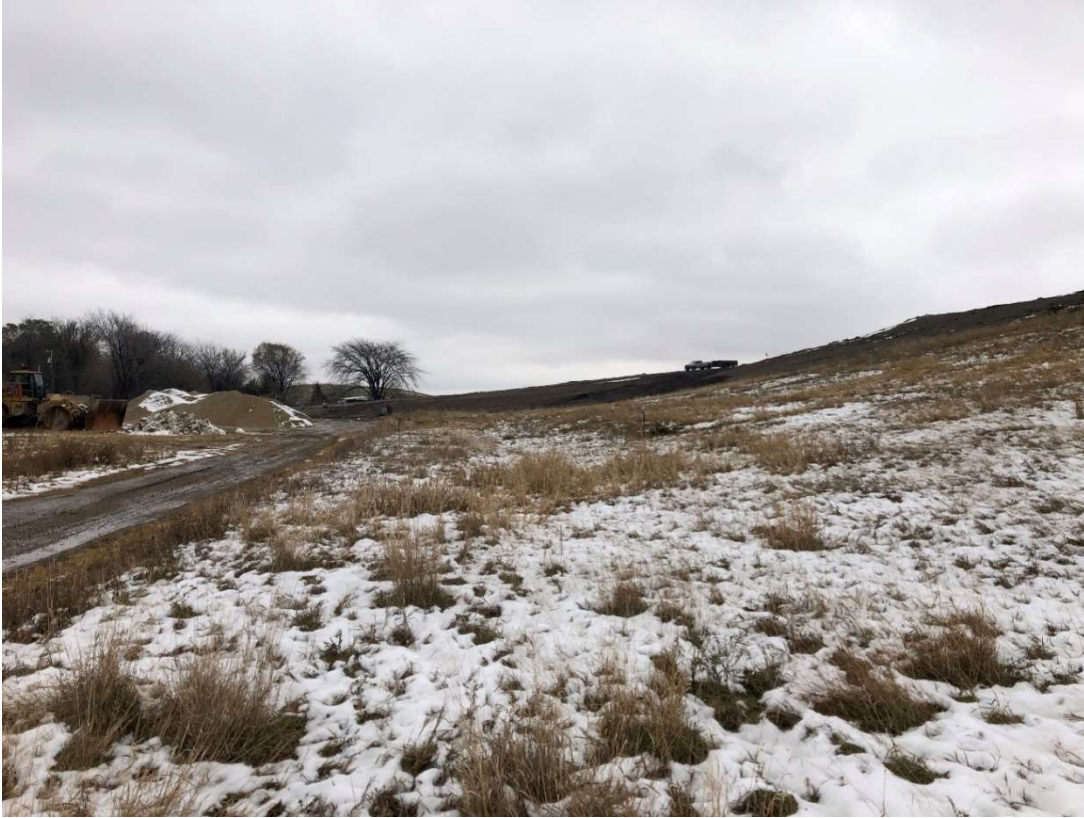
Location 2 – Looking Southeast, Phase 3A Anchor Trench and Northeastern Waste Slope

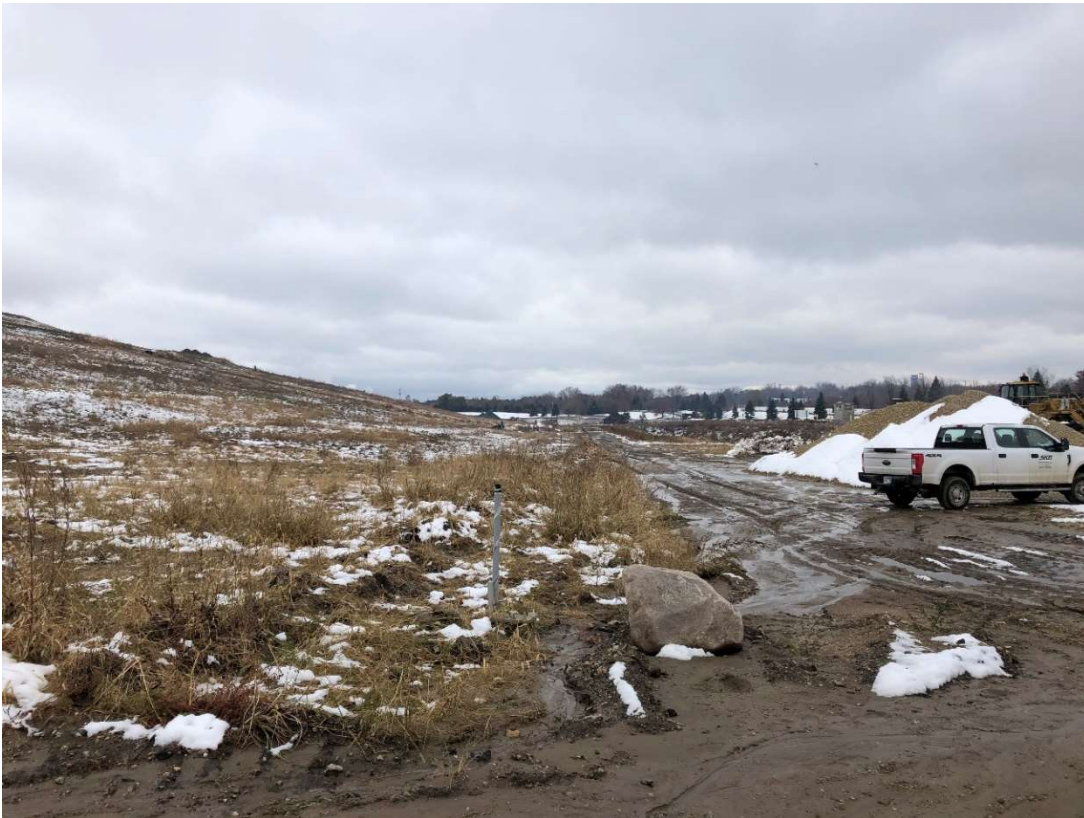
Location 3 – Looking Northwest, Phase 3A Anchor Trench and Northeastern Waste Slope

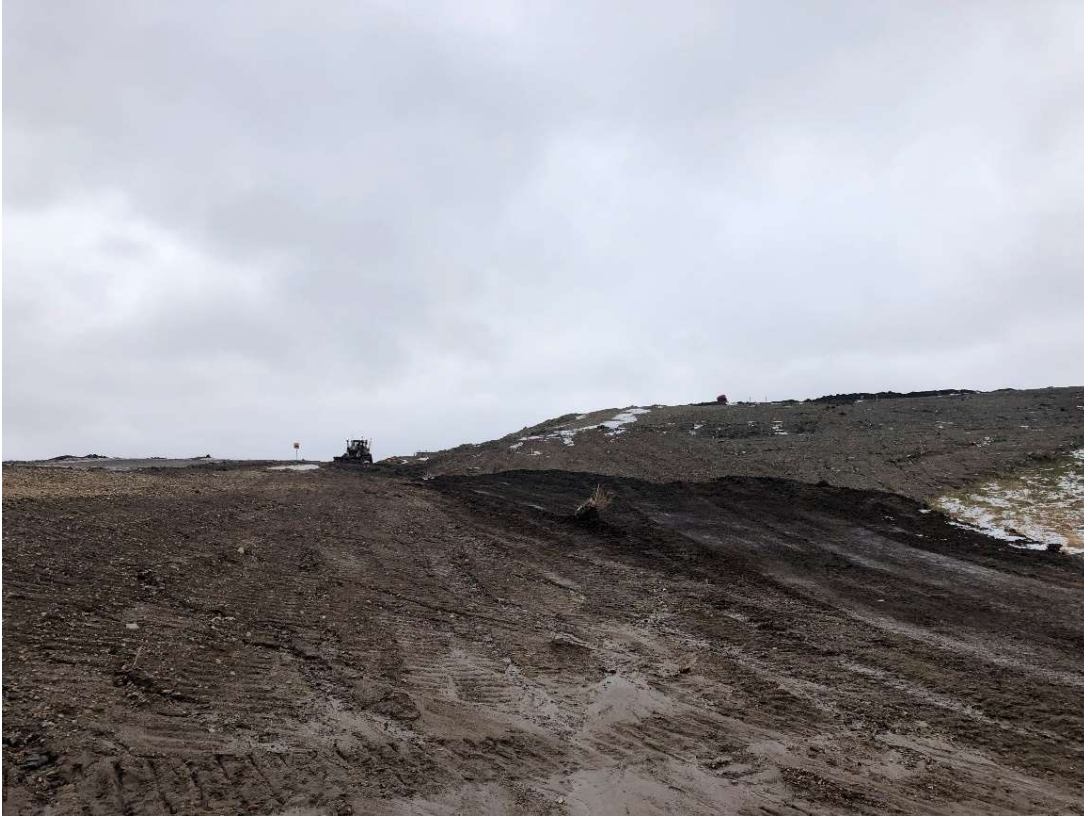
Location 3 – Looking Southwest, Phase 3 East Corner at toe of Interior Access Road

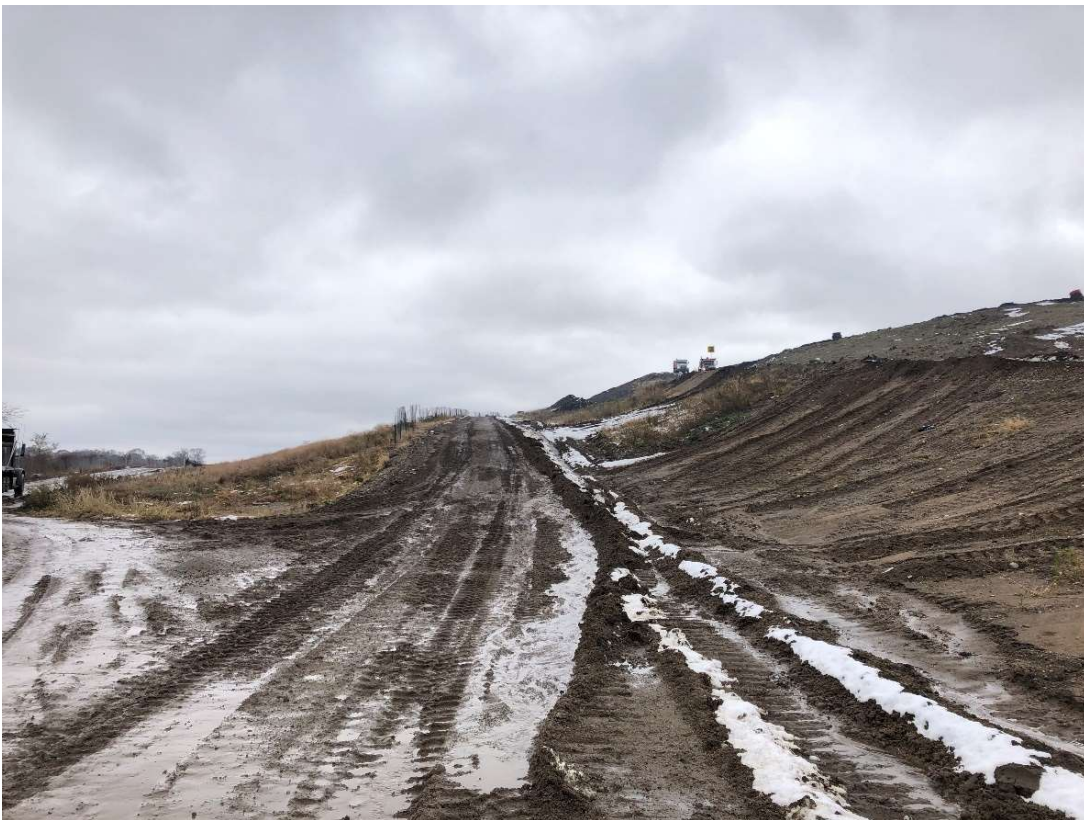
Location 3 – Looking Southwest along Cell 5 Access road/Phase 3F Liner Limit

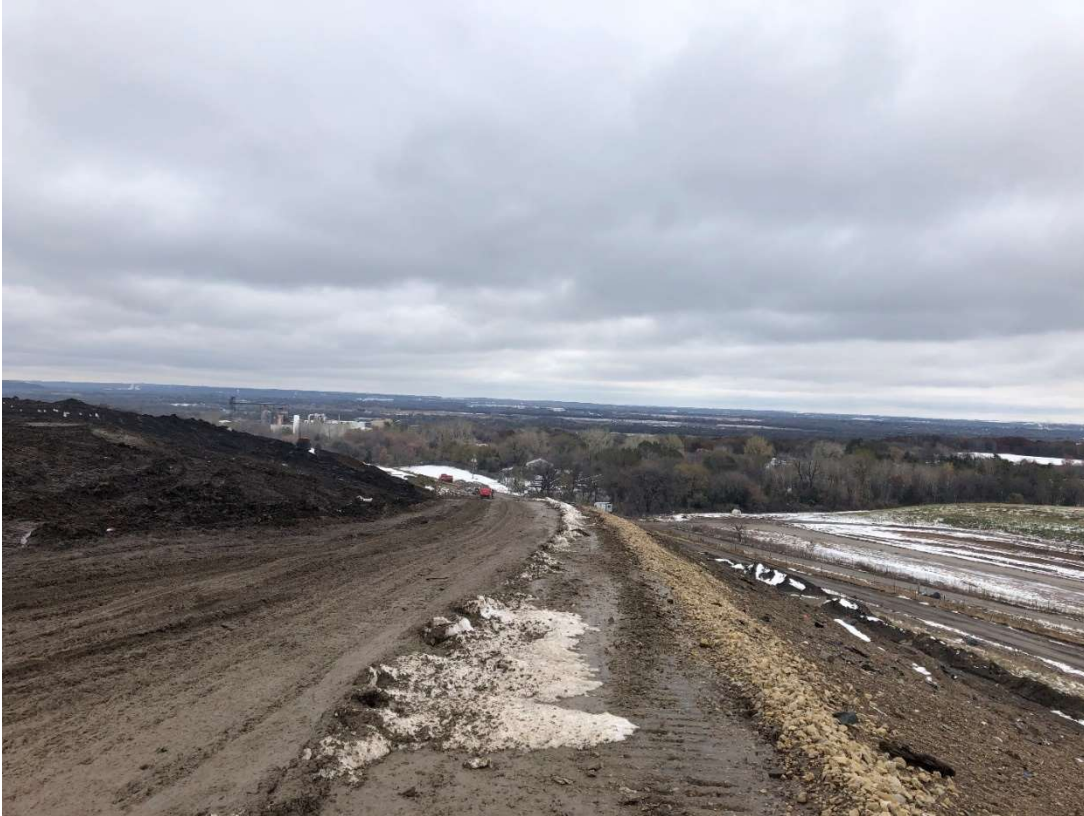
Location 4 – Looking Northeast, Phase 3F Liner Limit

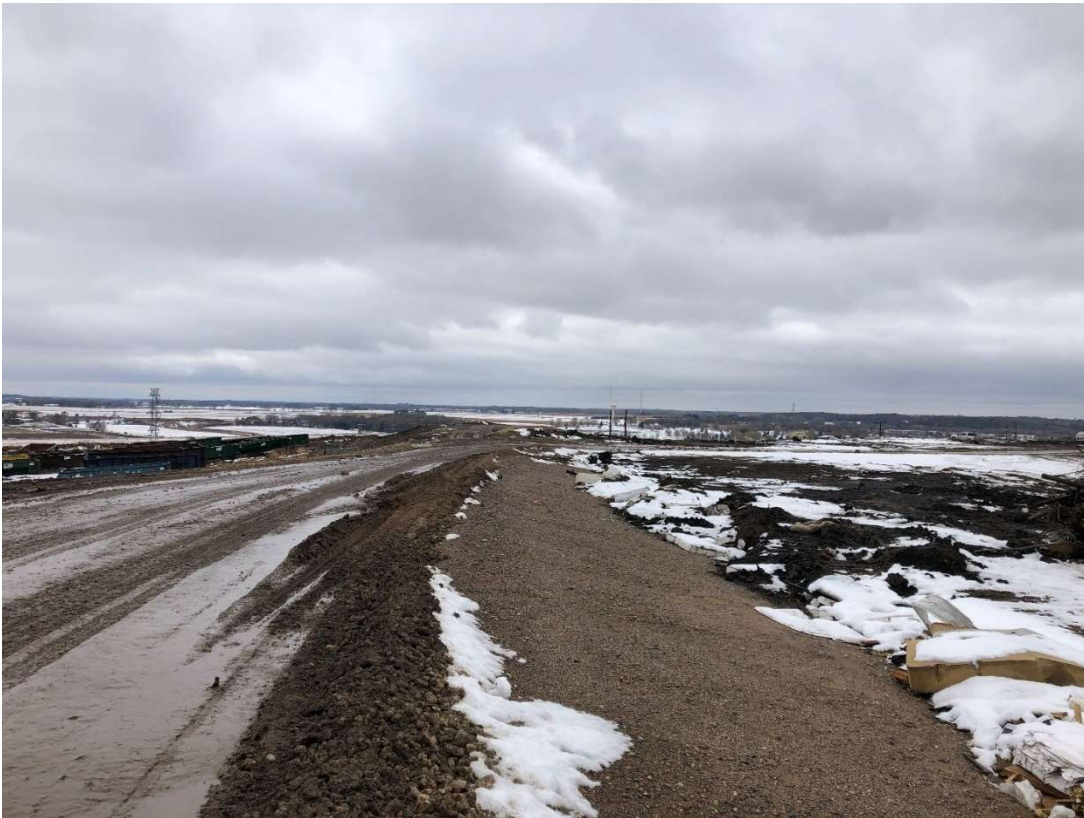
Location 4 – Looking Southwest, Phase 3F Liner Limit

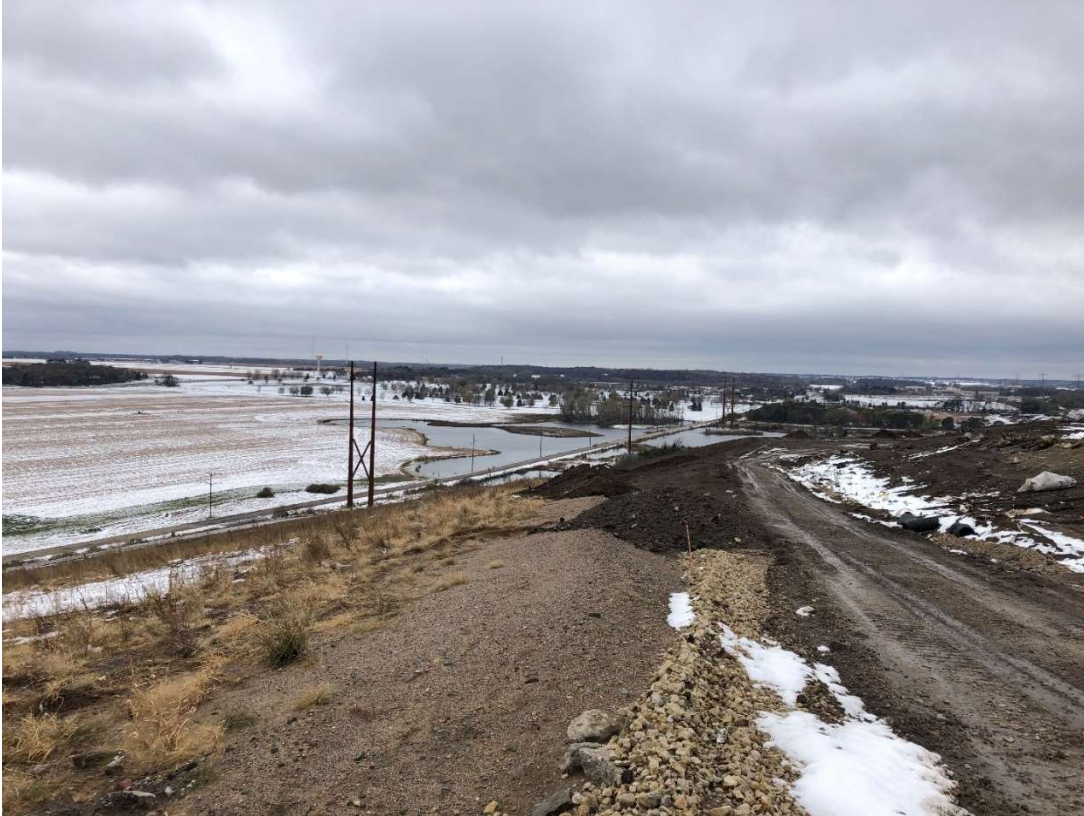
Location 5 – Looking Southwest, Phase 3F Liner Limit

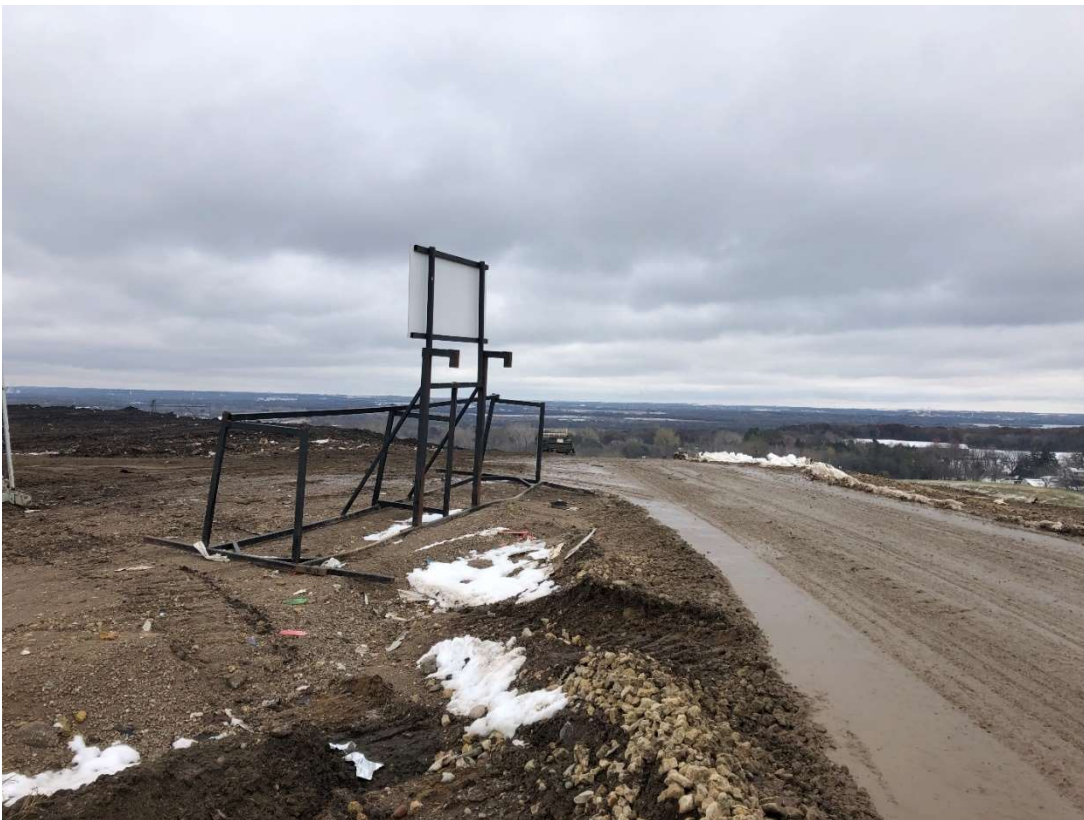
Location 5 – Looking Northeast, Phase 3F Liner Limit

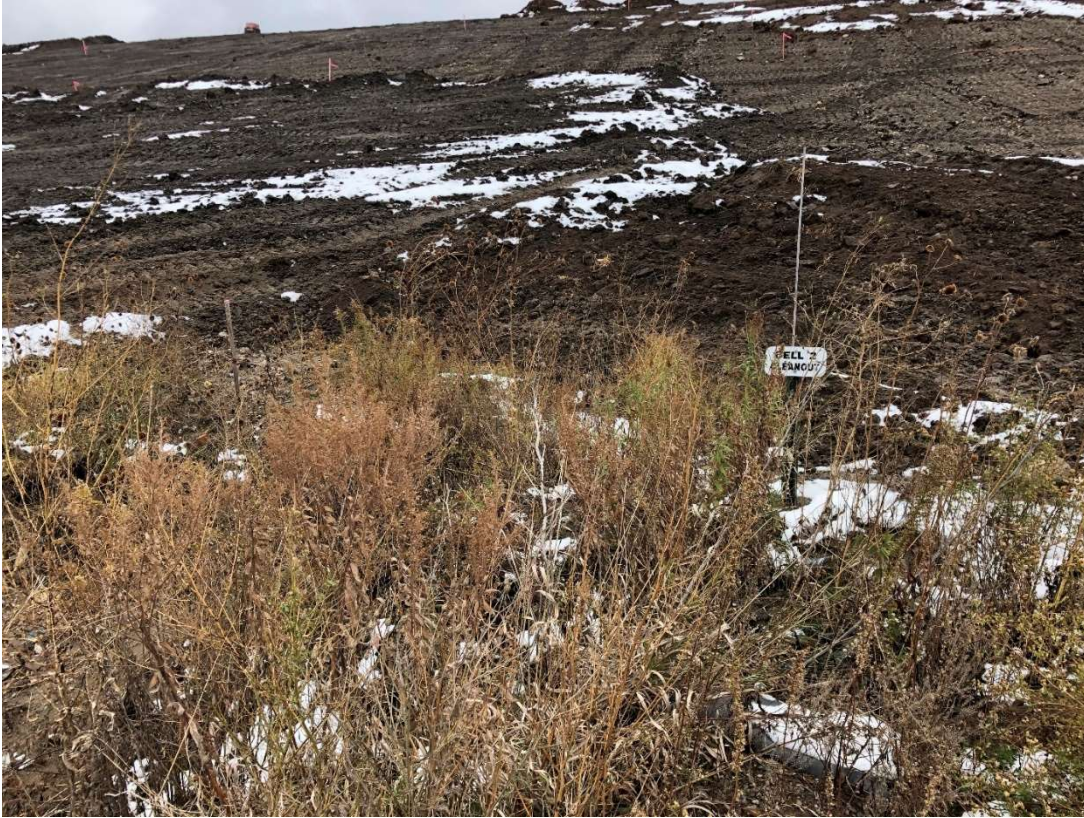
Location 6 – Looking Northeast, Southeastern Slope, Anchor Trench & New Liner Construction

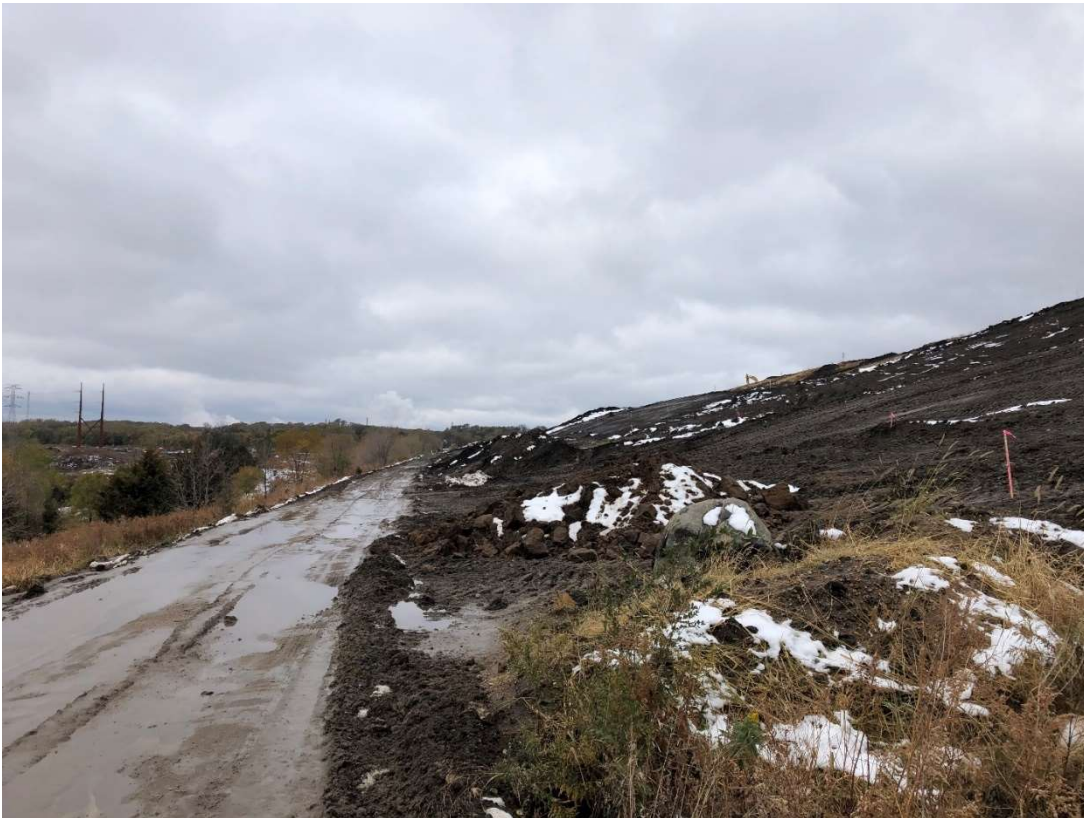
Location 6 – Looking Northwest, Cell 2D Southwestern Slope and Perimeter Road

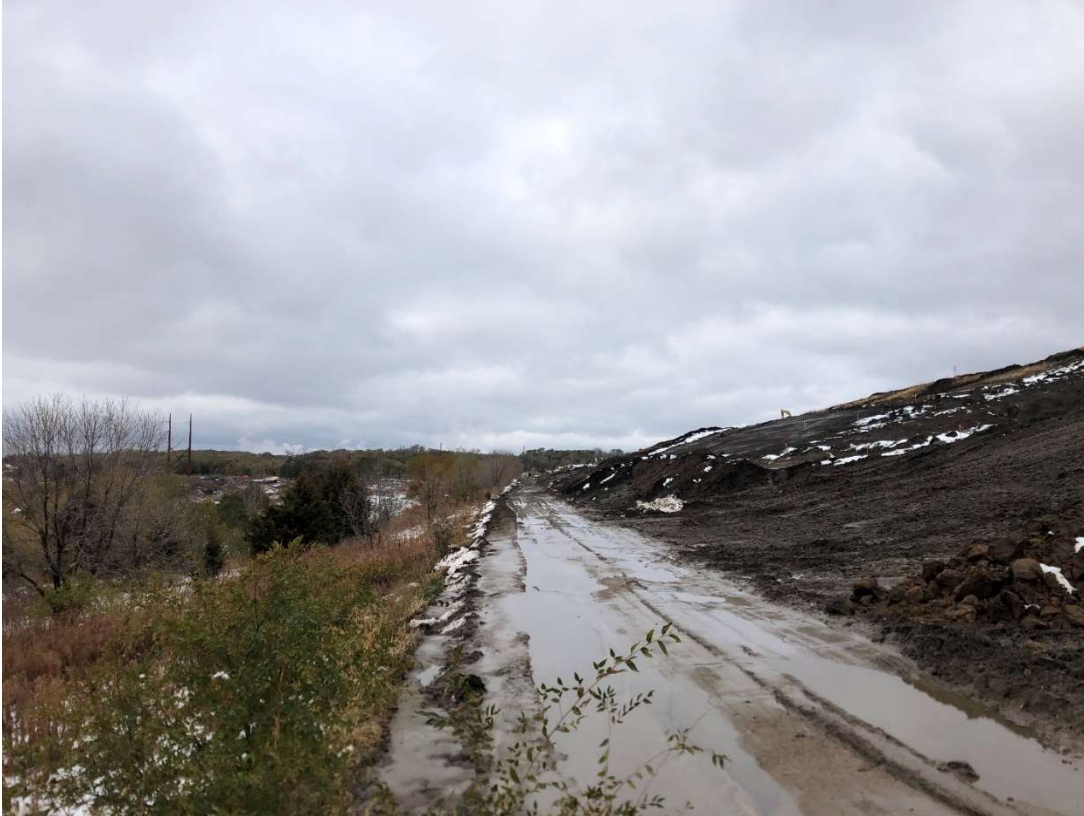
Location 6 – Looking North, Cell 2D Berm

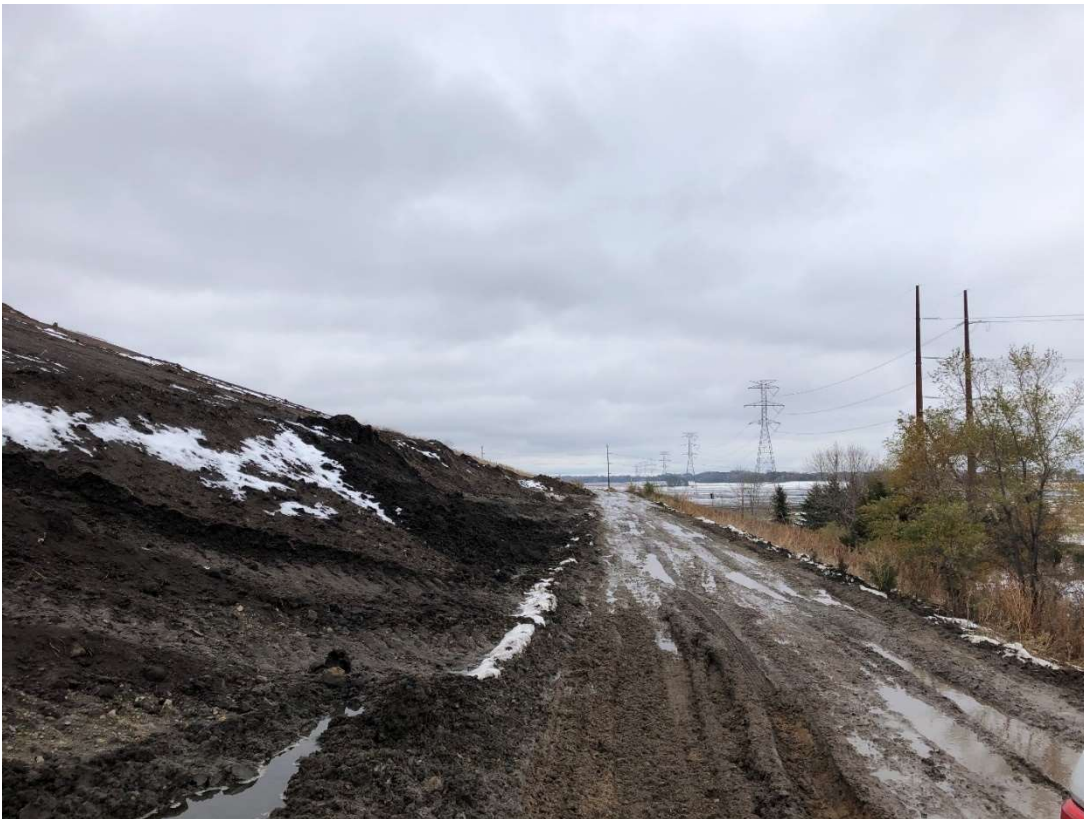
Location 7 – Looking Southeast, Cell 2D Southwestern Slope, Anchor Trench, and Road

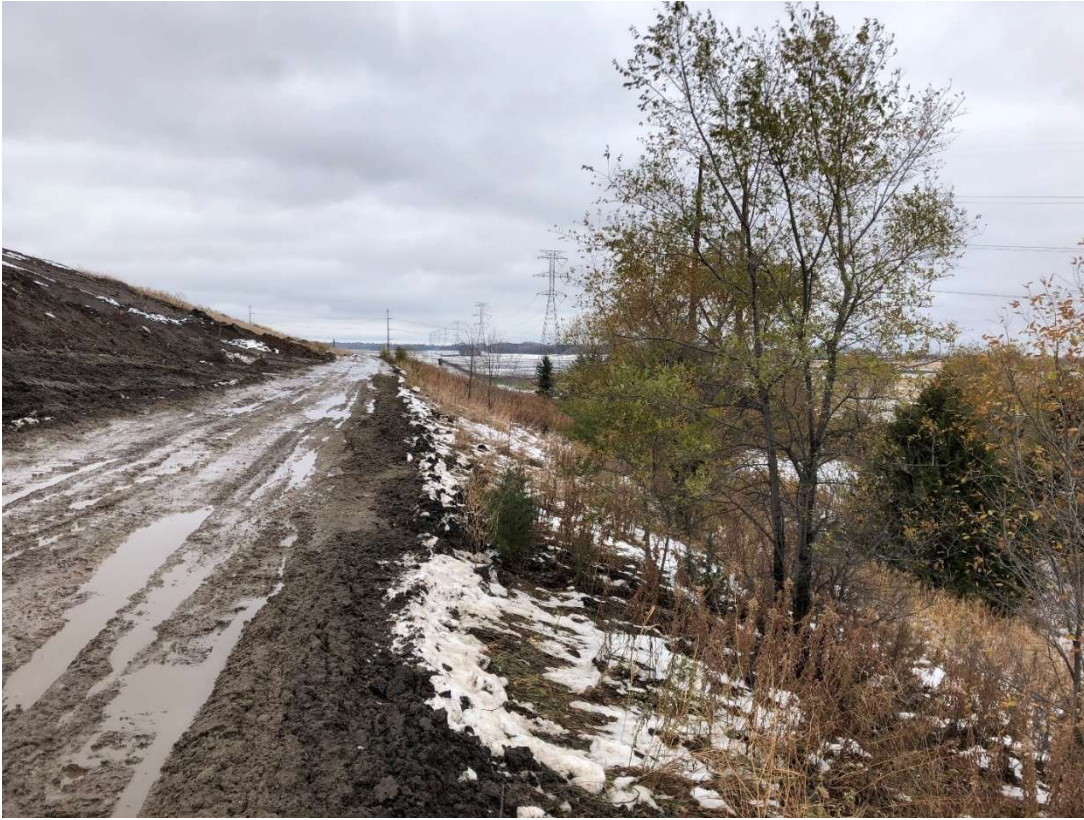
Location 7 – Looking Southeast, Cell 2D Berm
