To:	Geoff Strack, PE, Waste Connections	From:	Bradley W Sullivan, PE, Stantec Consulting Services Inc.
File:	Project #B3053-20-518	Date:	January 9, 2021

**Reference: SKB Rosemount Industrial Waste Facility 2020 Annual CCR Inspection Report****Purpose**

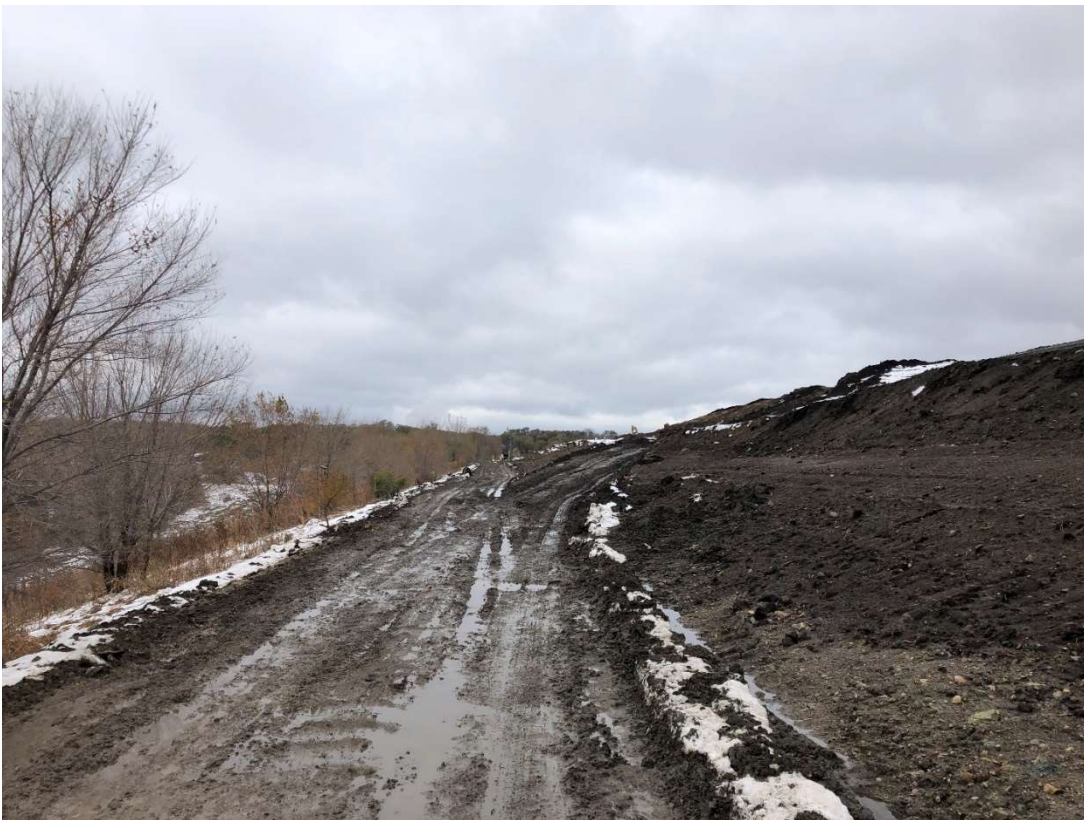
Location 7 – Looking Northwest, Cell 2C Southwestern Slope, Anchor Trench, and Road

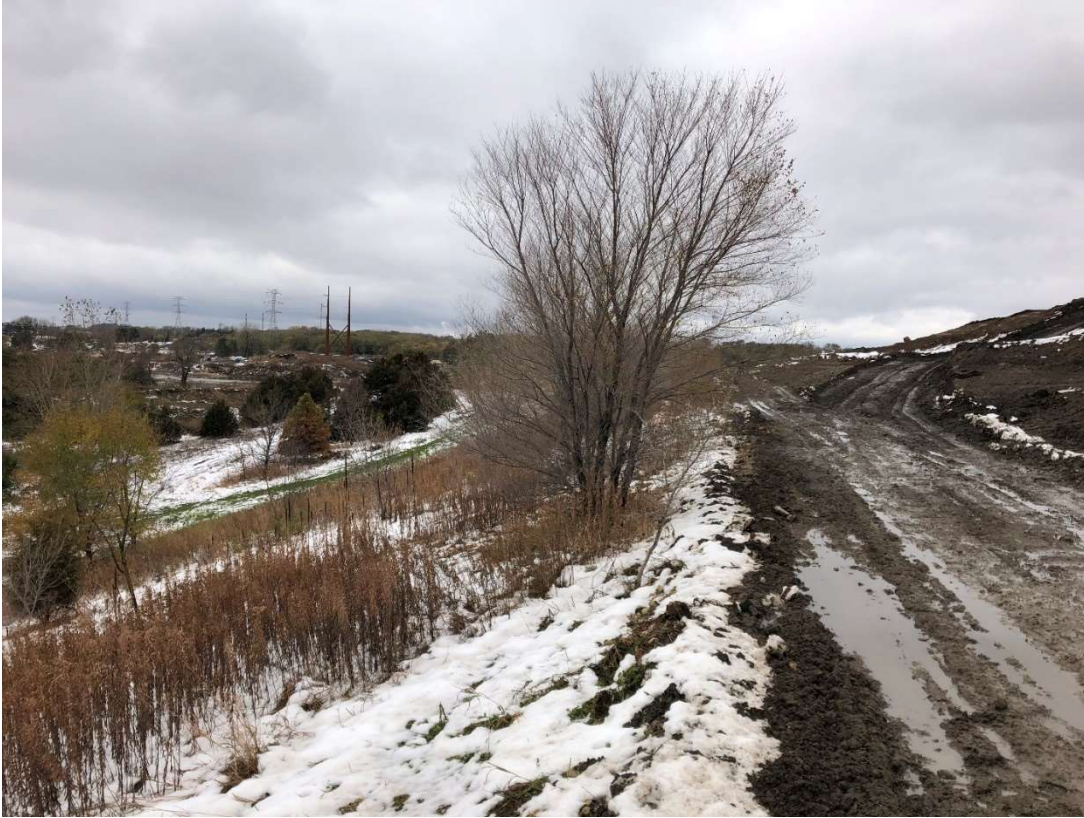
Location 7 – Looking Northwest, Cell 2C Cell 2C Southwestern Berm

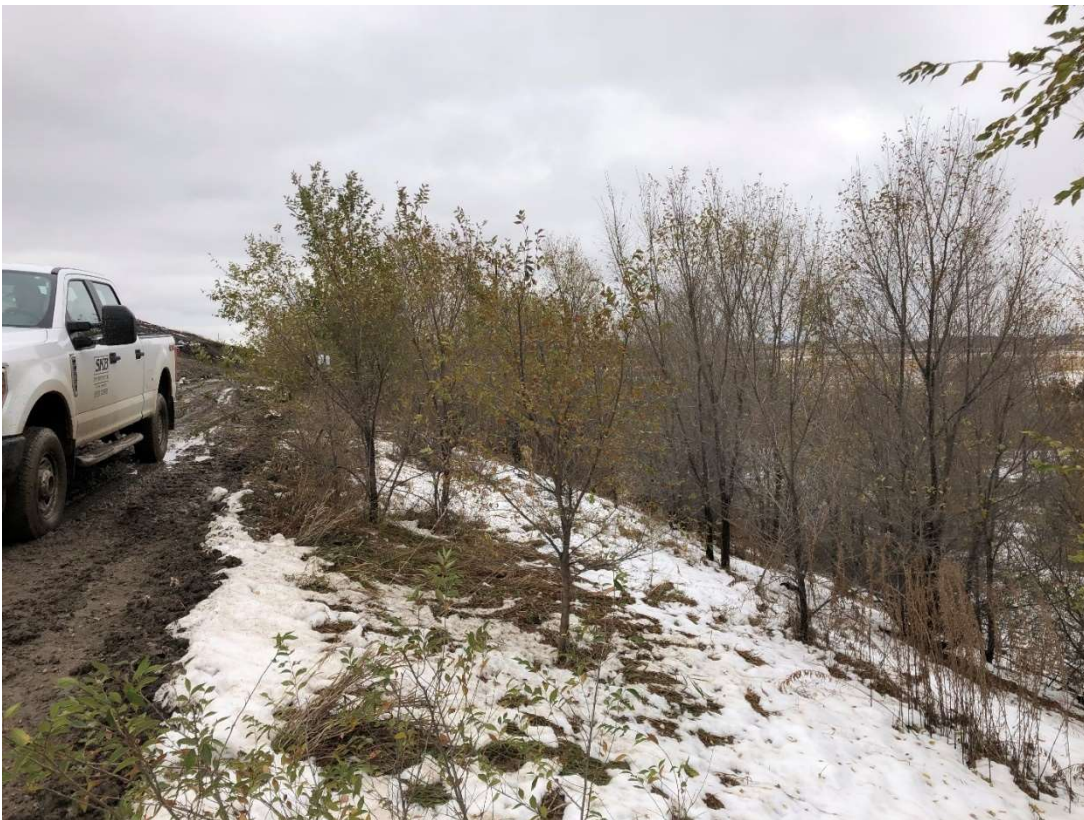
Location 8 – Looking Southwest, Cell 2C Southwestern Berm

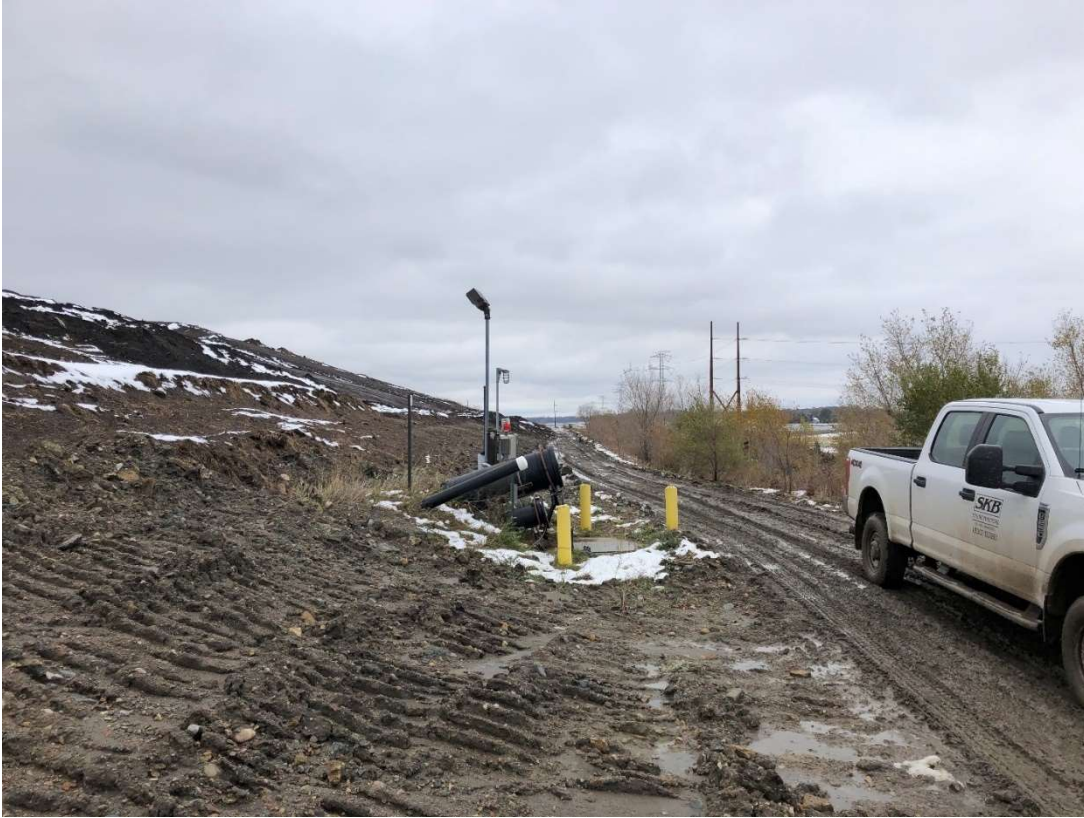
Location 8 – Looking Southwest, Cell 2C Southwestern Waste Slope and Anchor Trench

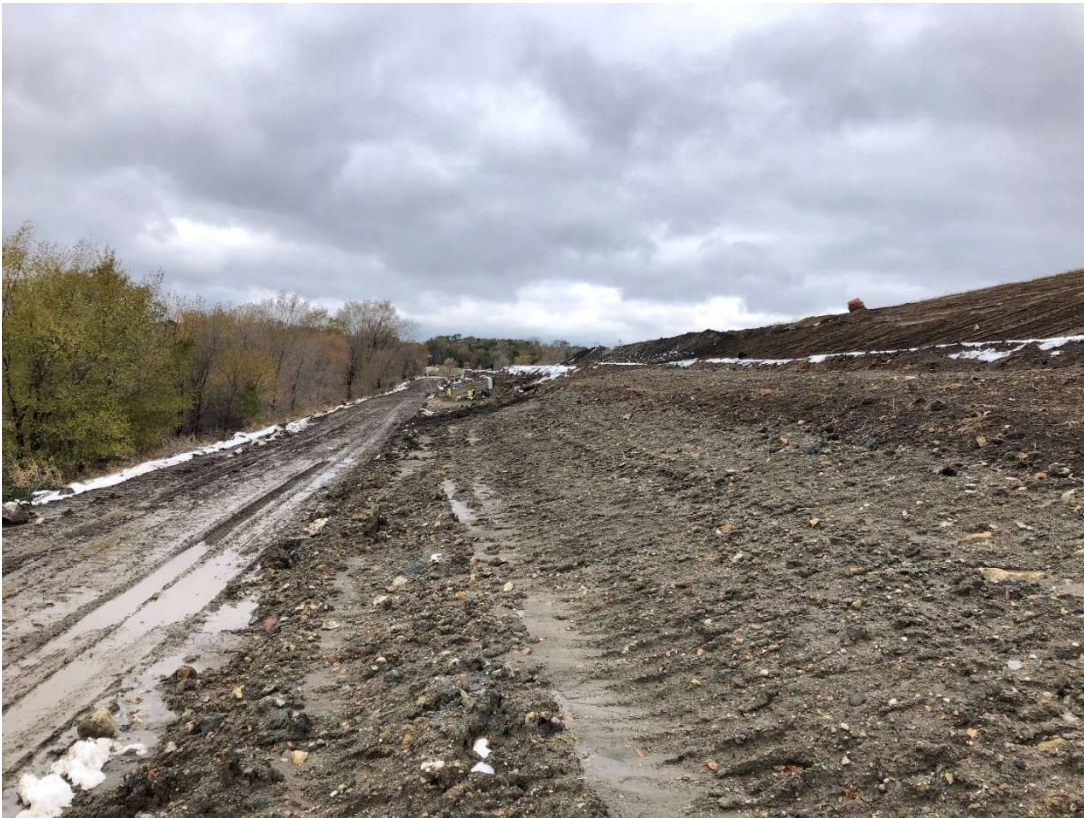
Location 8 – Looking Northwest, Cell 2C & 2B Southwestern Waste Slope and Anchor Trench

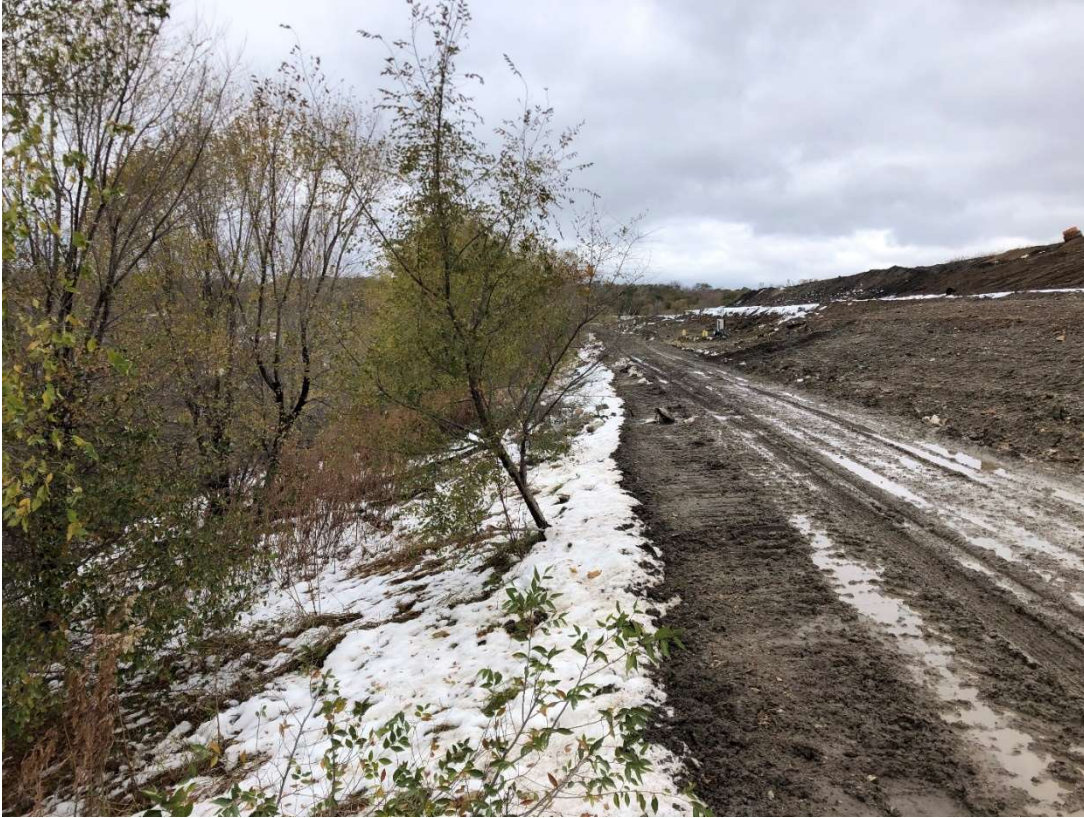
Location 8 – Looking Northwest, Cell 2C & 2B Berm

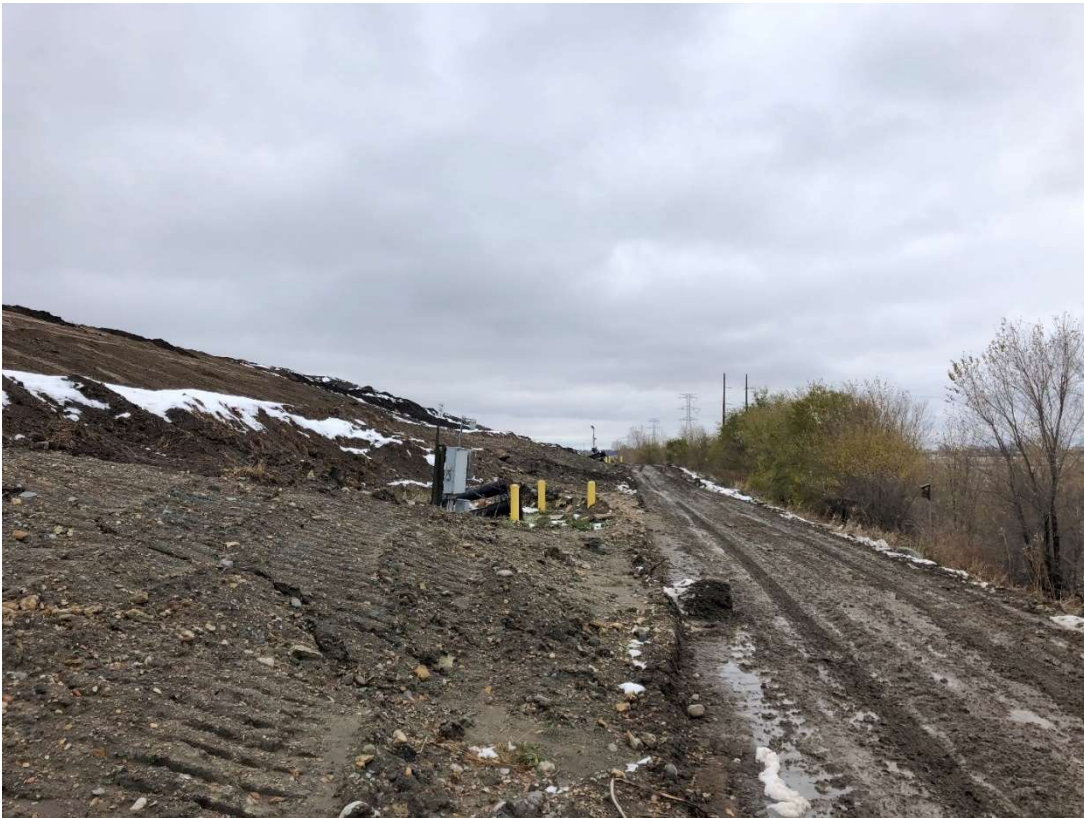
Location 9 – Looking Southeast, Cell 2C Southwestern Waste Slope and Anchor Trench

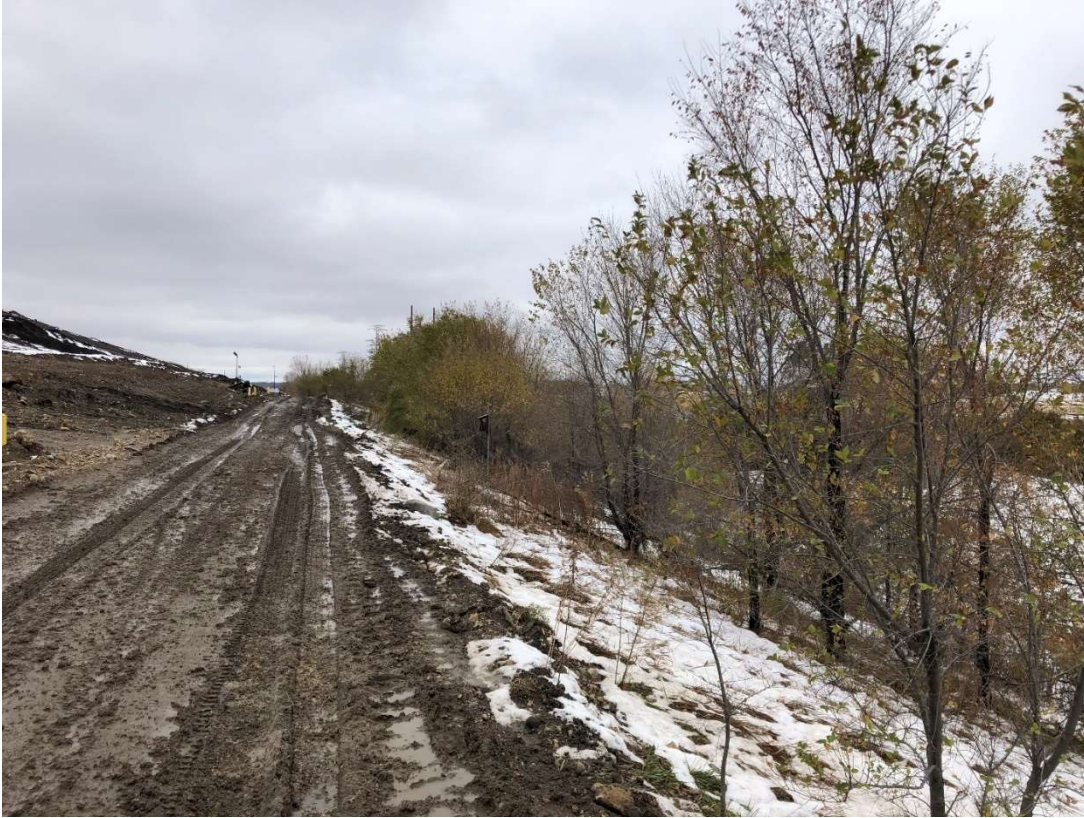
Location 9 – Looking Southeast, Cell 2C Southwestern Berm

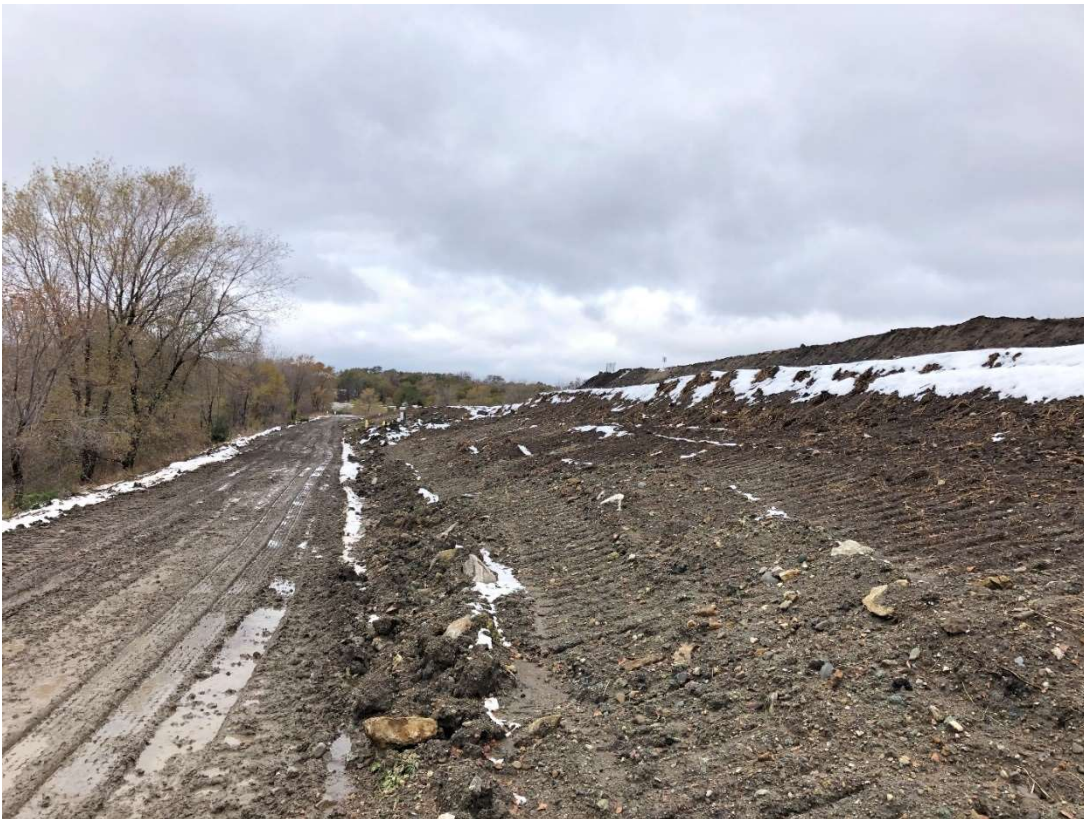
Location 9 – Looking Northwest, Cell 2B Southwestern Waste Slope and Anchor Trench

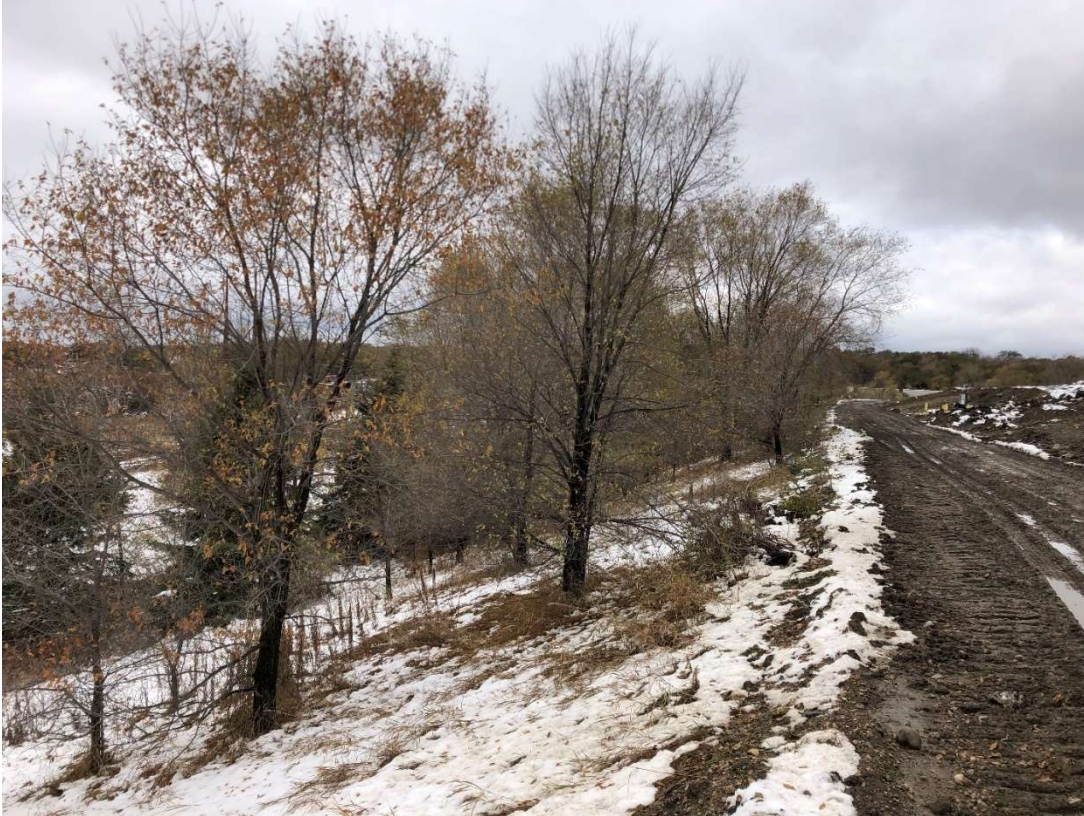
Location 9 – Looking Northwest, Cell 2B Southwestern Berm

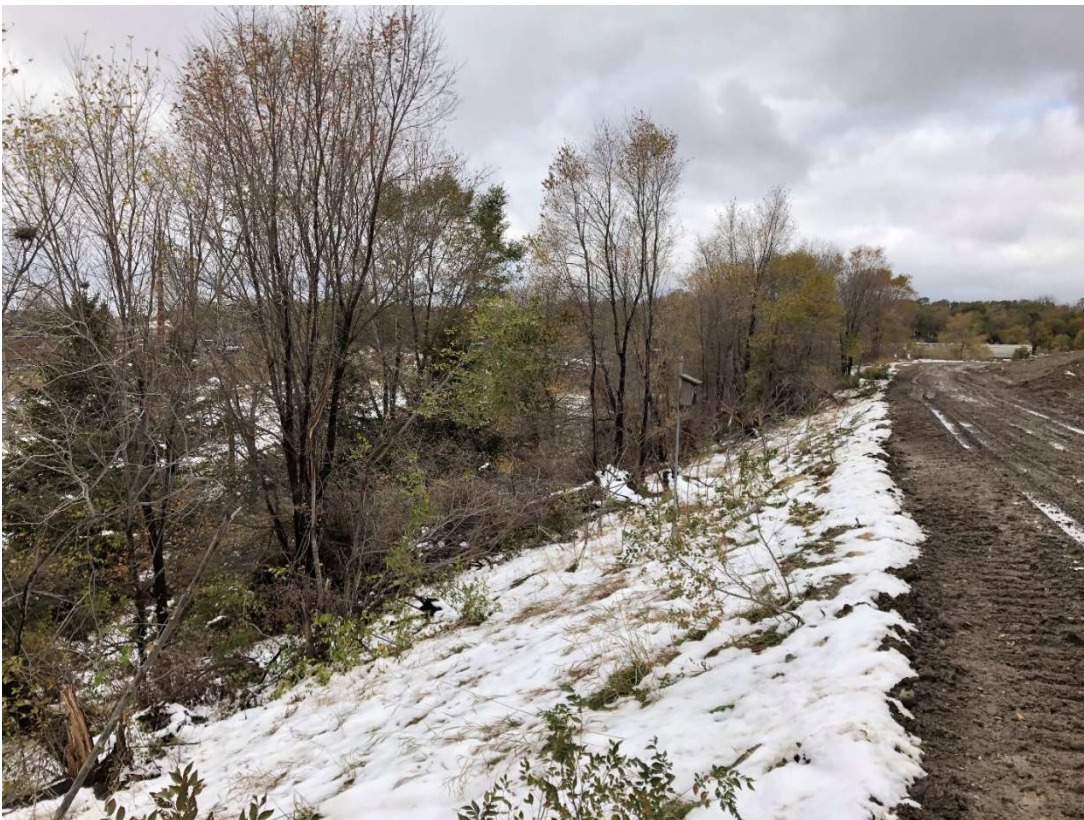
Location 10 – Looking Northwest, Cell 2A Southwestern Berm

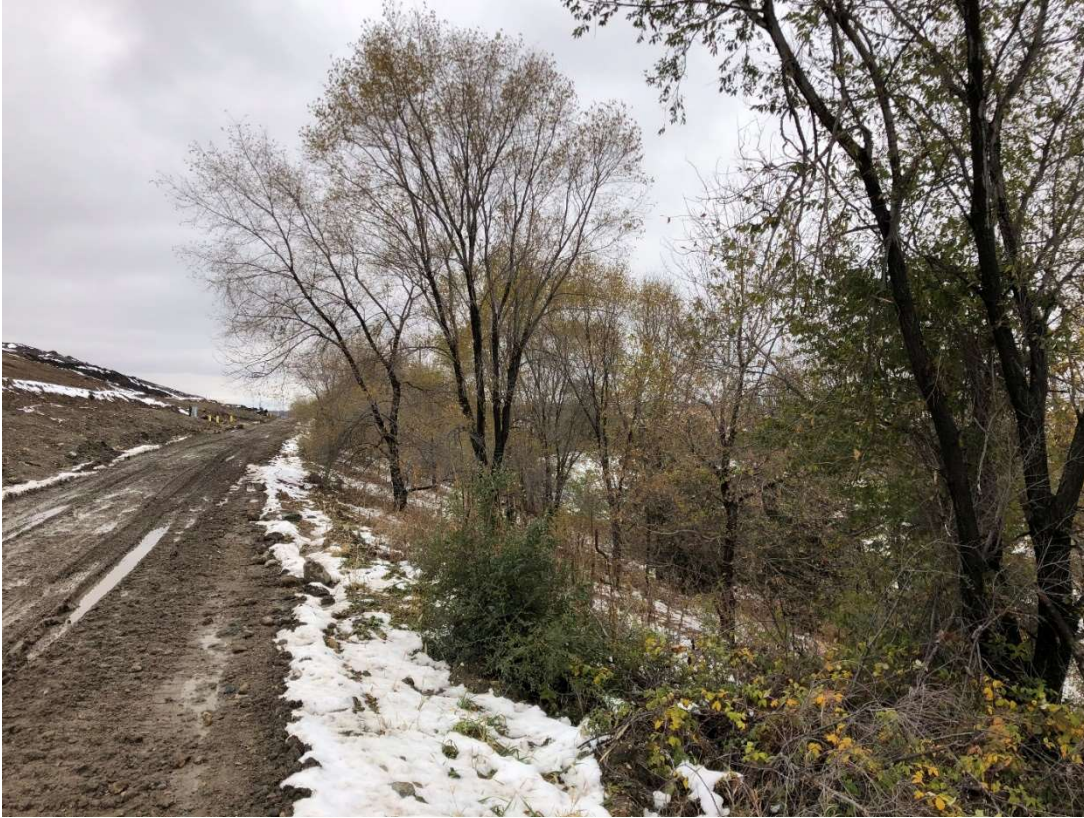
Location 10 – Looking Southeast, Cell 2B Southwestern Berm

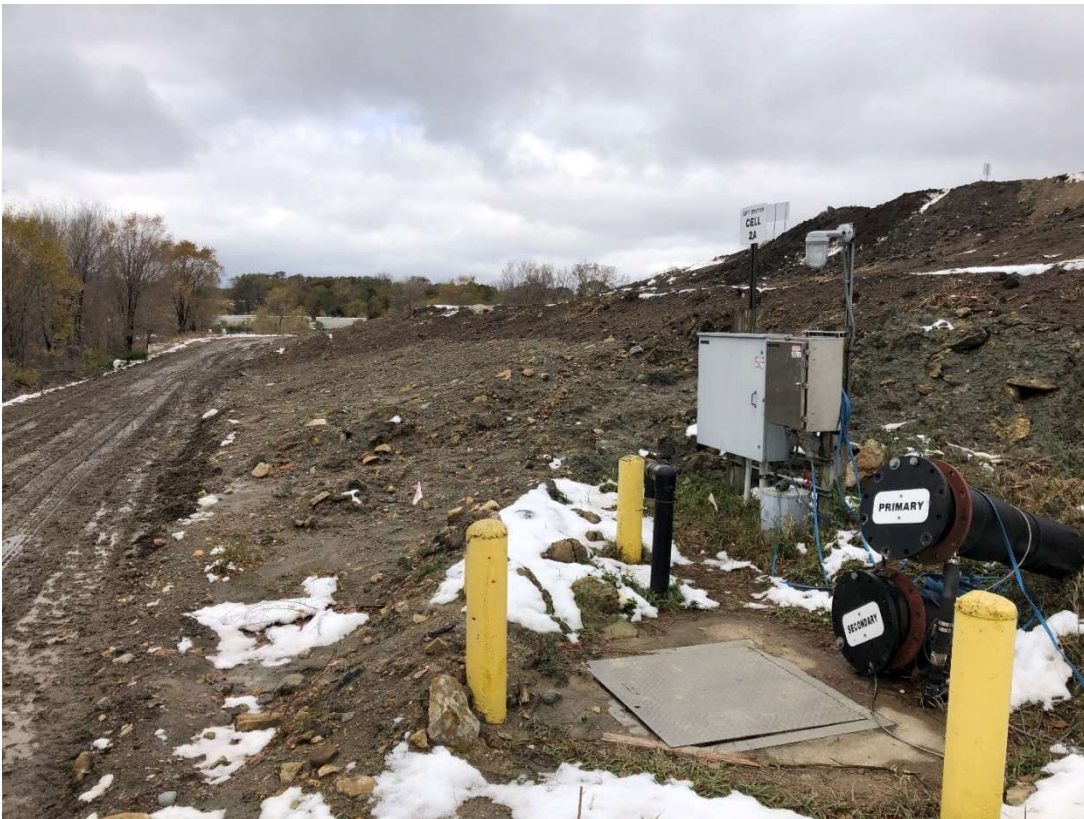
Location 10 – Looking Northwest, Cell 2A Southwestern Waste Slope and Perimeter Road

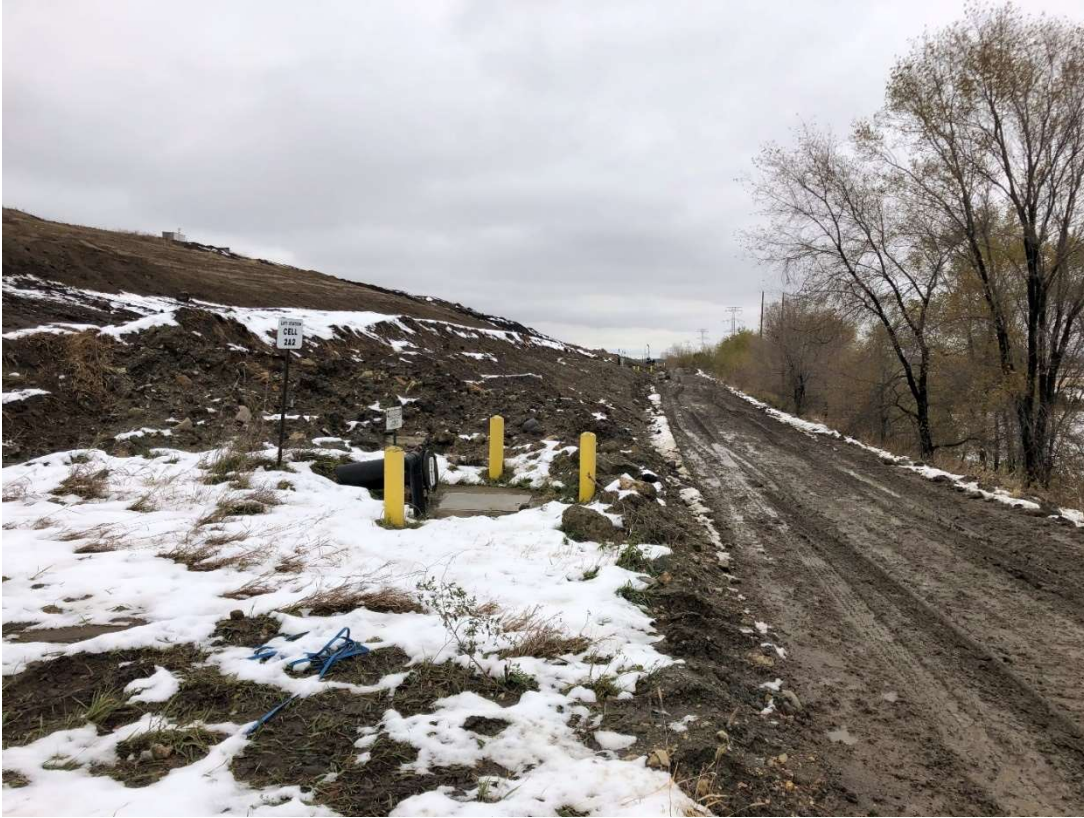
Location 10 – Looking Southeast, Cell 2B Southwestern Waste Slope and Perimeter Road

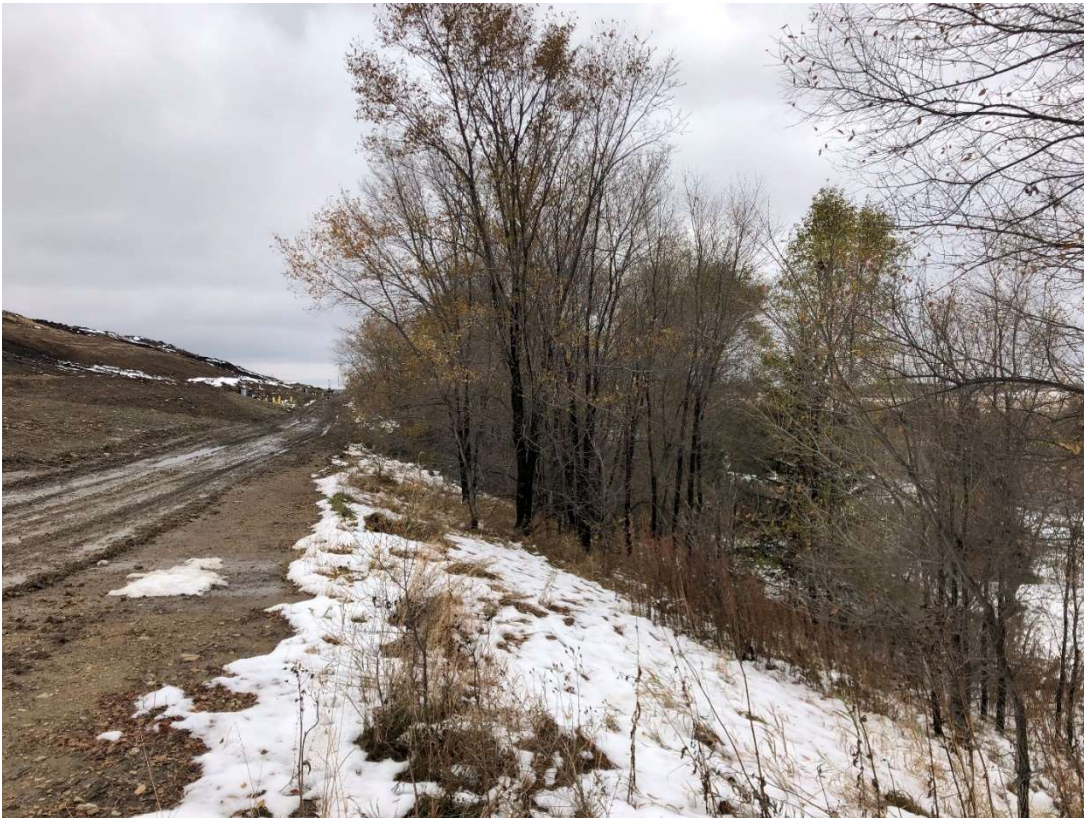
Location 11 – Looking Southeast, Cell 2A Southwestern Berm

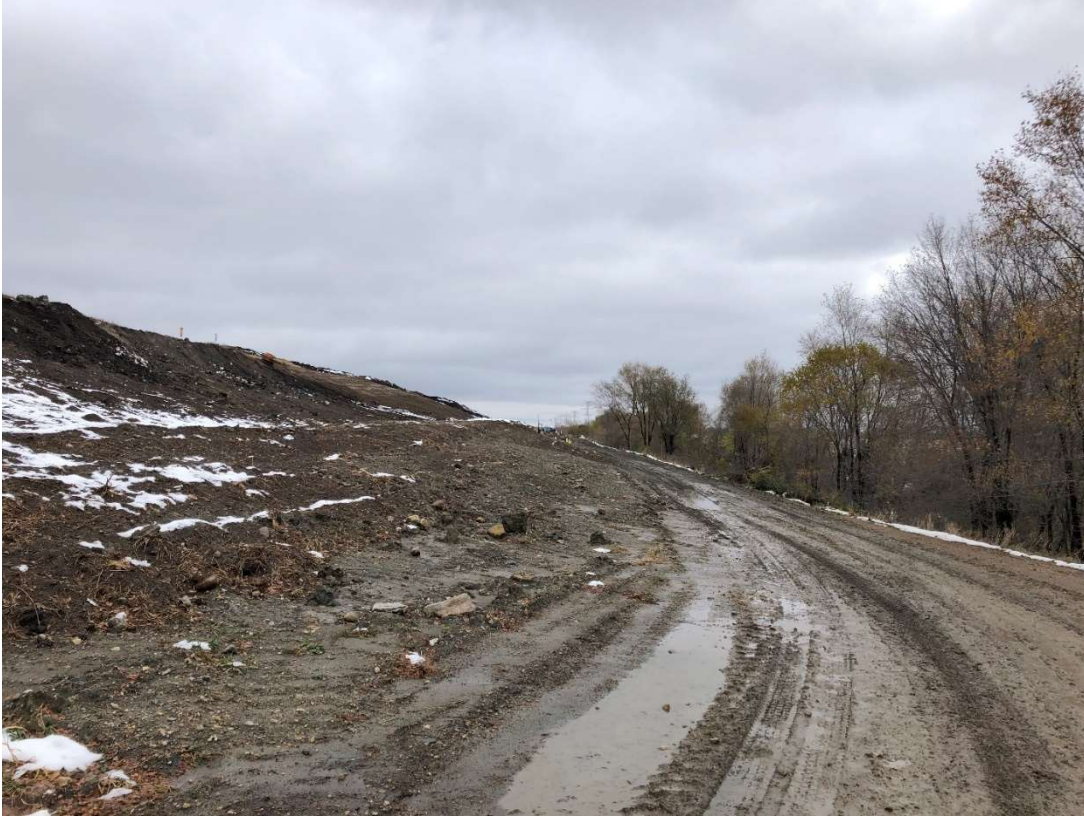
Location 11 – Looking Southeast, Cell 2A Southwestern Waste Slope

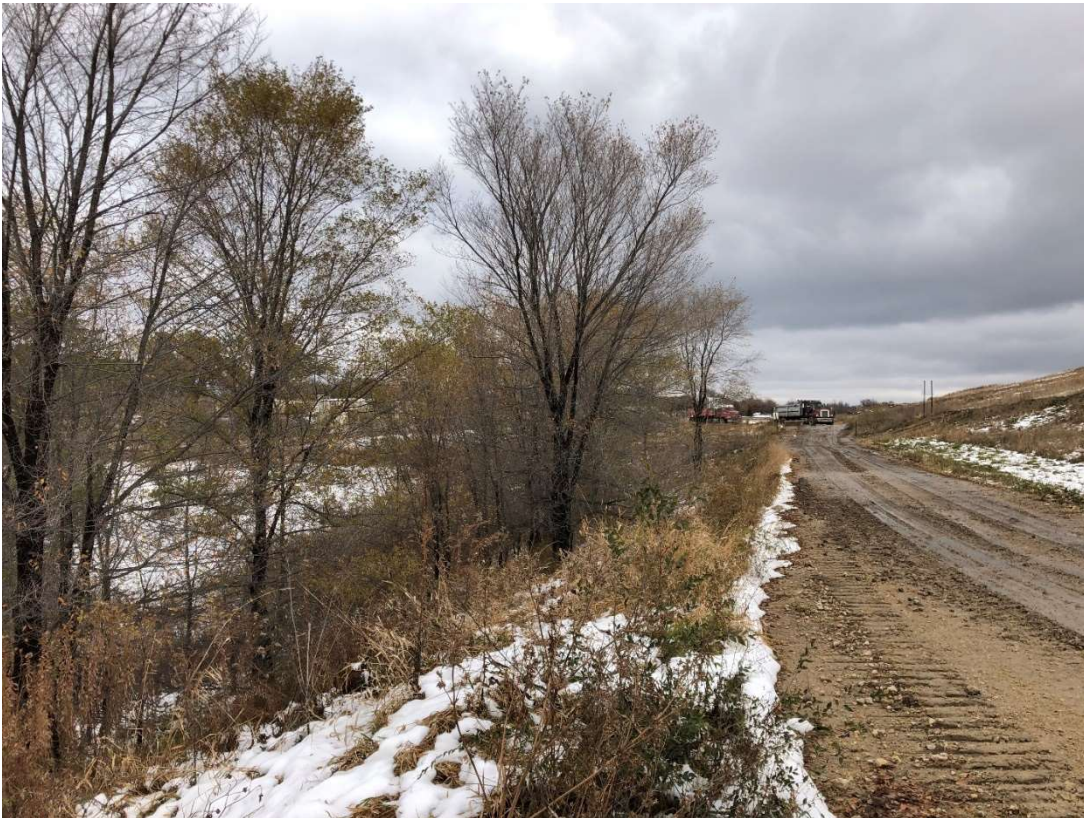
Location 11 – Looking Northeast, Cell 2A Northwestern Berm

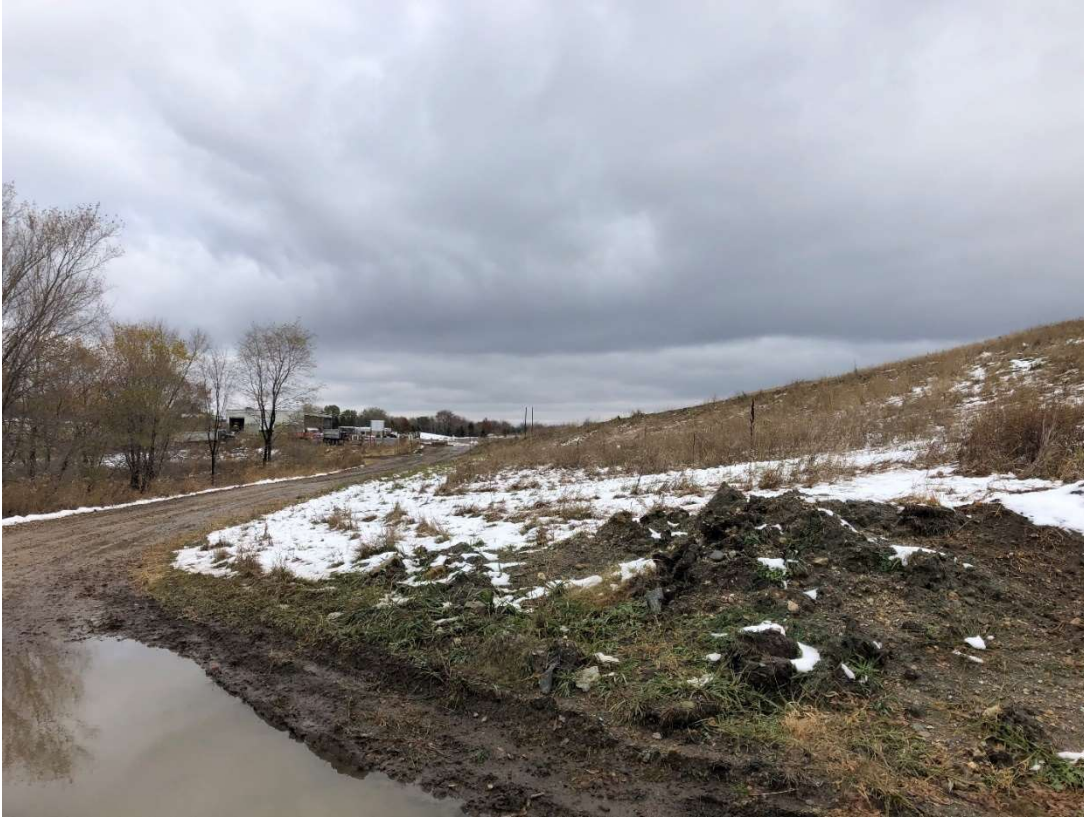
Location 11 – Looking Northeast, Cell 2A Northwestern Perimeter Road and Anchor Trench

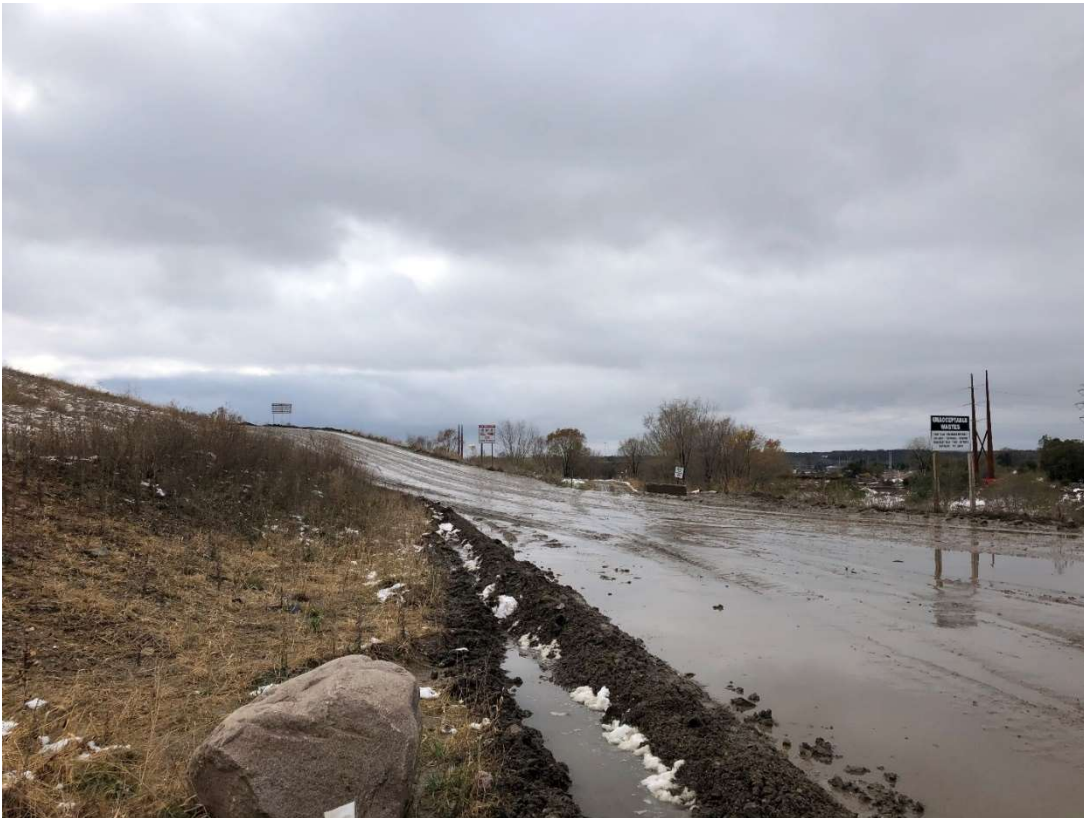
Location 12 – Looking Southwest, Cell 2A Northwest Waste Slope and Anchor Trench

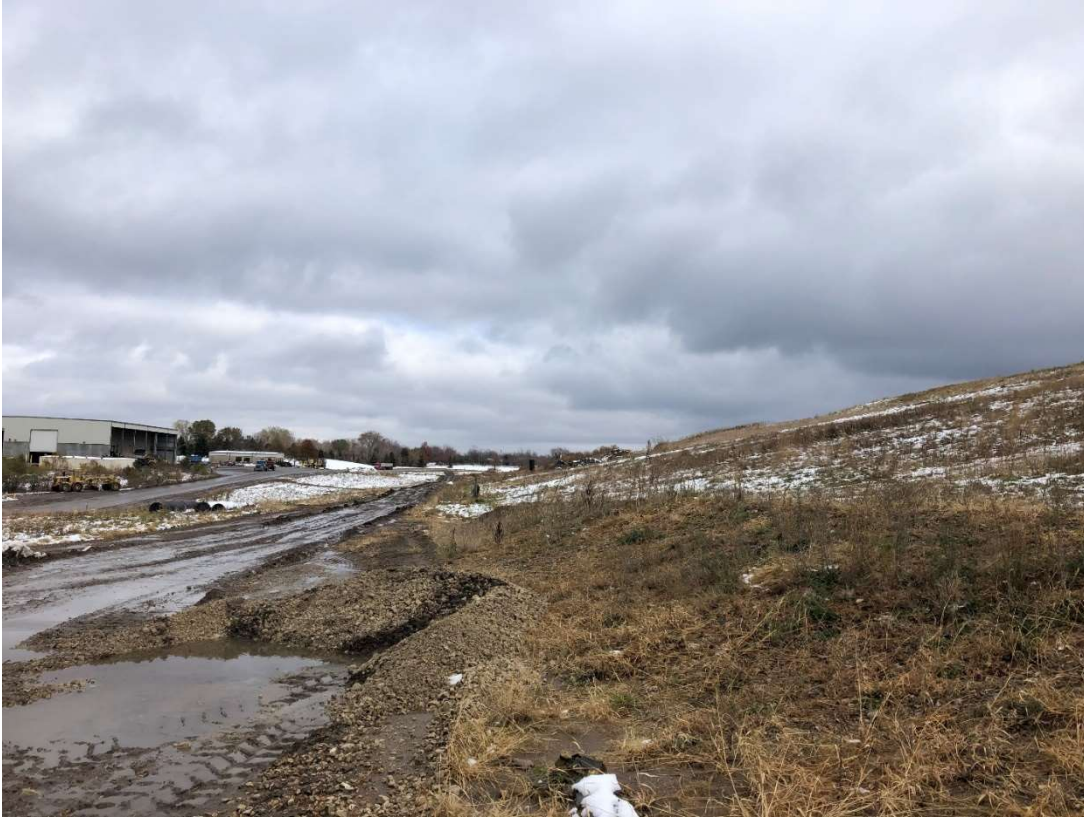
Location 12 – Looking Northeast, Cell 1 Northwestern Waste Slope

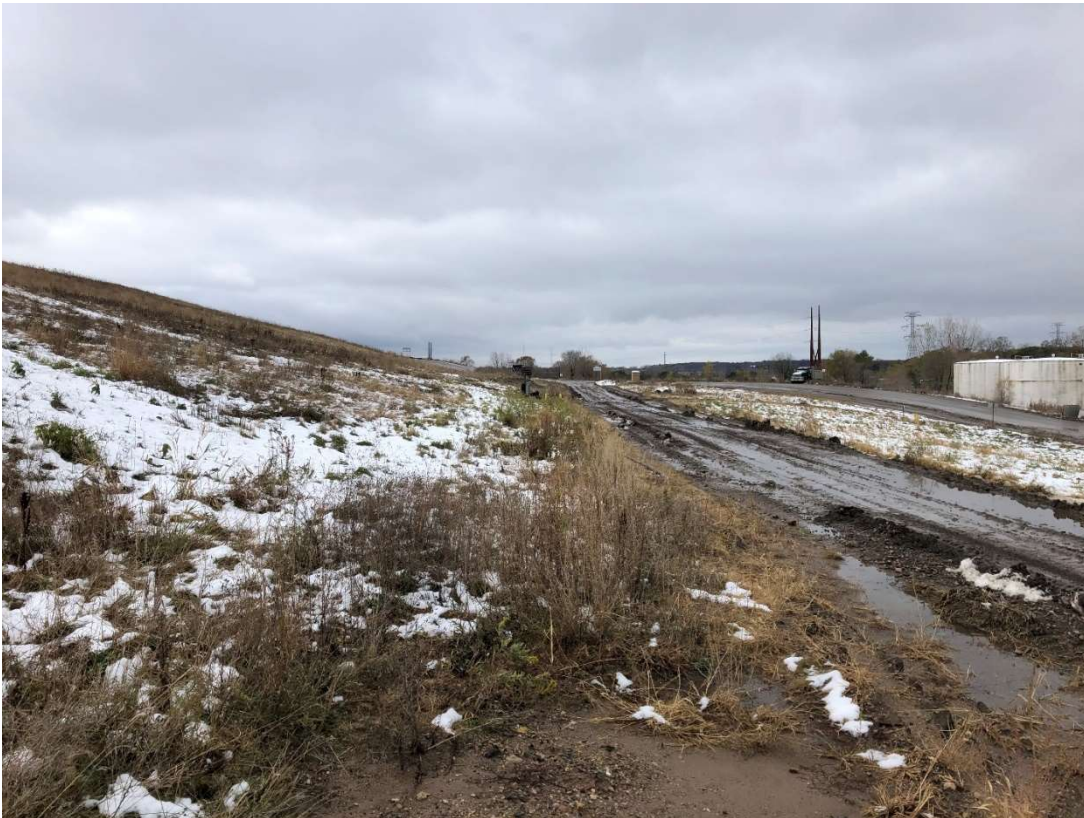
Location 13 – Looking Southwest, Cell 1 Toe of Waste Slope, Limit of Industrial Waste (CCR)

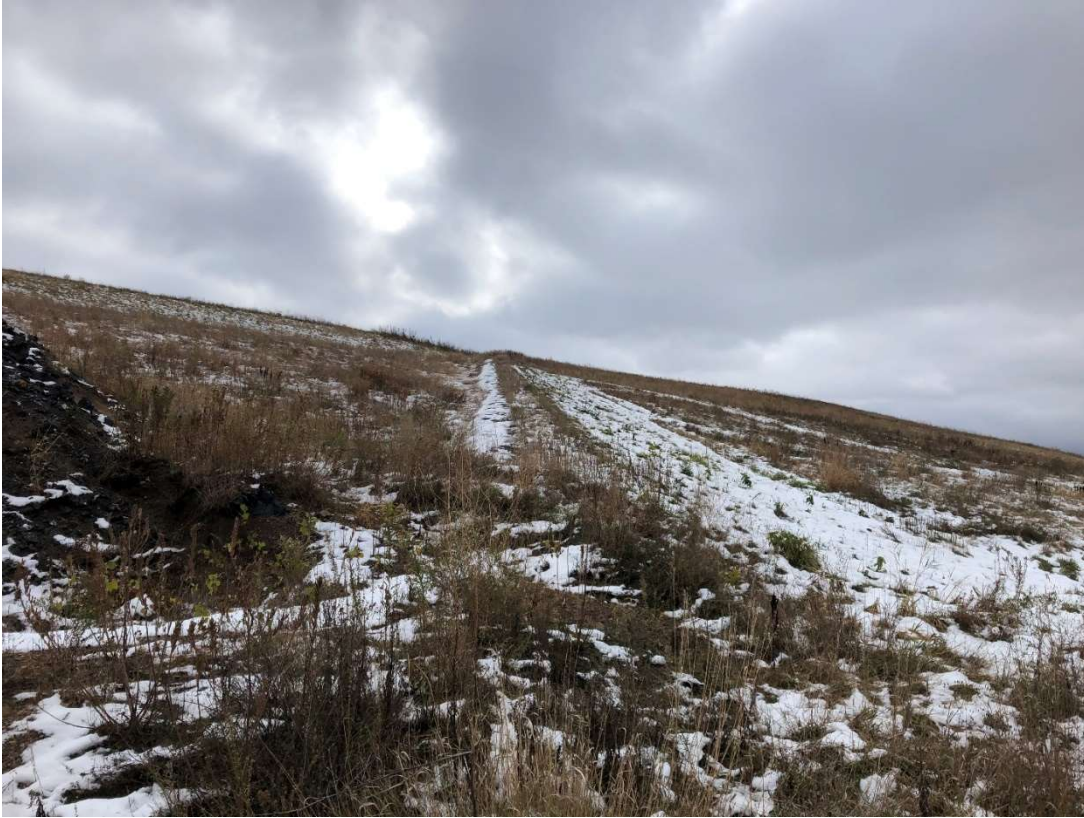
Location 13 – Looking South, Edge of Cap over Cell 1, Limit of Industrial Waste (CCR)
