To:	Geoff Strack, P.E. Waste Connections	From:	Bradley W Sullivan, P.E. Stantec Consulting Services Inc.
File:	Project #227704387	Date:	January 7, 2022

Reference: SKB Rosemount Industrial Waste Facility 2021 Annual CCR Inspection Report

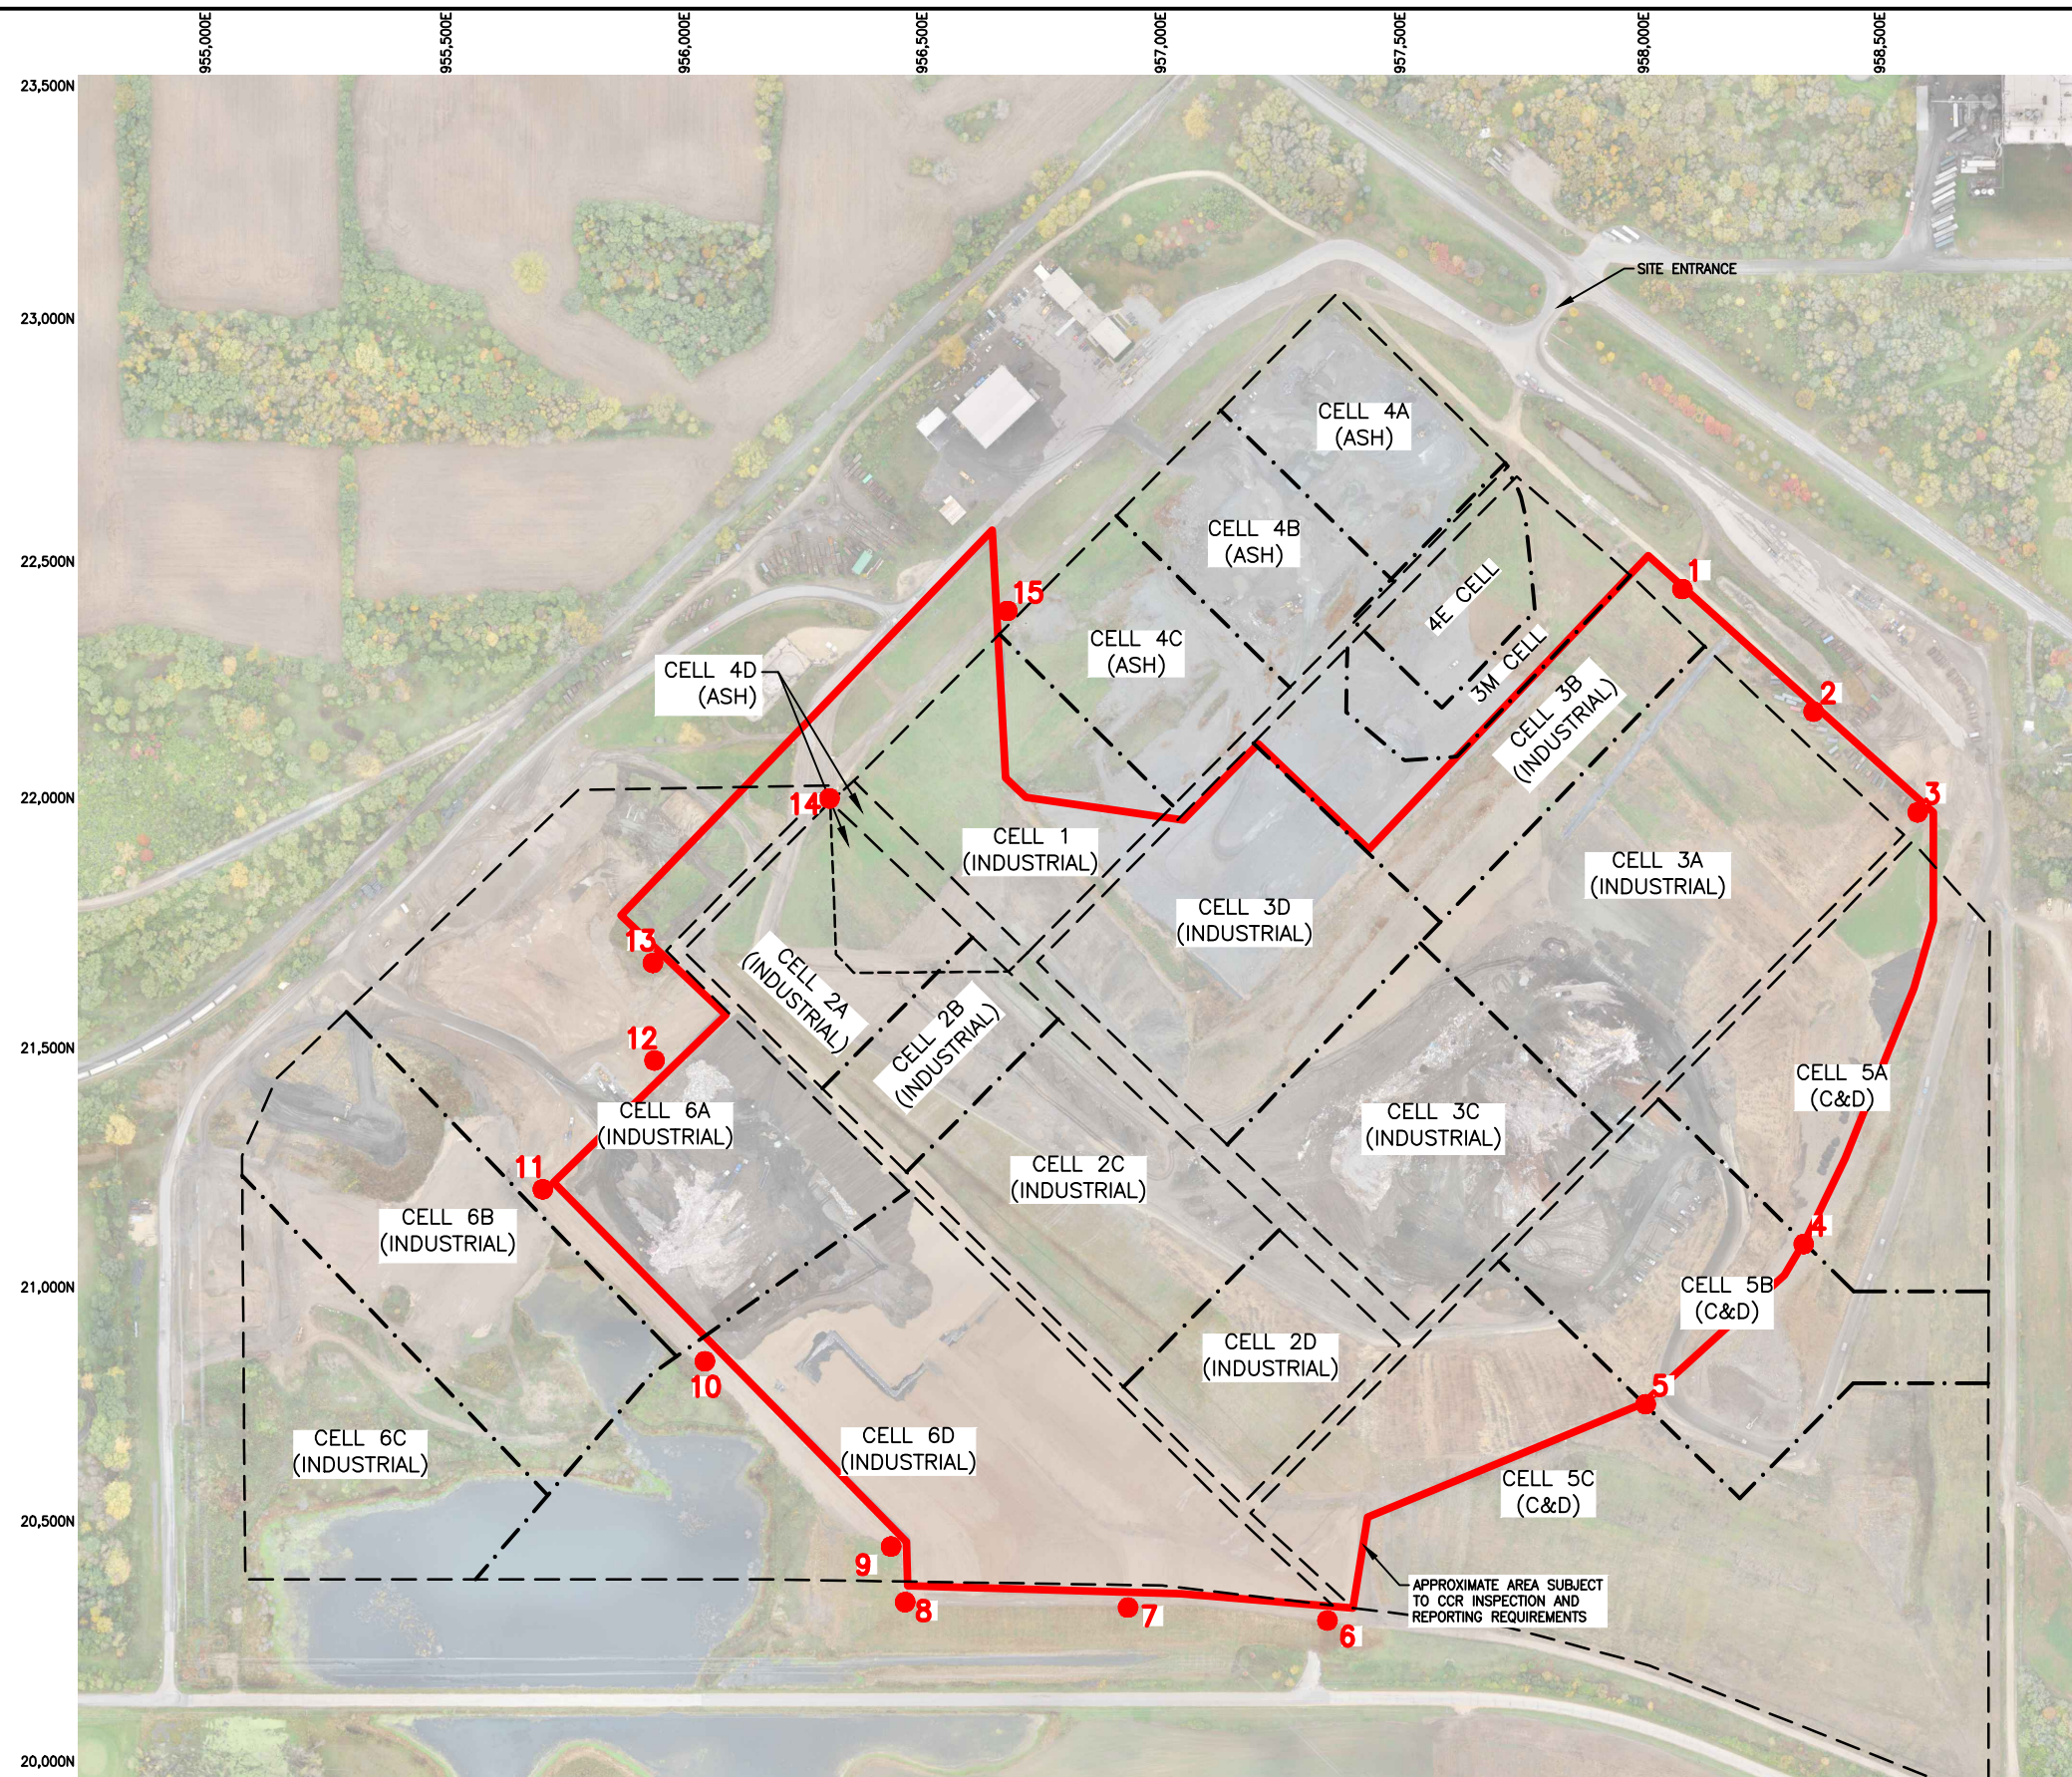
SHEET TITLE
 PHOTO LOCATIONS
 DWN BY: JVB, CHK'D: TJS, APP'D: BWS, DWG DATE: JAN. 2022, SCALE: AS NOTED
 PROJECT NO.: 227704387, SHEET NO.: FIGURE 1, REV NO.: 0

Photos of the landfill embankments and waste slopes were taken during the inspection. Figure 1 presents the photo locations, and Attachment 1 contains a photo log from the inspections.

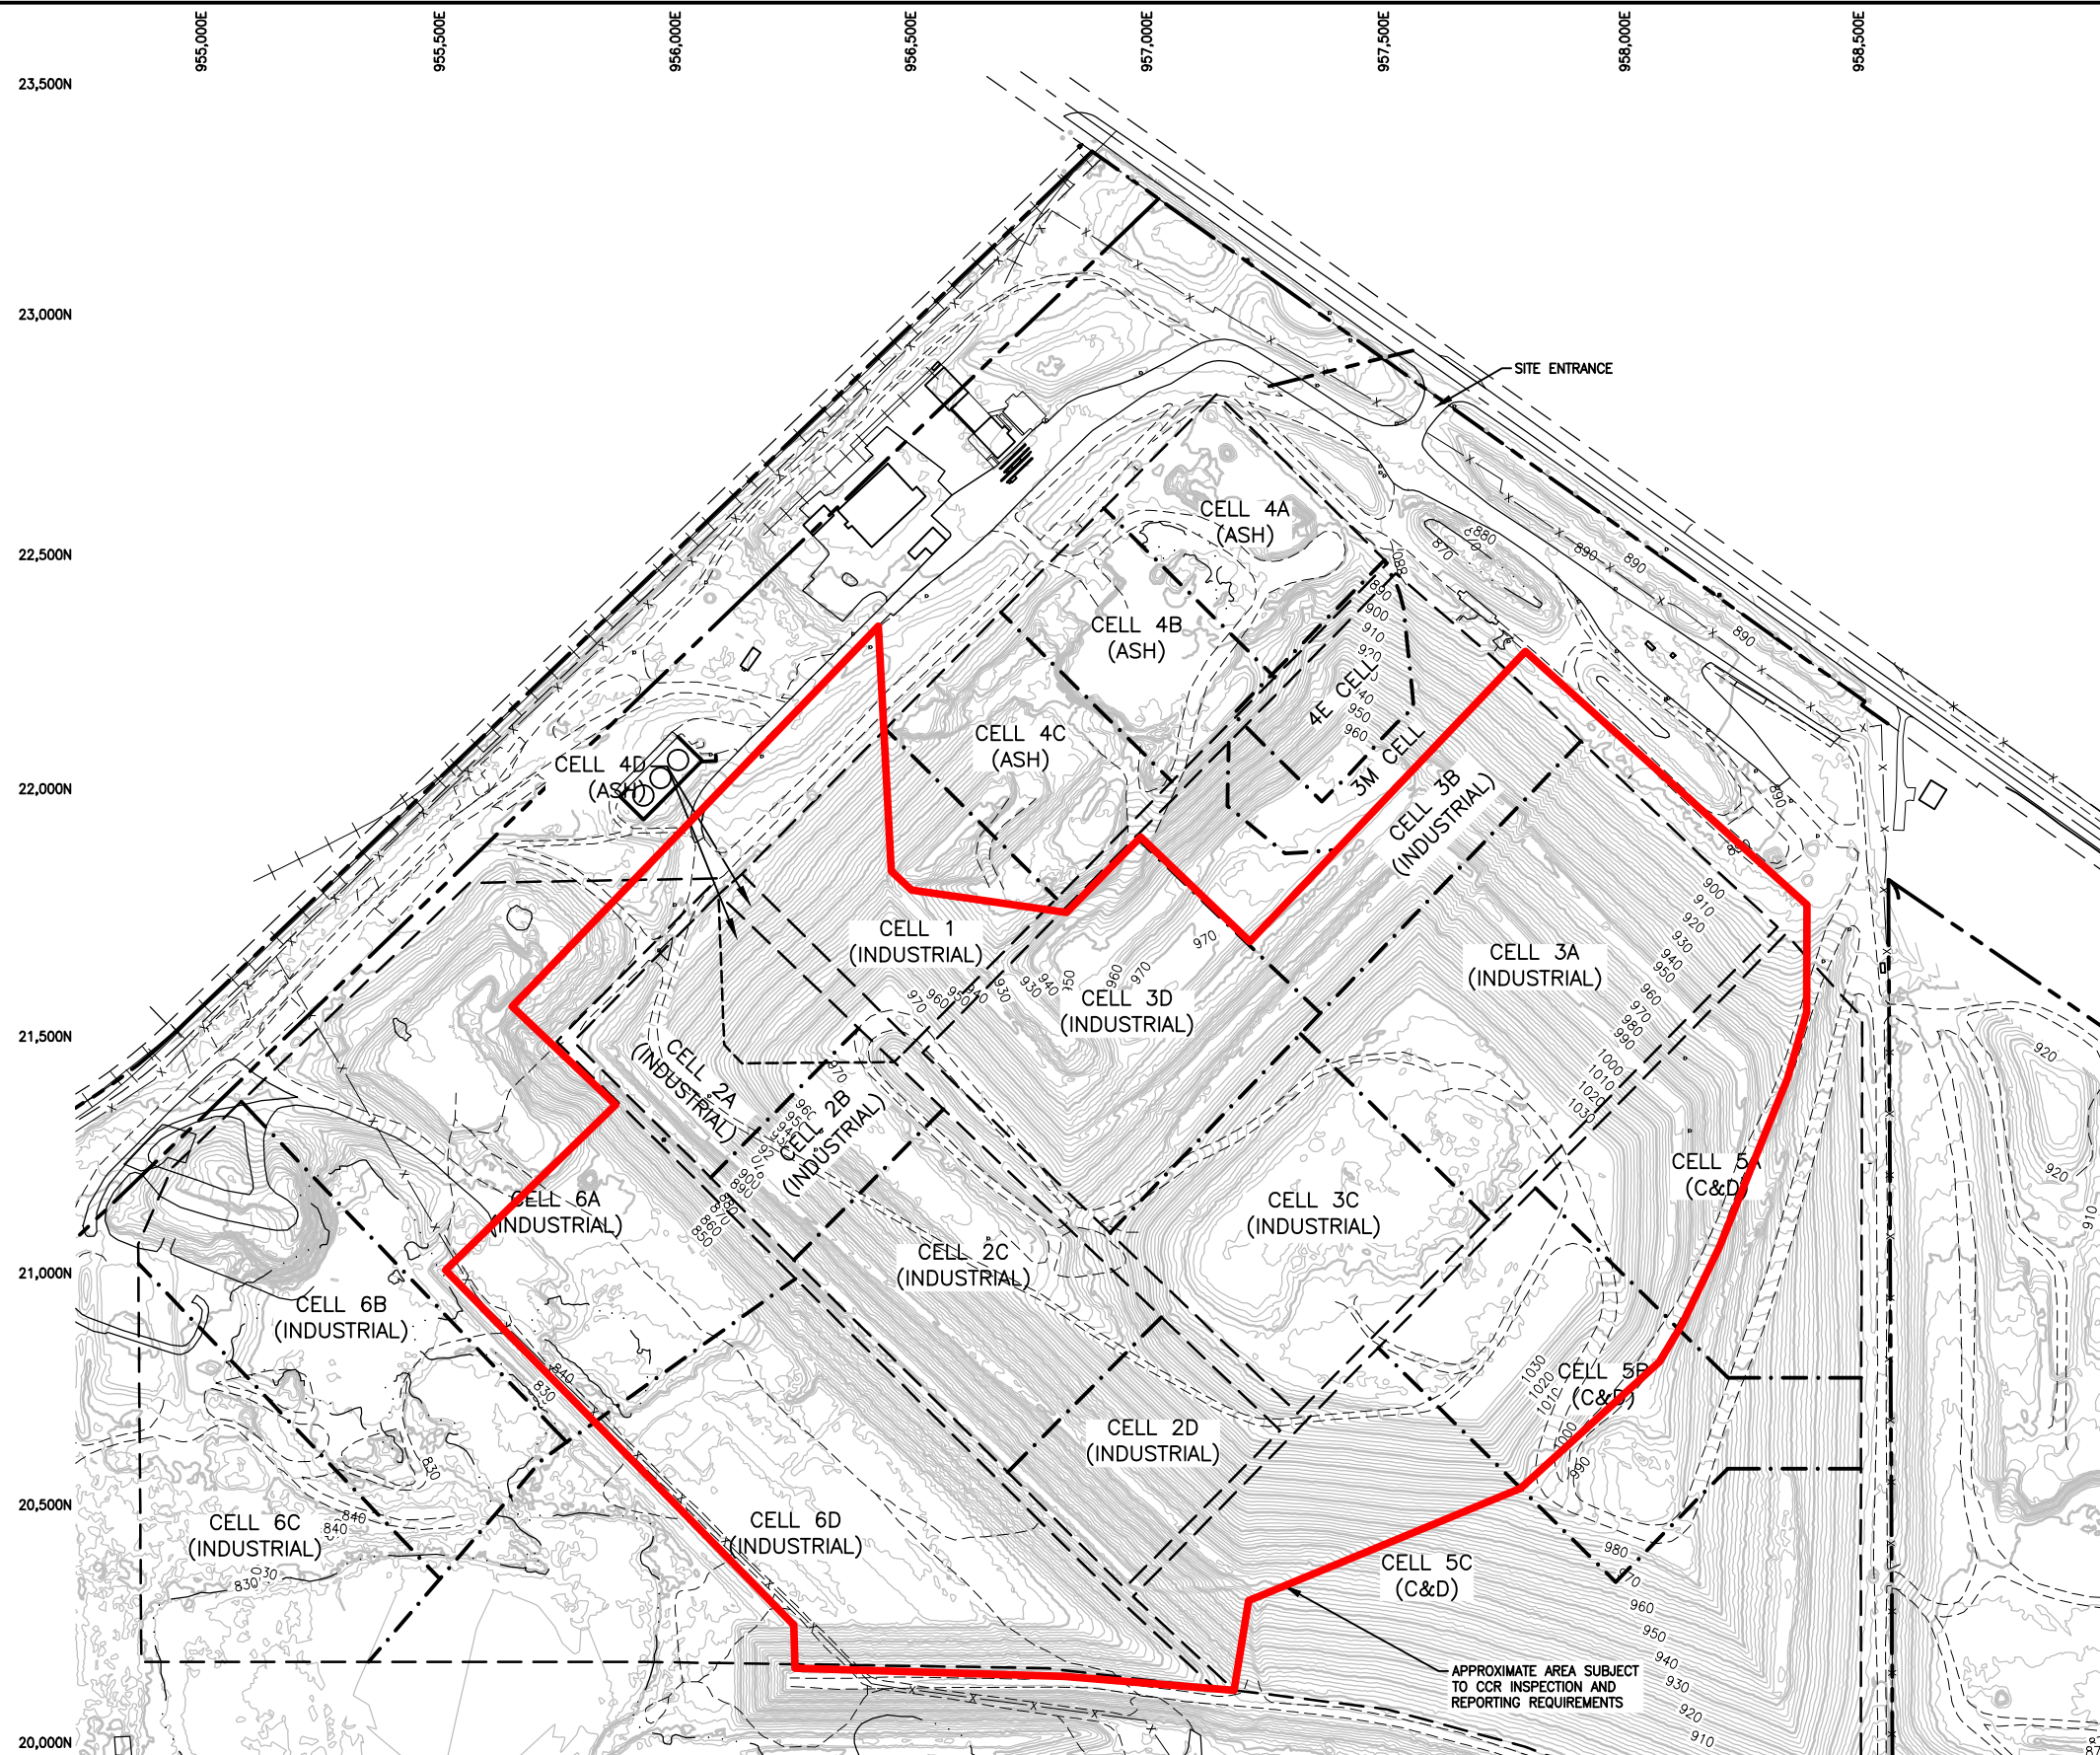
DWN BY: JVB, CHK'D: TJS, APP'D: BWS, DWG DATE: JAN. 2022, SCALE: AS NOTED
PROJECT NO.: 227704387, SHEET NO.: FIGURE 2, REV NO.: 0

The annual aerial photogrammetry survey was performed on October 21, 2021, which the estimated in-place volume of total waste (including all accepted wastes) is based on. A comparison of the 2021 and 2020 aerial surveys confirm that the embankment and slope topography is substantially unchanged with no significant movement. The 2021 aerial survey is included as Figure 2.

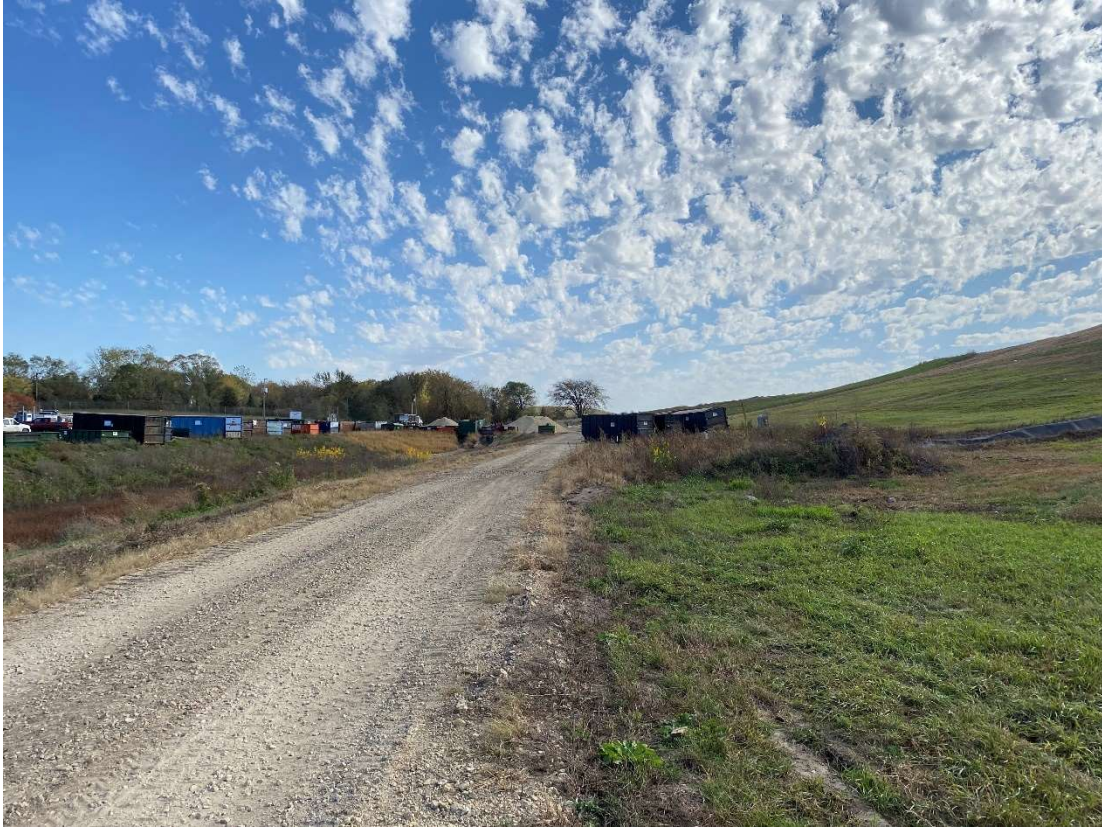
Location 1 – Looking Southeast, Cell 3A & 3B Waste Slope & Anchor Trench

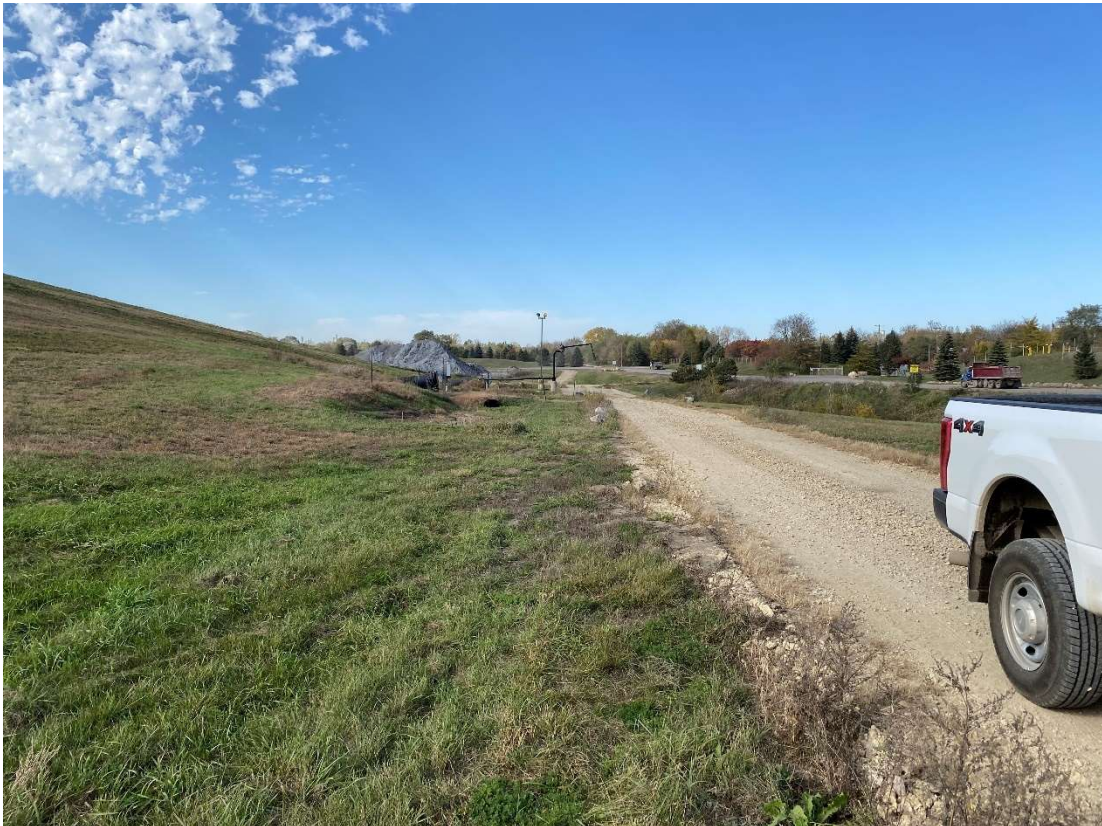
Location 1 – Looking Northwest, Cell 3 Berm

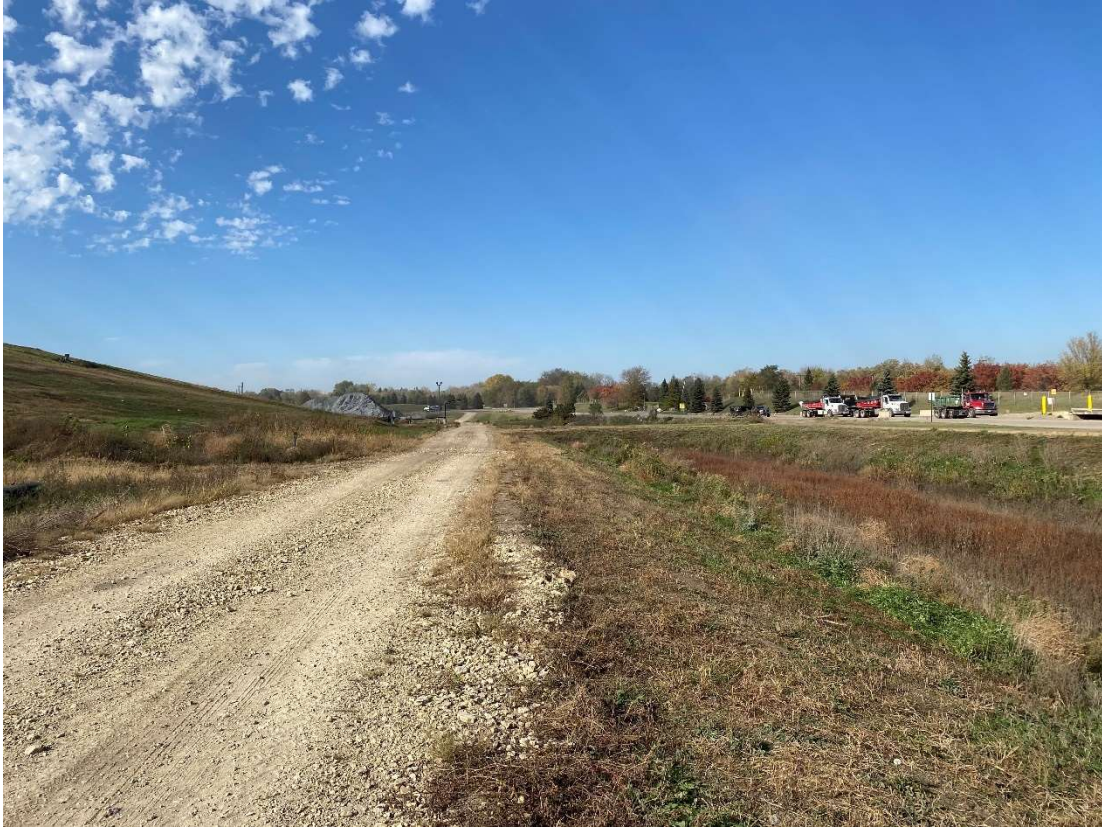
Location 2 – Looking Northwest, Cell 3 Berm & Stormwater Pond

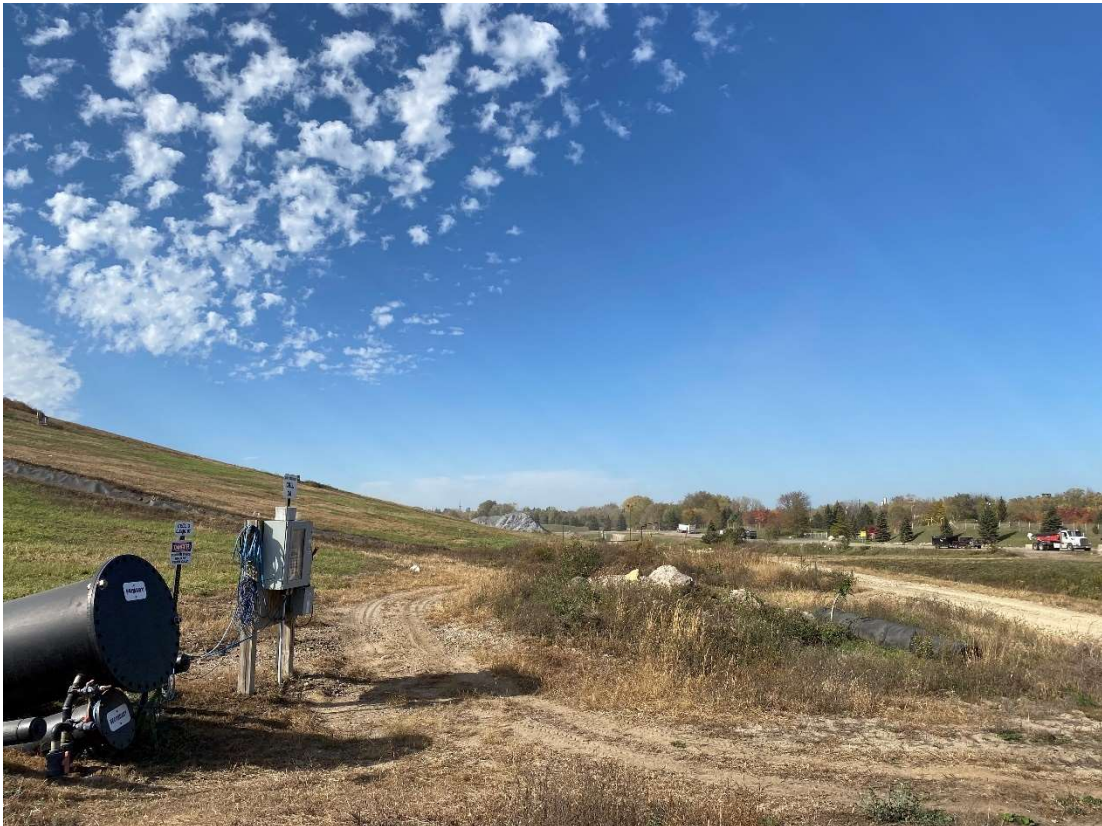
Location 2 – Looking Northwest, Cell 3 Anchor Trench and Waste Slope

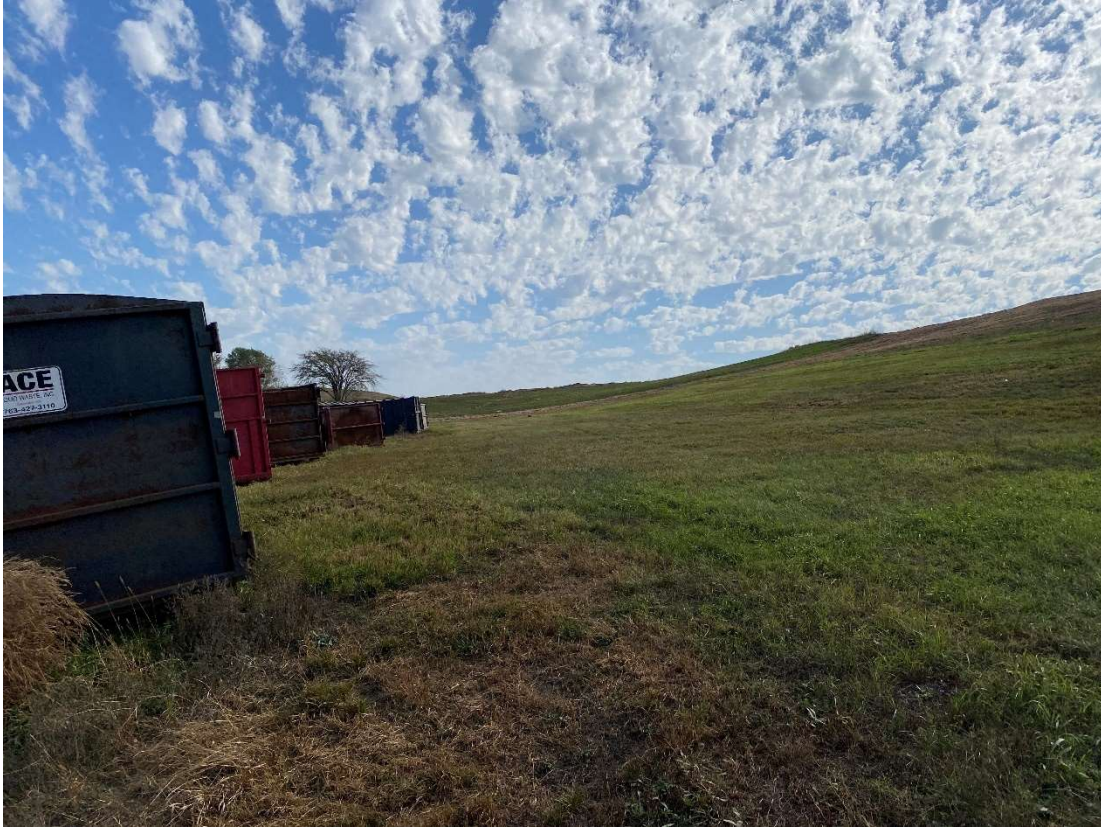
Location 2 – Looking Southeast, Phase 3A Anchor Trench and Northeastern Waste Slope

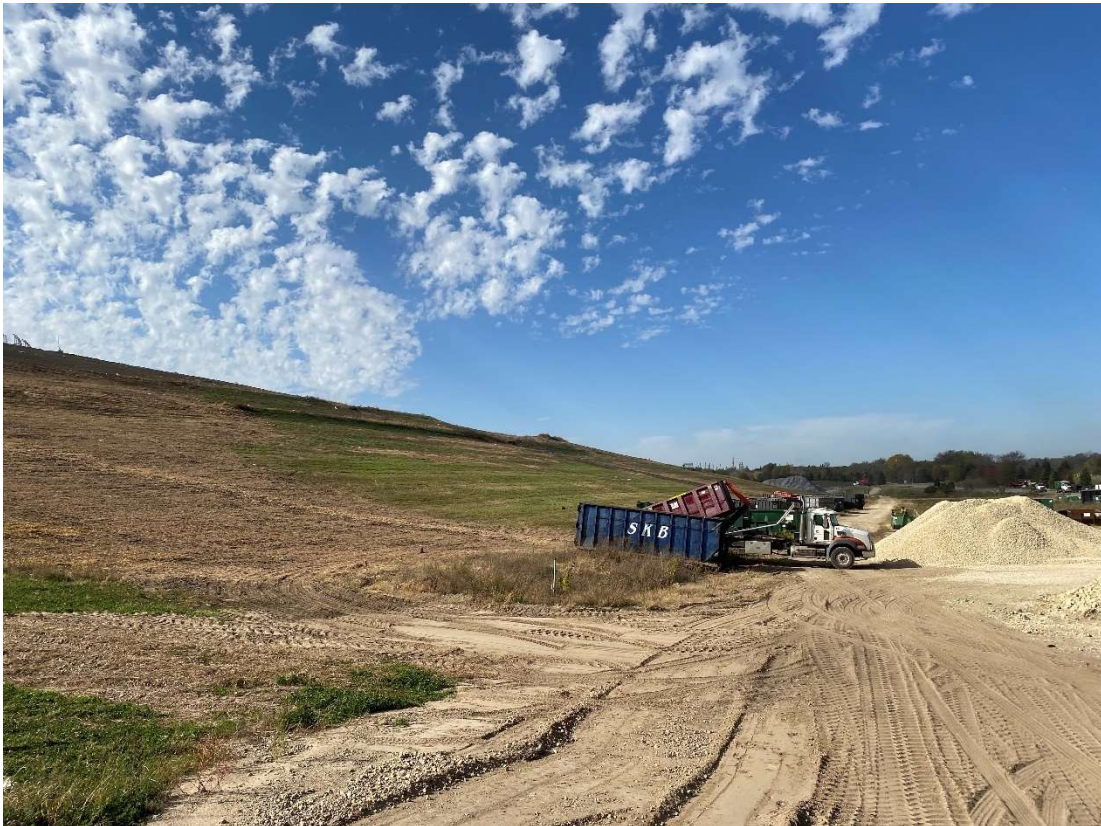
Location 3 – Looking Northwest, Phase 3A Anchor Trench and Northeastern Waste Slope

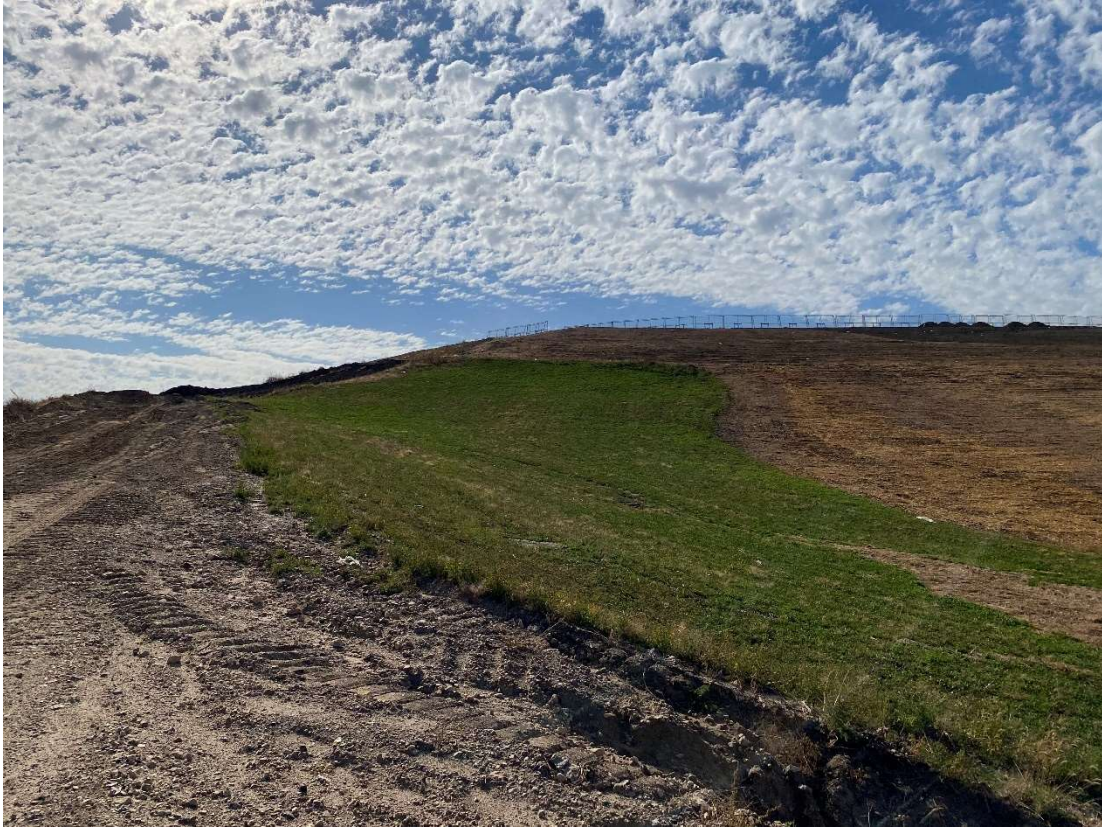
Location 3 – Looking Southwest, Phase 3 East Corner at toe of Interior Access Road

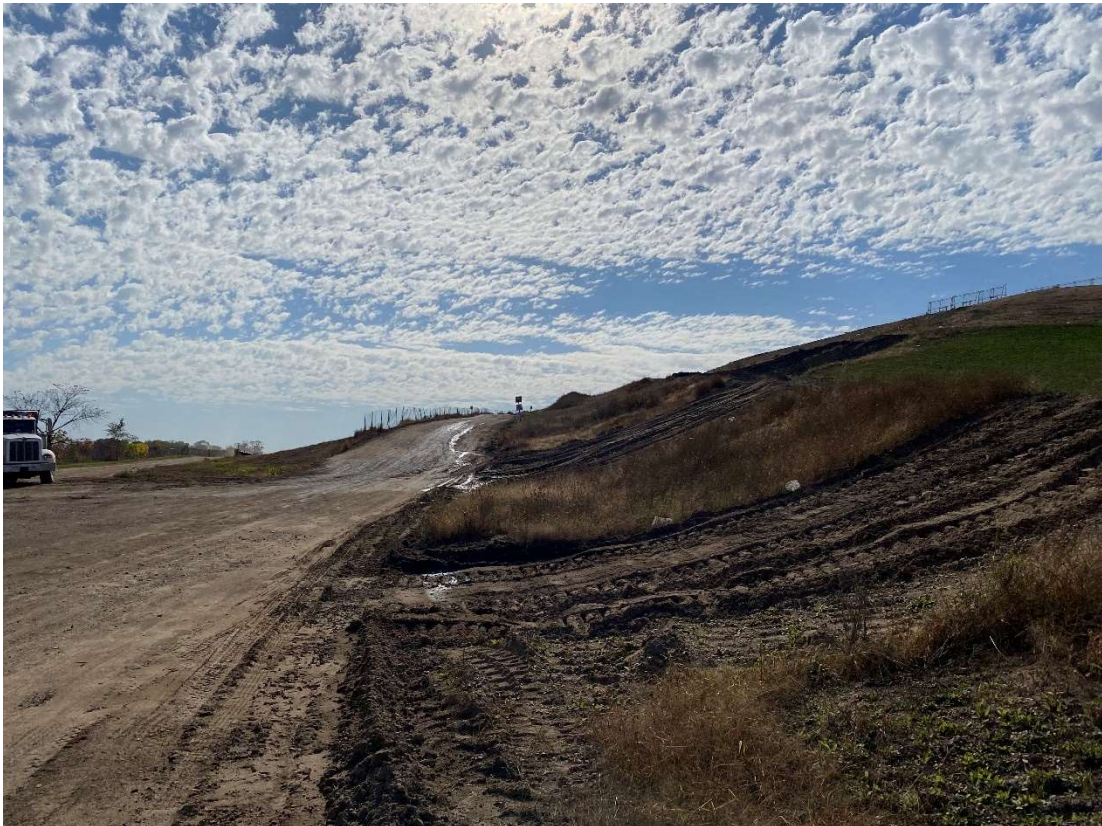
Location 3 – Looking Southwest along Cell 3 Access road/Phase 3 Liner Limit

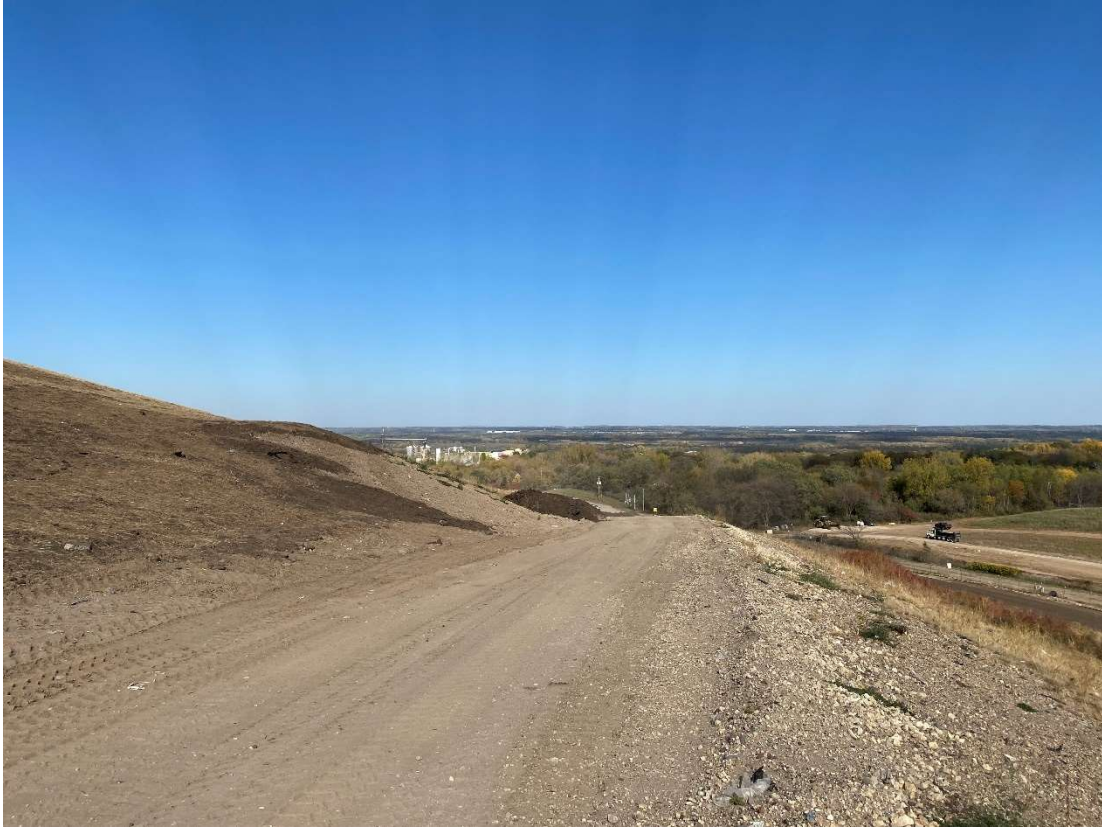
Location 4 – Looking Northeast, Phase 3 Liner Limit

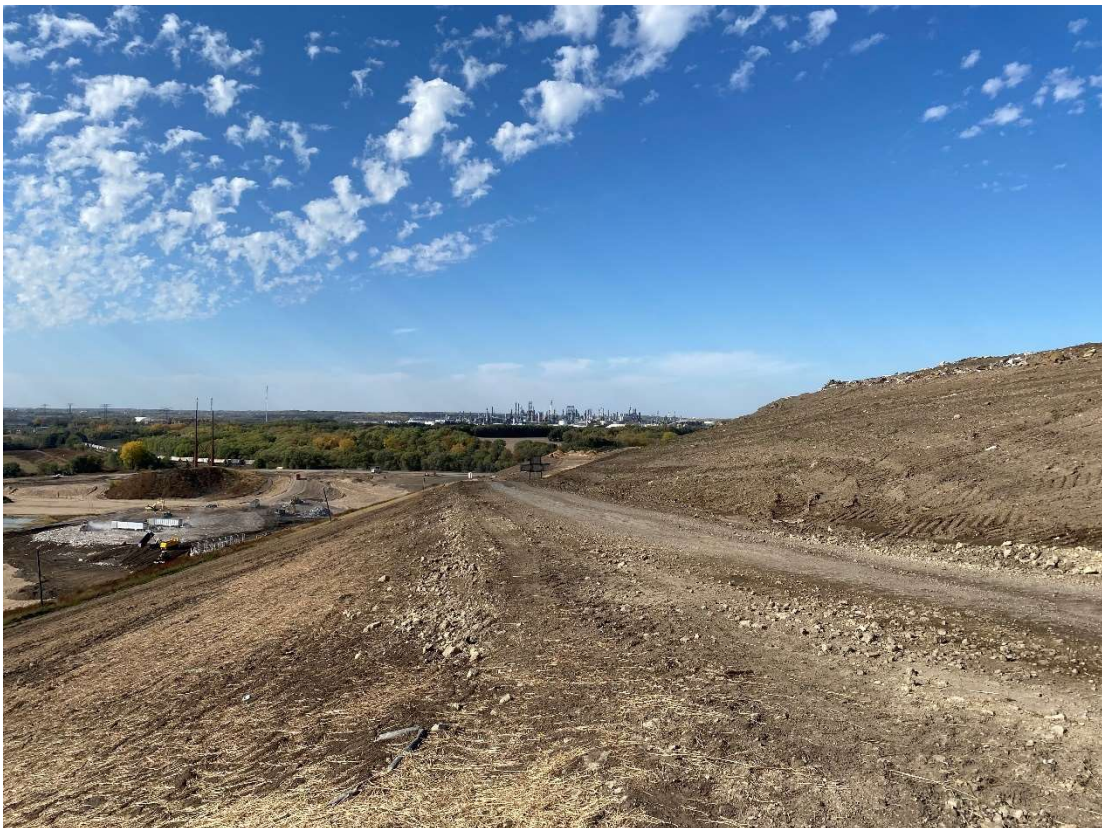
Location 4 – Looking Southwest, Phase 3 Liner Limit

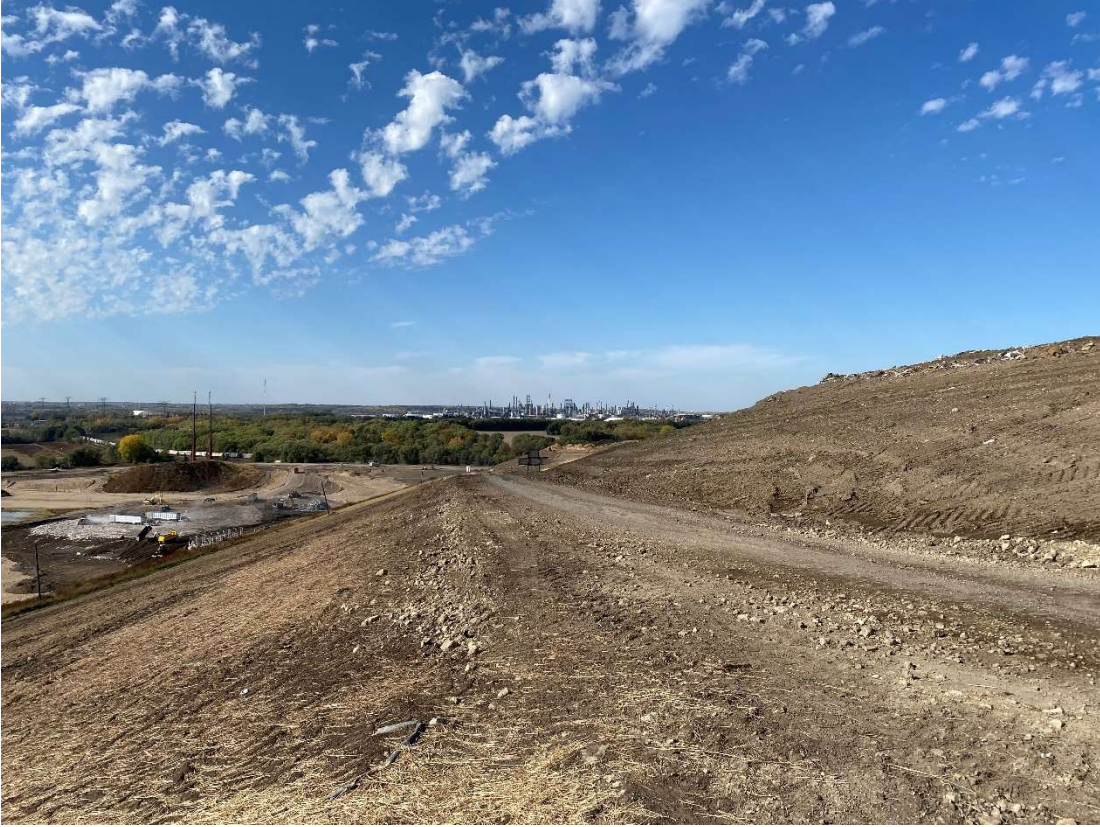
Location 5 – Looking Southwest, Phase 3 Liner Limit

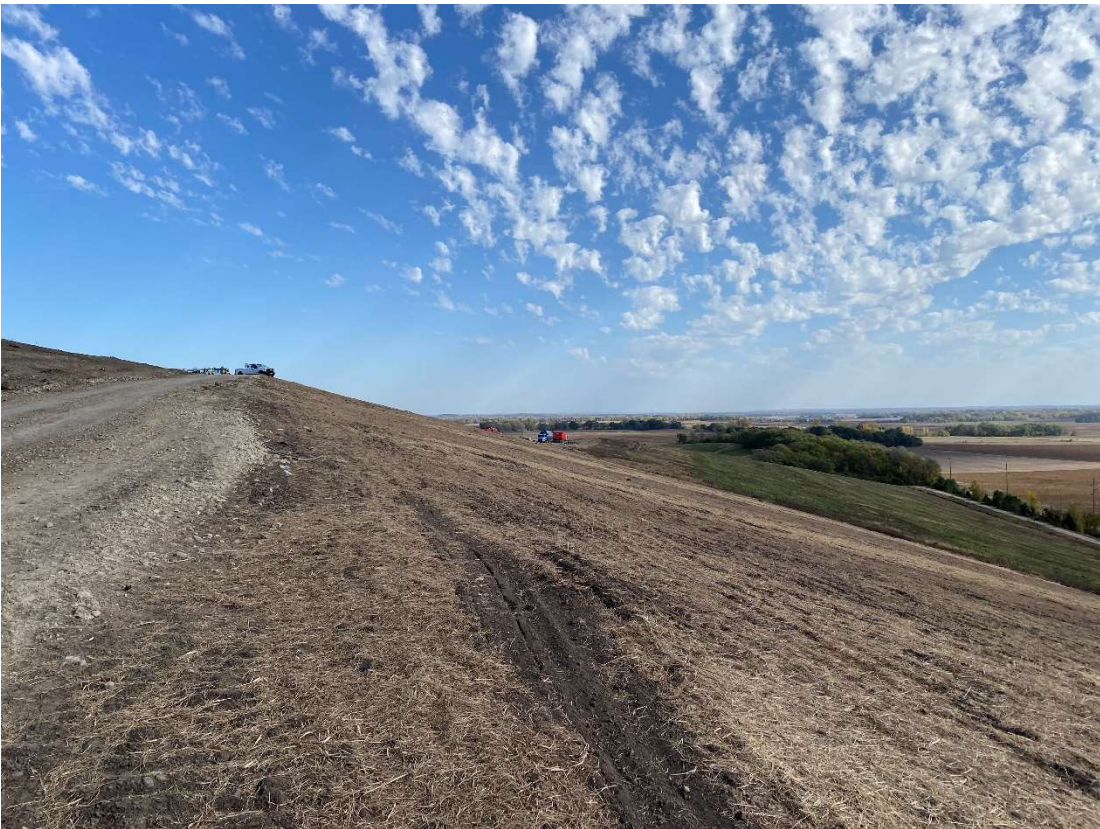
Location 5 – Looking Northeast, Phase 3 Liner Limit

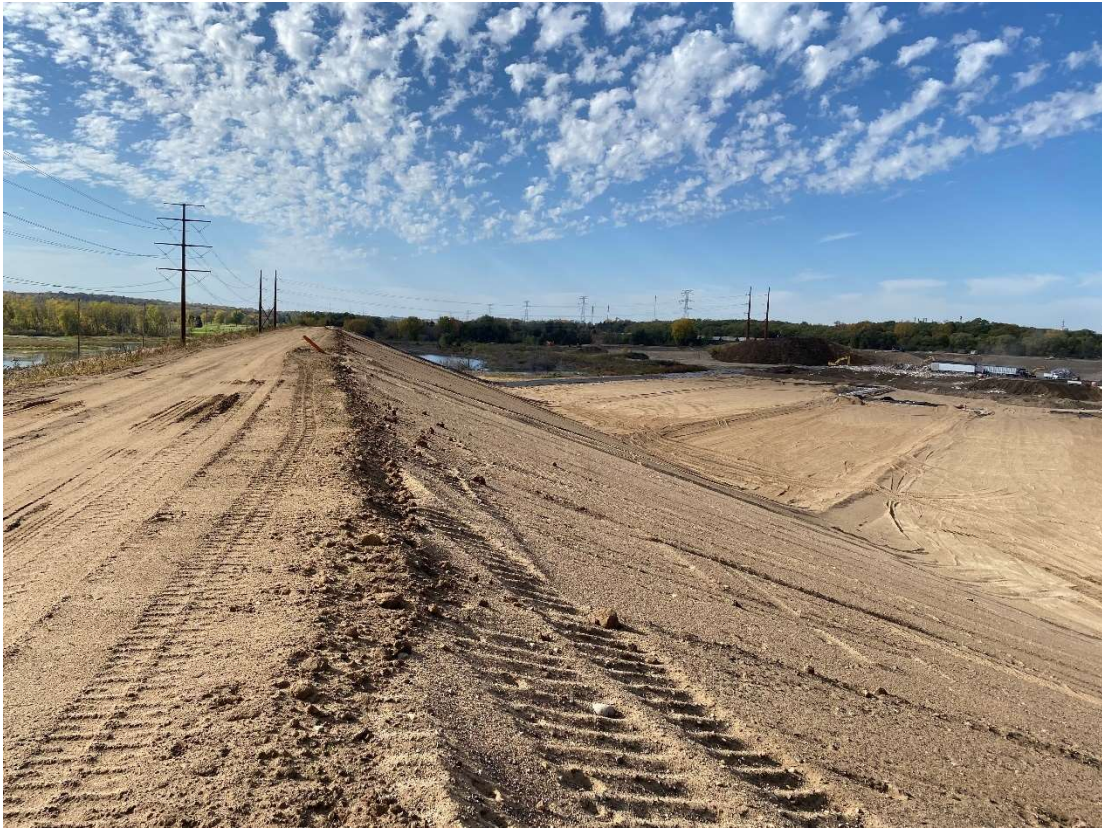
Location 6 – Cell 6 SE corner, inner berm, looking west

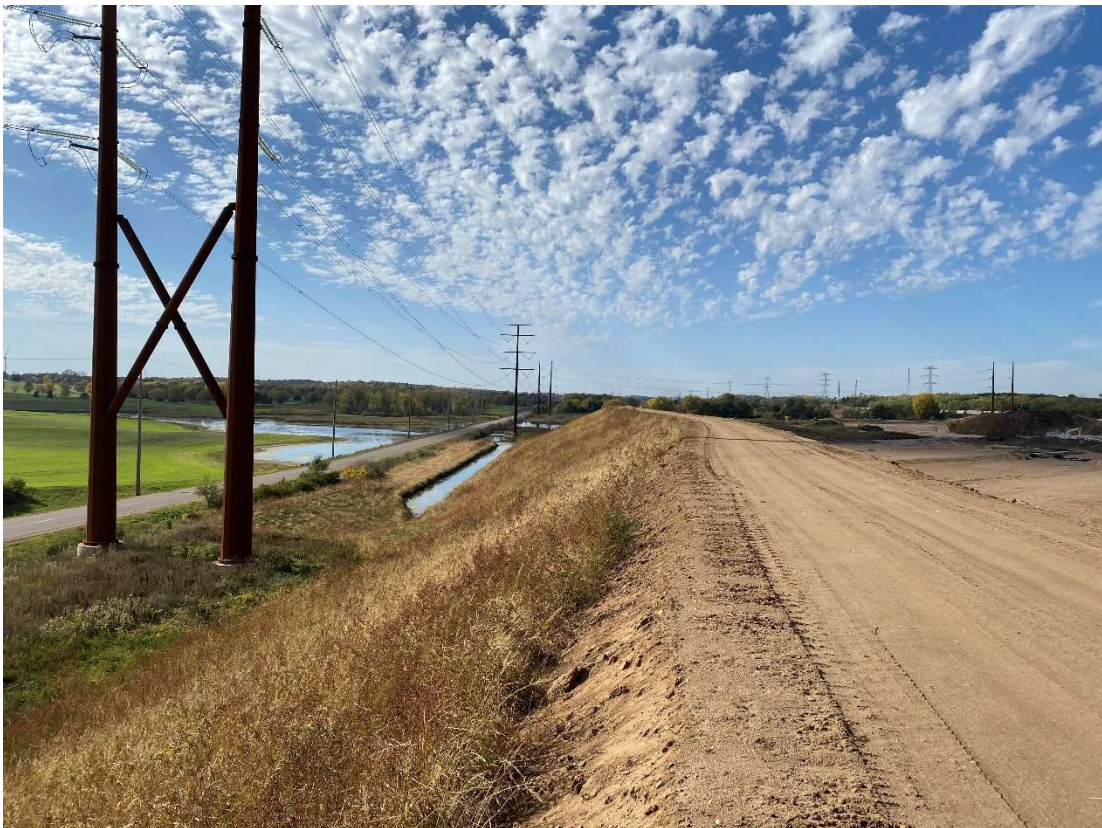
Location 6 – Cell 6 SE corner, outer berm, looking west

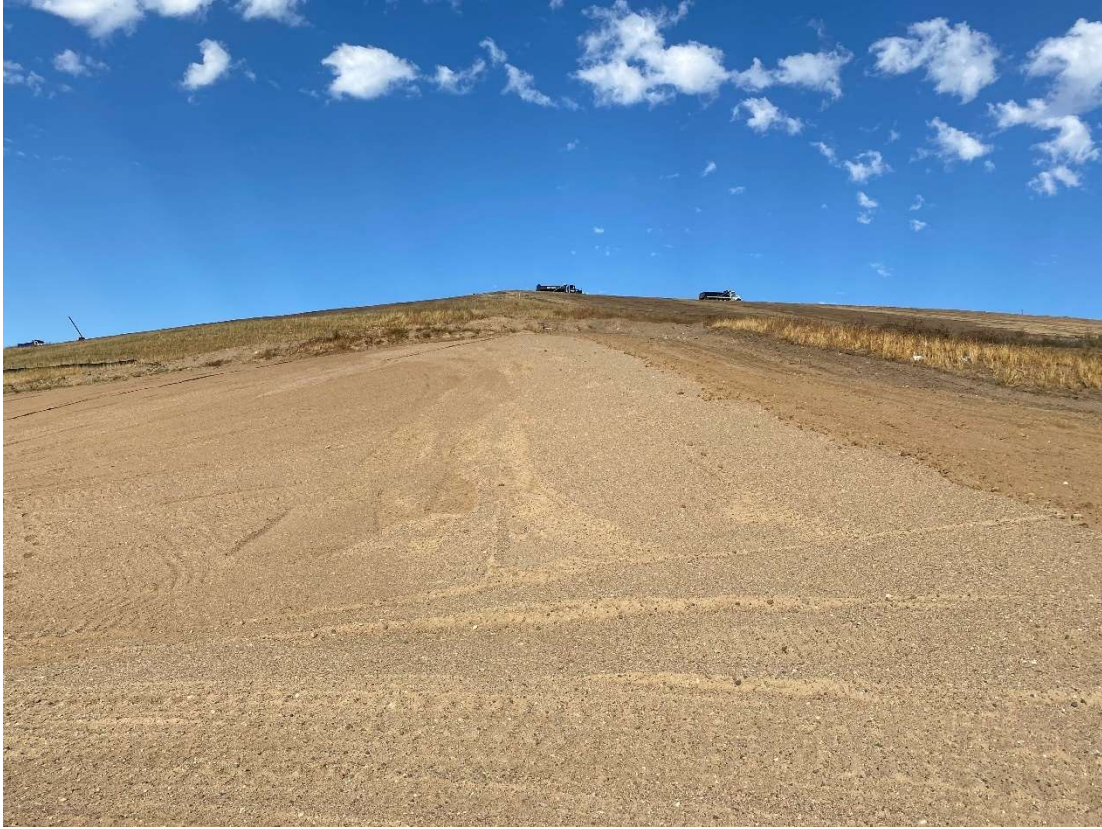
Location 6 – Cell 6, SE corner Looking northwest

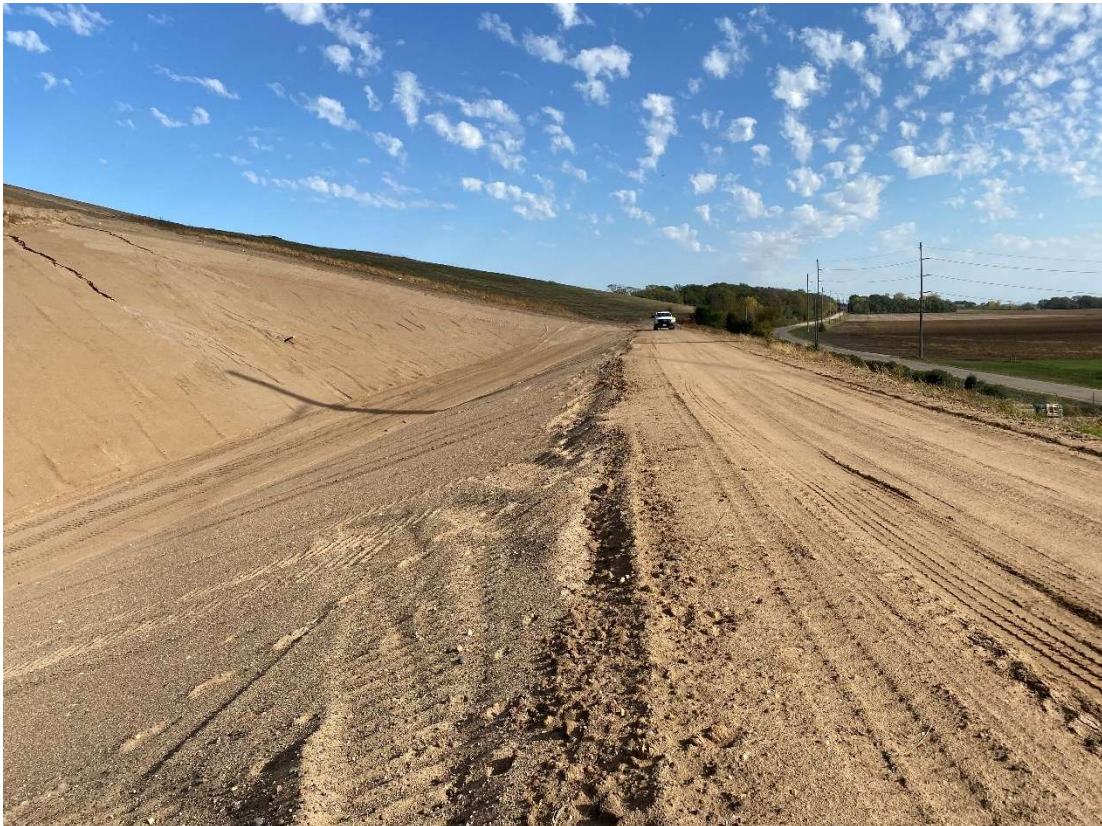
Location 7 – Cell 6, midpoint of inner berm, looking east
