To:	Geoff Strack, P.E. Waste Connections	From:	Bradley W Sullivan, P.E. Stantec Consulting Services Inc.
File:	Project #227704387	Date:	January 7, 2022

Reference: SKB Rosemount Industrial Waste Facility 2021 Annual CCR Inspection Report

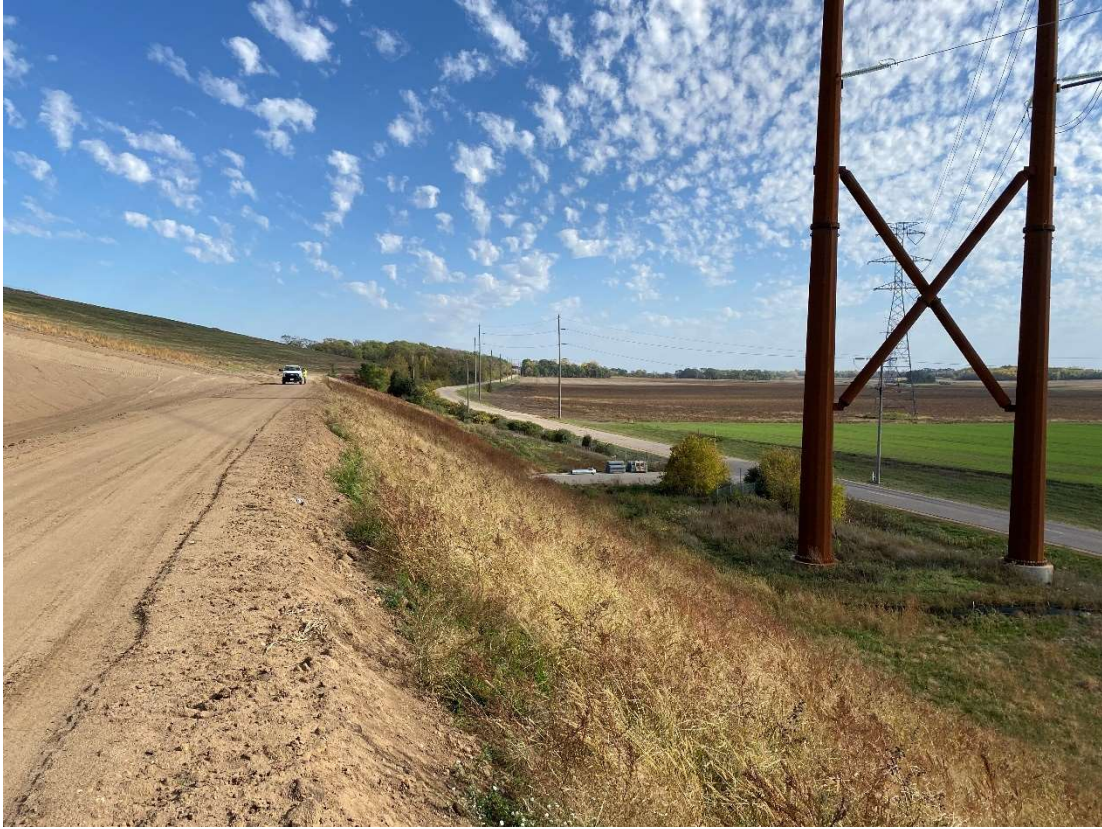
Location 7 – Cell 6, midpoint of outer berm, looking east

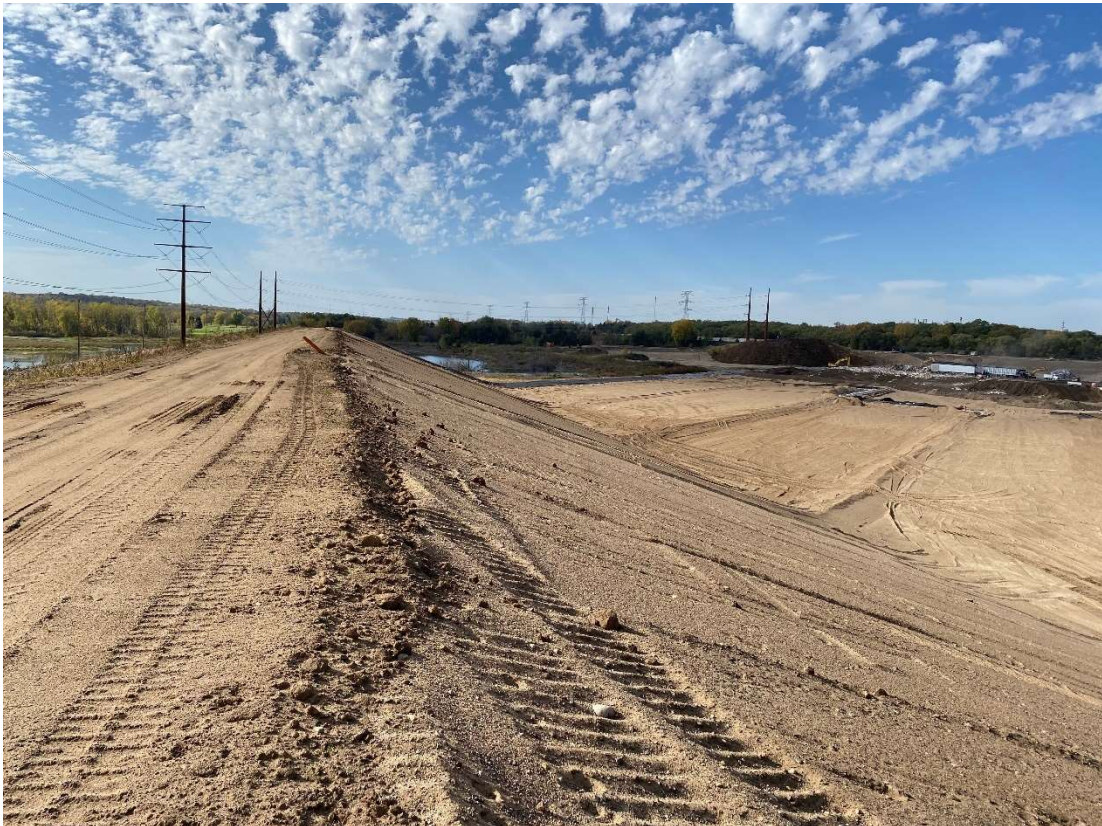
Location 7 – Cell 6, midpoint of inner berm, looking west

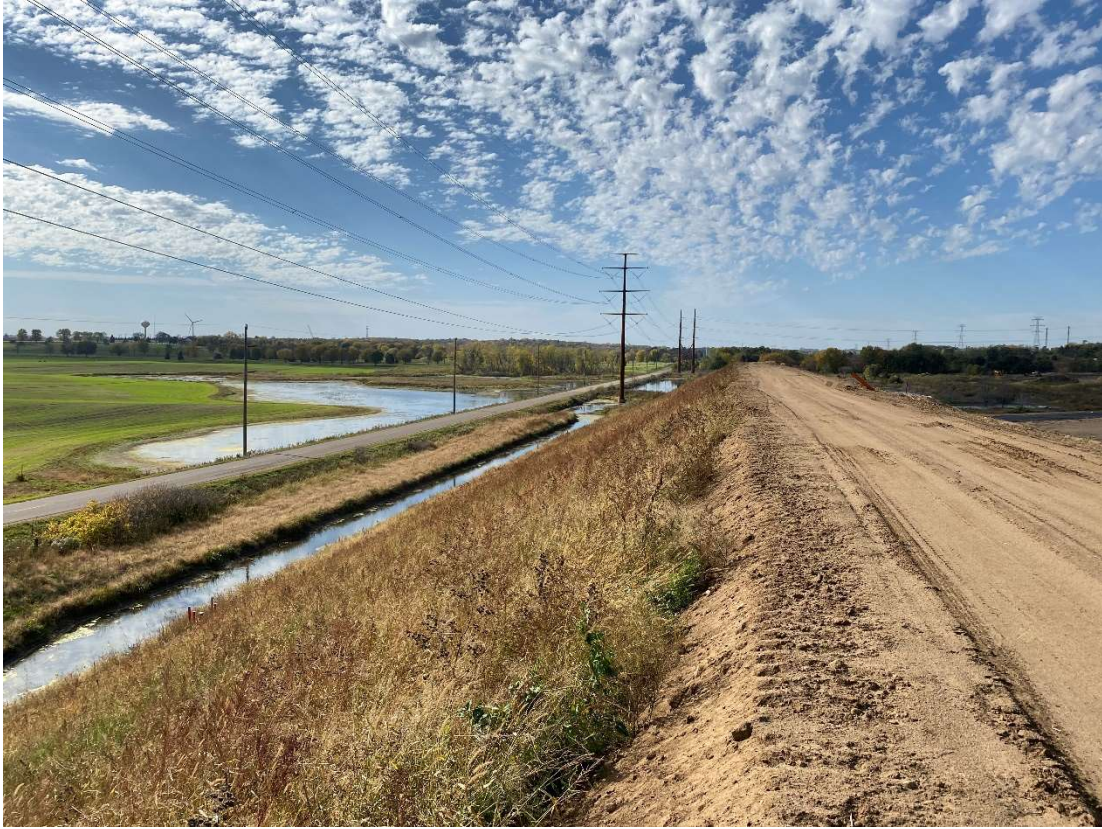
Location 7 – Cell 6, midpoint of outer berm, looking west

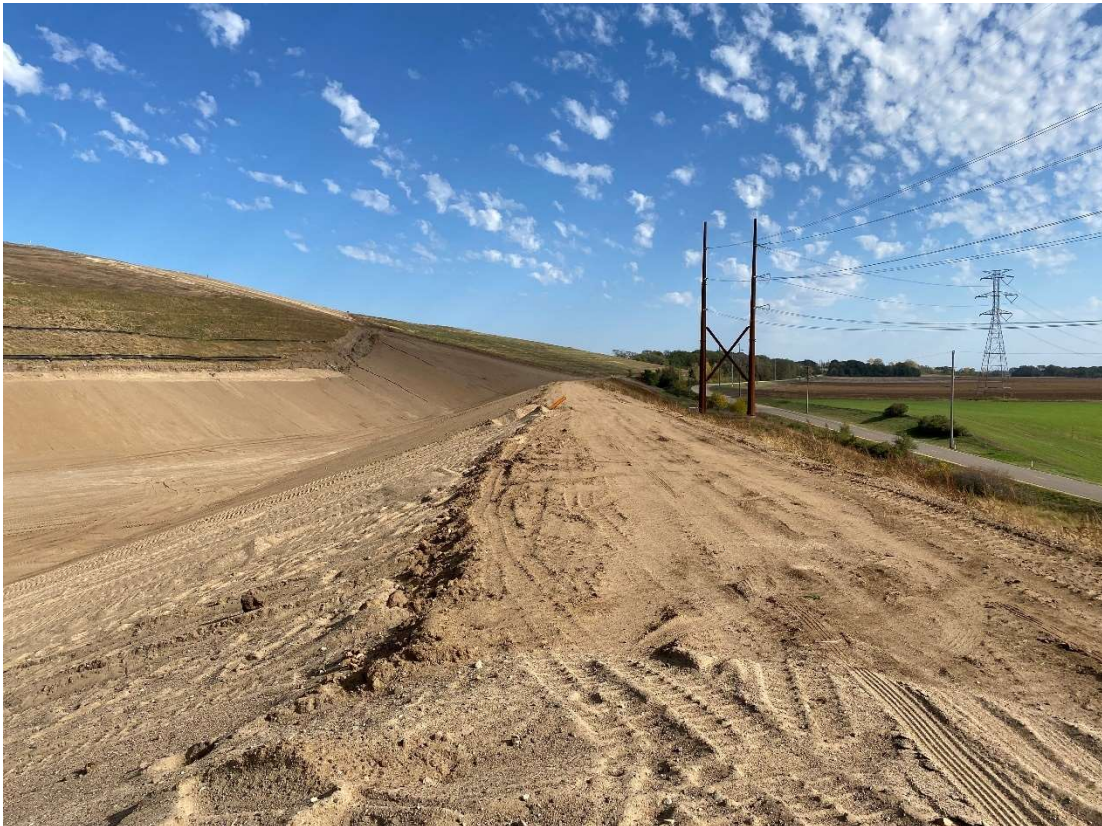
Location 8 – Cell 6, SW corner inner berm, looking east

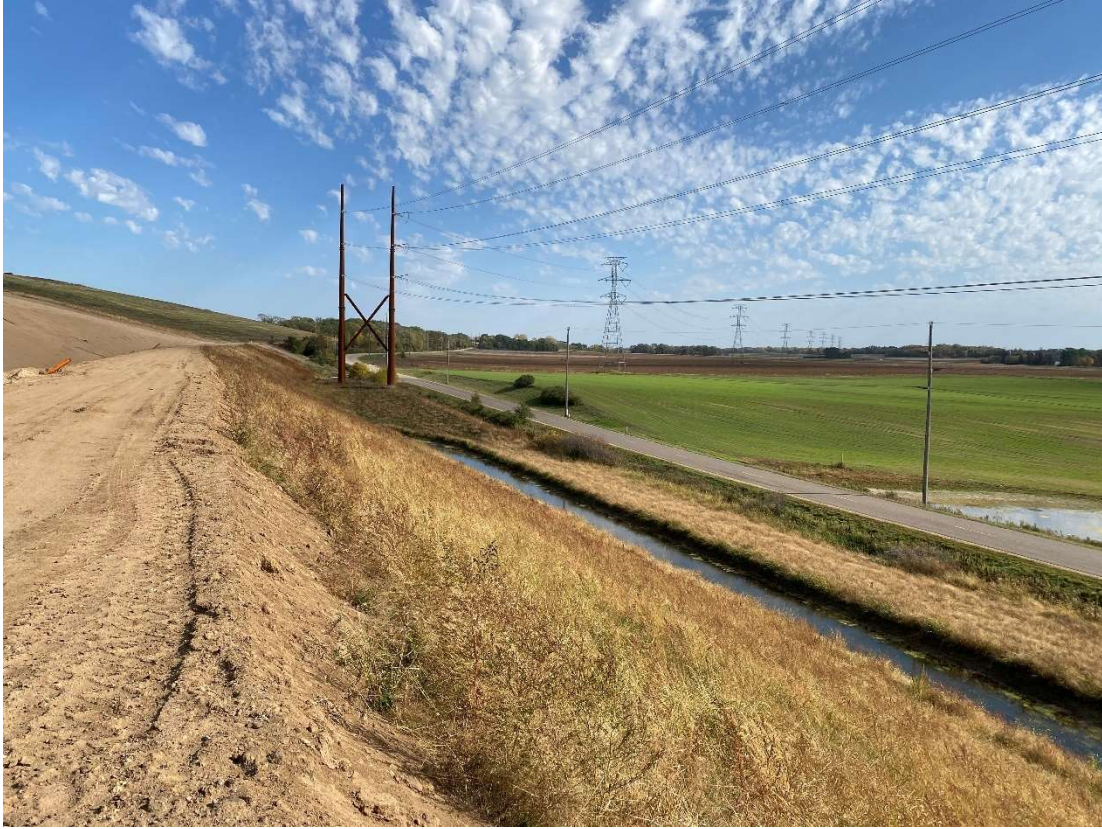
Location 8 – Cell 6, SW corner outer berm, looking east

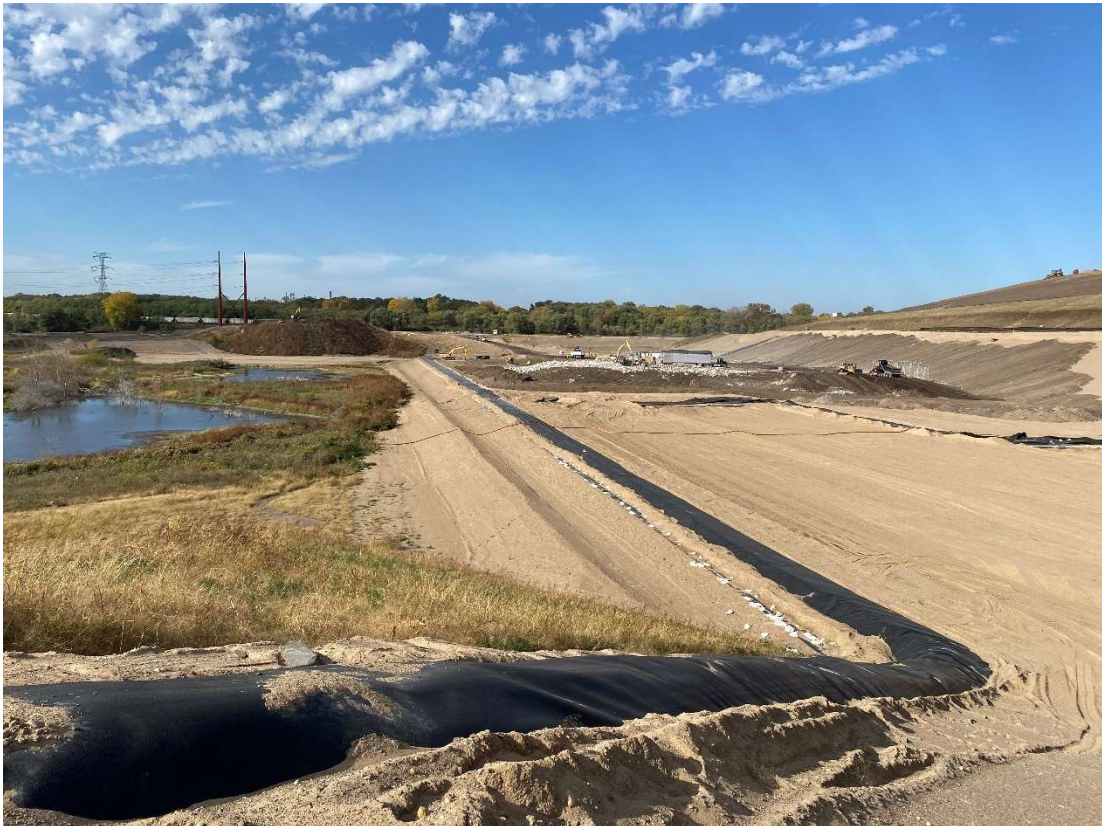
Location 8 – Cell 6, SW corner inner berm, looking west

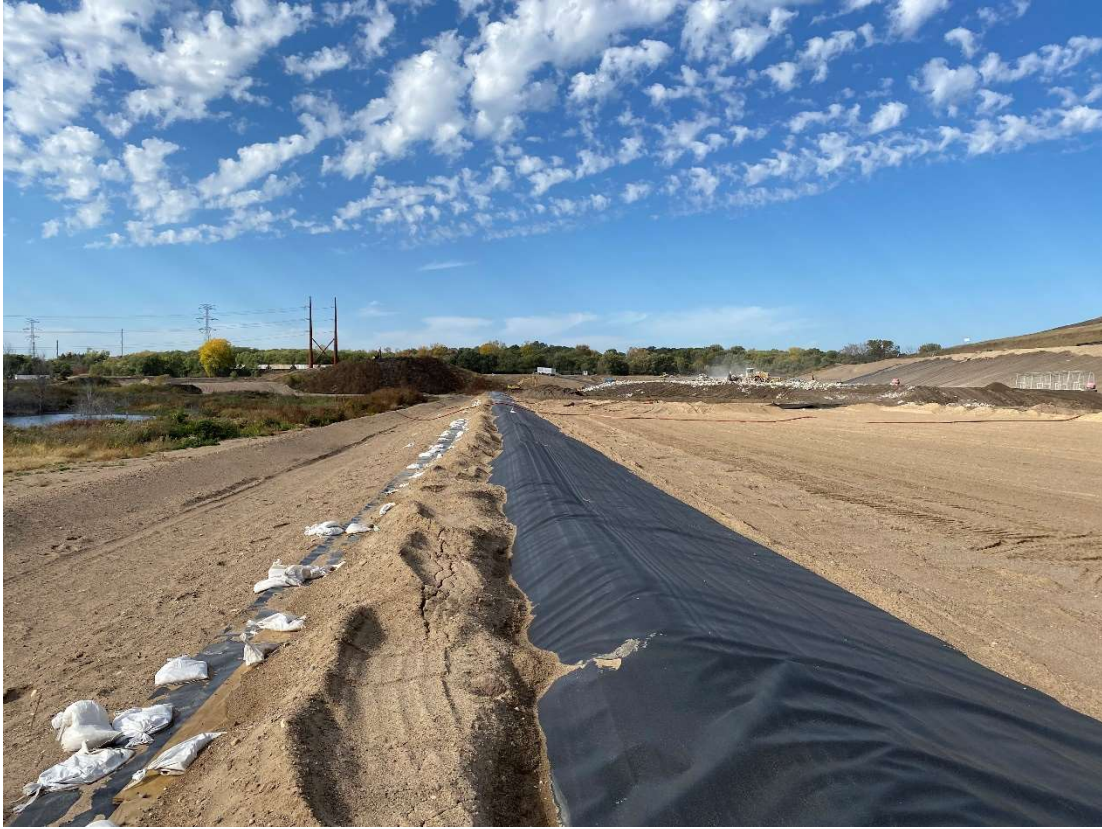
Location 9 – Cell 6, looking northwest

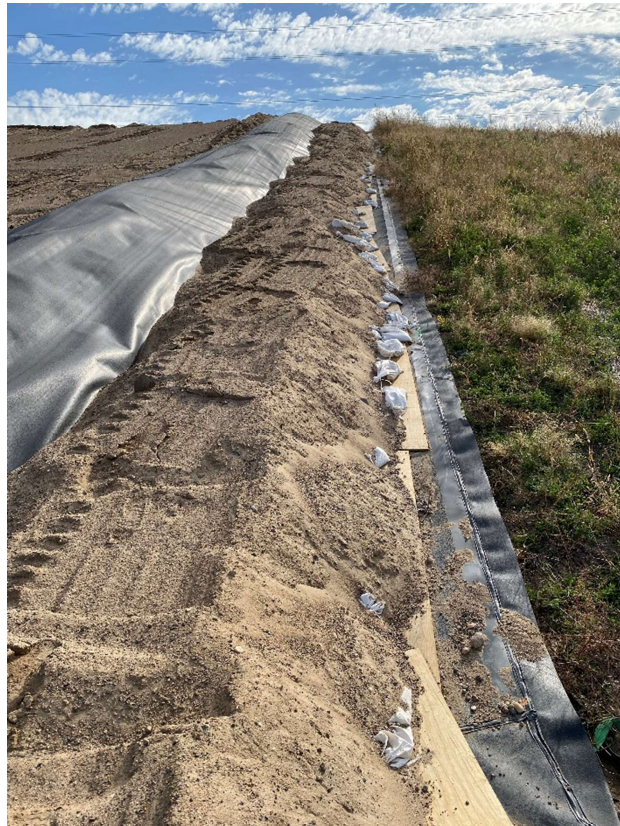
Location 9 – Cell 6, looking south

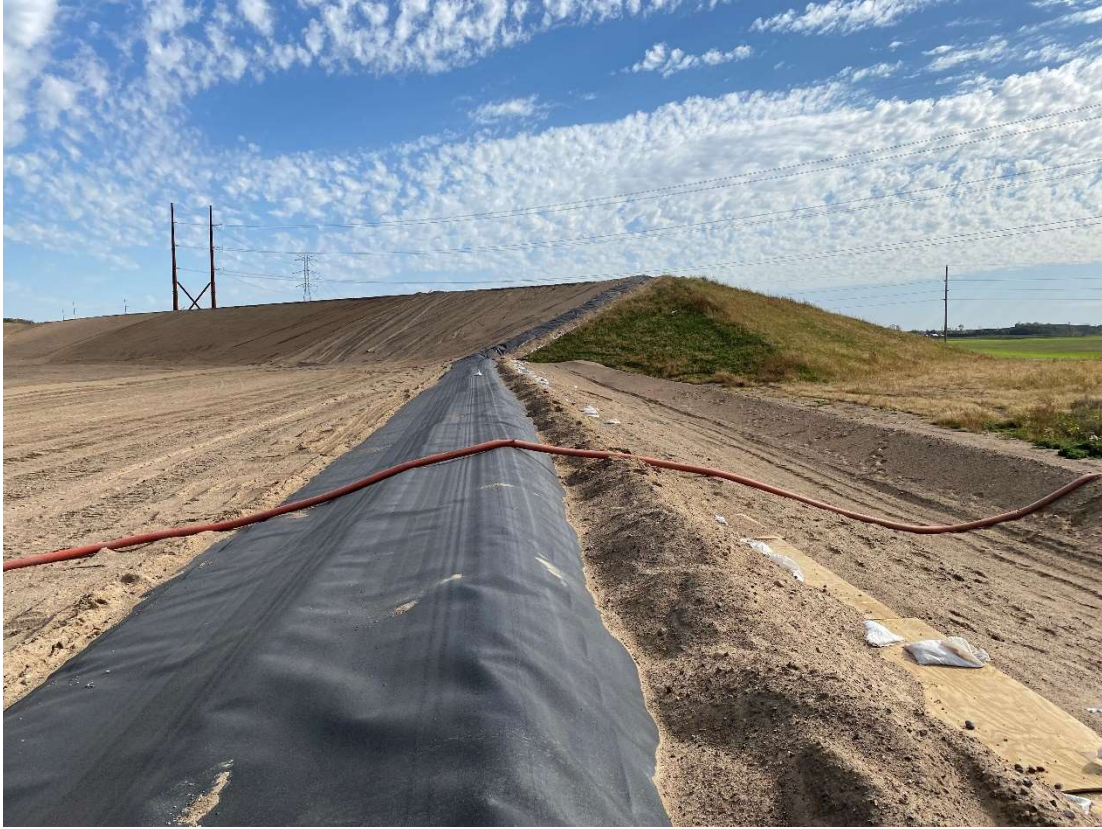
Location 10 – Cell 6, SW limit at midpoint, looking southeast

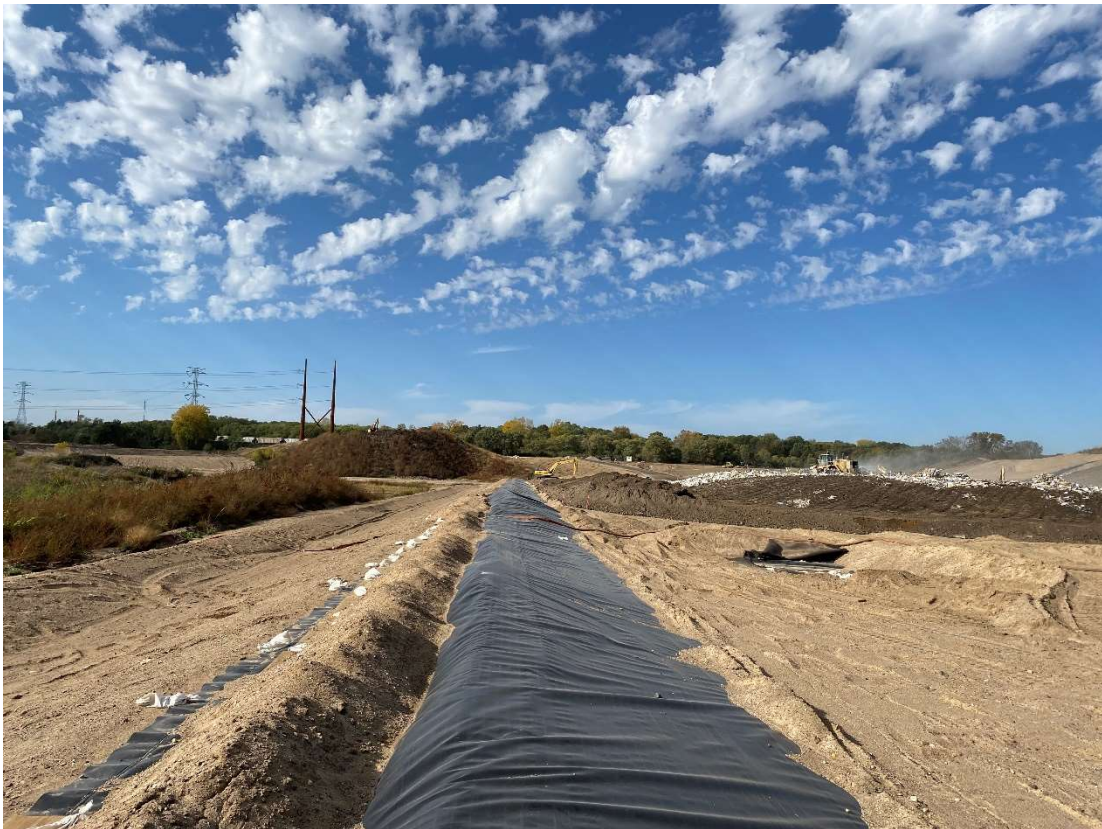
Location 10 – Cell 6, SW limit at midpoint, looking northwest

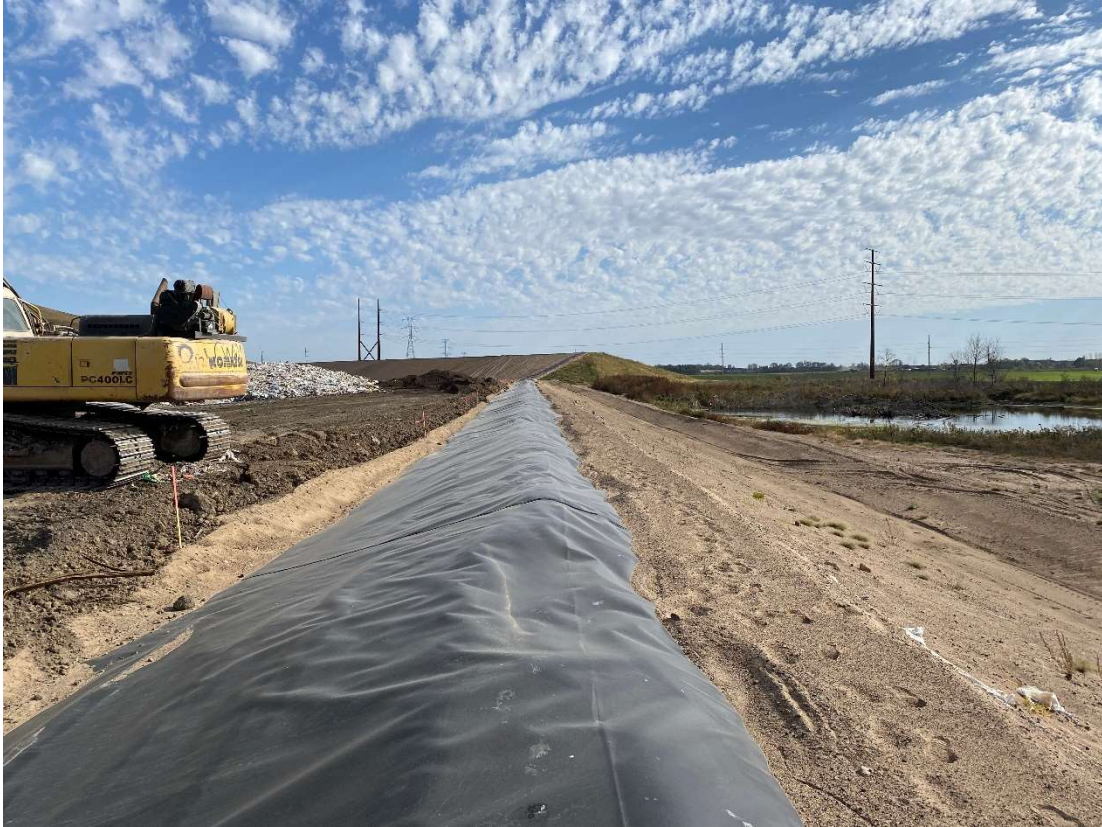
Location 11 – Cell 6, SW corner, looking southeast

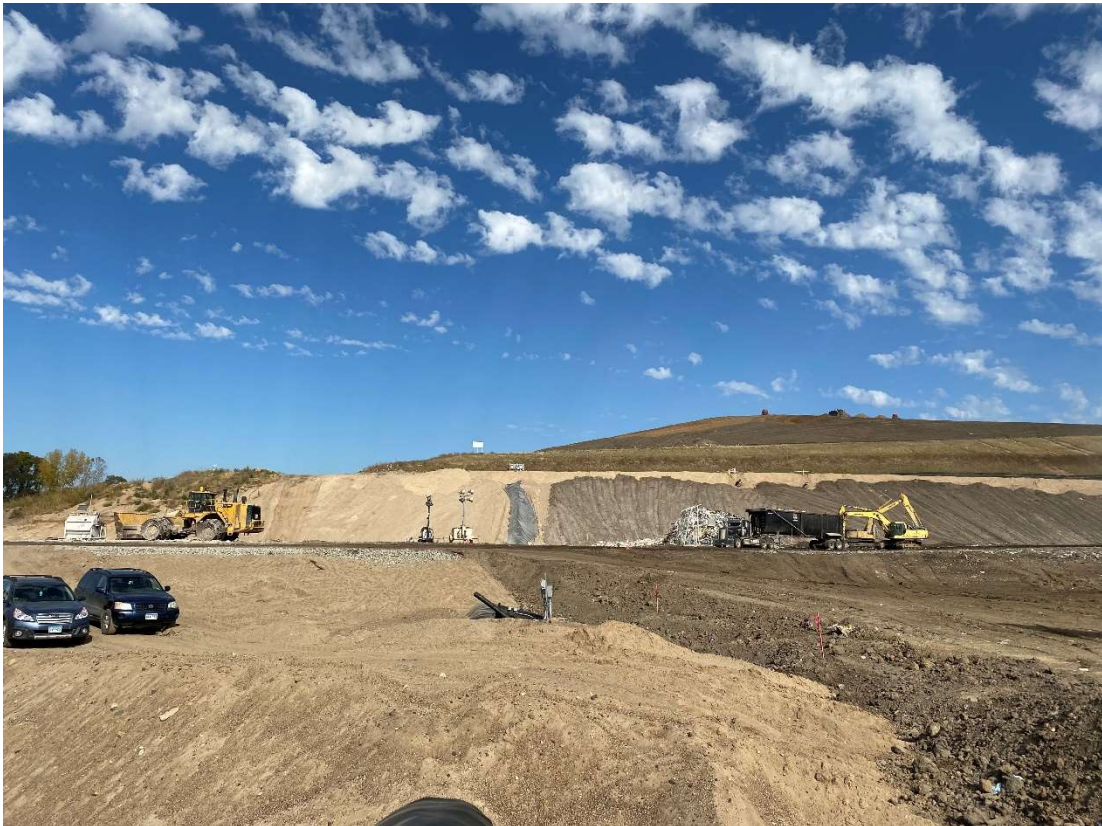
Location 11 – Cell 6, SW corner, looking northeast

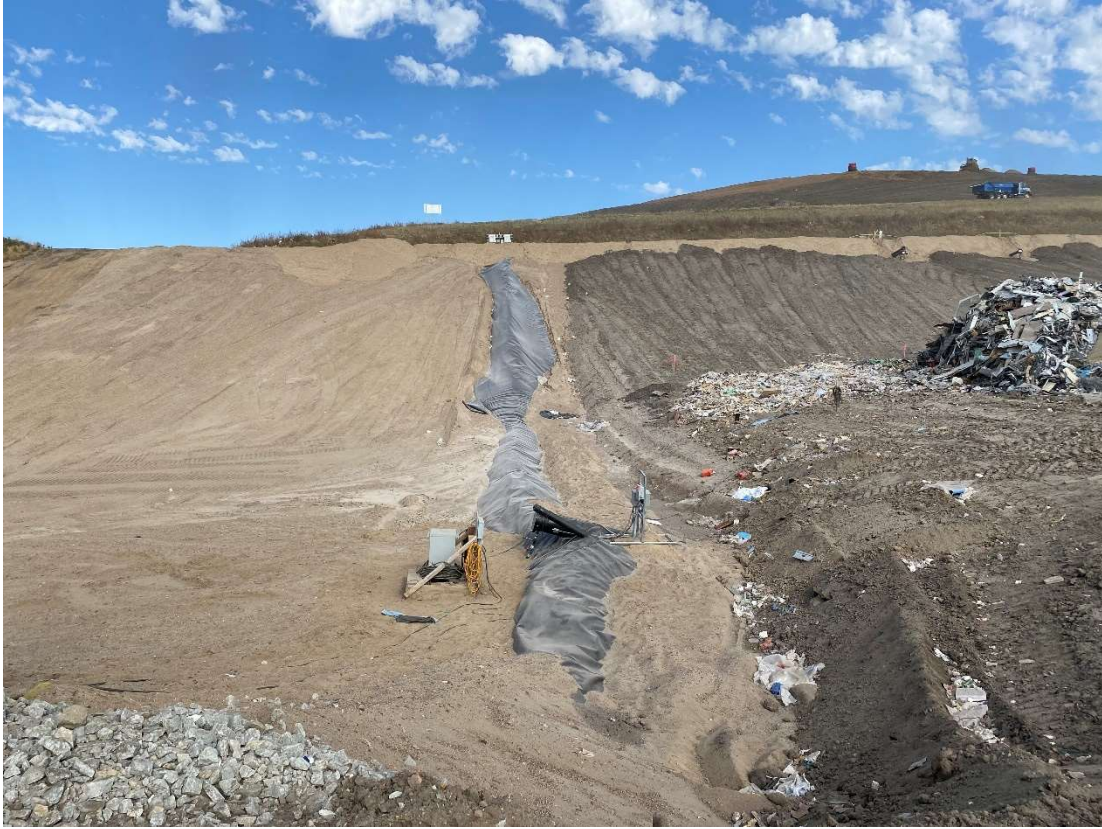
Location 12 – Cell 6, midpoint of NW limit, looking northeast

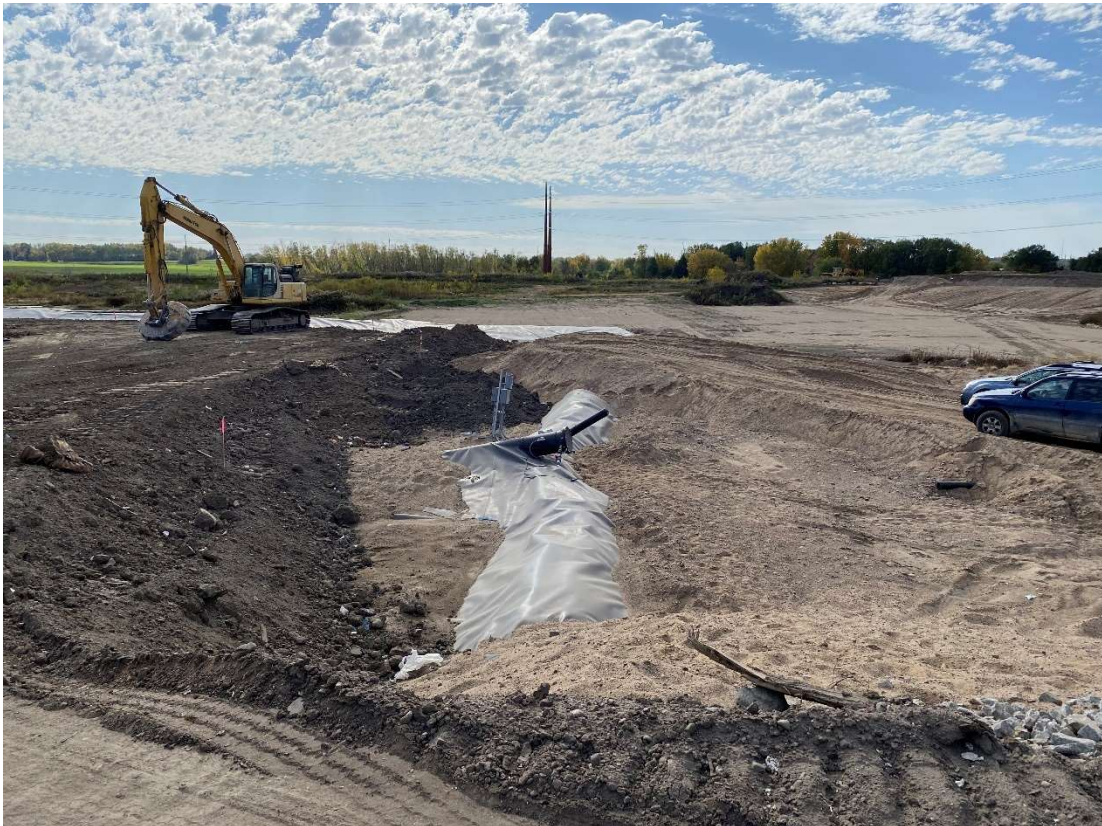
Location 12 – Cell 6, midpoint of NW limit, looking southwest

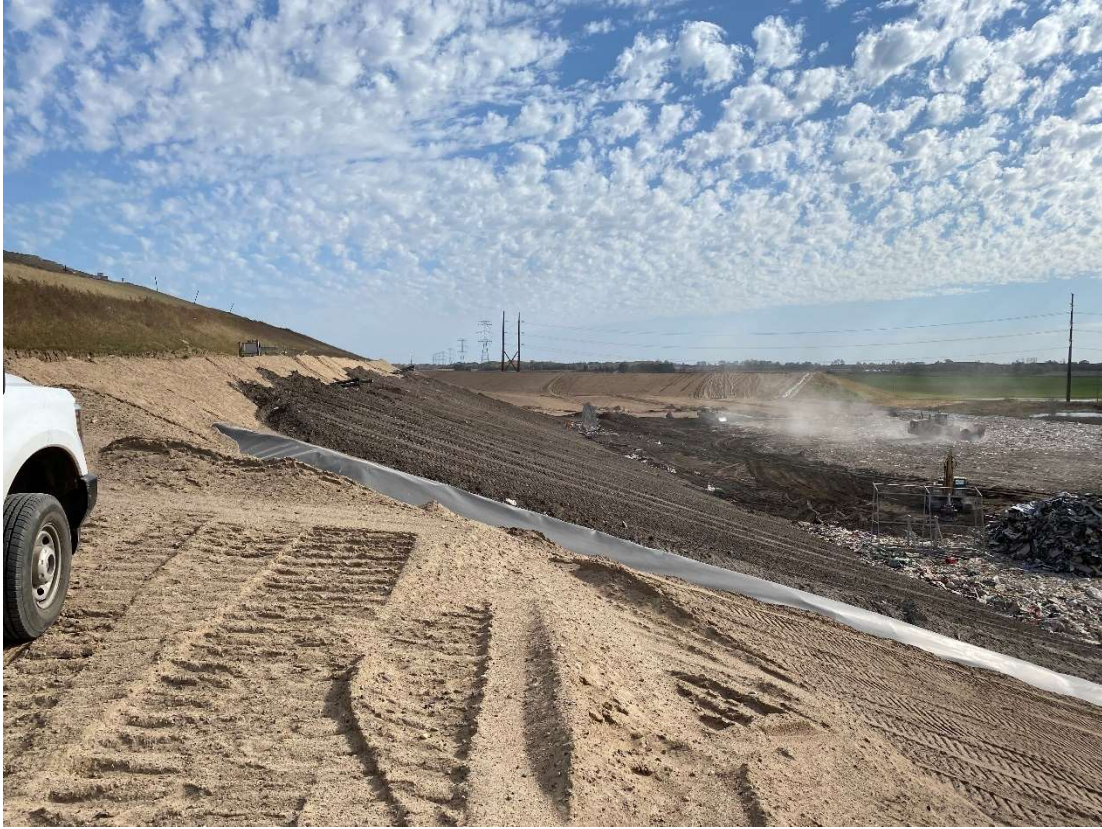
Location 13 – Looking Southeast, Cell 2A Southwestern Berm and into Cell 6

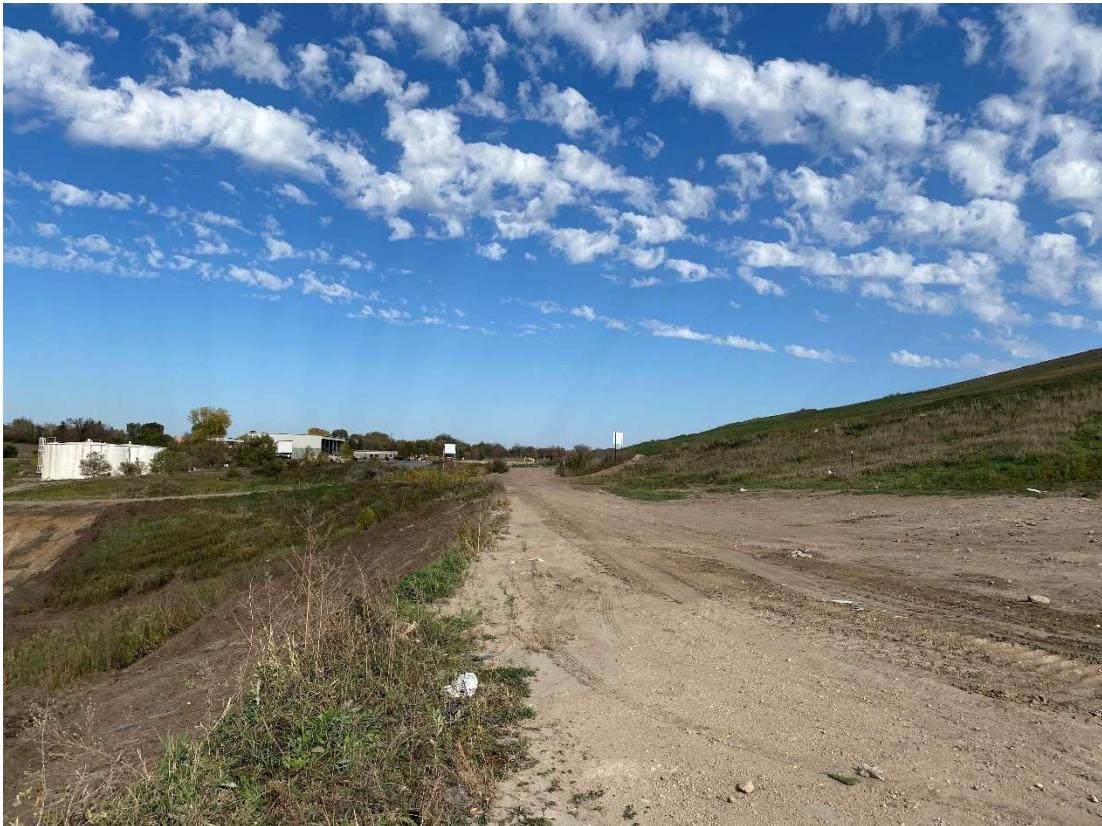
Location 13 – Looking Northeast, Cell 2A Northwestern Berm

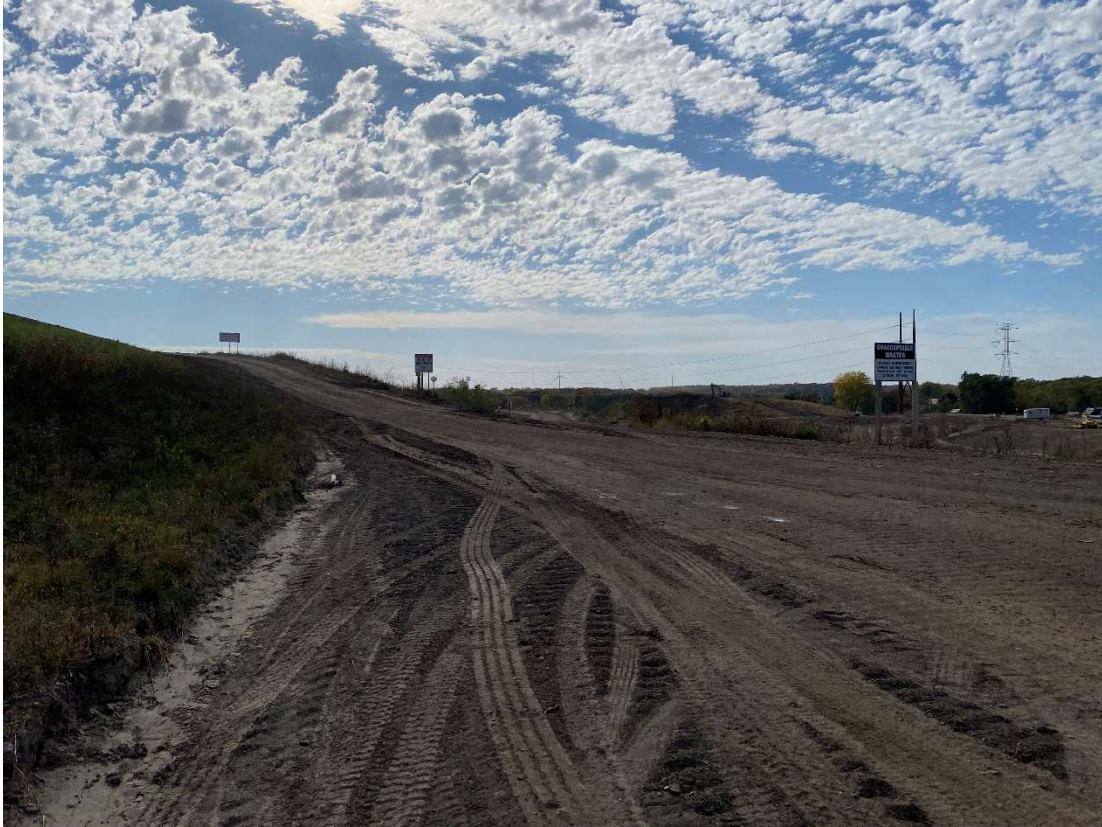
Location 14 – Looking Southwest, Cell 2A Northwestern Waste Slope and Anchor Trench

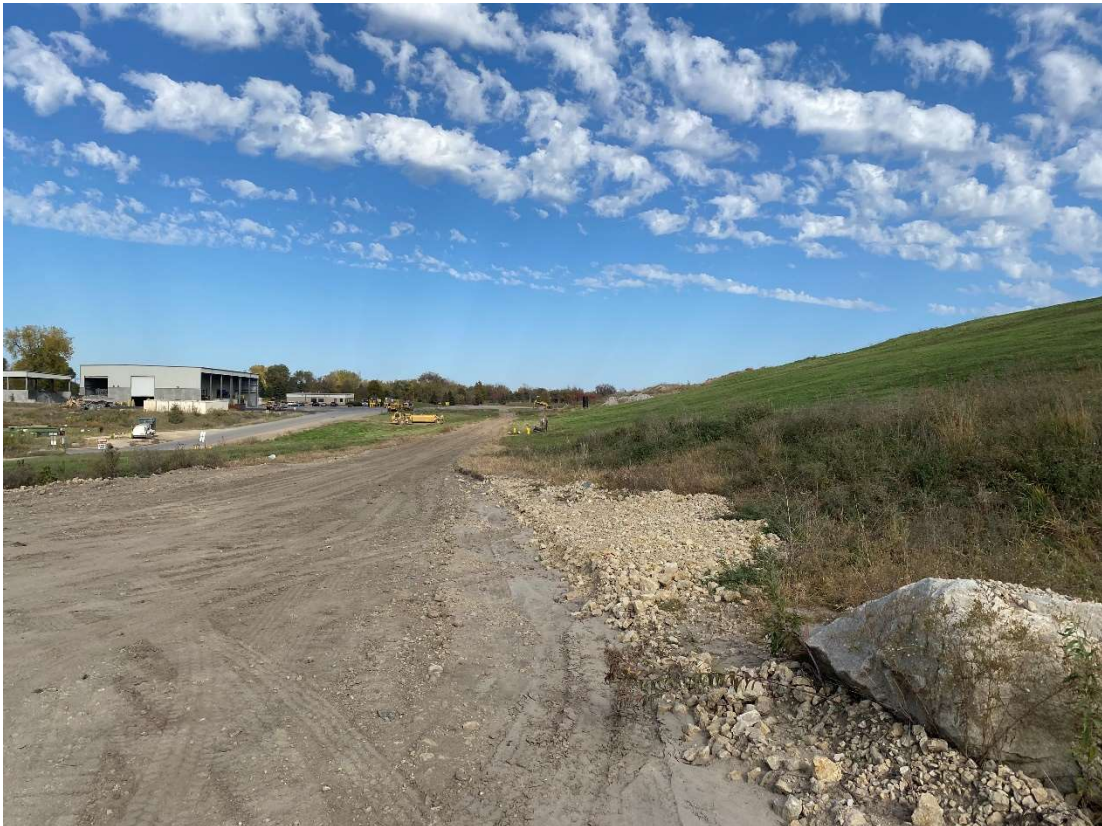
Location 14 – Looking Northeast, Cell 1 Northwestern Waste Slope

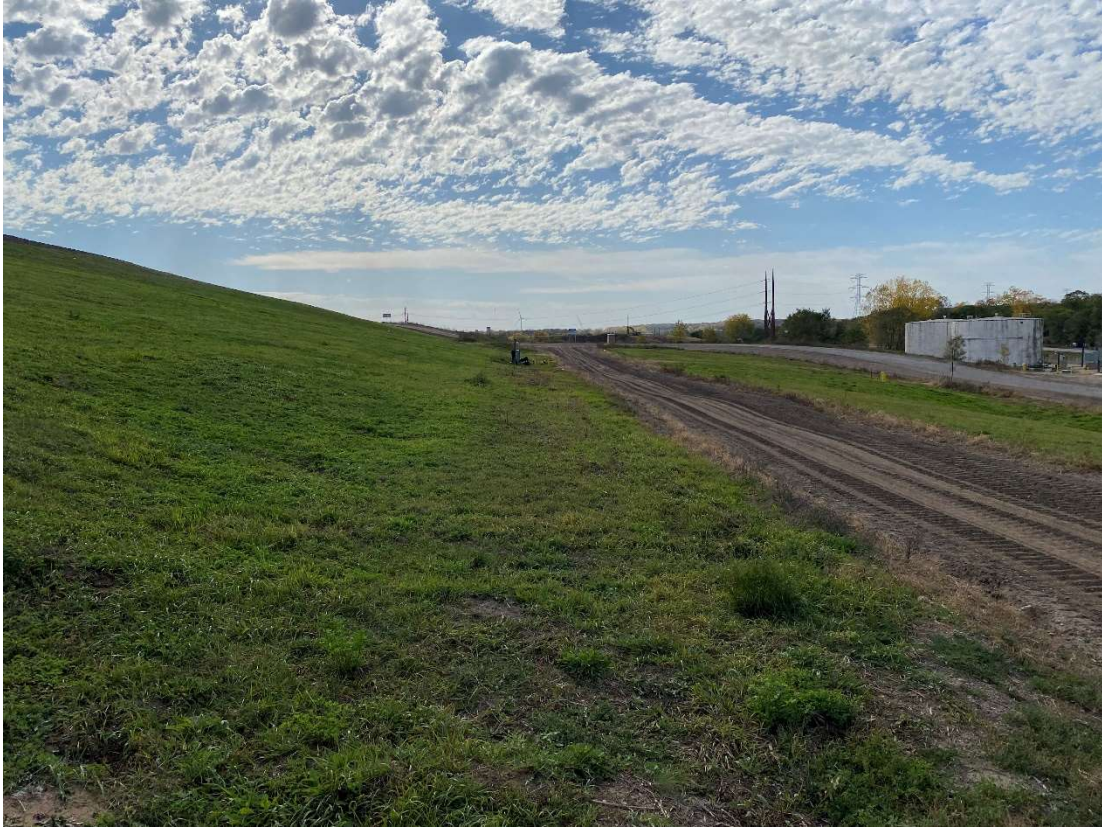
Location 15 – Looking Southwest, Cell 1 Toe of Waste Slope

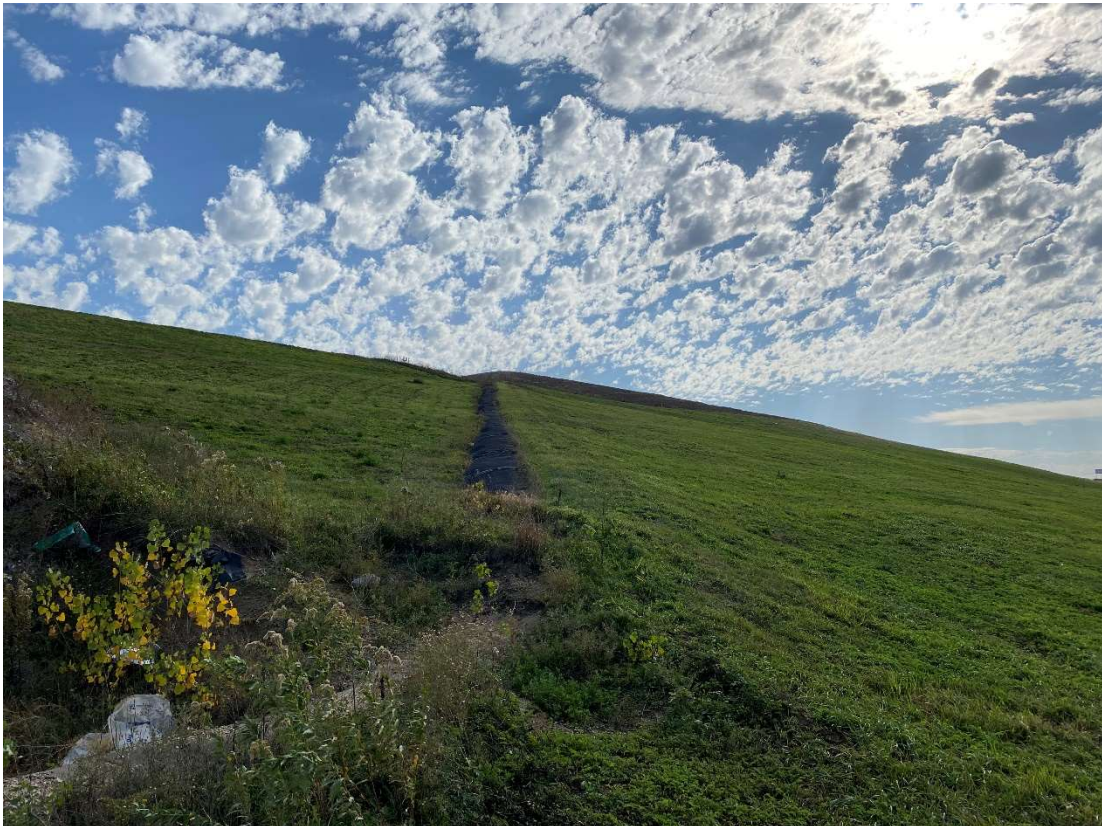
Location 15 – Looking South, Edge of Cap over Cell 1
