To:	Geoff Strack, P.E. Waste Connections	From:	Brad Sullivan, P.E., Stantec
File:	227704387	Date:	January 7, 2023

**Reference: SKB Rosemount Industrial Waste Facility 2022 Annual CCR Inspection Report**

PROJECT TITLE  
 2022 CCR INSPECTION REPORT

SKB ROSEMOUNT LANDFILL  
 ROSEMOUNT, MINNESOTA

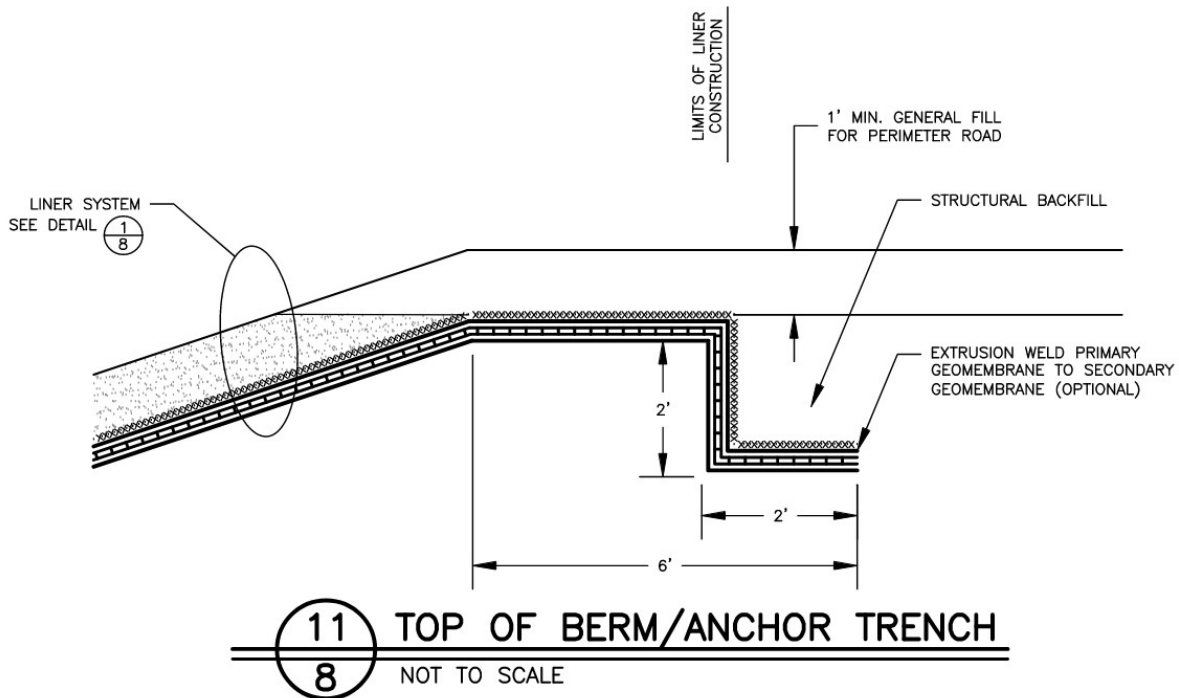
In general, most of the facility's landfill cell embankments were constructed using granular borrow material, which consisted of silty clay and clayey sand type soils. The fill was placed and compacted to 95% of Standard Proctor Dry Density in lift thicknesses ranging from 8 inches to 12 inches. The final subgrade surface was proof rolled prior to geosynthetics installation. The landfill lining systems varies from cell to cell, but all meet the requirements of CFR 257.70. A typical perimeter section from the 2021 Cell 6 Construction Drawings prepared by Tetra-Tech dated February 2021 is shown below.

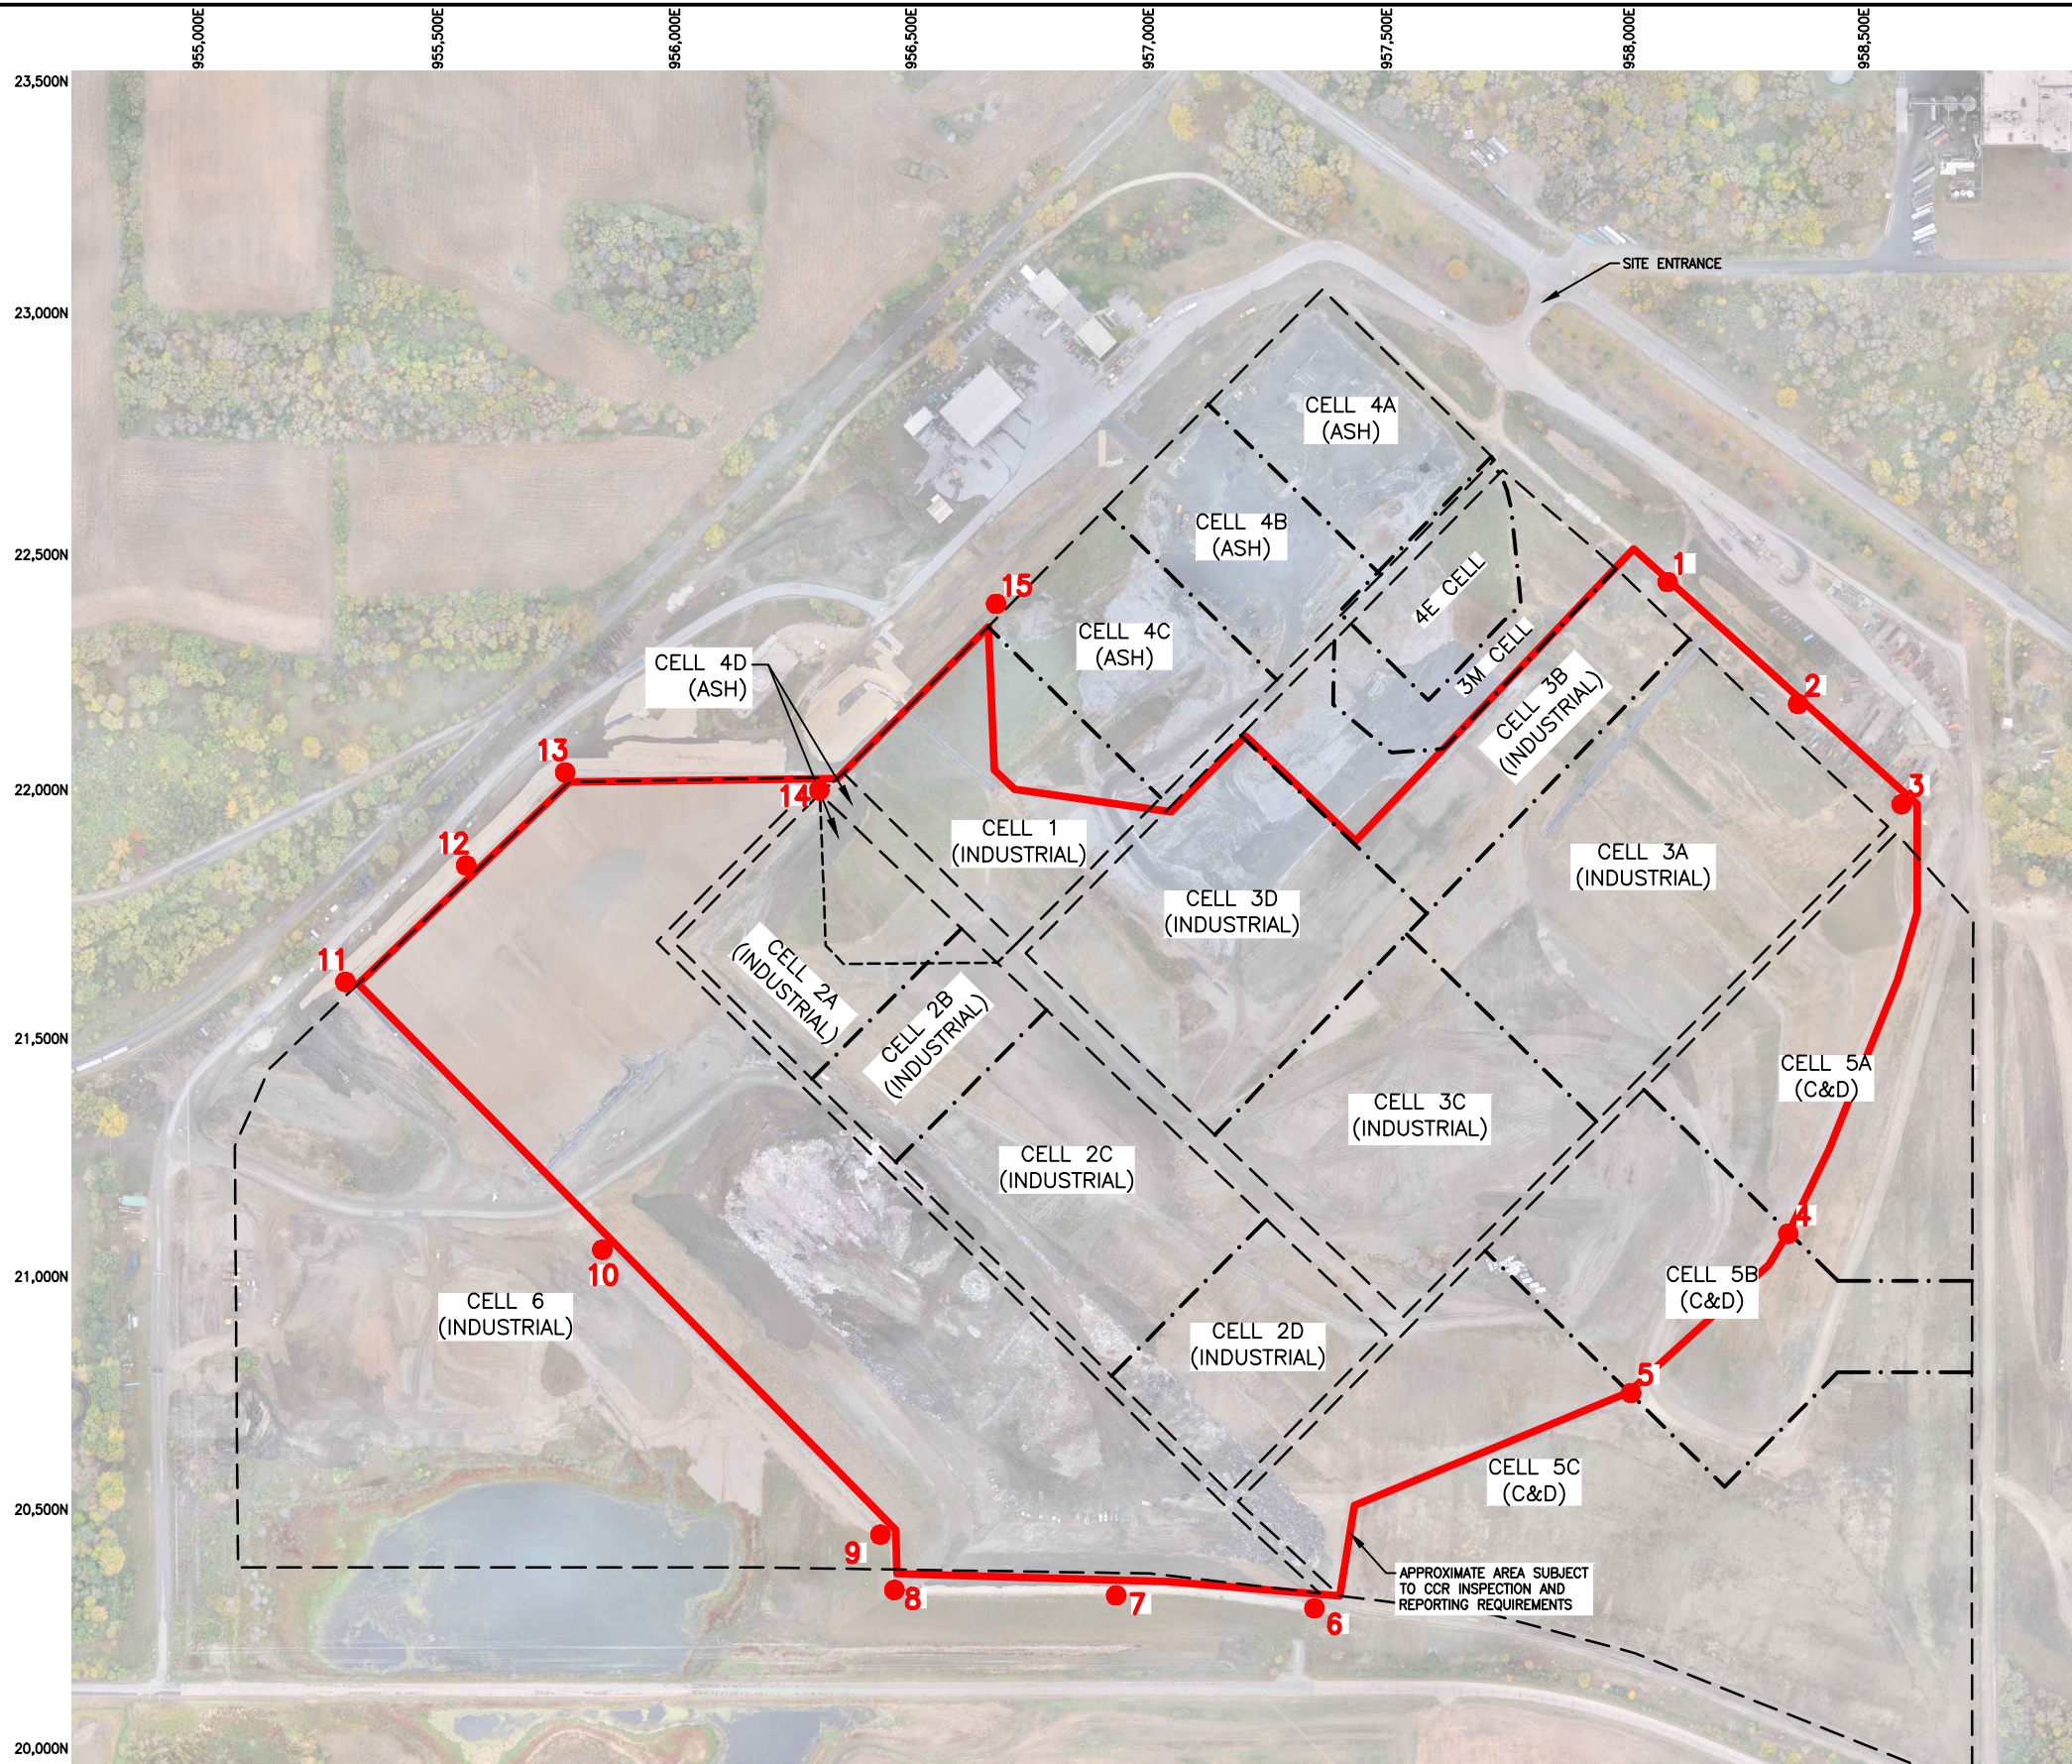
DWN BY JVB	CHK'D TJS	APP'D BWS	DWG DATE JAN. 2023
PROJECT NO. 227704387	SHEET NO. FIGURE 1	SCALE AS NOTED	REV NO. 0

Photos of the landfill embankments and waste slopes were taken during the inspection. Figure 1 presents the photo locations, and Attachment 1 contains a photo log from the inspections.

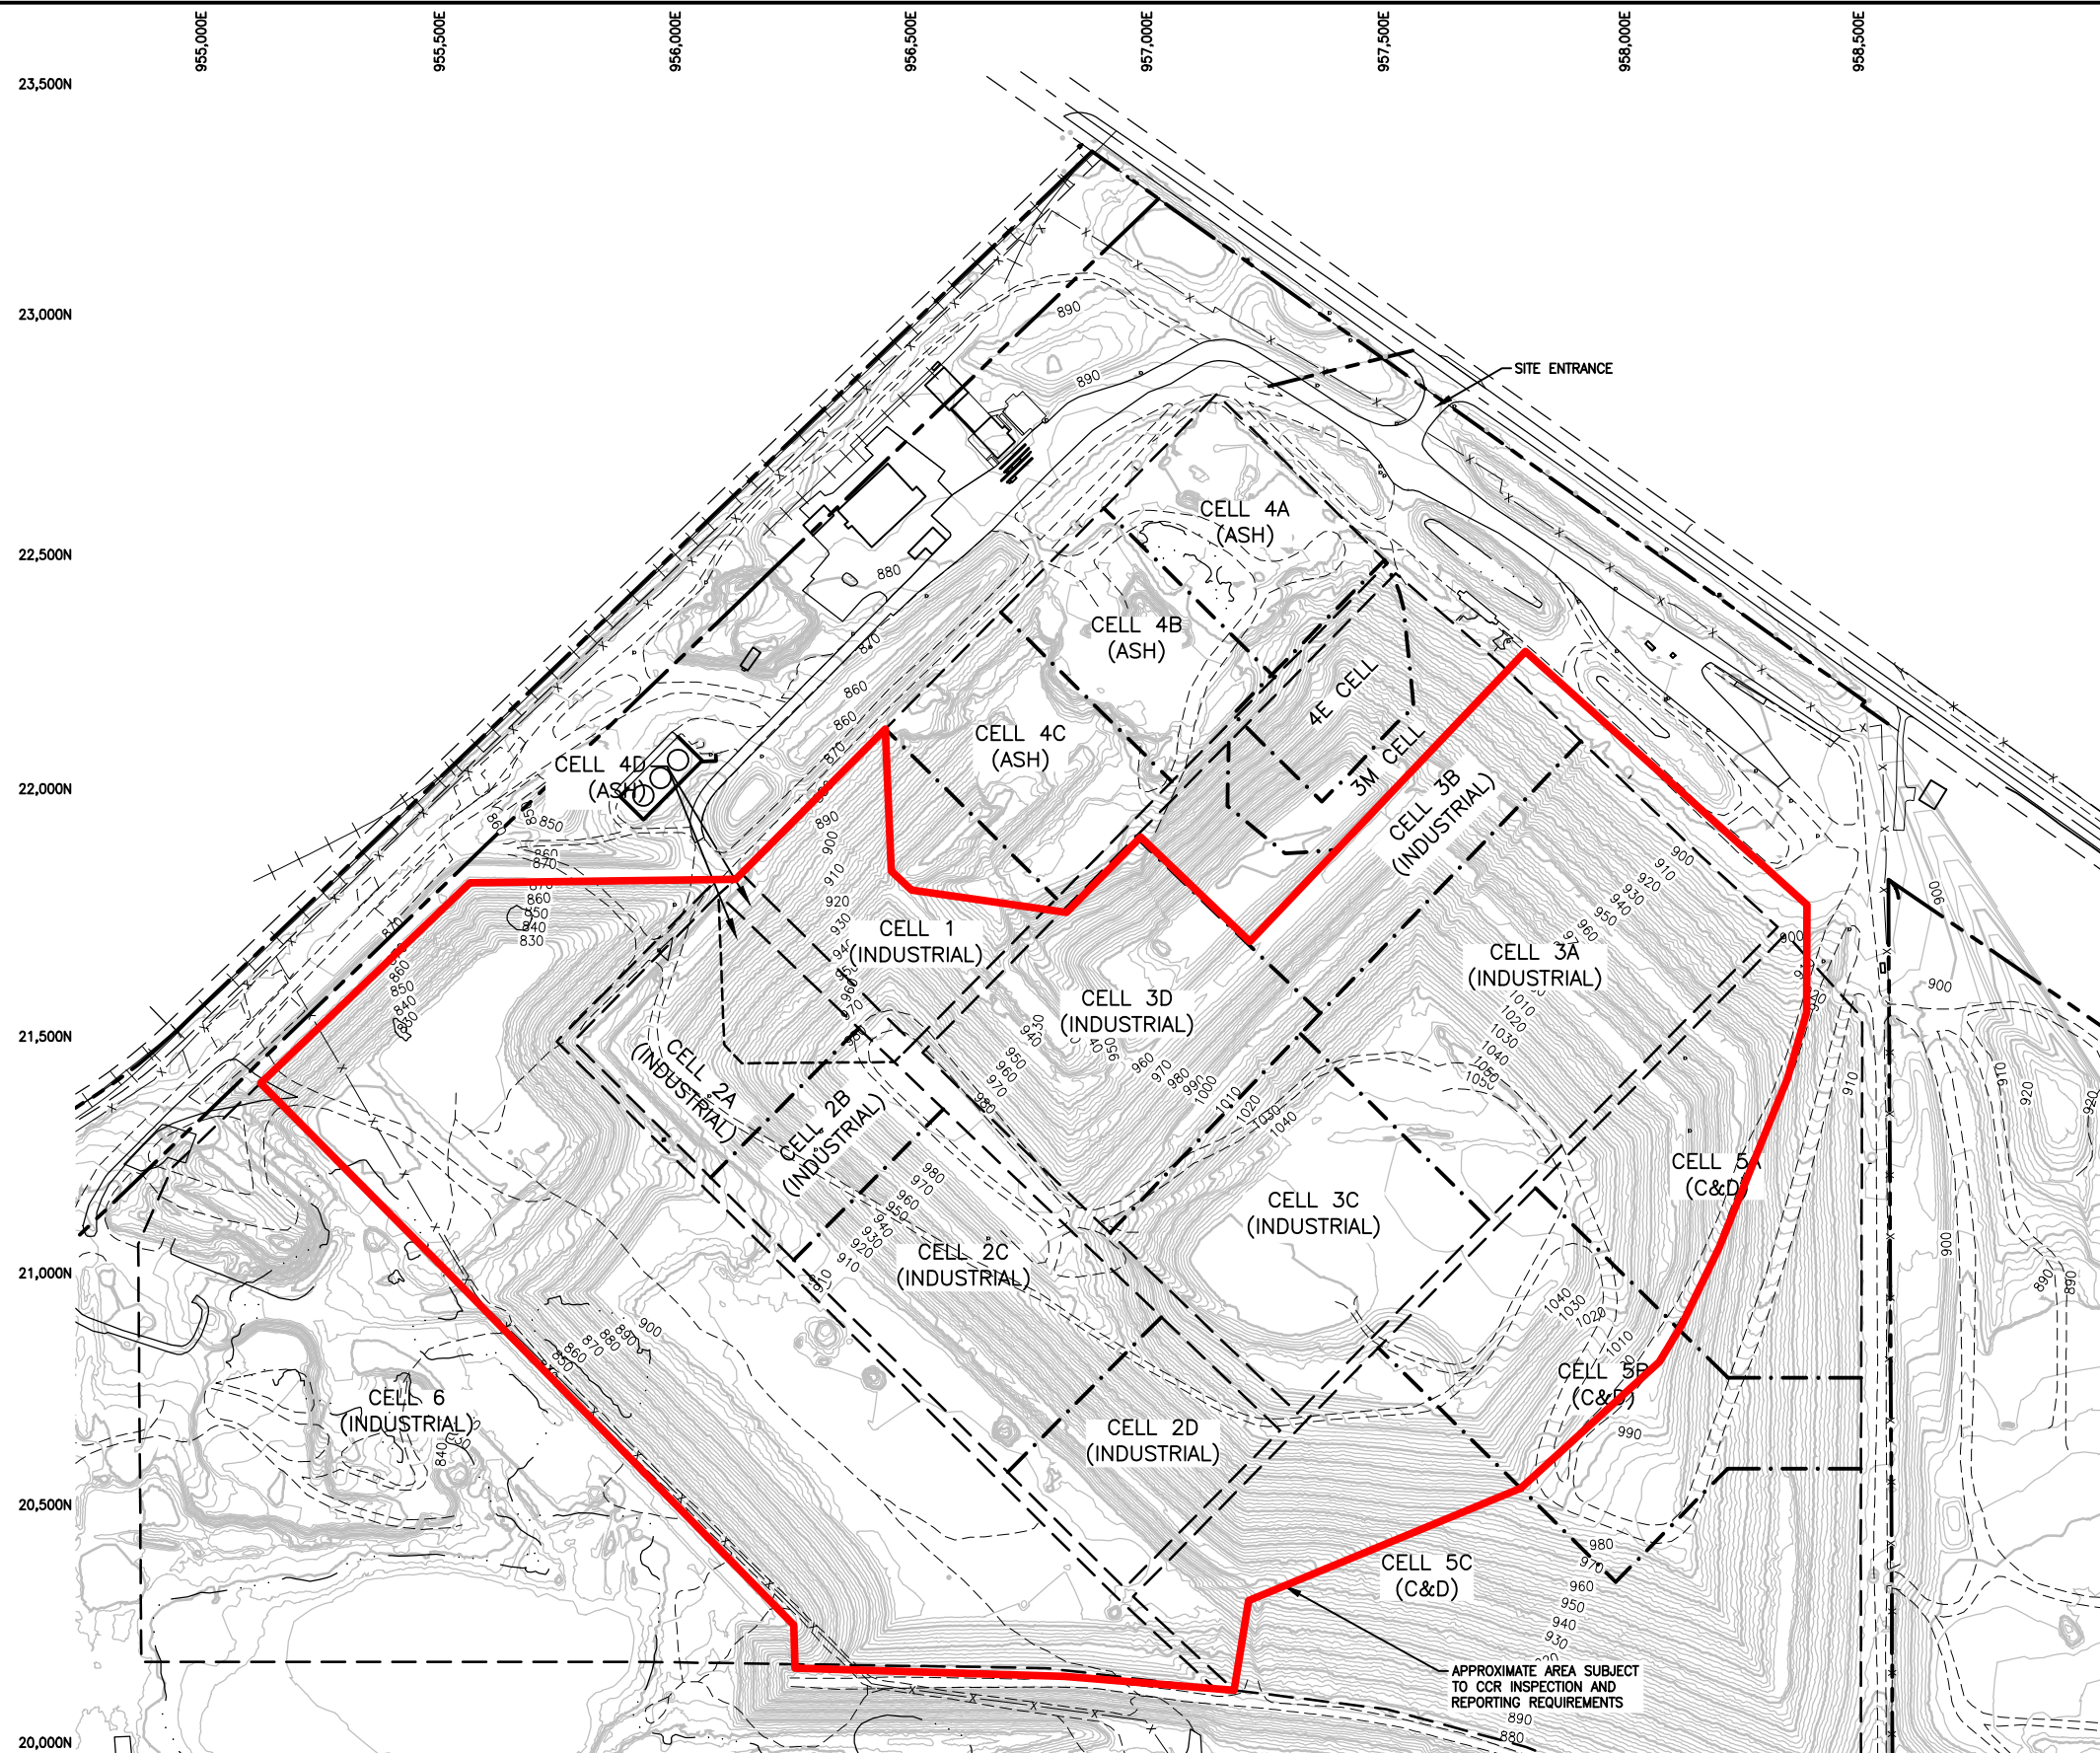
SHEET TITLE			
<b>SITE MAP</b>			
DWN BY	CHK'D	APP'D	DWG DATE
JVB	TJS	BWS	JAN. 2023
SCALE			AS NOTED
PROJECT NO.	SHEET NO.	REV NO.	
227704387	FIGURE 2	0

The annual aerial photogrammetry survey was performed on October 13, 2022, which the estimated in-place volume of total waste (including all accepted wastes) is based on. A comparison of the 2022 and 2021 aerial surveys confirm that the embankment and slope topography is substantially unchanged with no significant movement. The 2022 aerial survey is included as Figure 2.

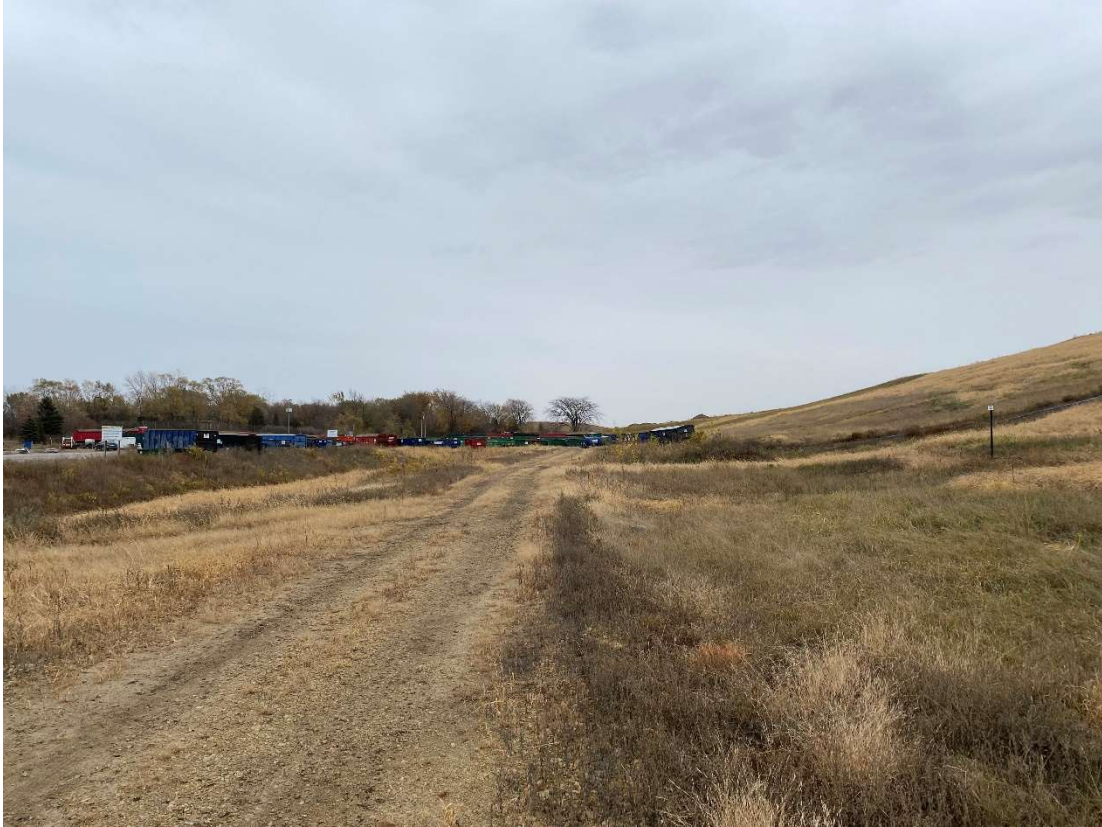
Location 1 – Looking Southeast, Cell 3A & 3B Waste Slope & Anchor Trench

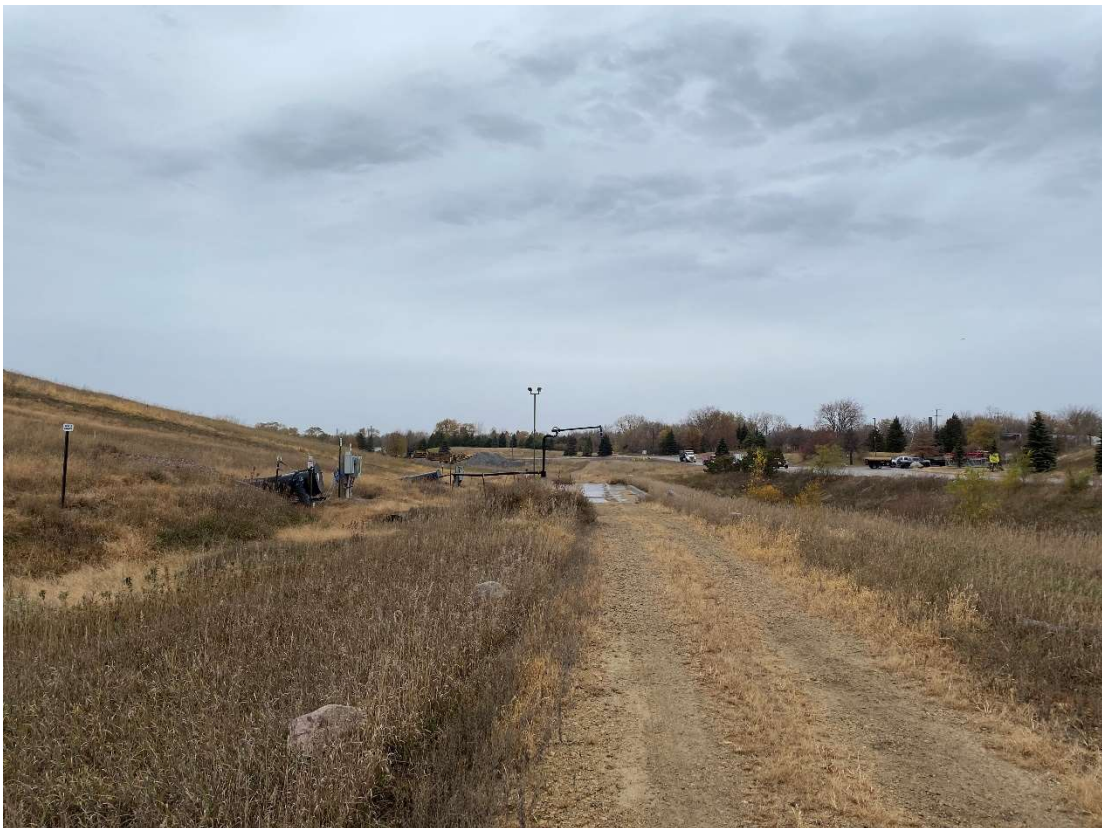
Location 1 – Looking Northwest, Cell 3 Berm

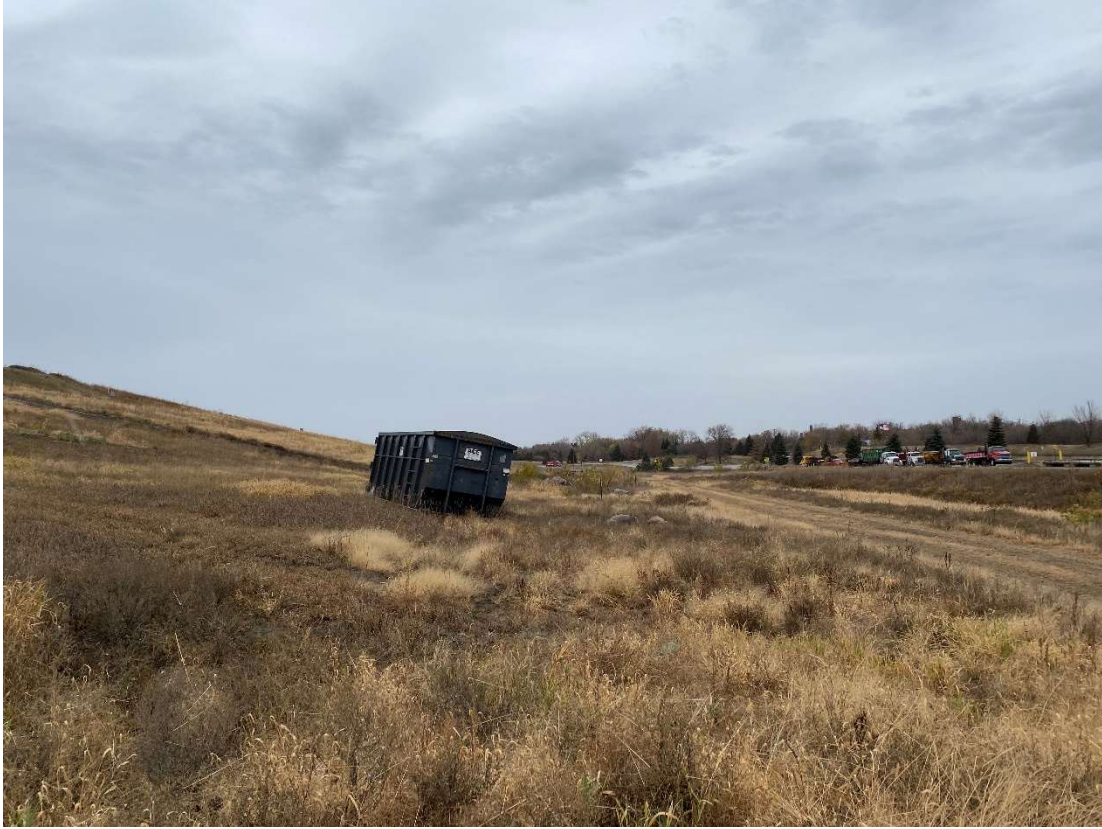
Location 2 – Looking Northwest, Cell 3 Berm & Stormwater Pond

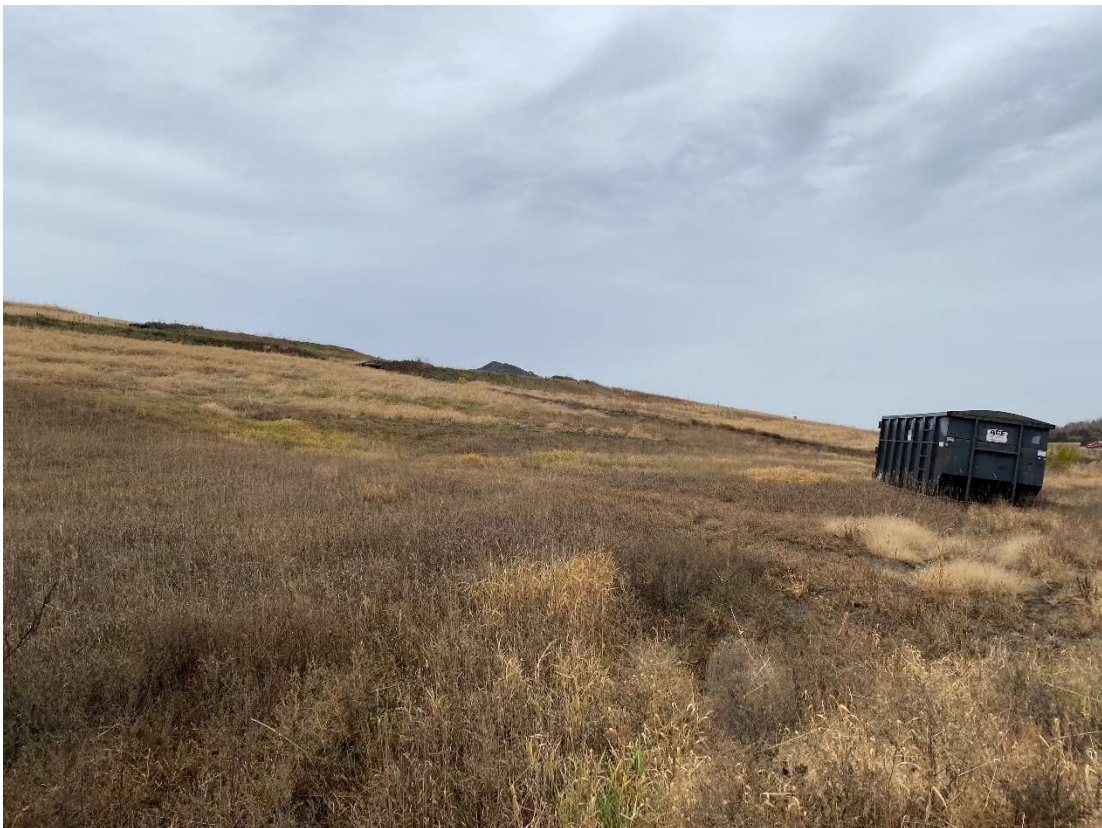
Location 2 – Looking Northwest, Cell 3 Anchor Trench and Waste Slope

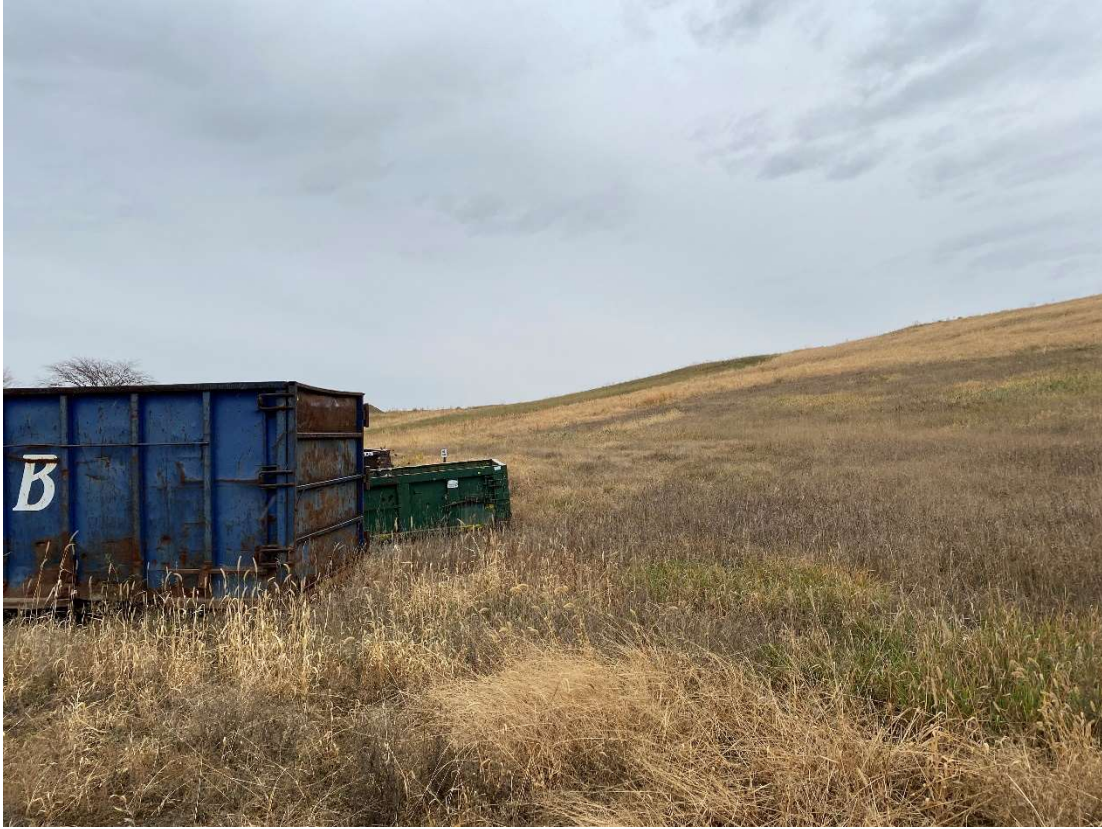
Location 2 – Looking Southeast, Phase 3A Anchor Trench and Northeastern Waste Slope

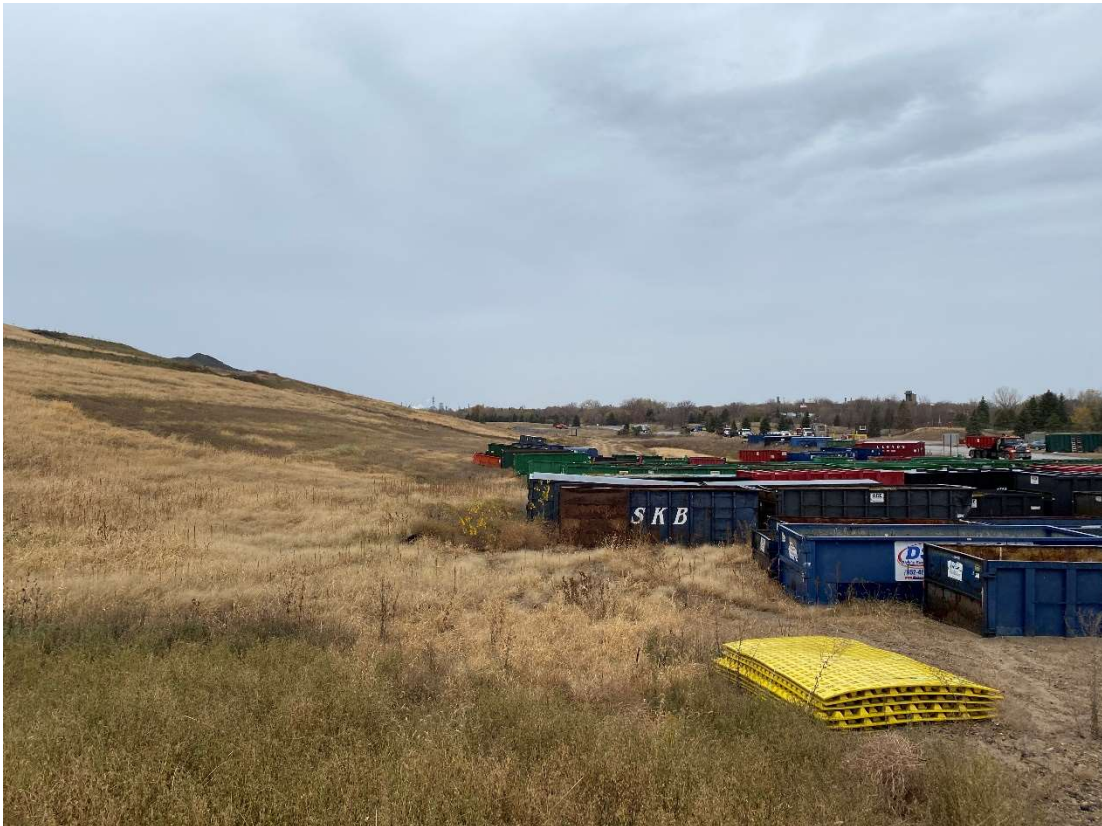
Location 3 – Looking Northwest, Phase 3A Anchor Trench and Northeastern Waste Slope

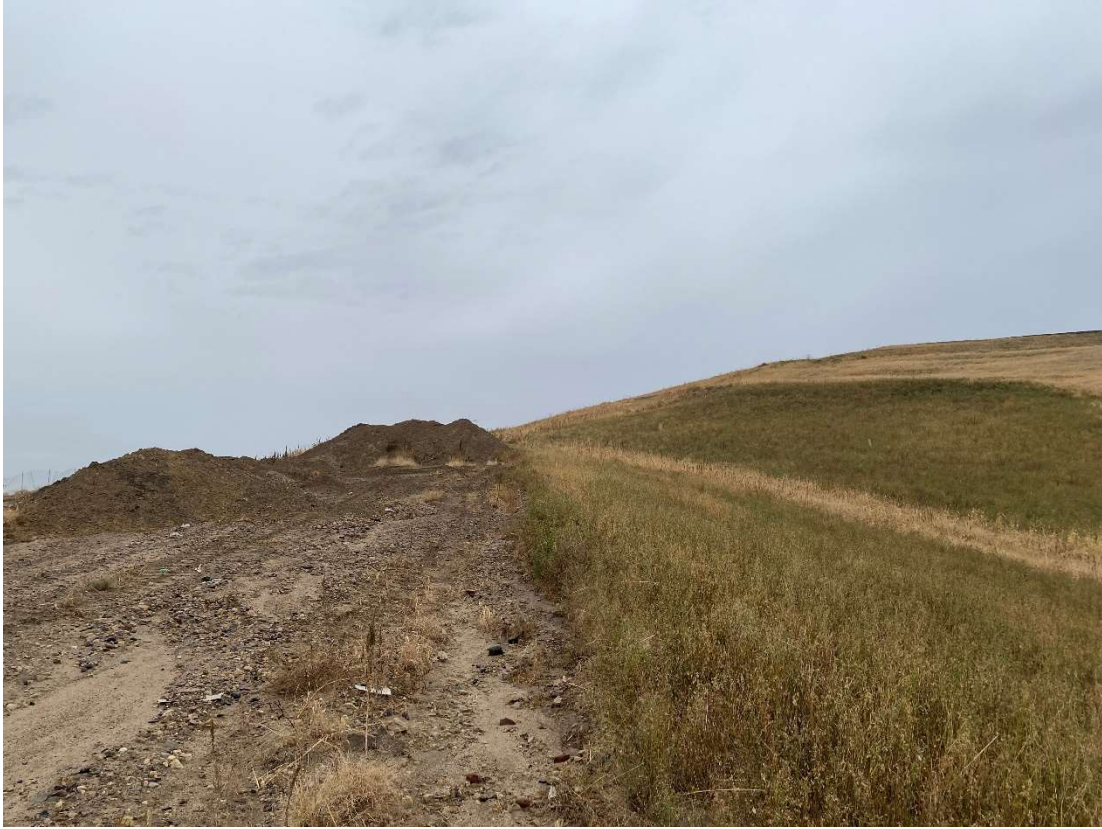
Location 3 – Looking Southwest, Phase 3 East Corner at toe of Interior Access Road

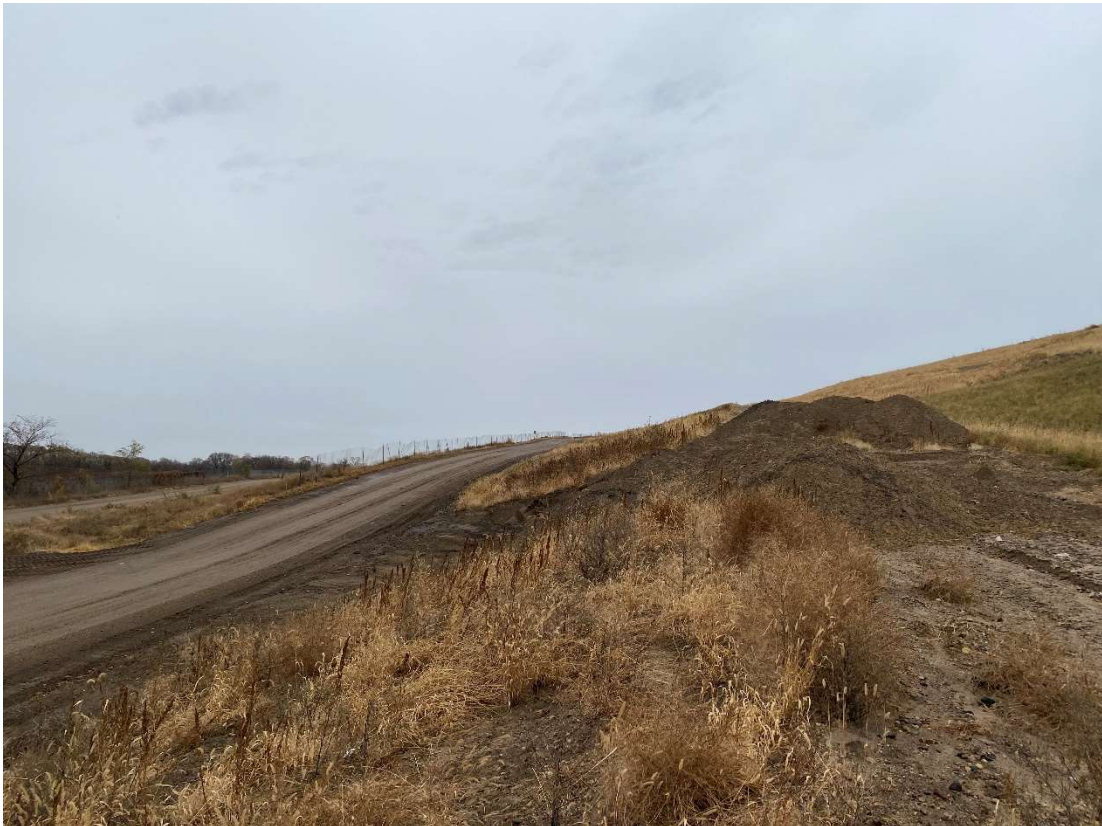
Location 3 – Looking Southwest along Cell 3 Access road/Phase 3 Liner Limit

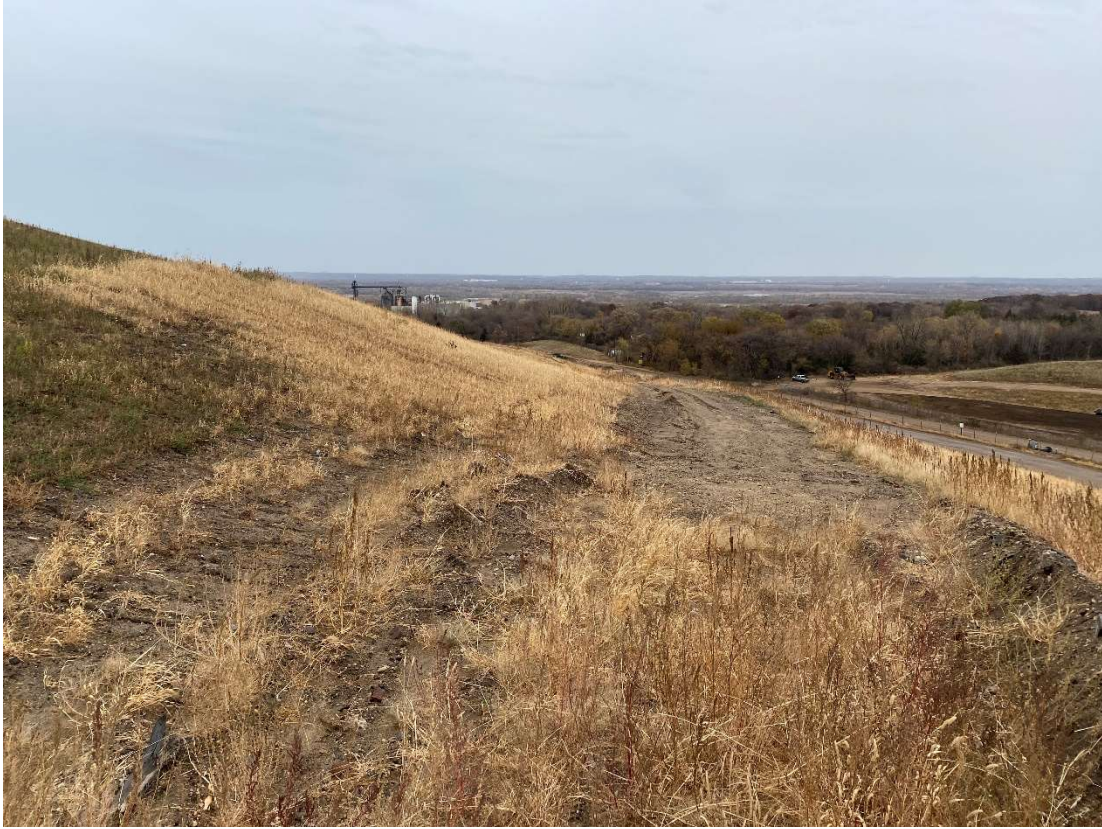
Location 4 – Looking Northeast, Phase 3 Liner Limit

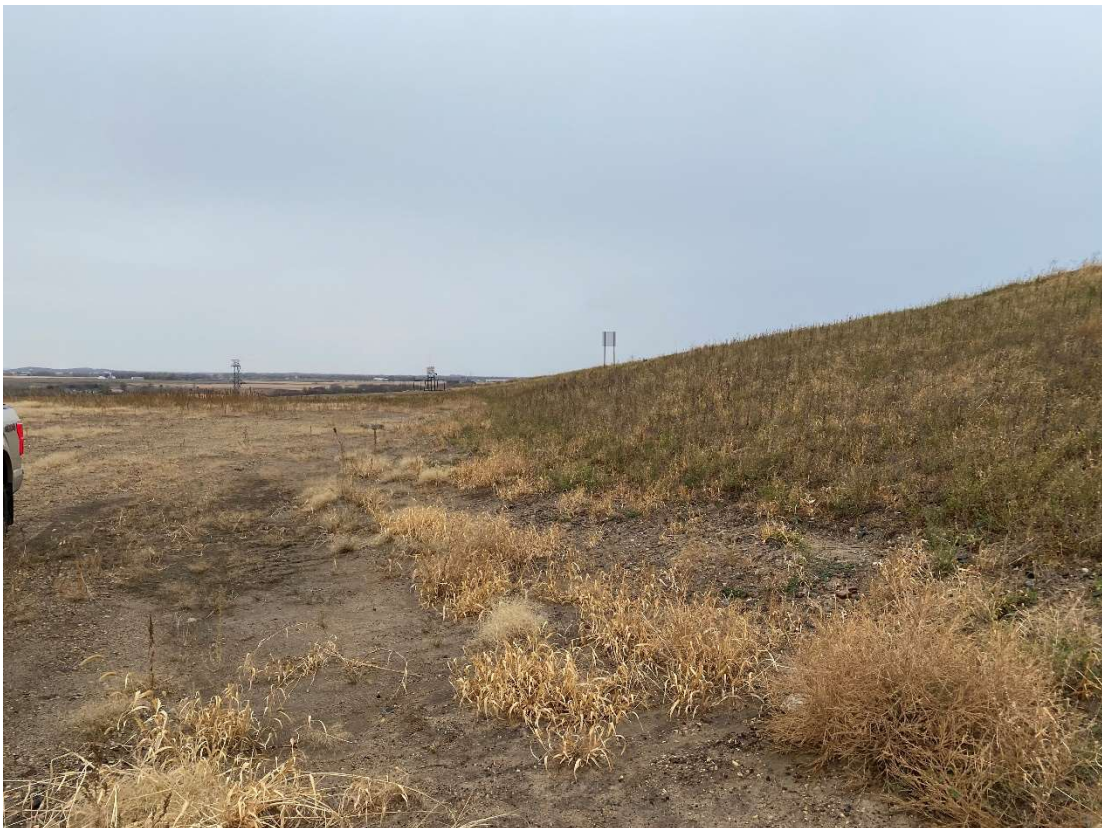
Location 4 – Looking Southwest, Phase 3 Liner Limit

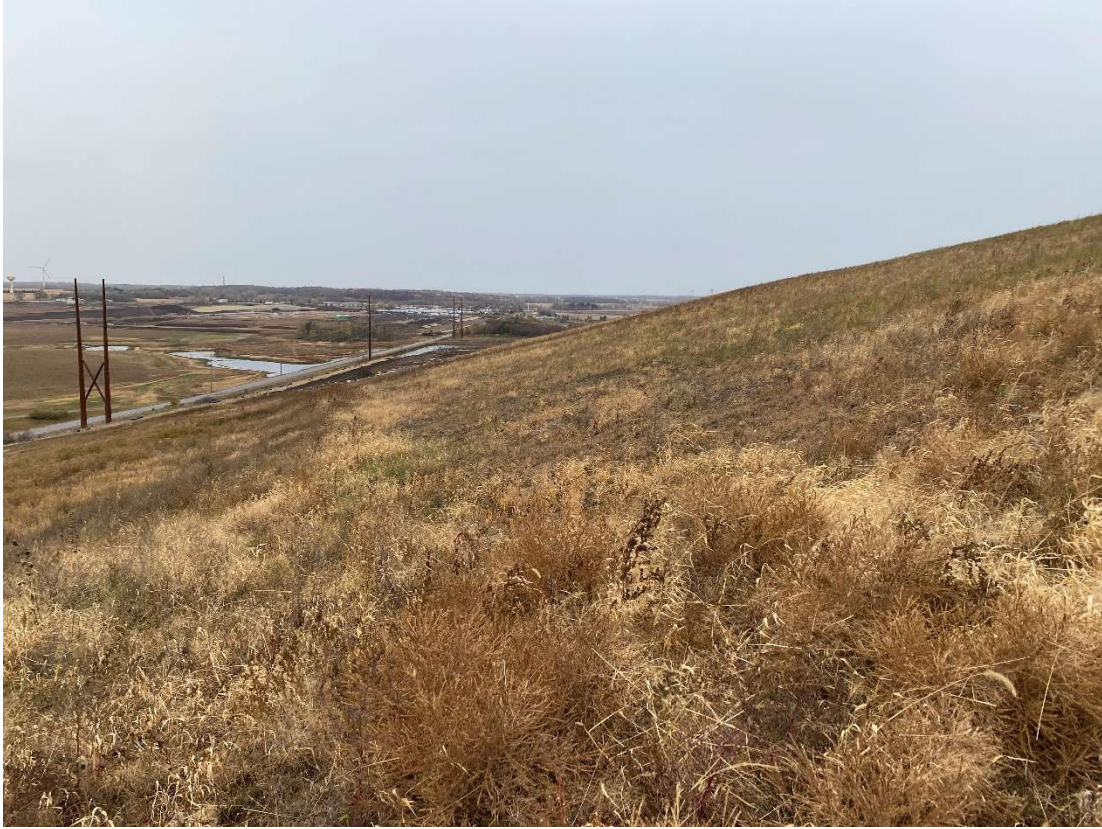
Location 5 – Looking Southwest, Phase 3 Liner Limit

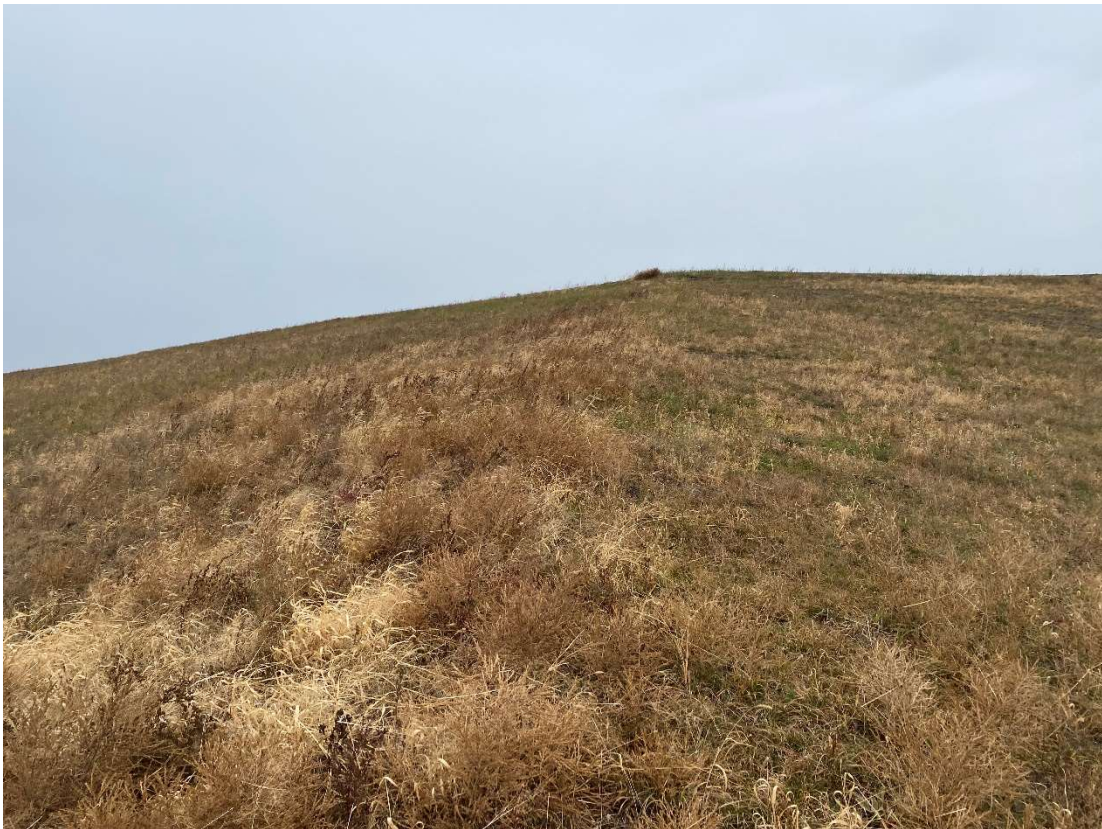
Location 5 – Looking Northeast, Phase 3 Liner Limit

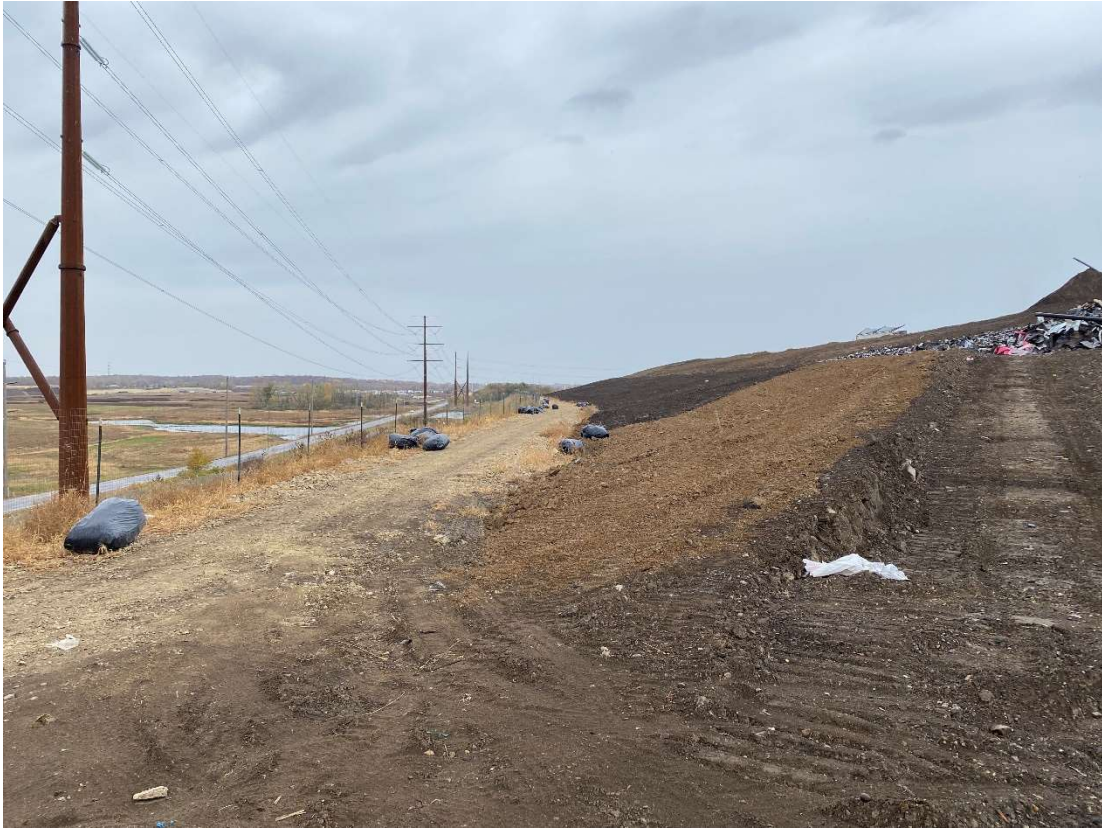
Location 6 – Cell 6D southeast corner, inner berm, looking west

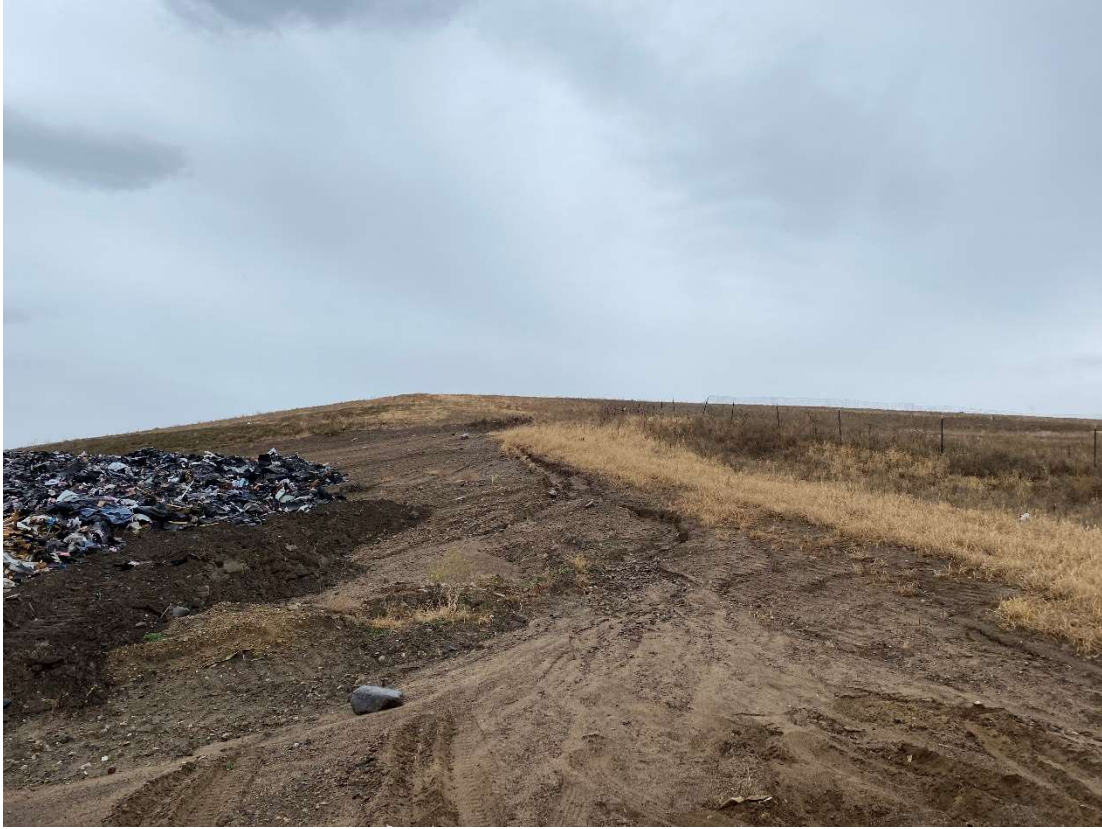
Location 6 – Cell 6D, southeast corner, looking northwest

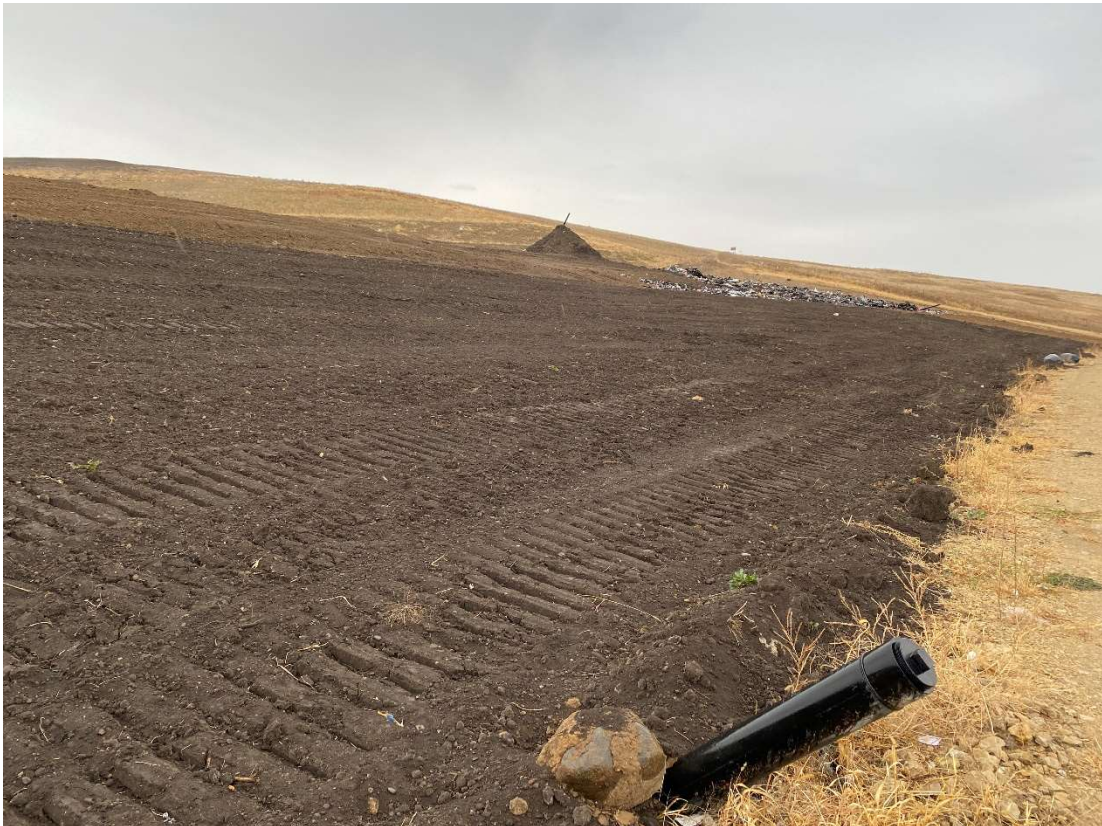
Location 7 – Cell 6D, midpoint of inner berm, looking east
