To:	Geoff Strack, P.E. Waste Connections	From:	Brad Sullivan, P.E., Stantec
File:	227704387	Date:	January 7, 2023

**Reference: SKB Rosemount Industrial Waste Facility 2022 Annual CCR Inspection Report**

PROJECT TITLE  
 2022 CCR INSPECTION REPORT

SKB ROSEMOUNT LANDFILL  
 ROSEMOUNT, MINNESOTA

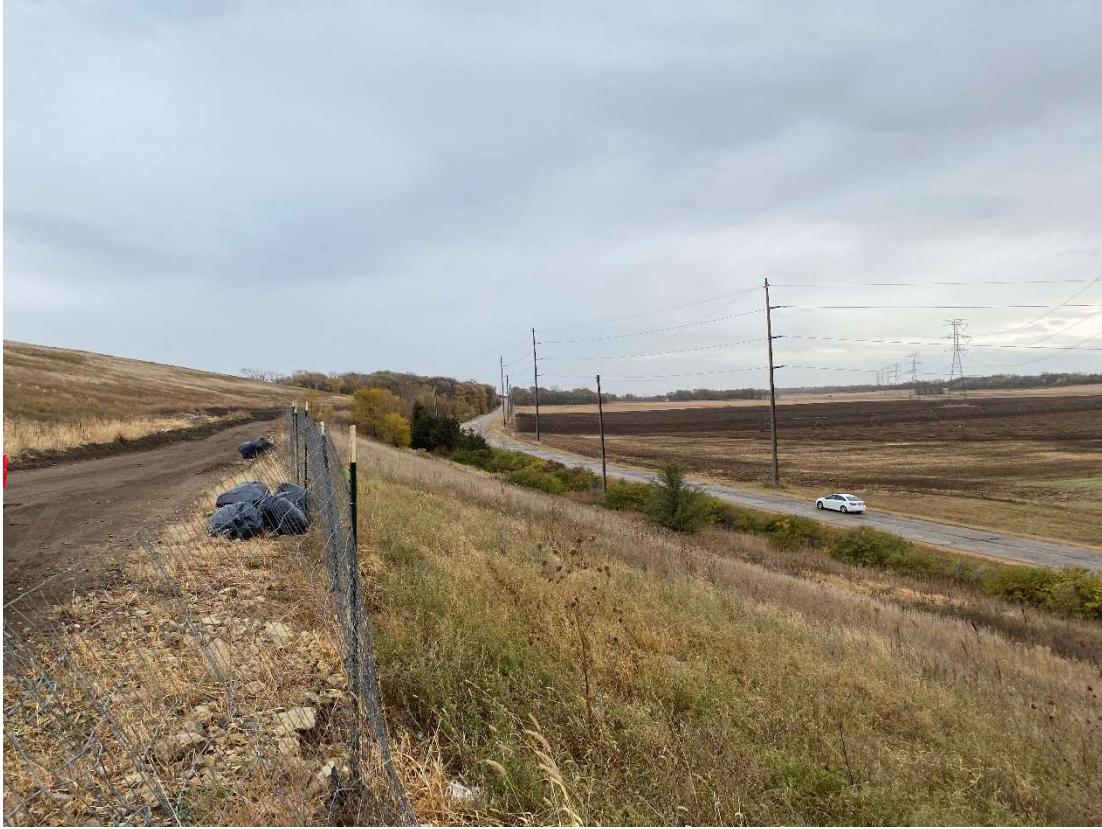
Location 7 – Cell 6D, midpoint of outer berm, looking east

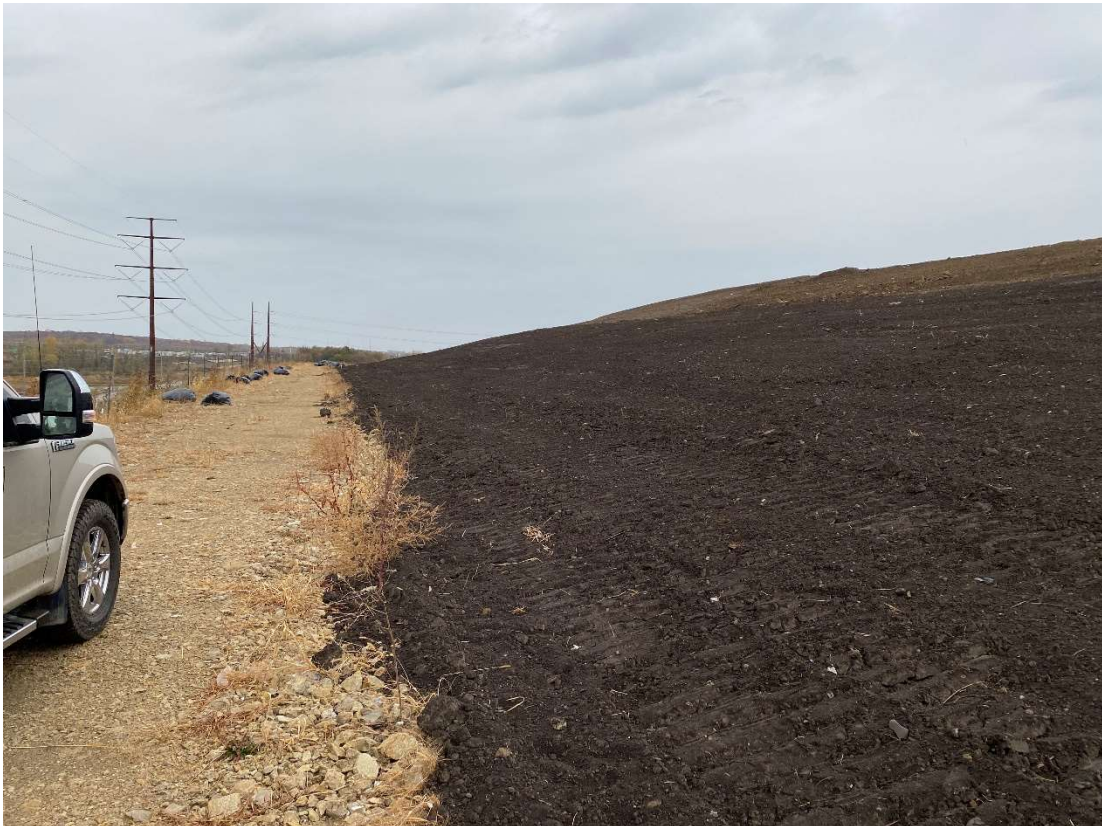
Location 7 – Cell 6D, midpoint of inner berm, looking west

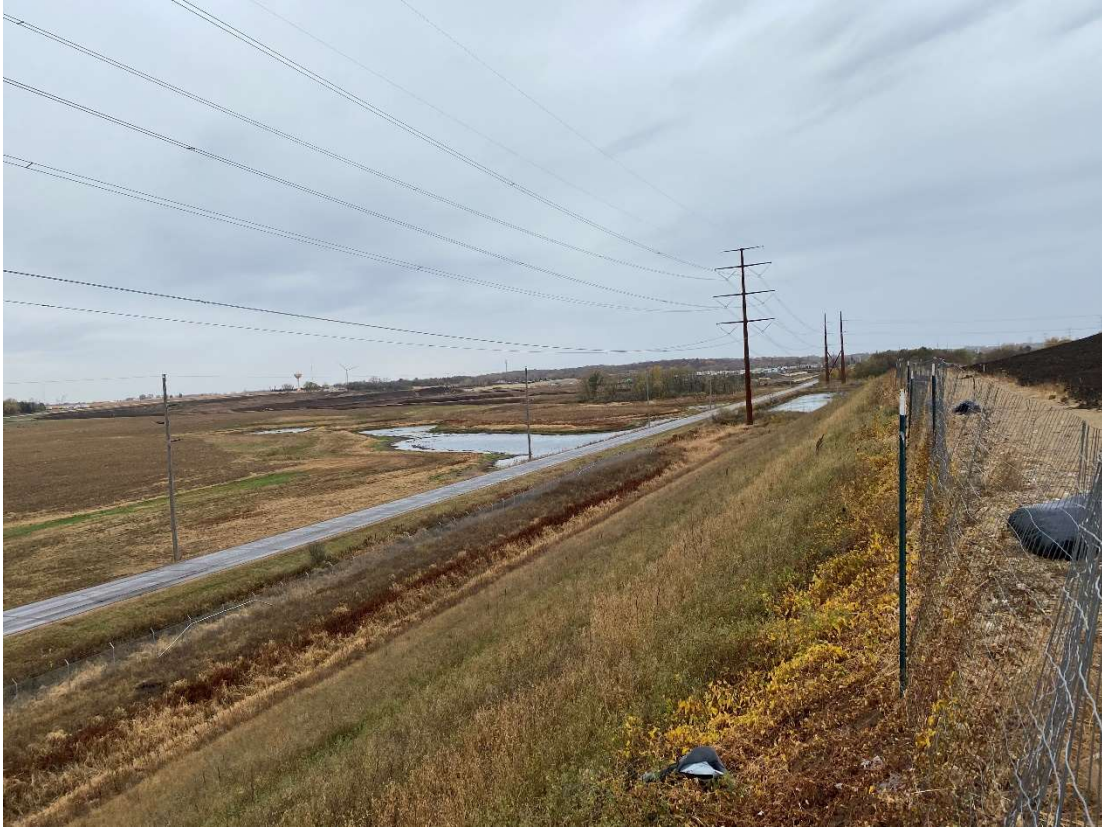
Location 7 – Cell 6D, midpoint of outer berm, looking west

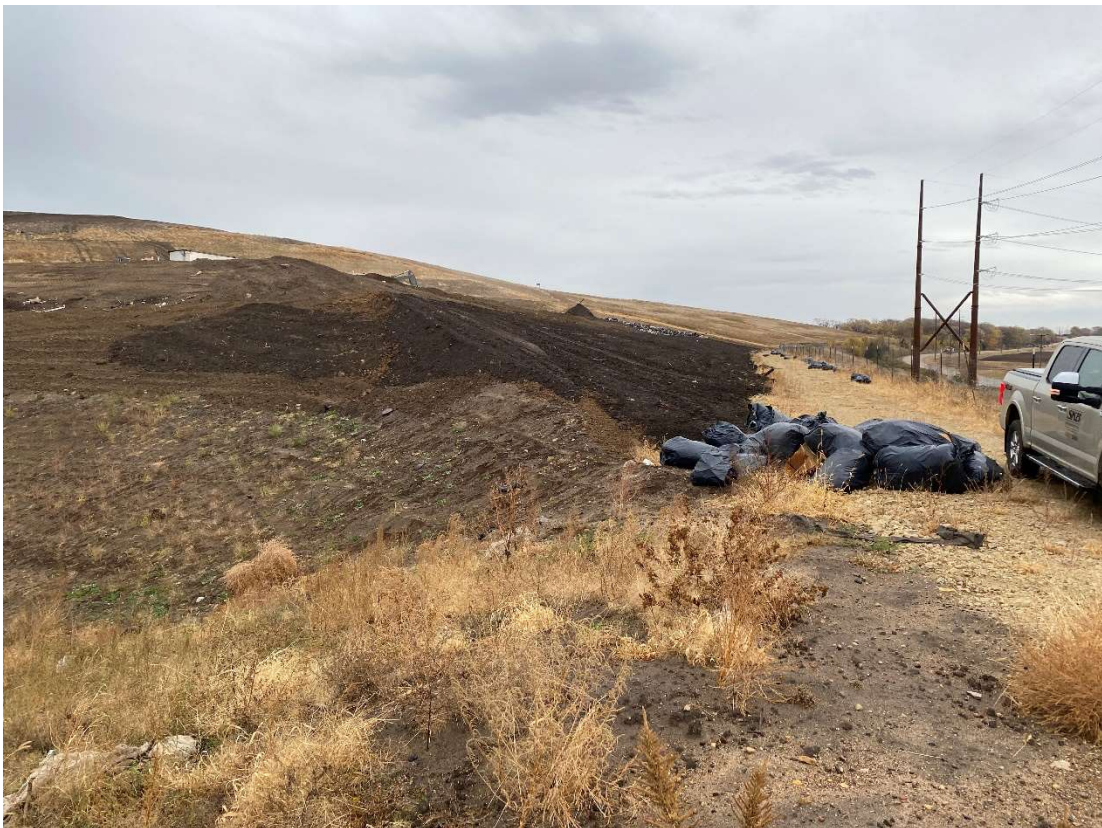
Location 8 – Cell 6D, southwest corner inner berm, looking east

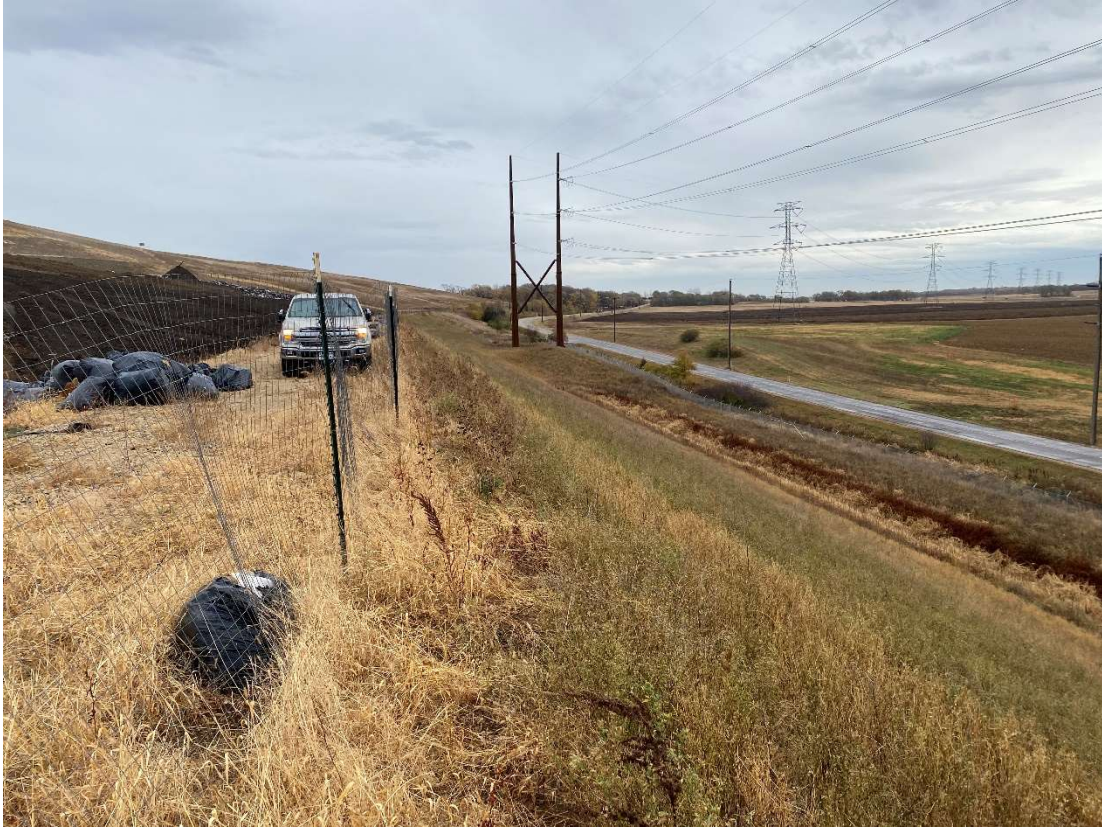
Location 8 – Cell 6D, southwest corner outer berm, looking east

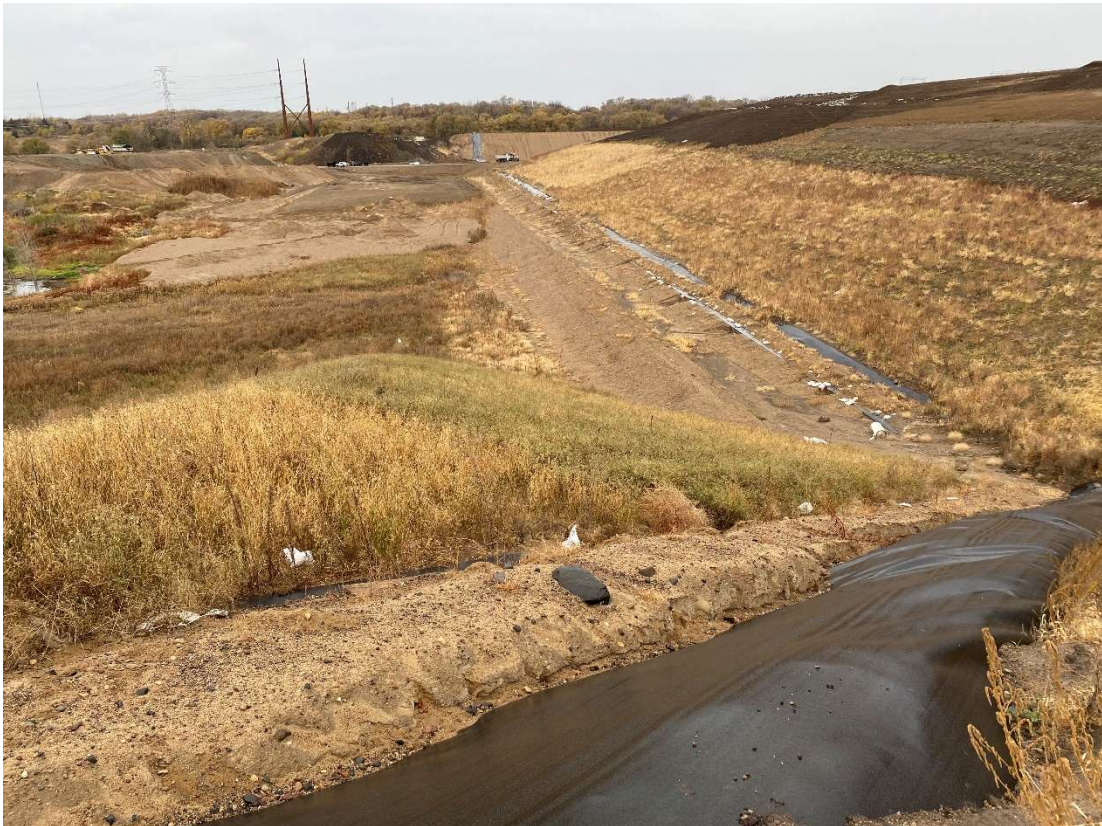
Location 8 – Cell 6D, southwest corner inner berm, looking west

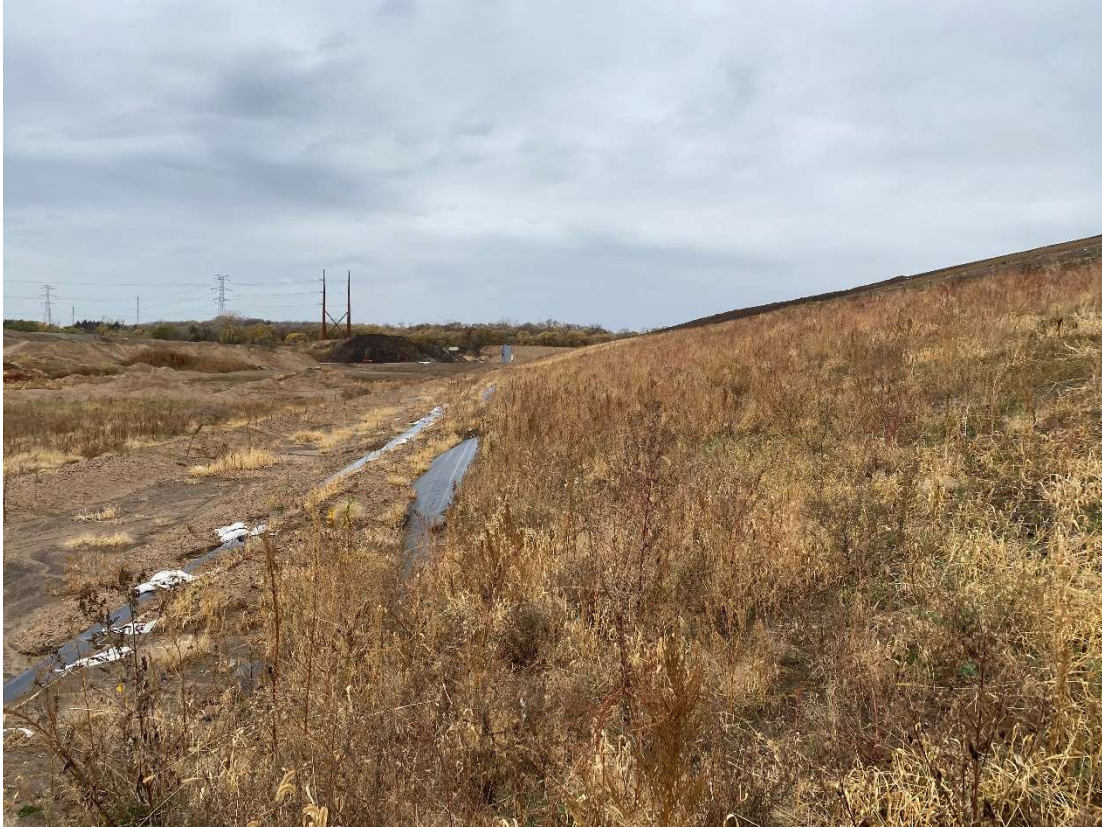
Location 9 – Cell 6D, looking northwest

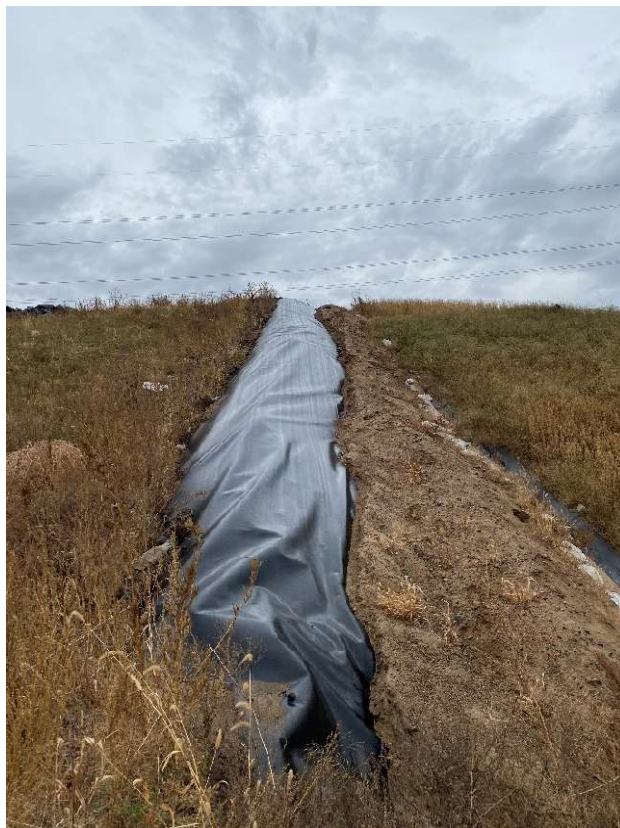
Location 9 – Cell 6D, looking south

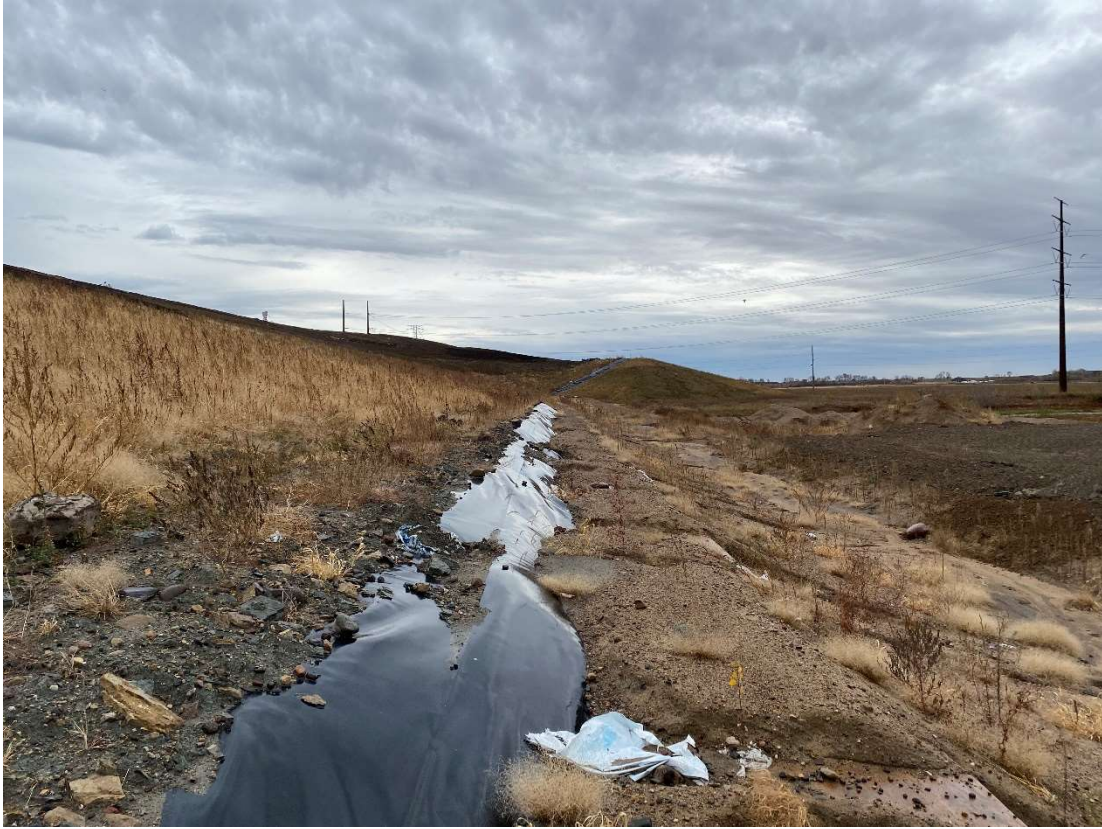
Location 10 – Cell 6D southwest limit, looking southeast

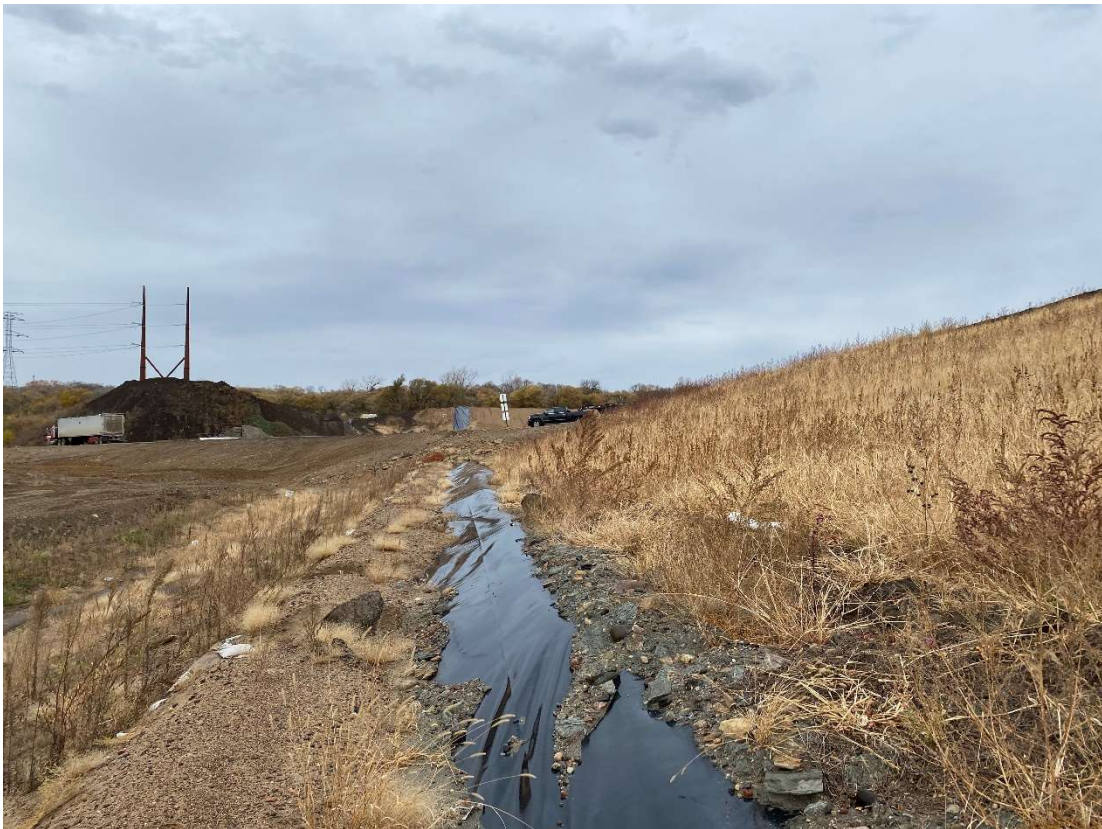
Location 10 – Cell 6A southwestern limits, looking northwest

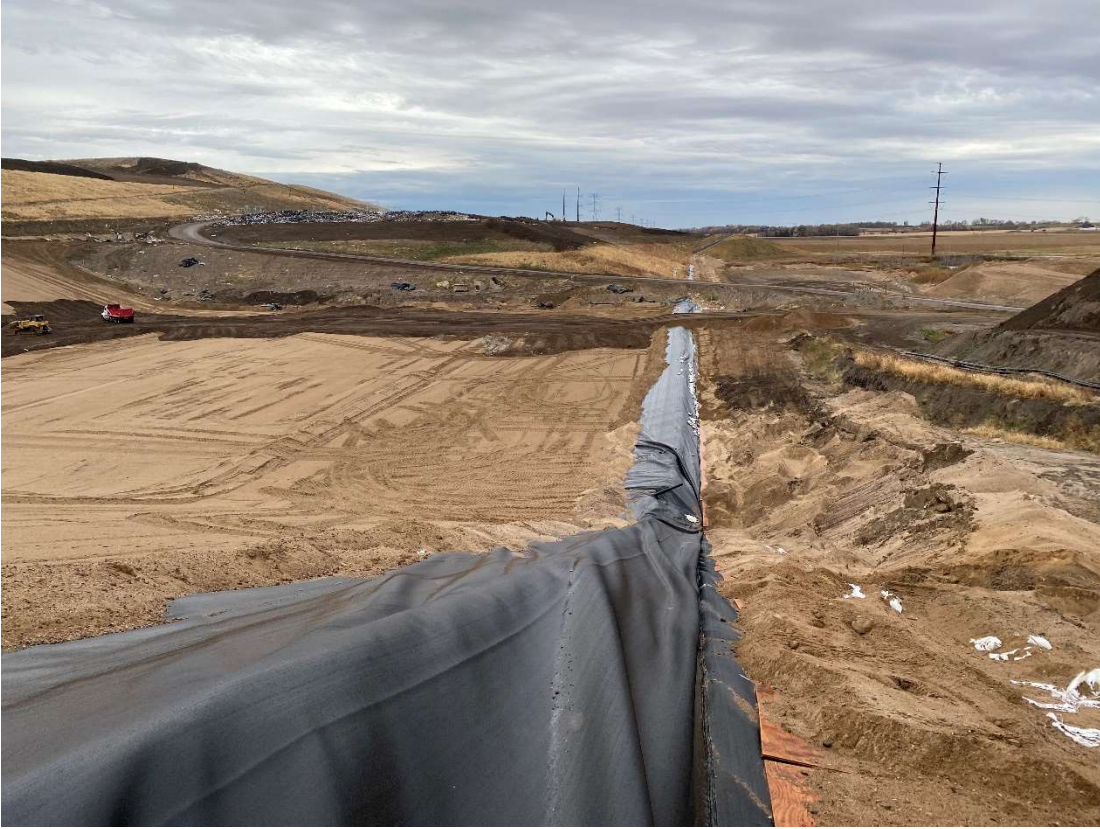
Location 11 – Cell 6A/6D western limits, looking southeast

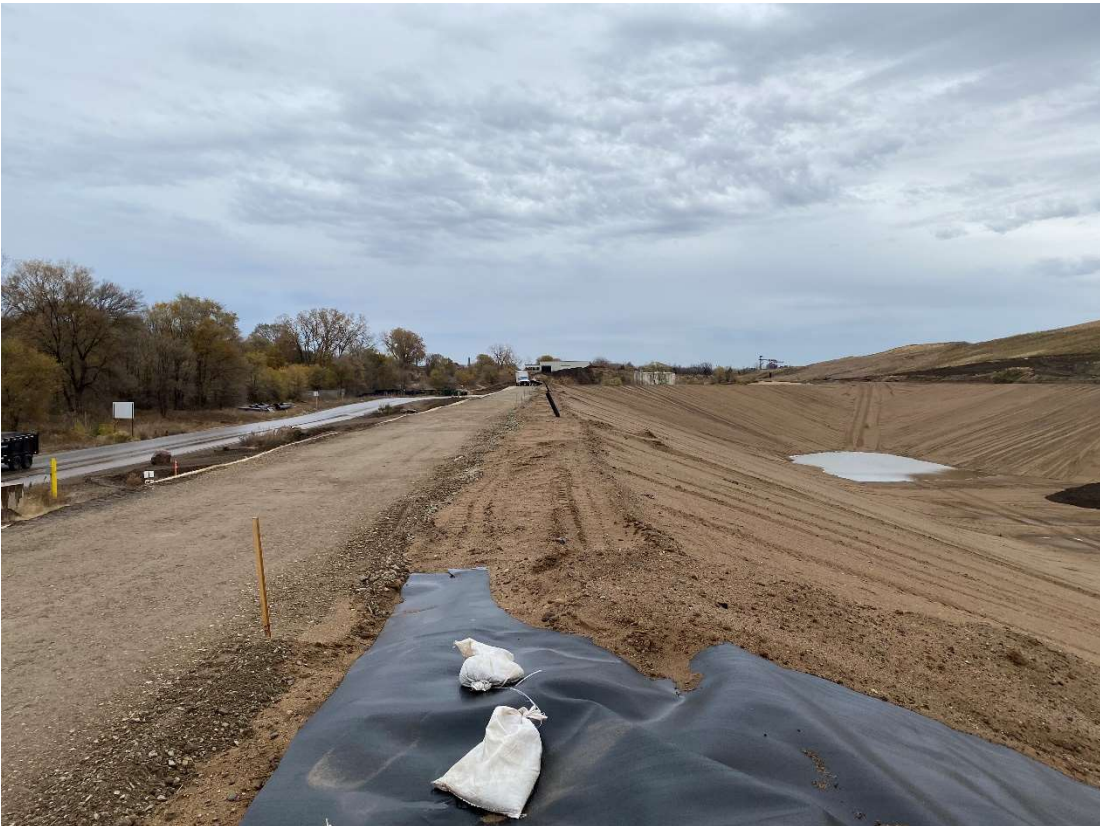
Location 11 – Cell 6A northwestern top of berm, looking northeast

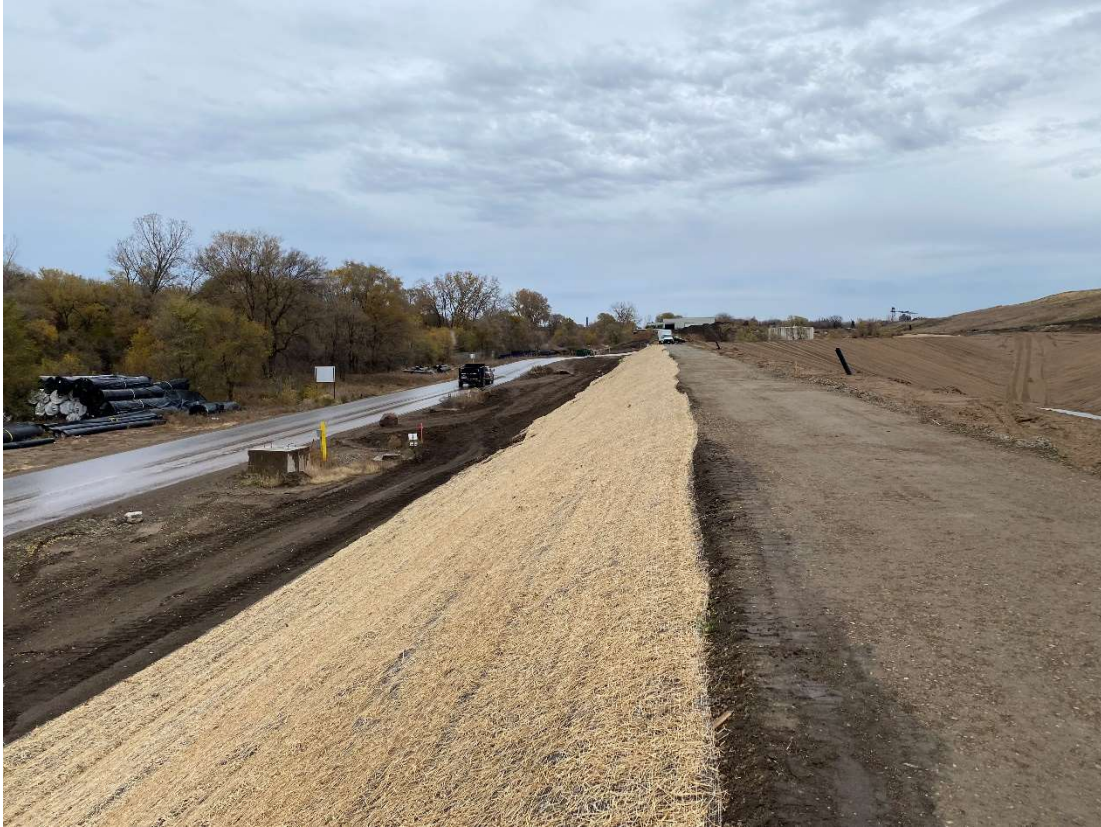
Location 11 – Cell 6A northwestern outer berm, looking northeast

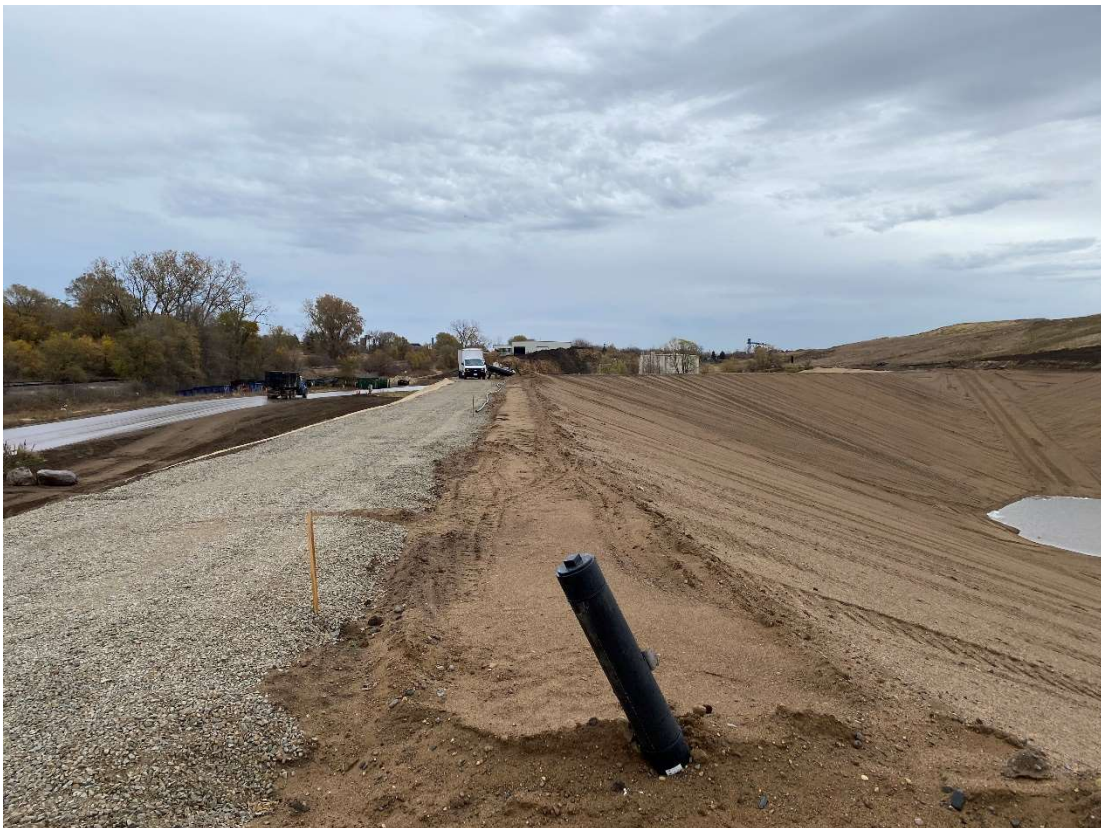
Location 12 – Cell 6A midpoint of northwestern top of berm, looking northeast

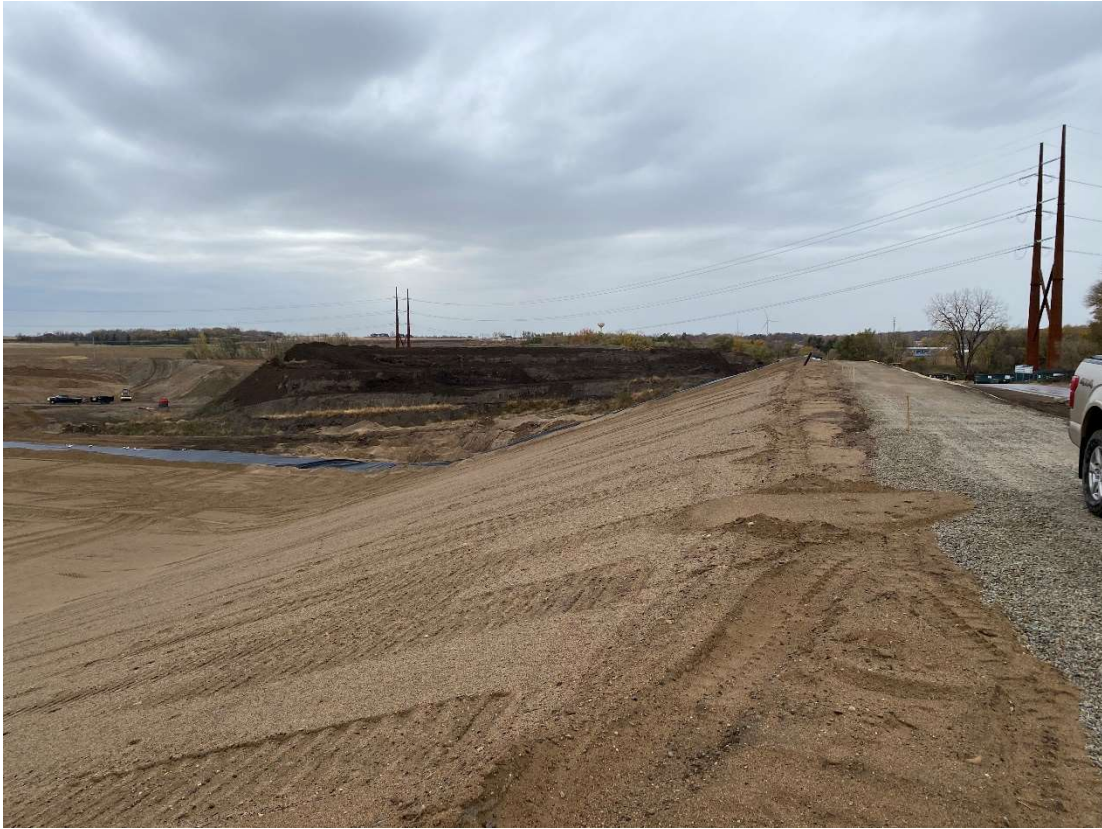
Location 12 – Cell 6A midpoint of northwestern inner berm, looking southwest

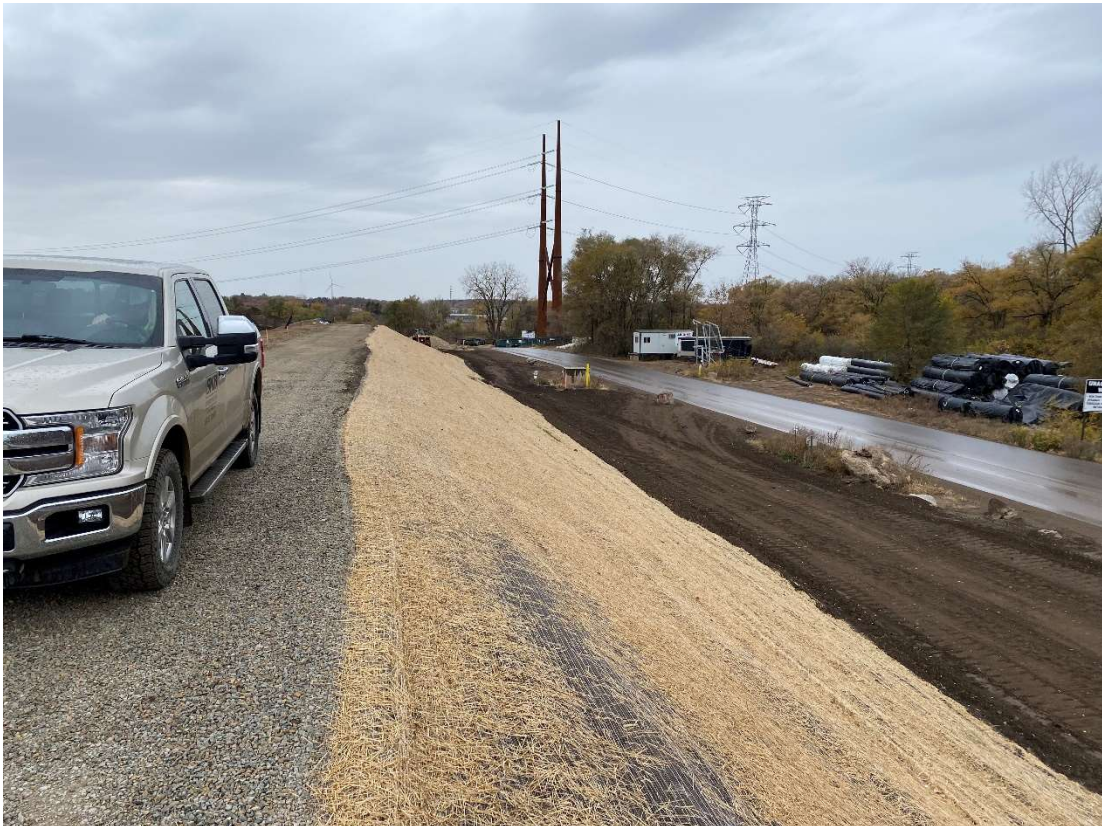
Location 12 – Cell 6A midpoint of northwestern outer berm, looking southwest

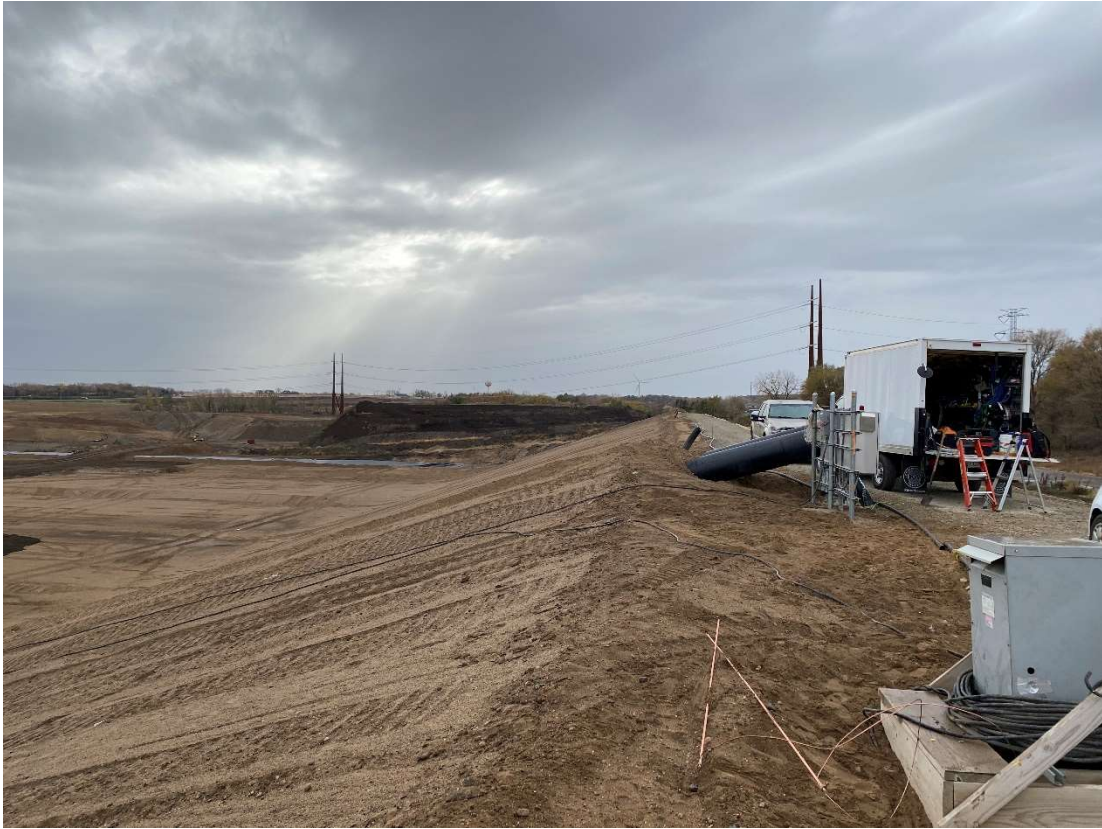
Location 13 – Cell 6A northwestern top of berm, looking southwest

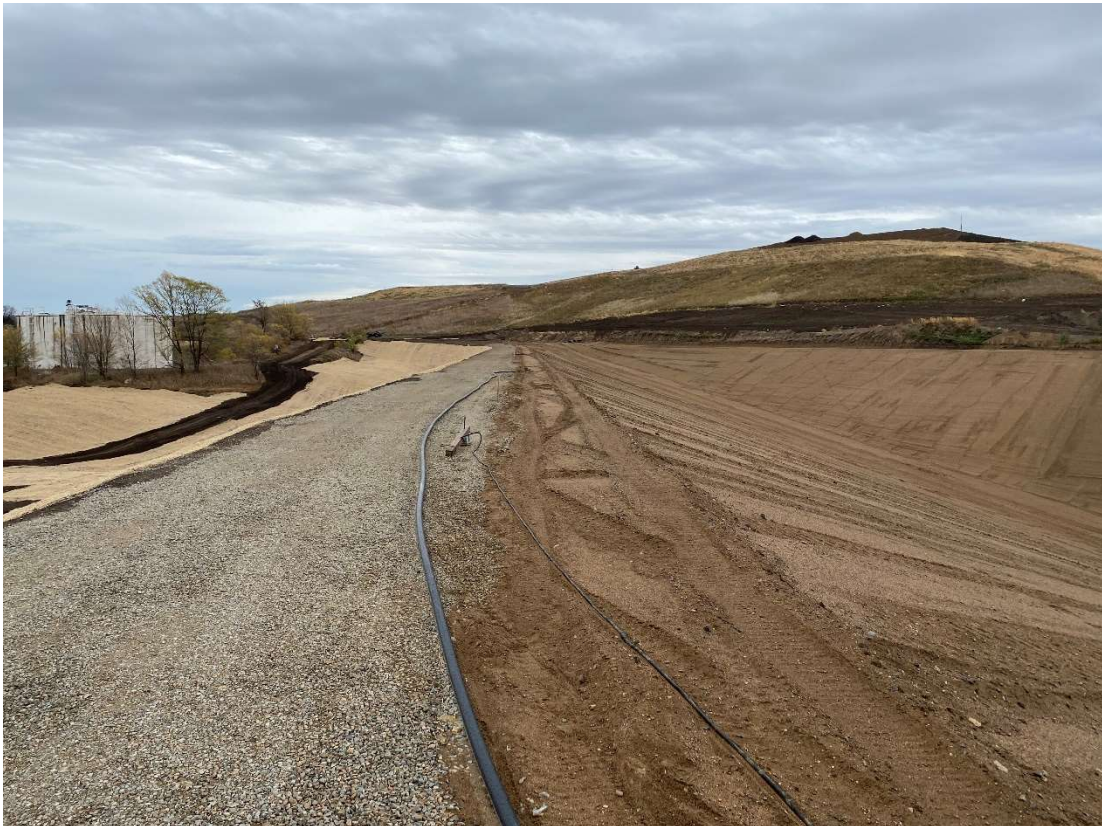
Location 13 – Cell 6A northern top of berm, looking northeast

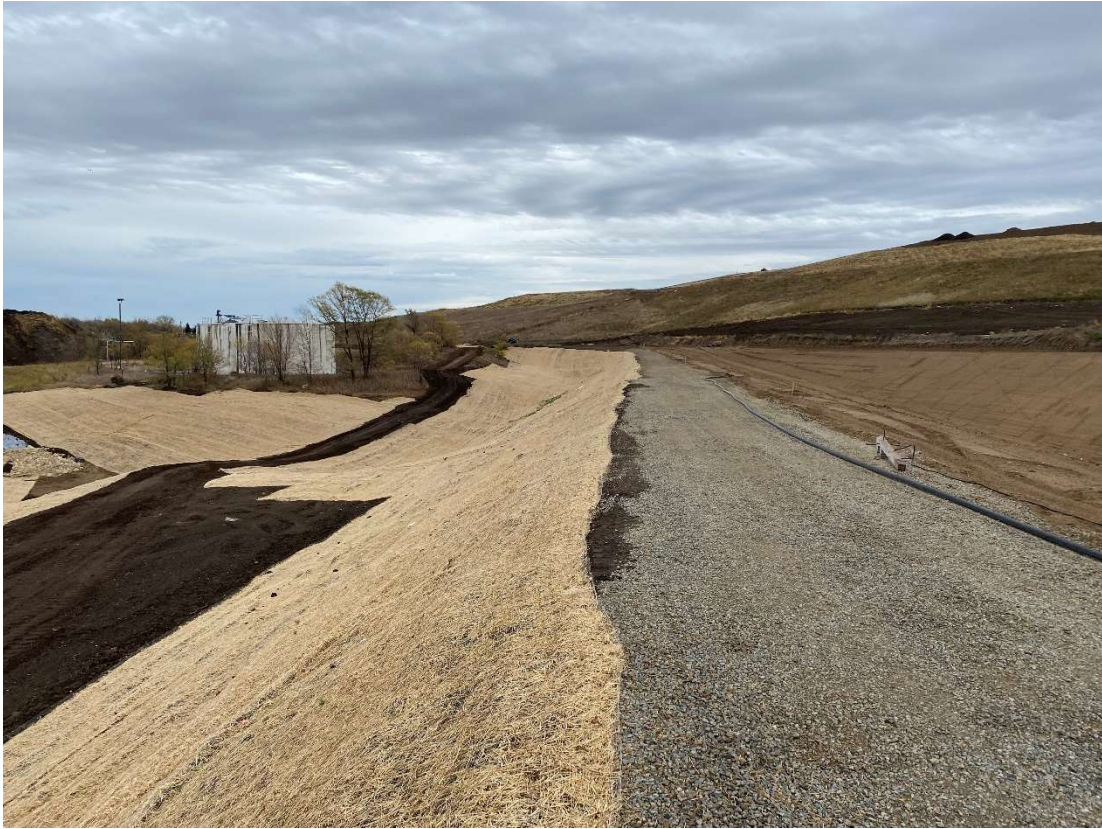
Location 13 – Cell 6A northern outer berm, looking northeast

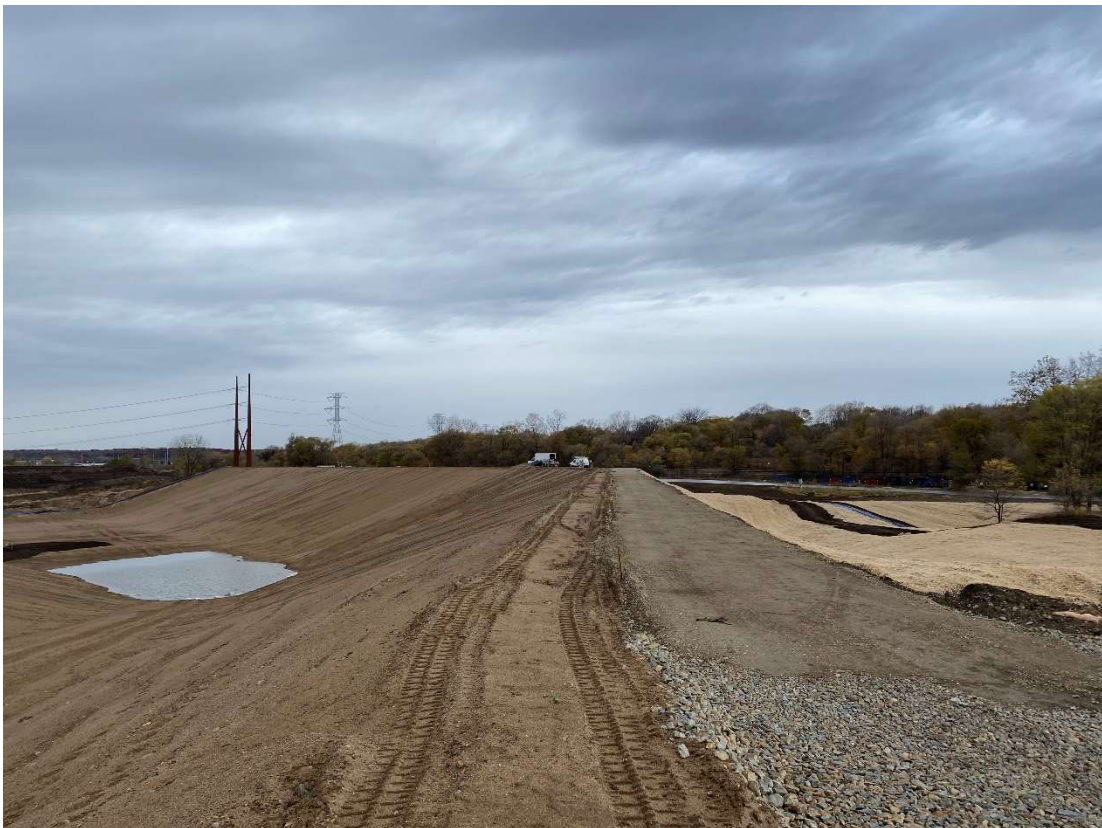
Location 14 – Cell 6A northern top of berm, looking southwest

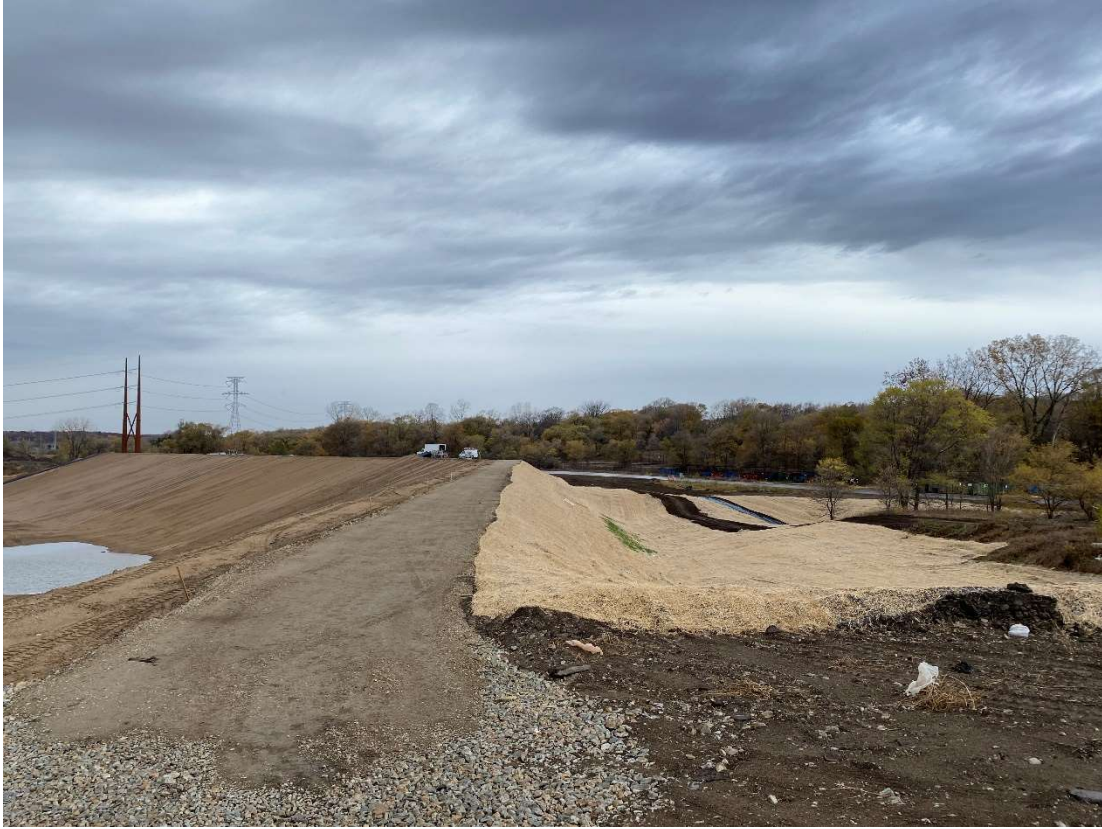
Location 14 – Cell 6A northern outer berm, looking southwest

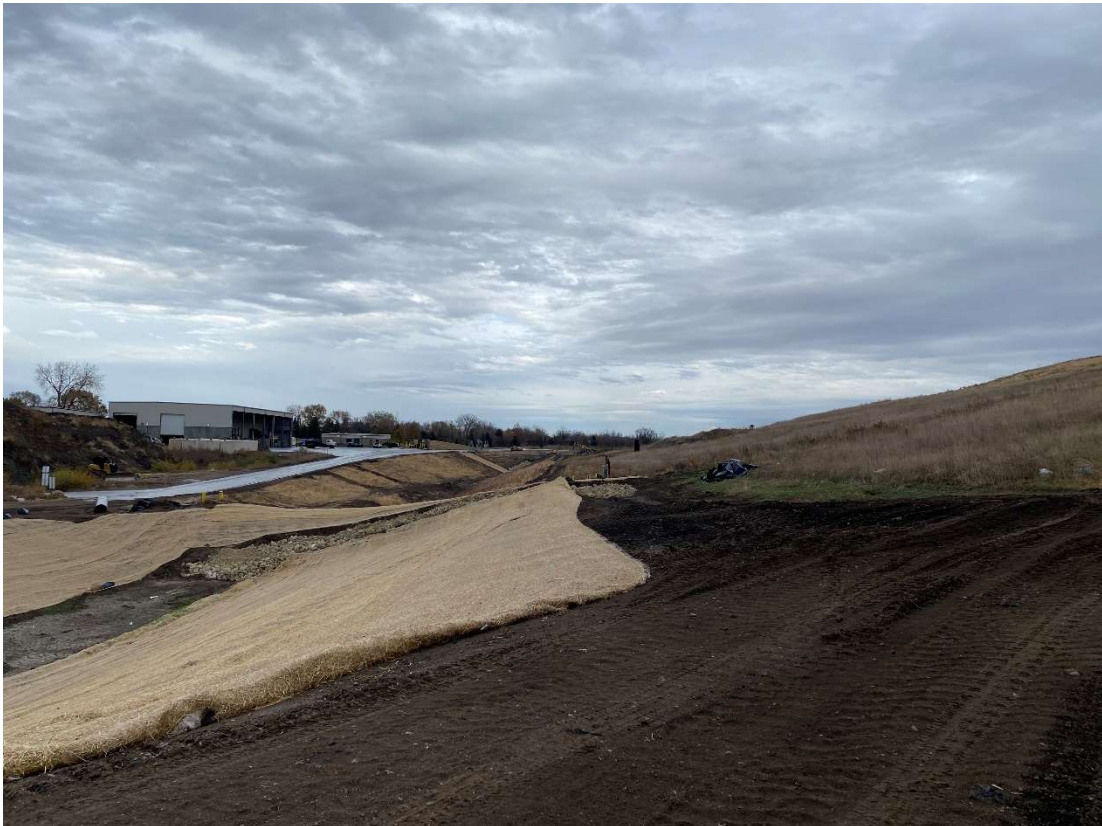
Location 14 – Cell 1 northwestern berm, looking northeast

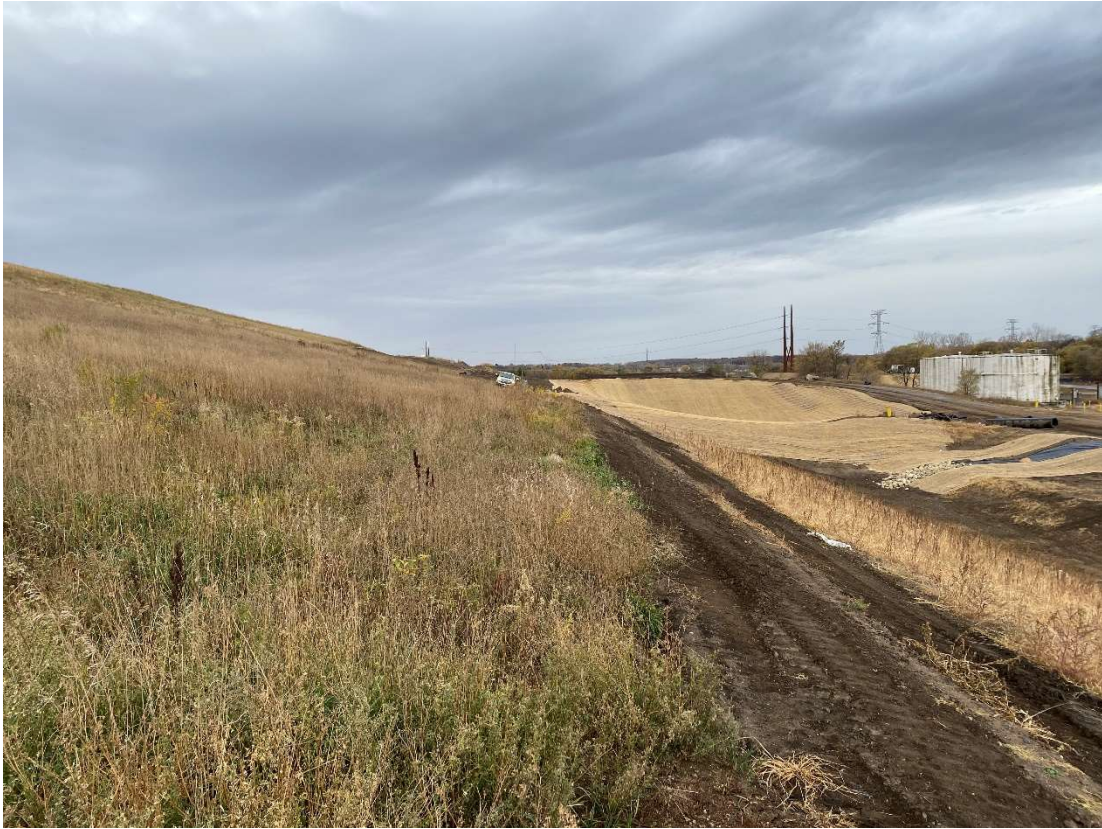
Location 15 – Cell 1 Toe of Waste Slope, looking southwest

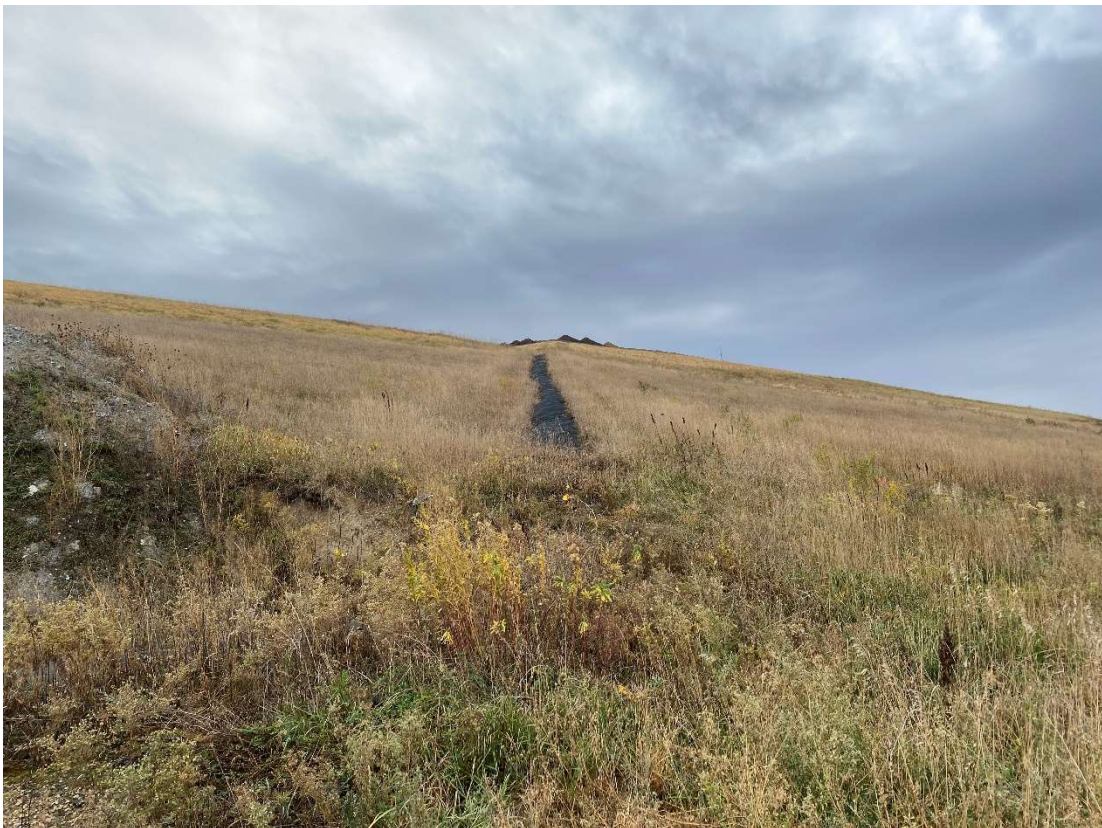
Location 15 – Cell 1 edge of cap, looking south
