To:	Geoff Strack, P.E. Waste Connections	From:	Brad Sullivan, P.E., Stantec
File:	227704387	Date:	January 7, 2024

Reference: SKB Rosemount Industrial Waste Facility 2023 Annual CCR Inspection Report

Purpose

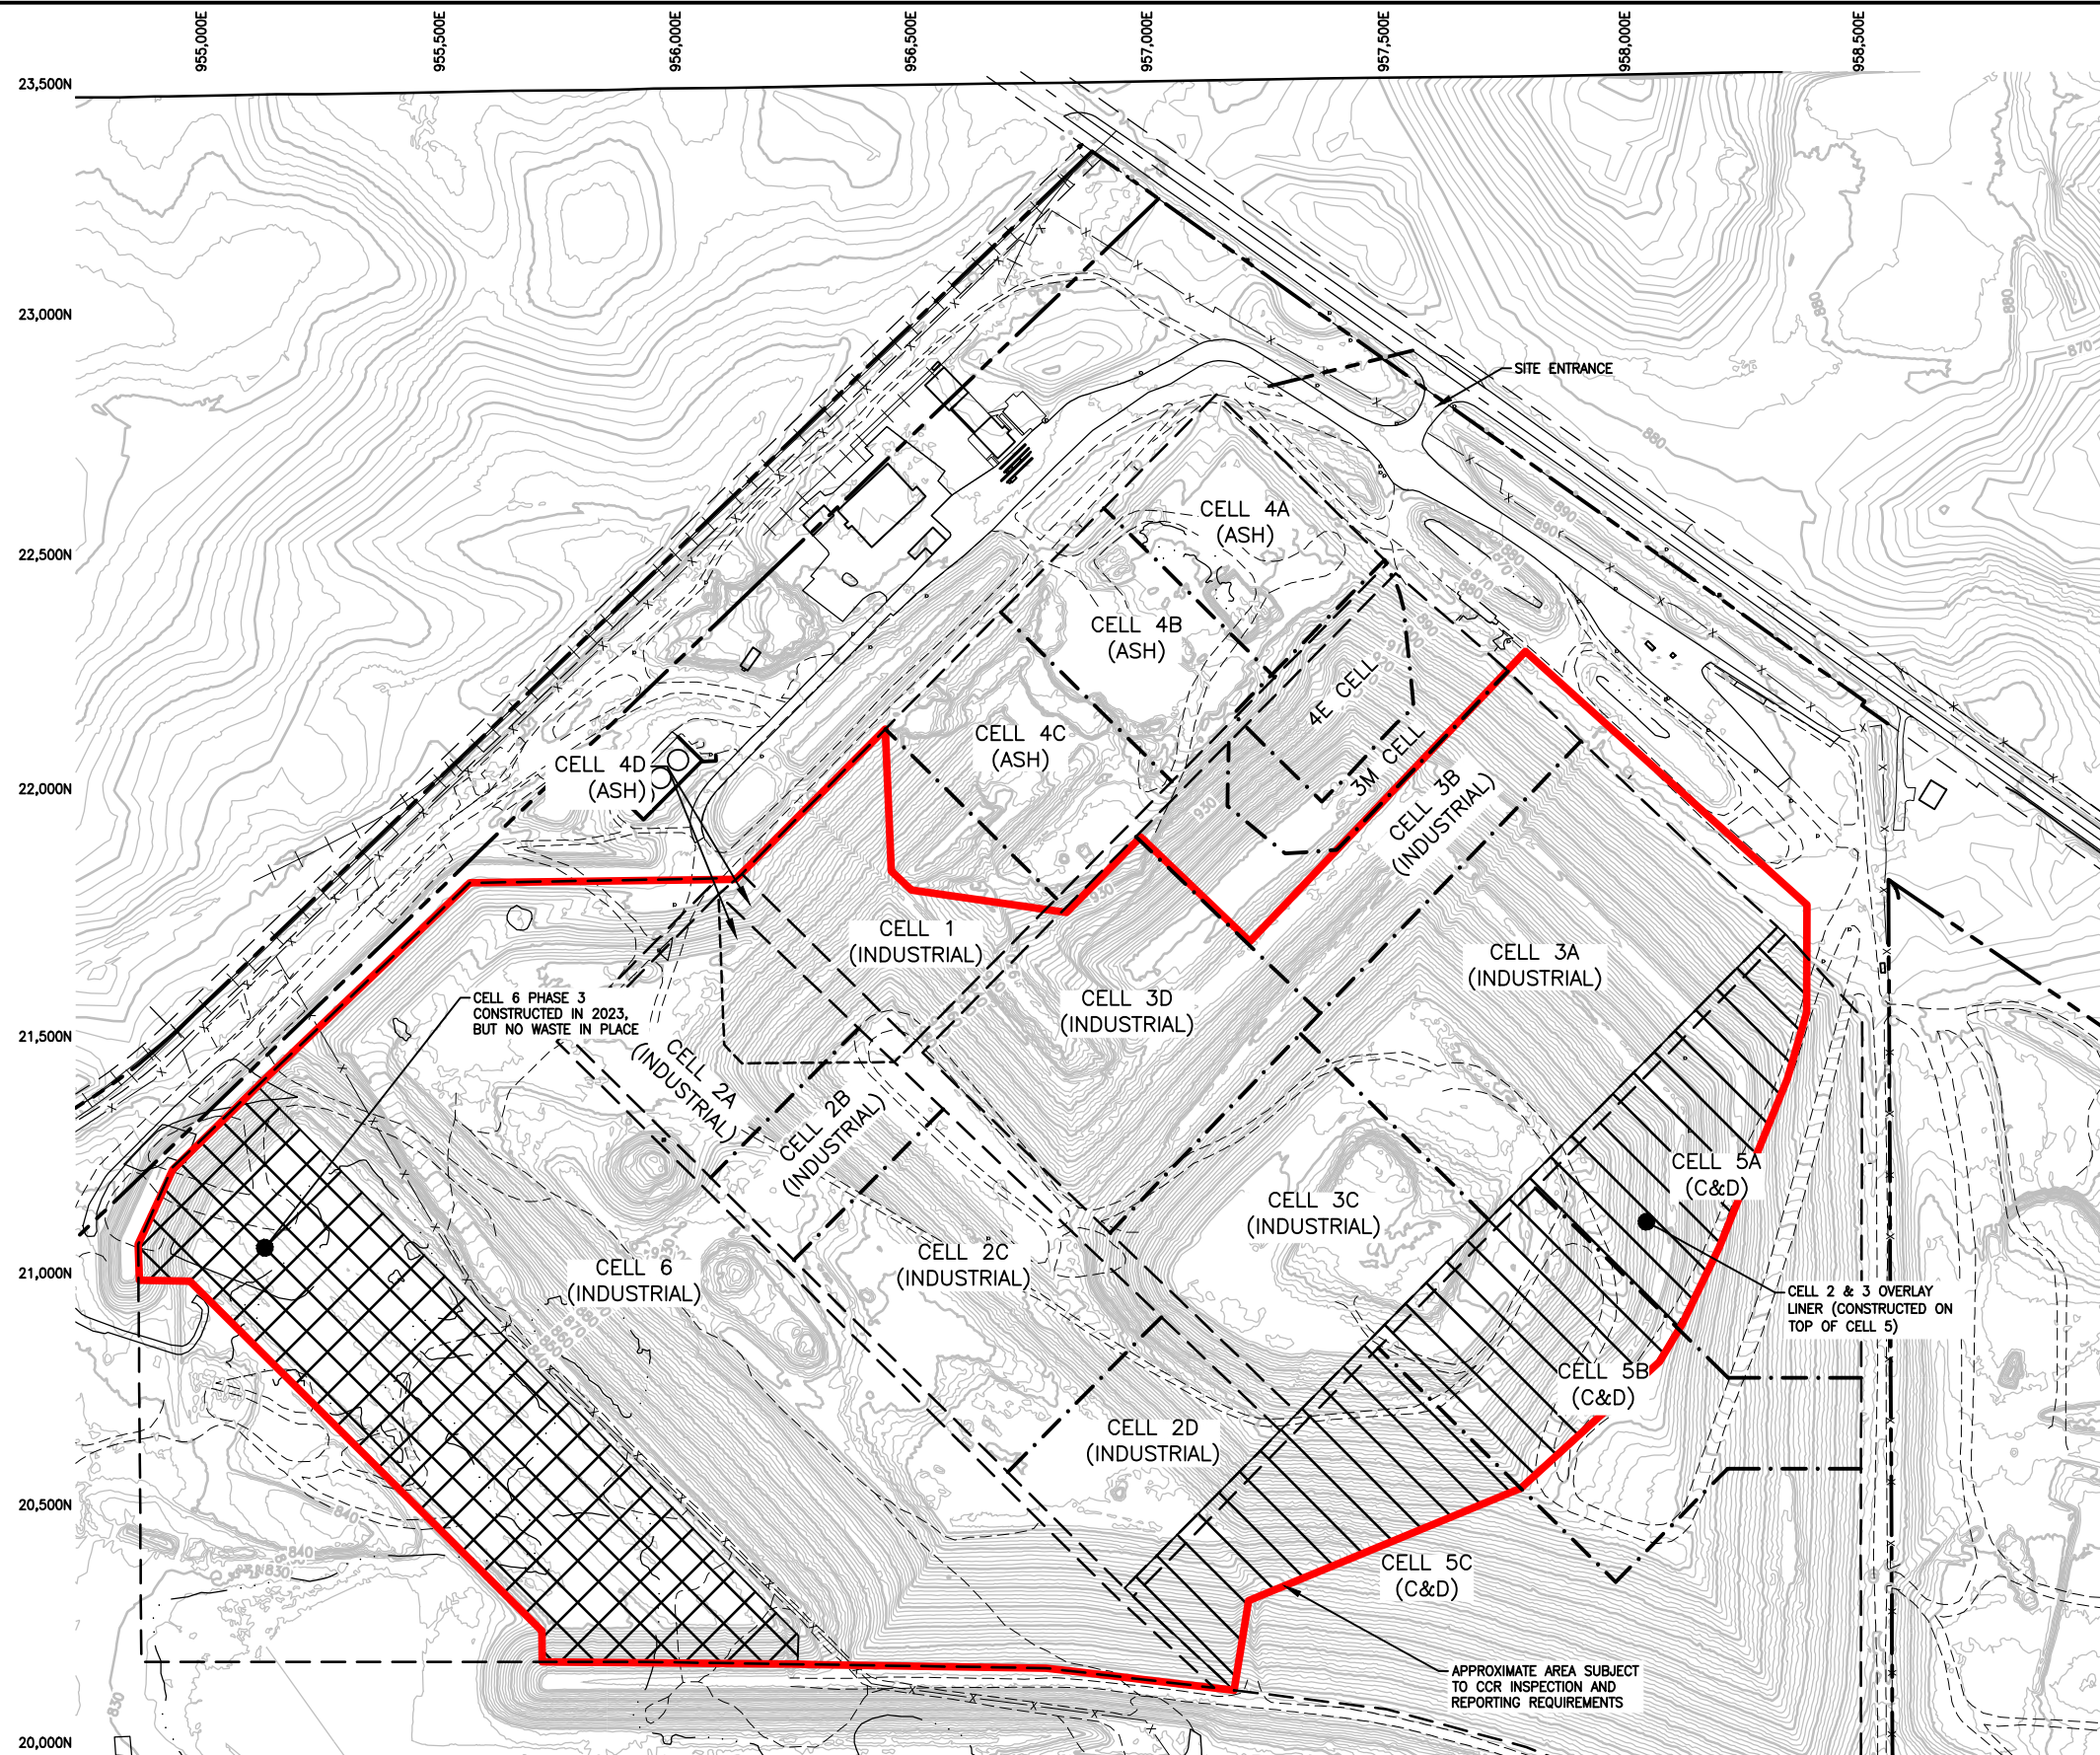
SHEET TITLE	SITE MAP		
DWN BY	CHK'D	APP'D	DWG DATE
SKM	TJS	BWS	JAN. 2024
PROJECT NO.	SHEET NO.	REV NO.	
227704387	FIGURE 1	0

The annual aerial photogrammetry survey was performed on October 18, 2023, which the estimated in-place volume of total waste (including all accepted wastes) is based on. A comparison of the 2023 and 2022 aerial surveys confirm that the embankment and slope topography is substantially unchanged. The 2023 aerial survey is shown on Figure 1.

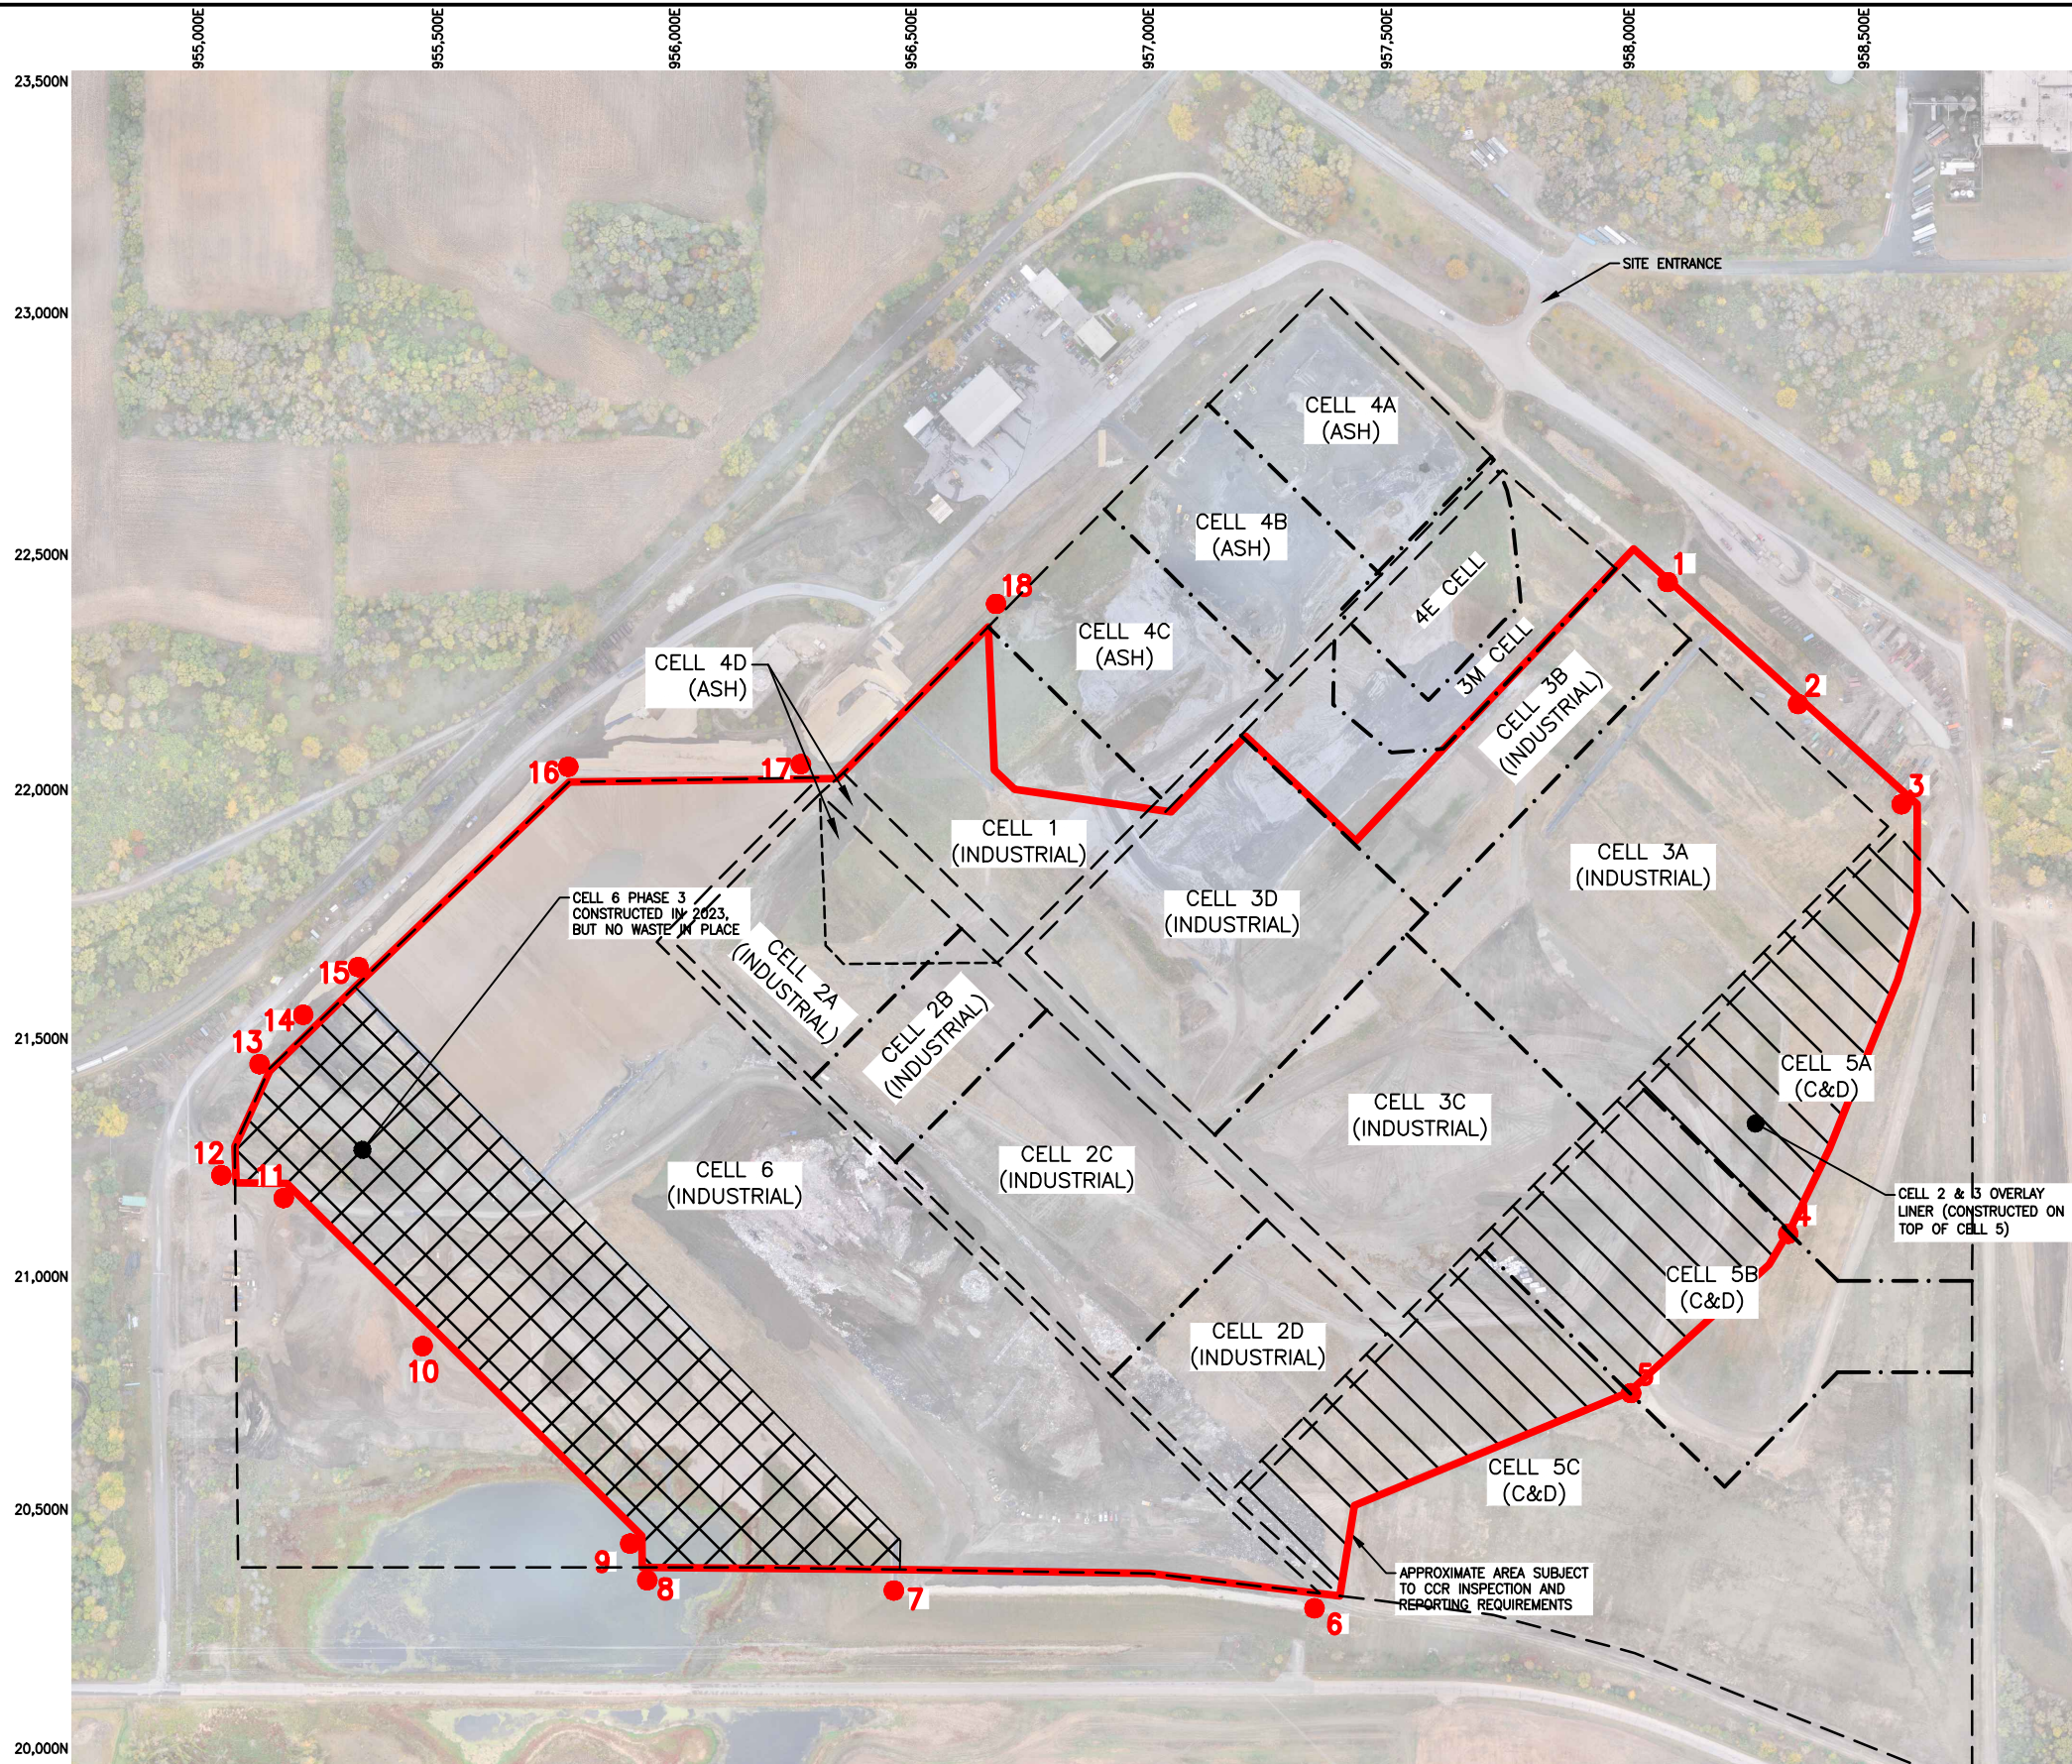
SHEET TITLE			
PHOTO LOCATIONS			
DWN BY	CHK'D	APP'D	DWG DATE
SKM	TJS	BWS	JAN. 2024
PROJECT NO.		SCALE	
227704387		AS NOTED	
SHEET NO.		REV NO.	
FIGURE 2		0

Photos of the landfill embankments and waste slopes were taken during the inspection. Figure 2 presents the photo locations, and Attachment 1 contains a photo log from the inspections.

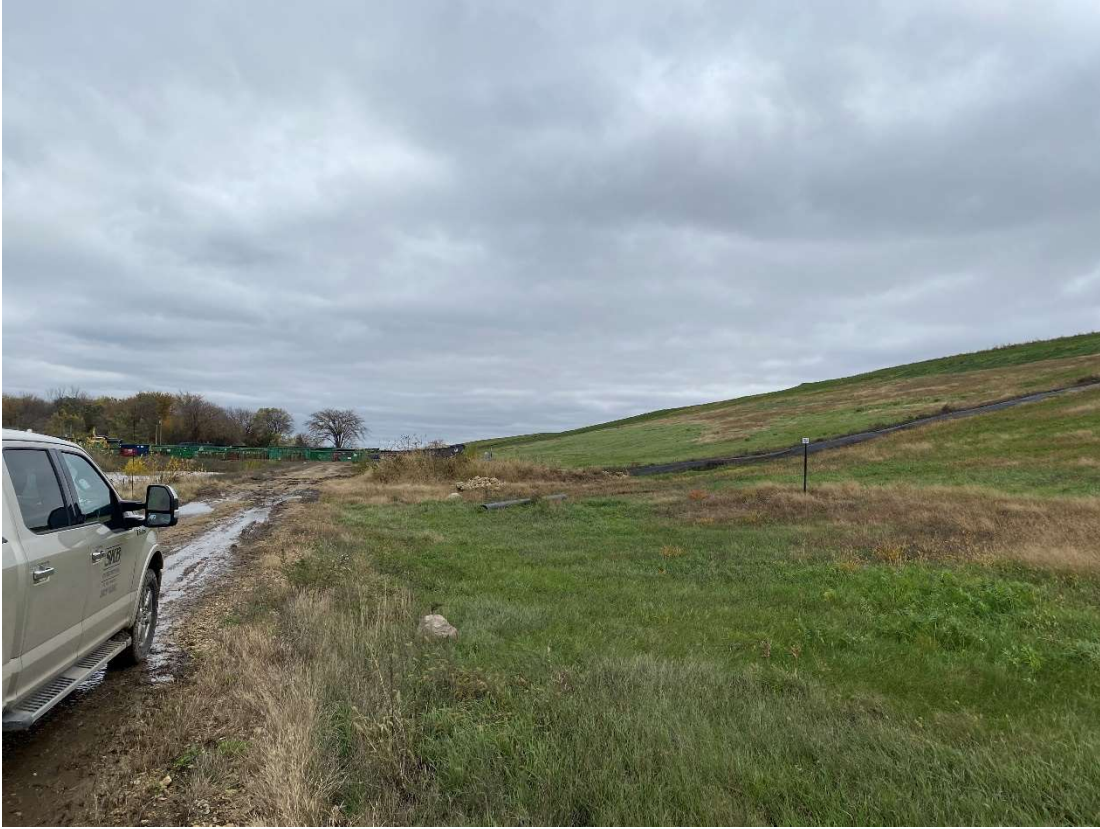
Location 1 – Looking Southeast, Cell 3A & 3B Waste Slope & Anchor Trench

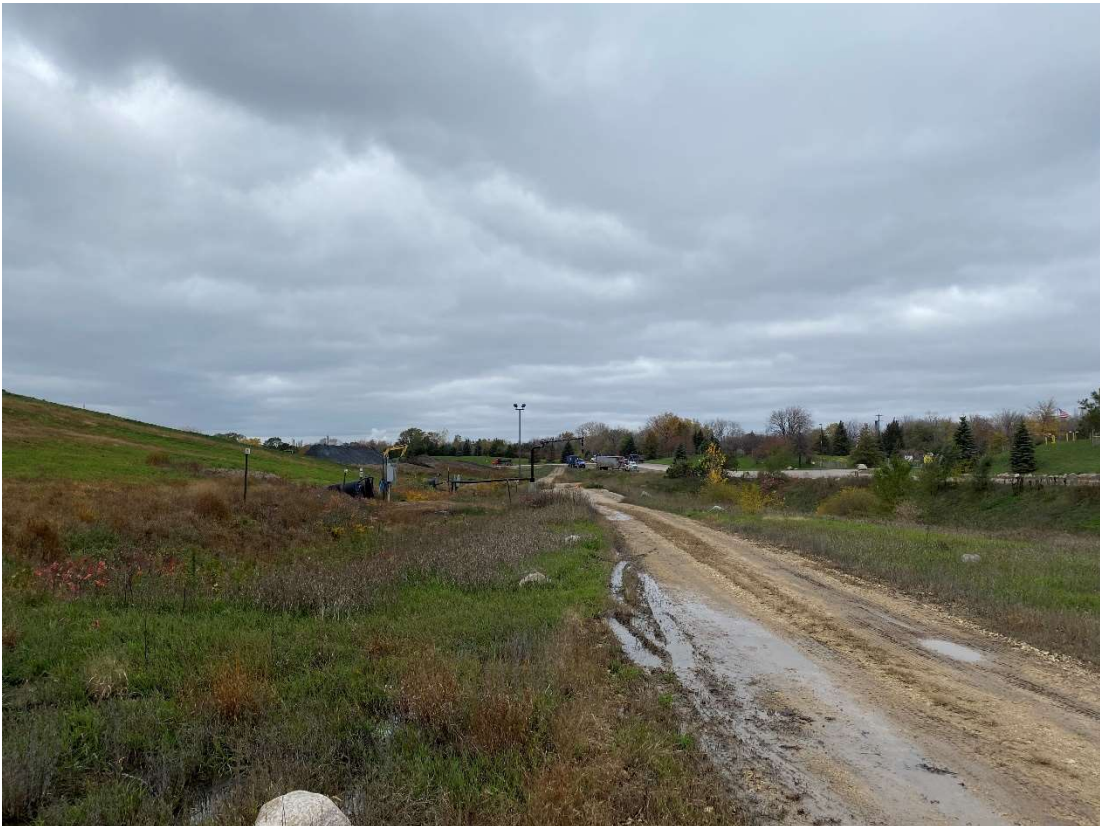
Location 1 – Looking Northwest, Cell 3 Berm

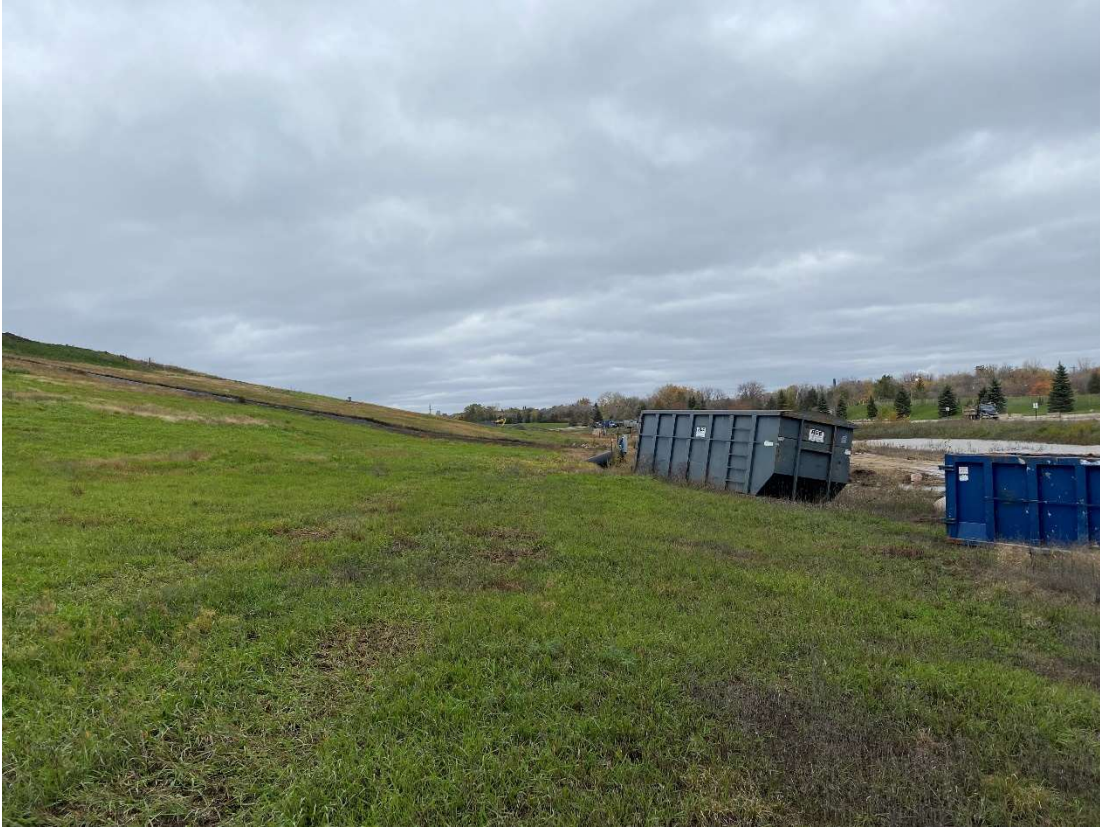
Location 2 – Looking Northwest, Cell 3 Berm & Stormwater Pond

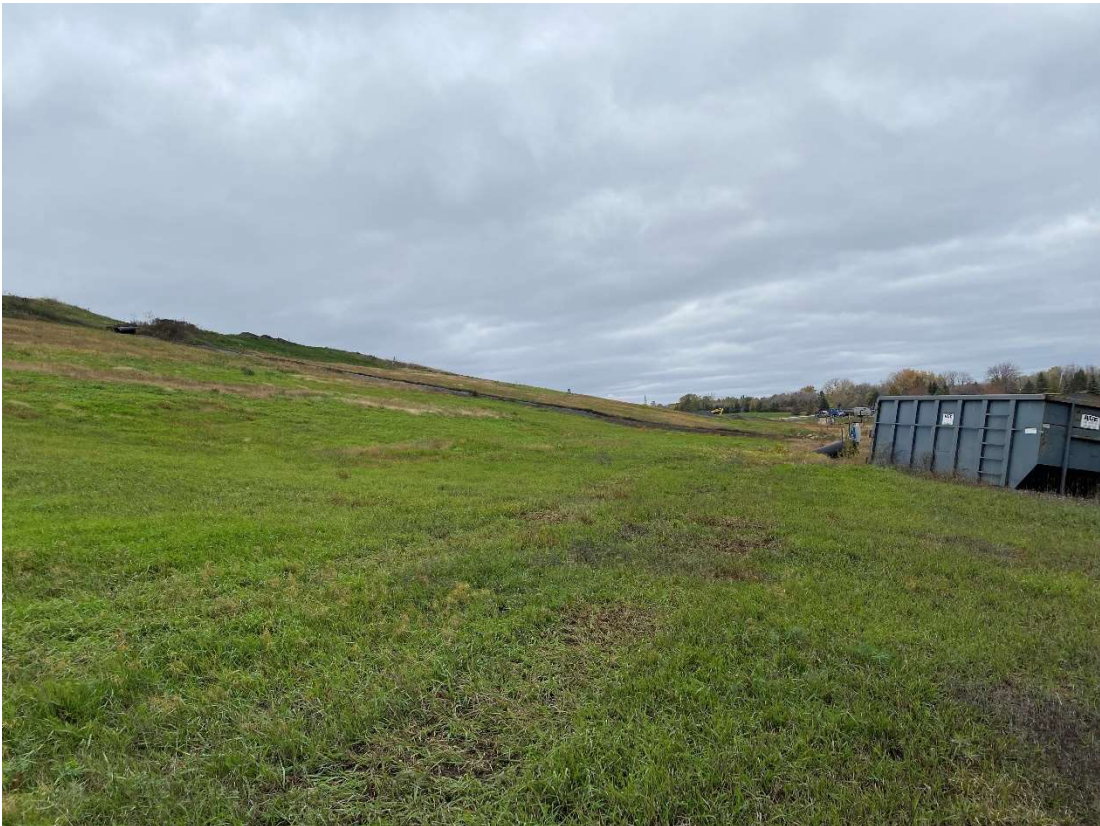
Location 2 – Looking Northwest, Cell 3 Anchor Trench and Waste Slope

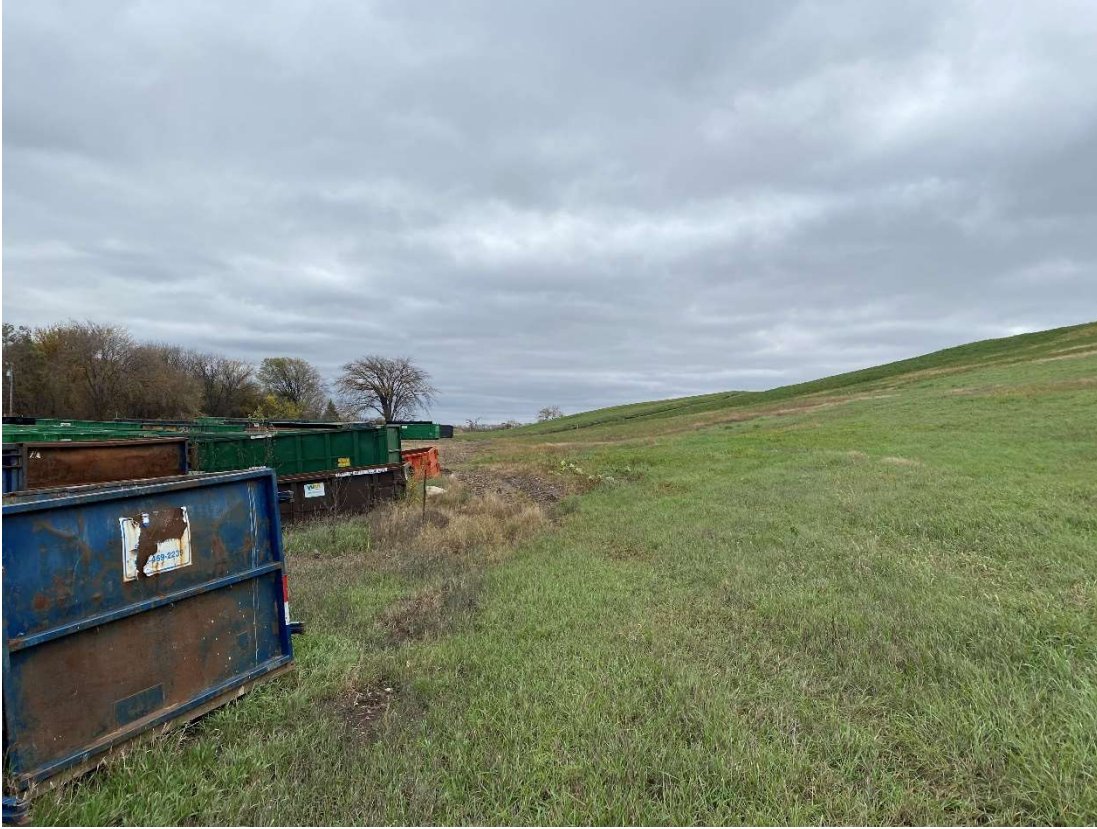
Location 2 – Looking Southeast, Cell 3A Anchor Trench and Northeastern Waste Slope

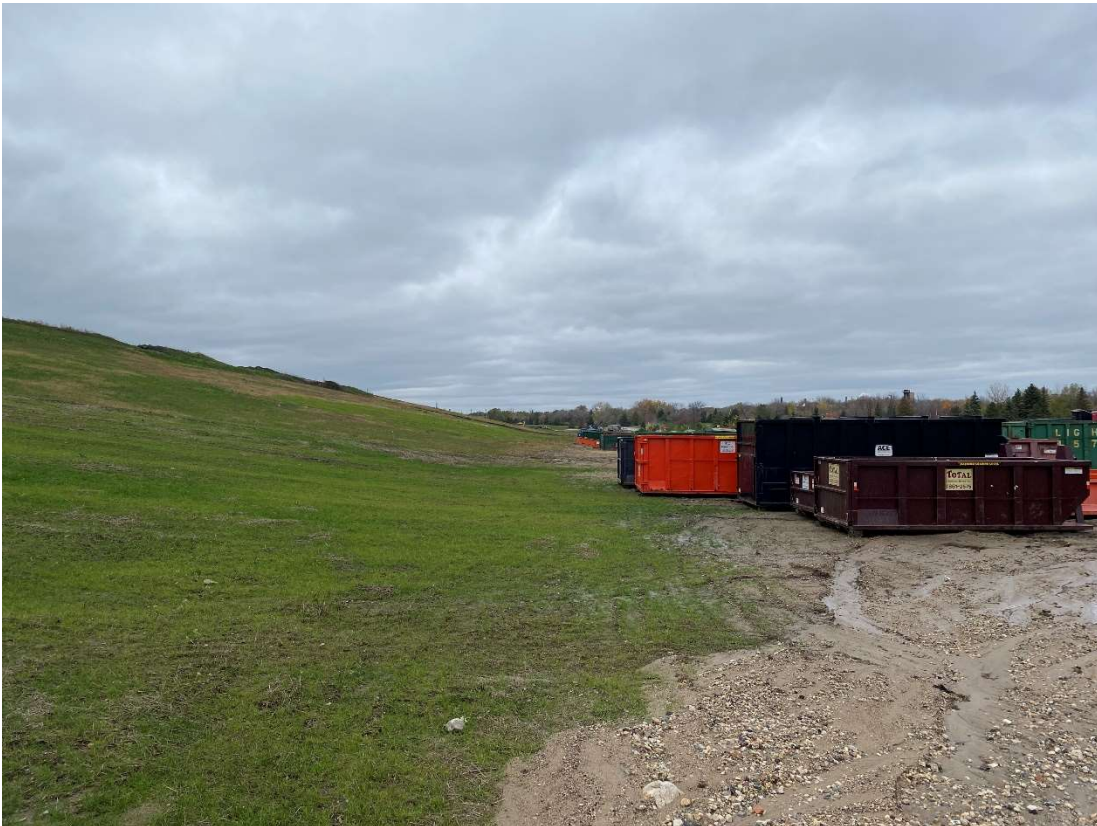
Location 3 – Looking Northwest, Cell 3A Anchor Trench and Northeastern Waste Slope

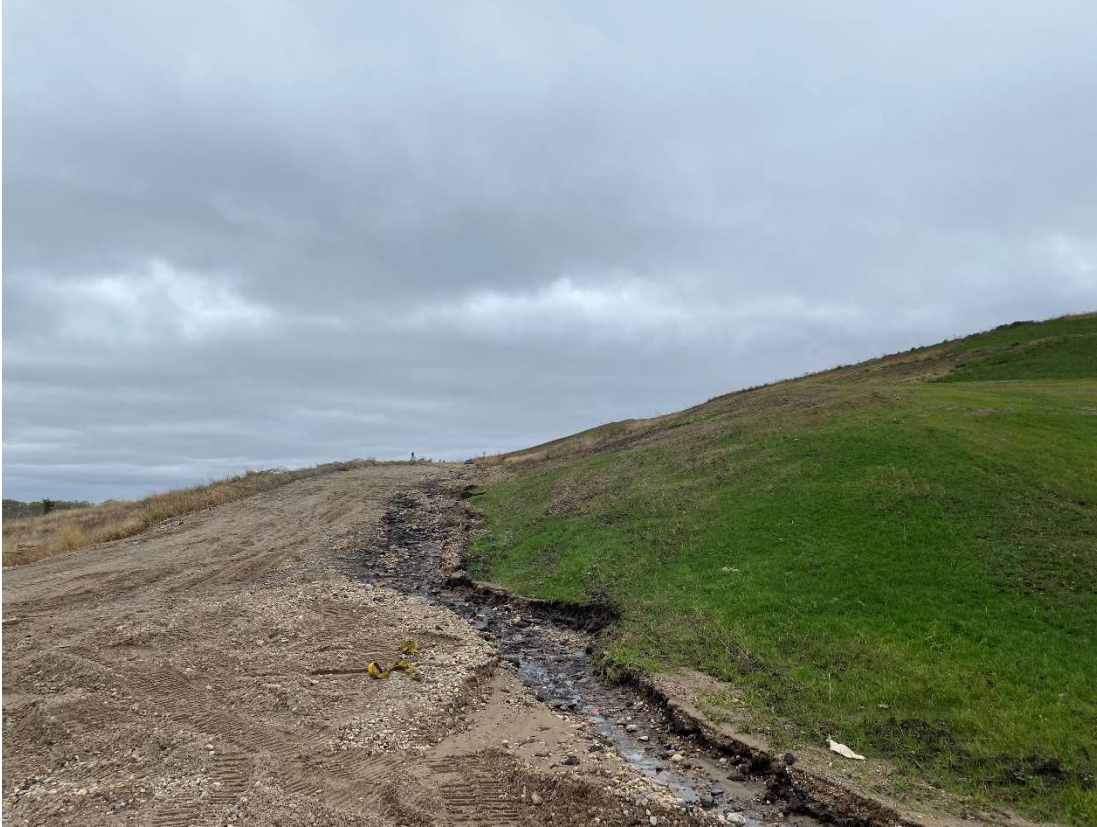
Location 3 – Looking Southwest, Cell 3 East Corner at toe of Interior Access Road

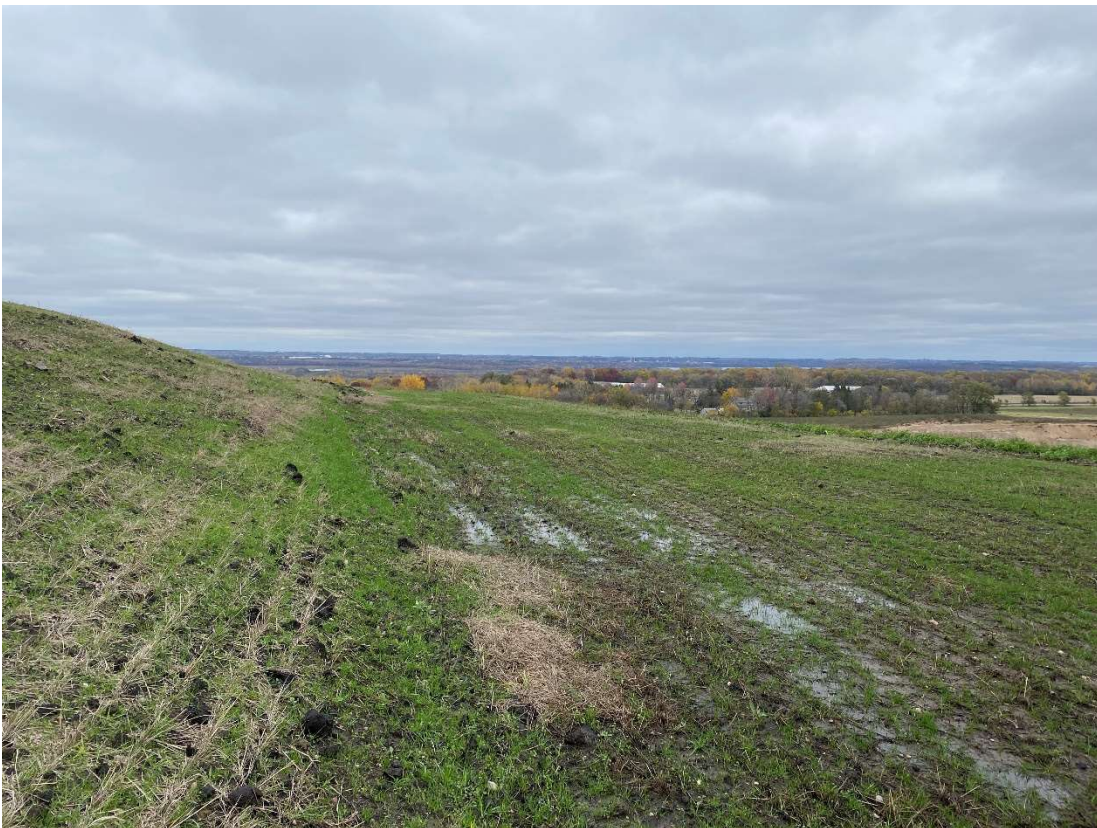
Location 4 – Looking Northeast, Cell 3 Liner Limit

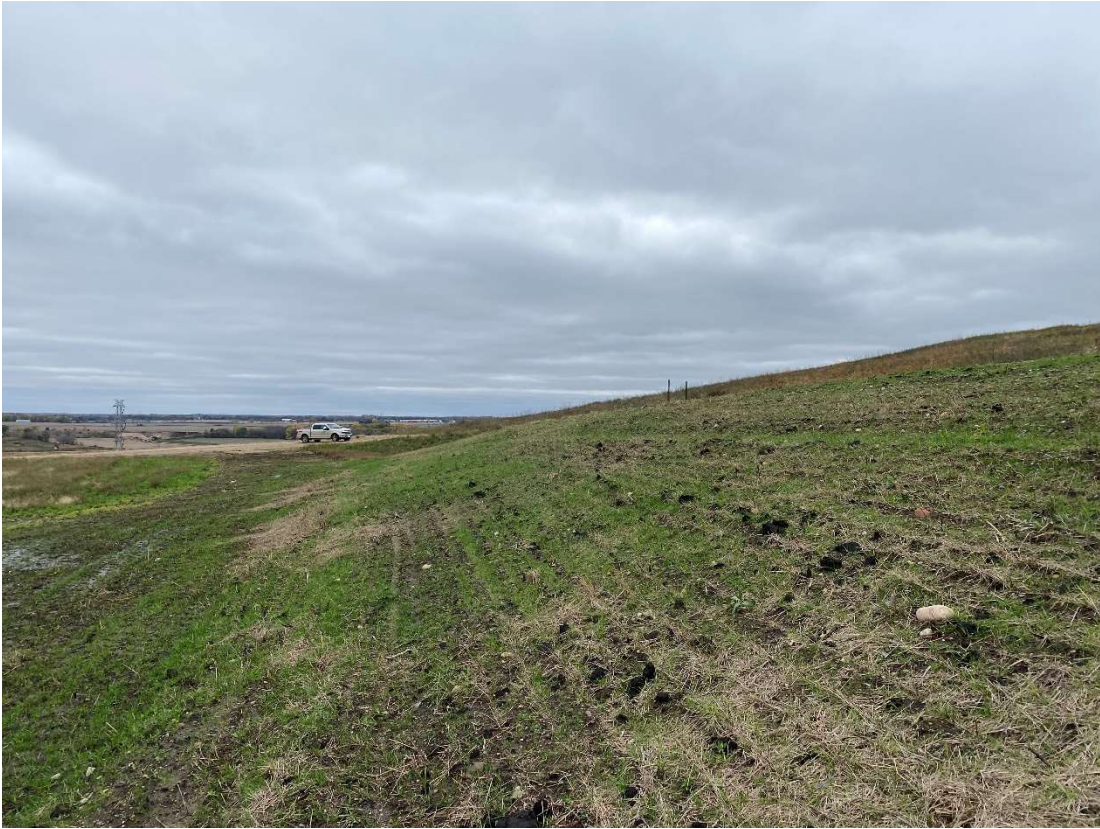
Location 4 – Looking Southwest, Cell 3 Liner Limit

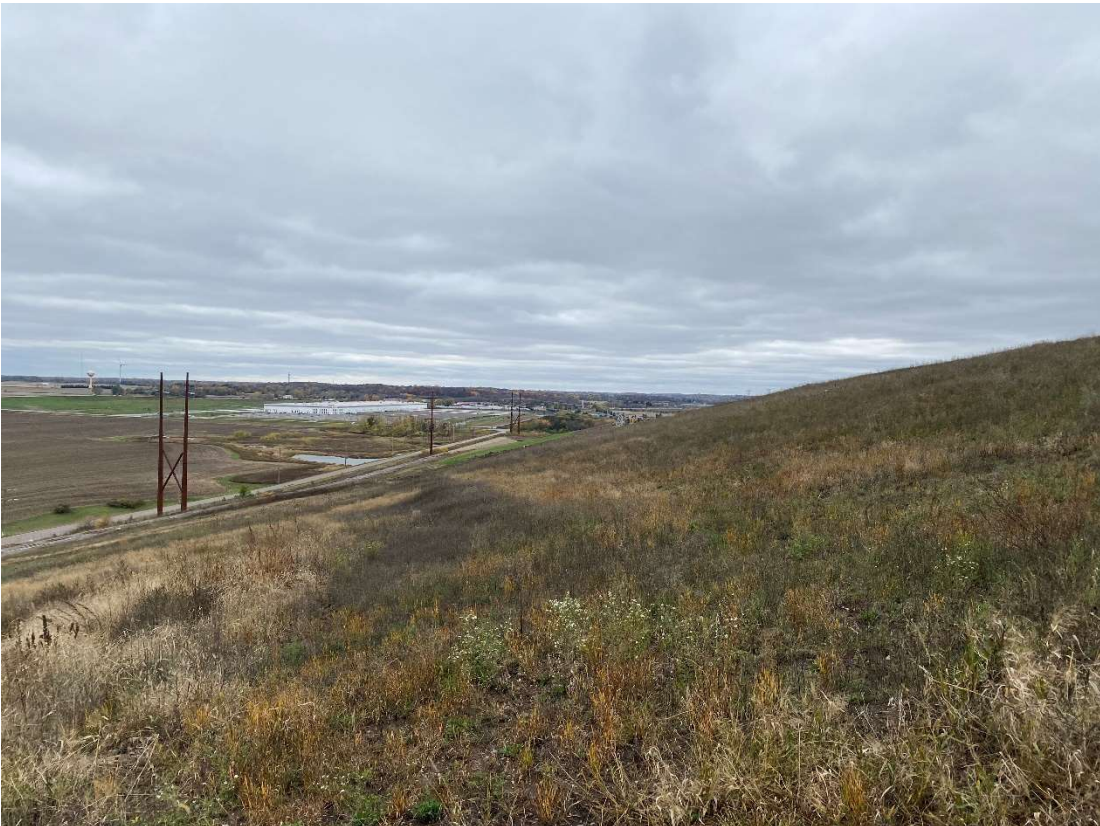
Location 5 – Looking Southwest, Phase 3 Liner Limit

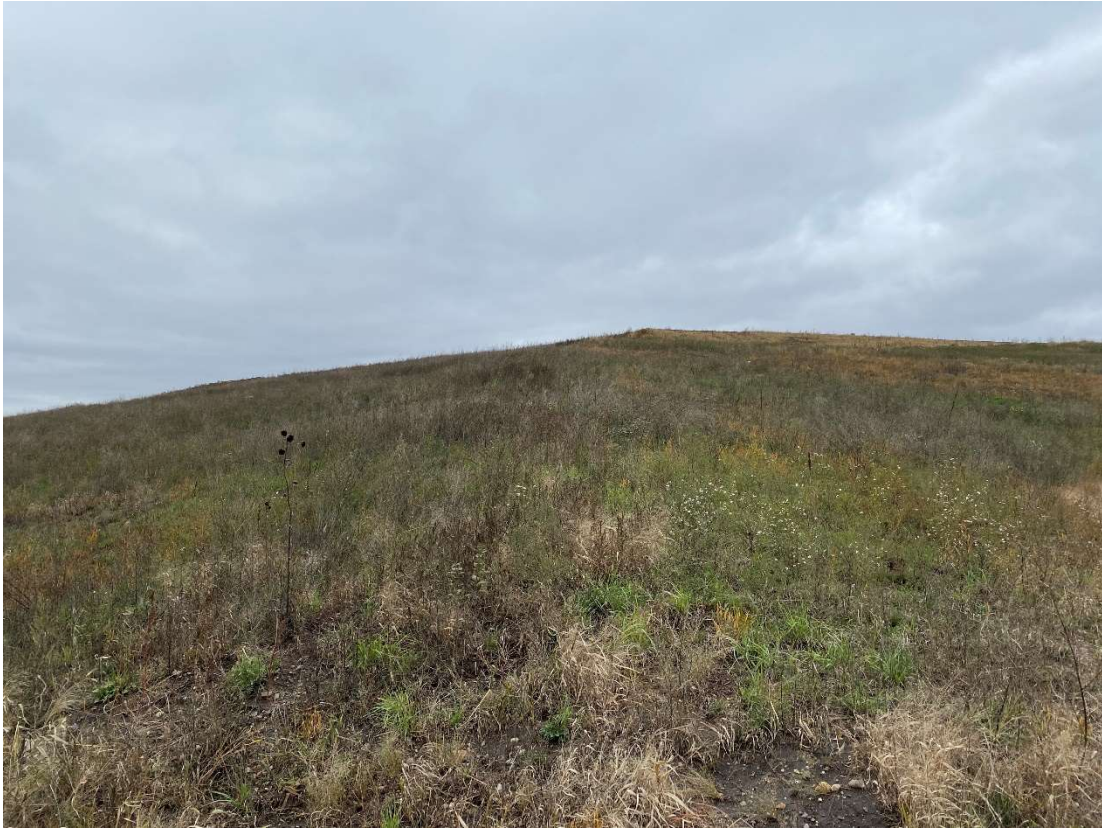
Location 5 – Looking Northwest, at Phase 3 Liner Limit

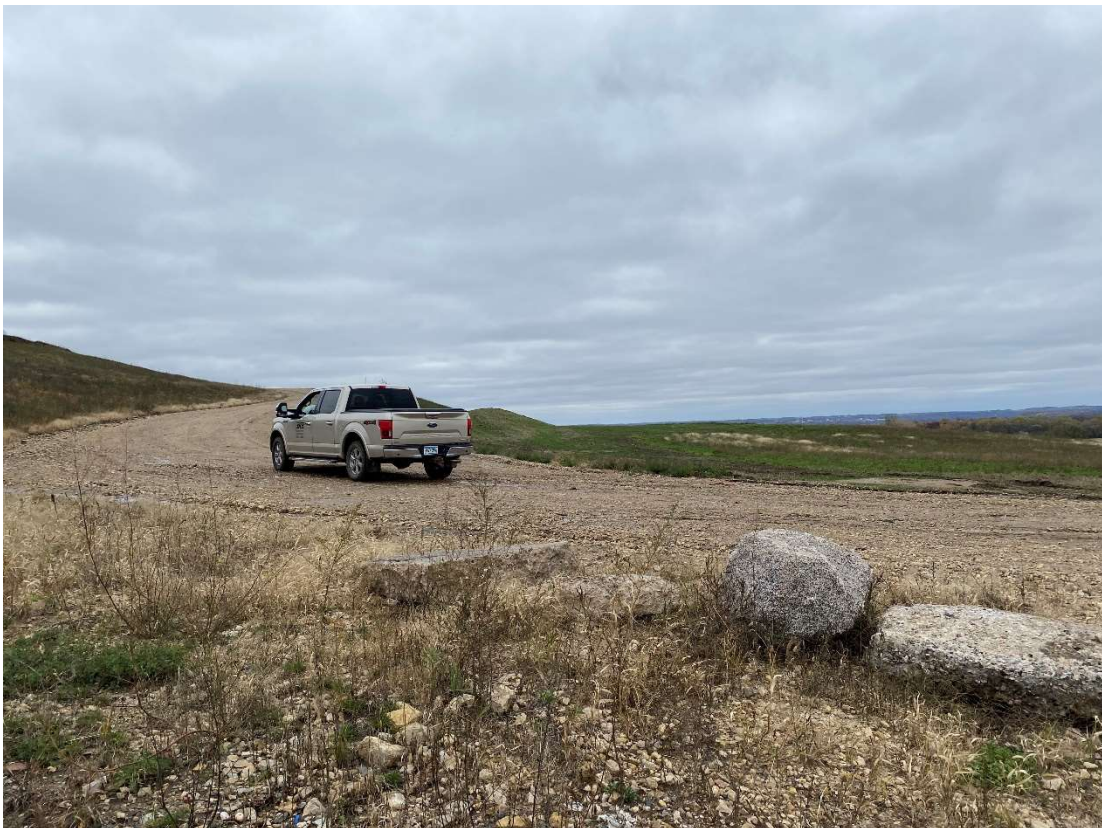
Location 5 – Looking Northeast, Phase 3 Liner Limit

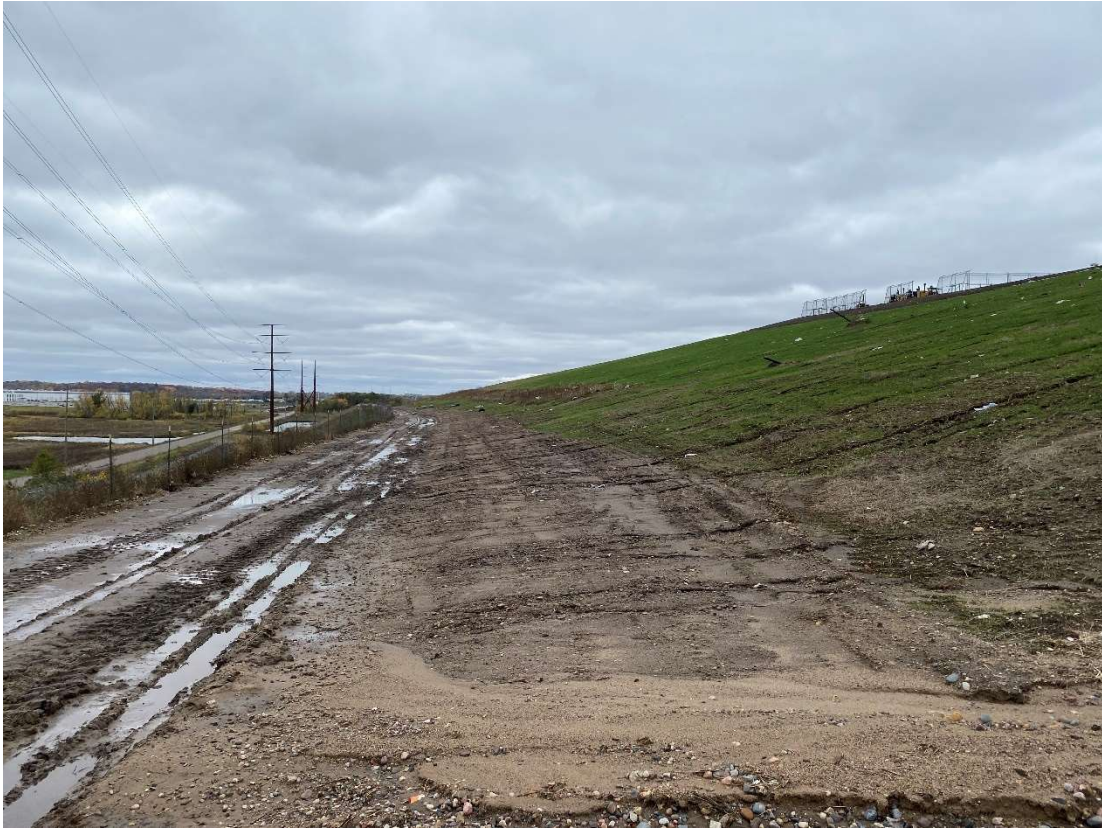
Location 6 – Cell 6 southeast corner, toe of southern waste slope, looking west

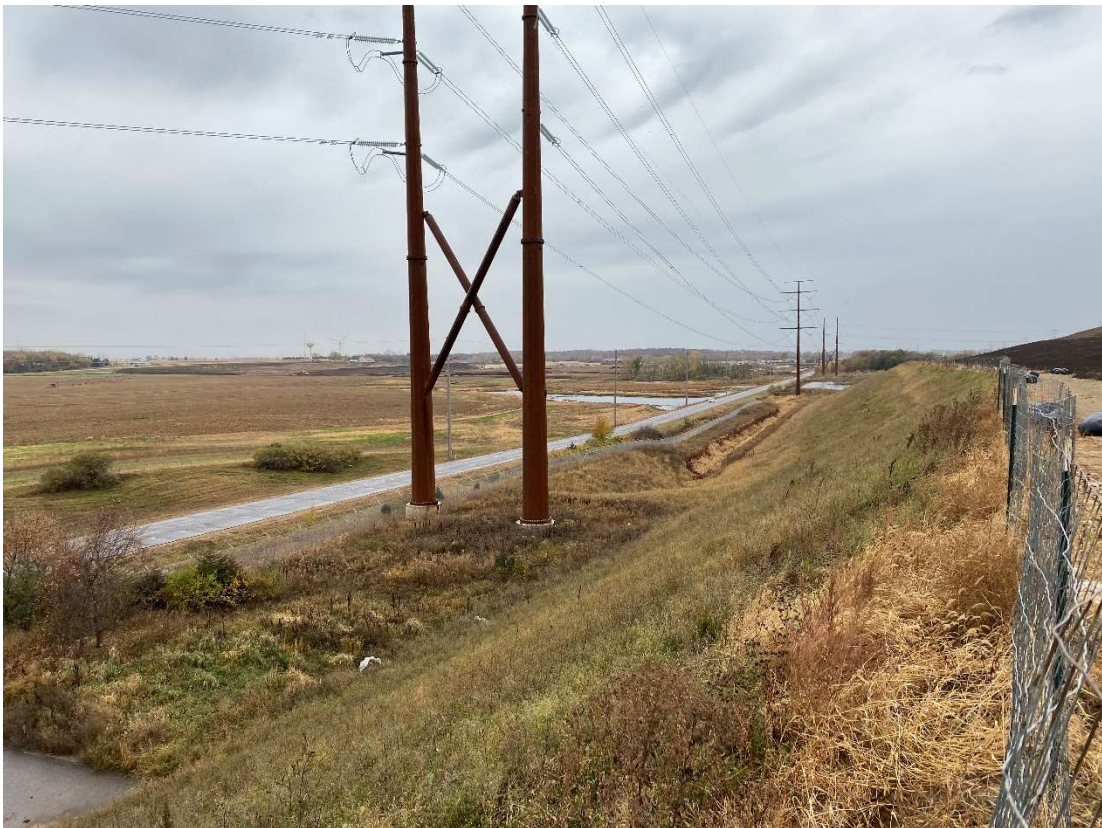
Location 6 – Cell 6, southeast corner, outer berm, looking west

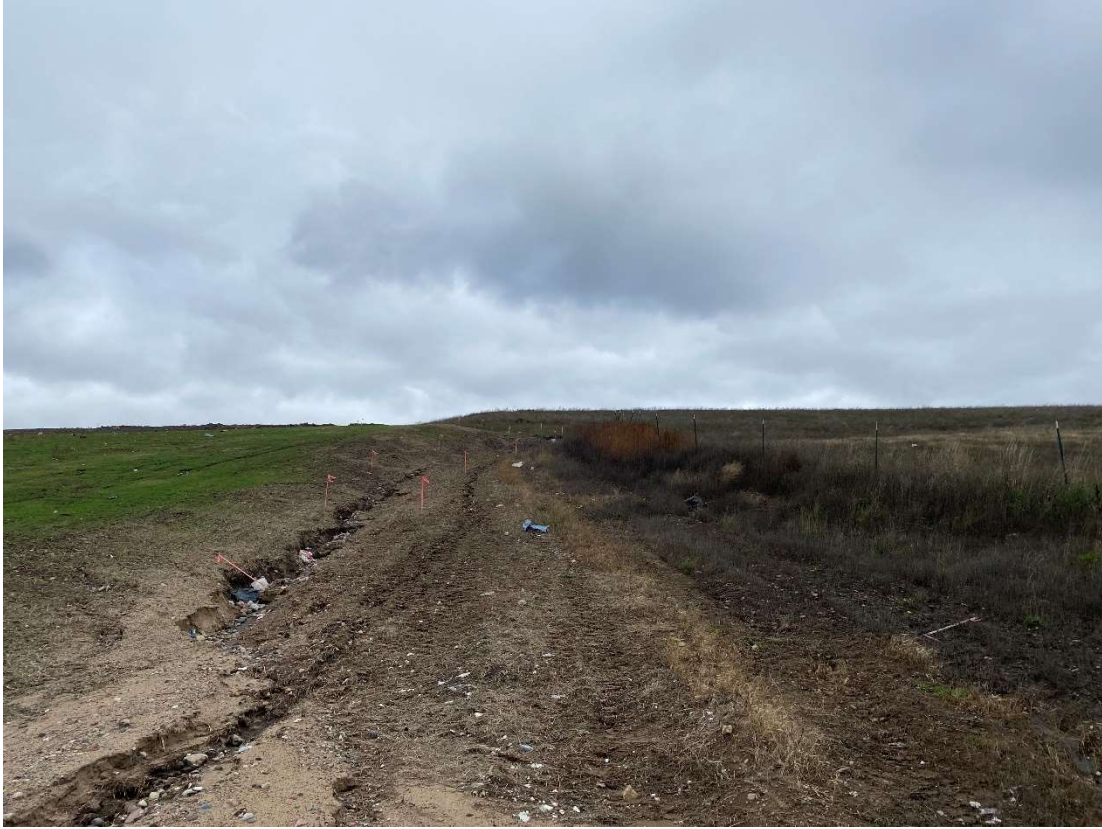
Location 6 – Cell 6, southeast corner, looking north at edge of overlay liner

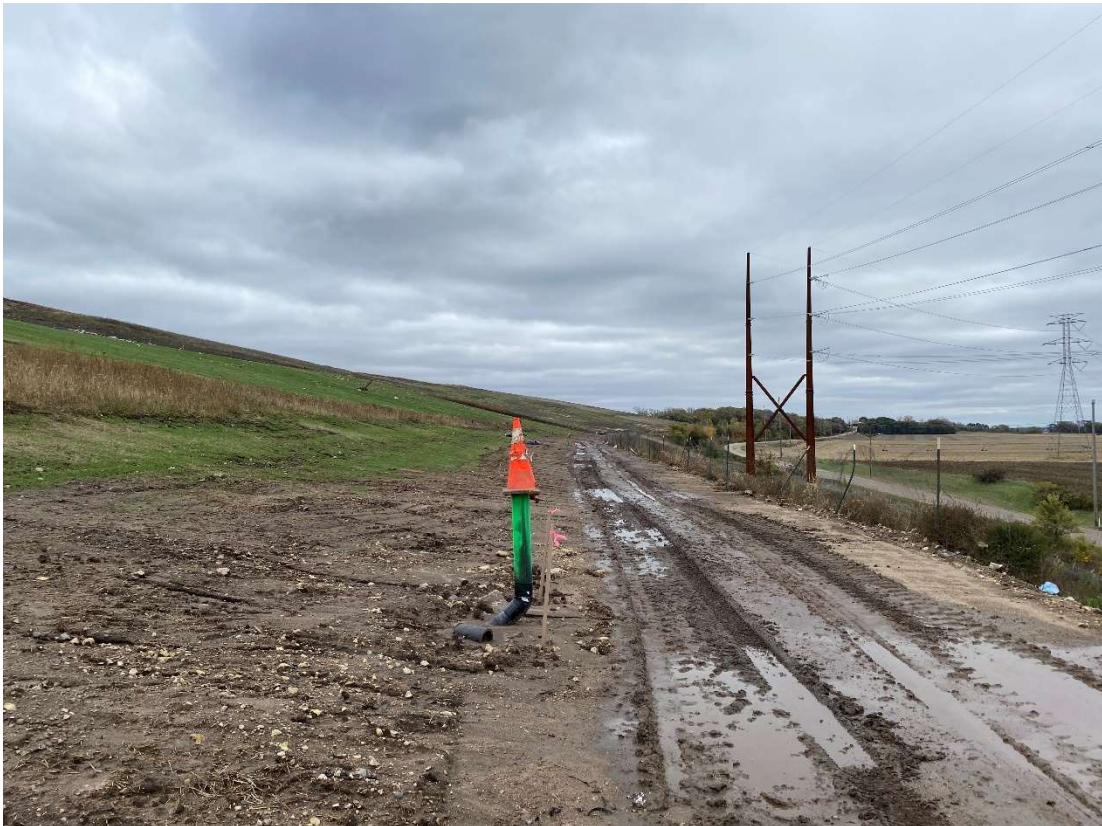
Location 7 – Cell 6, toe of southern waste slope, looking east
