To:	Geoff Strack, P.E. Waste Connections	From:	Brad Sullivan, P.E., Stantec
File:	227704387	Date:	January 7, 2024

Reference: SKB Rosemount Industrial Waste Facility 2023 Annual CCR Inspection Report

Purpose

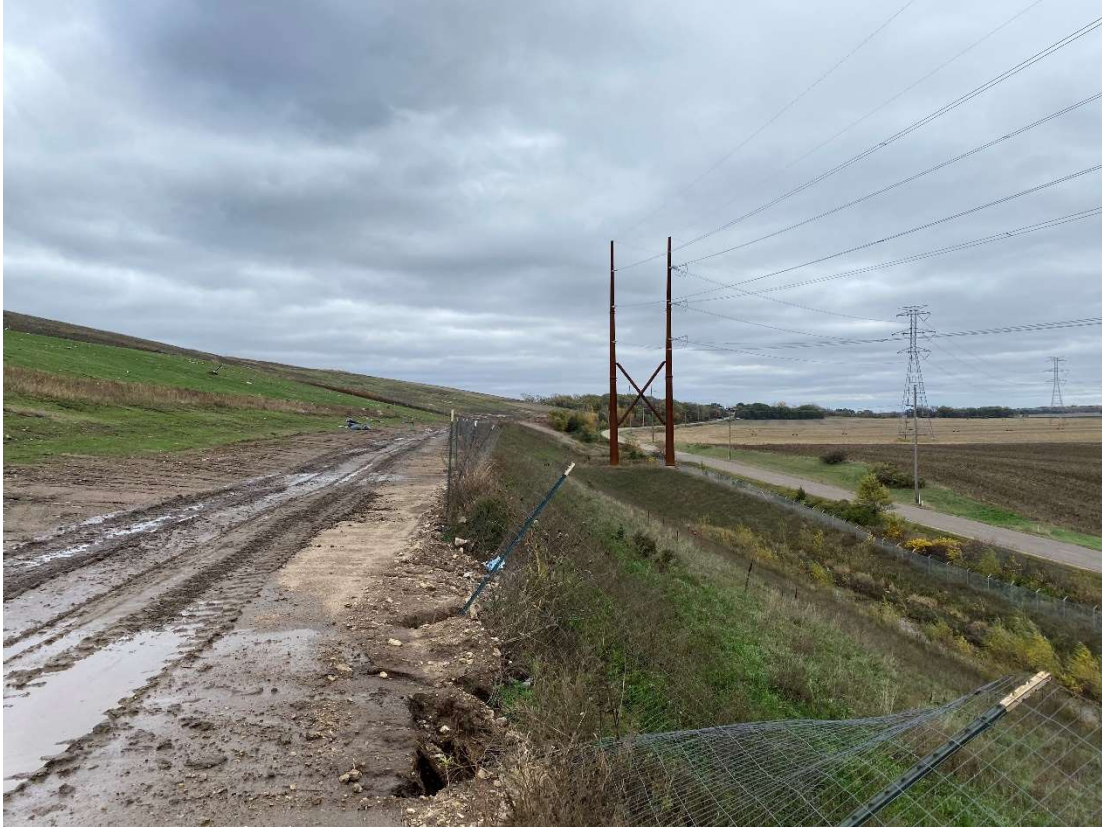
Location 7 – Cell 6, southern outer berm, looking east

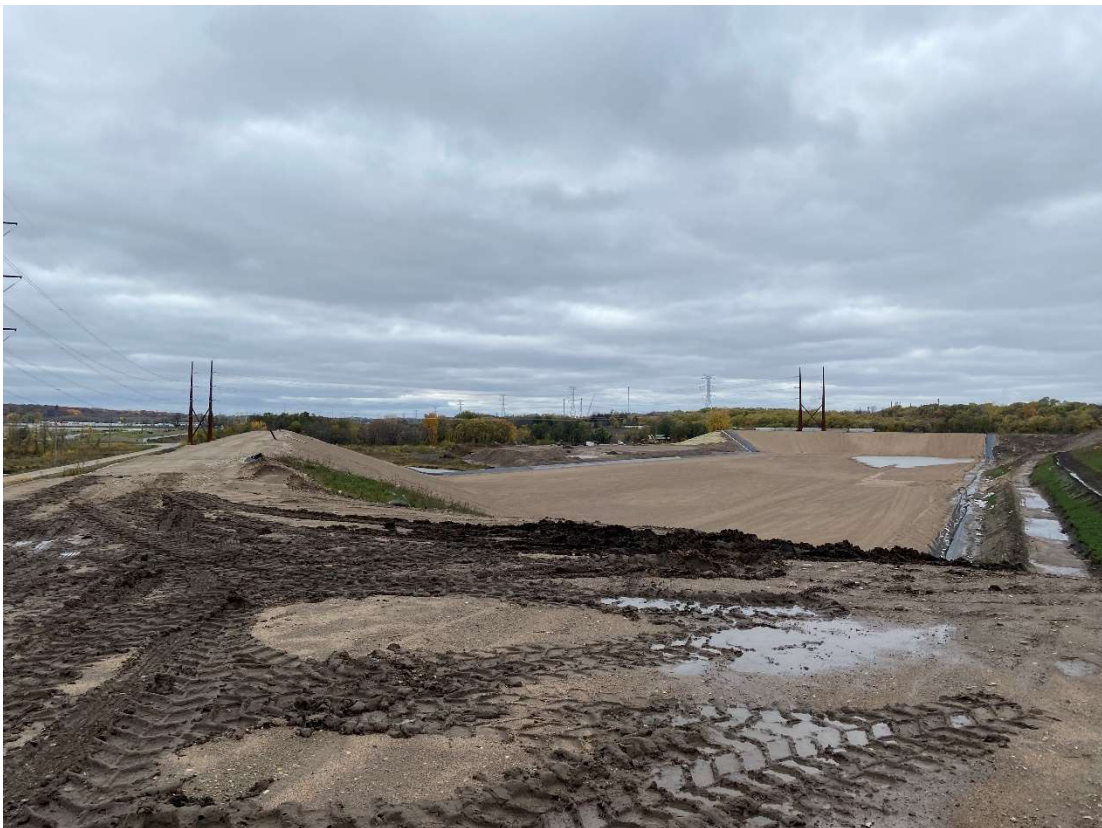
Location 7 – Cell 6, interior of southern landfill berm, looking west

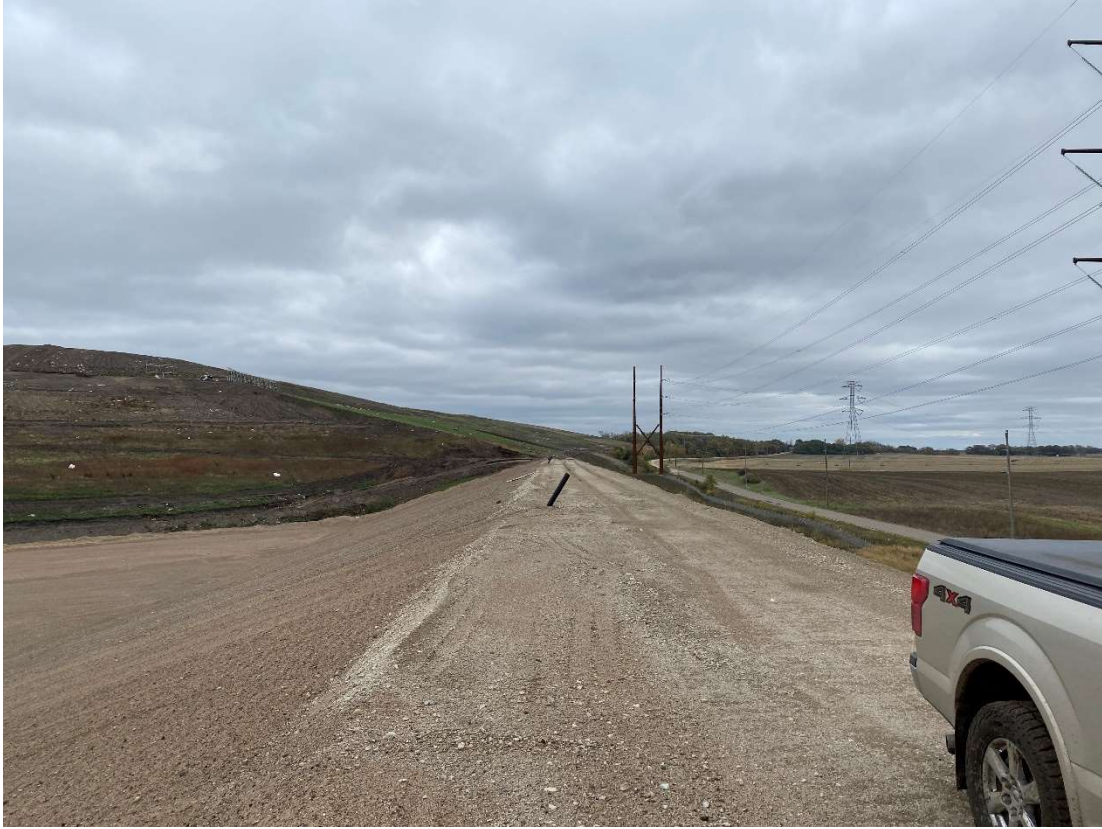
Location 8 – Cell 6, interior of southern landfill berm, looking west

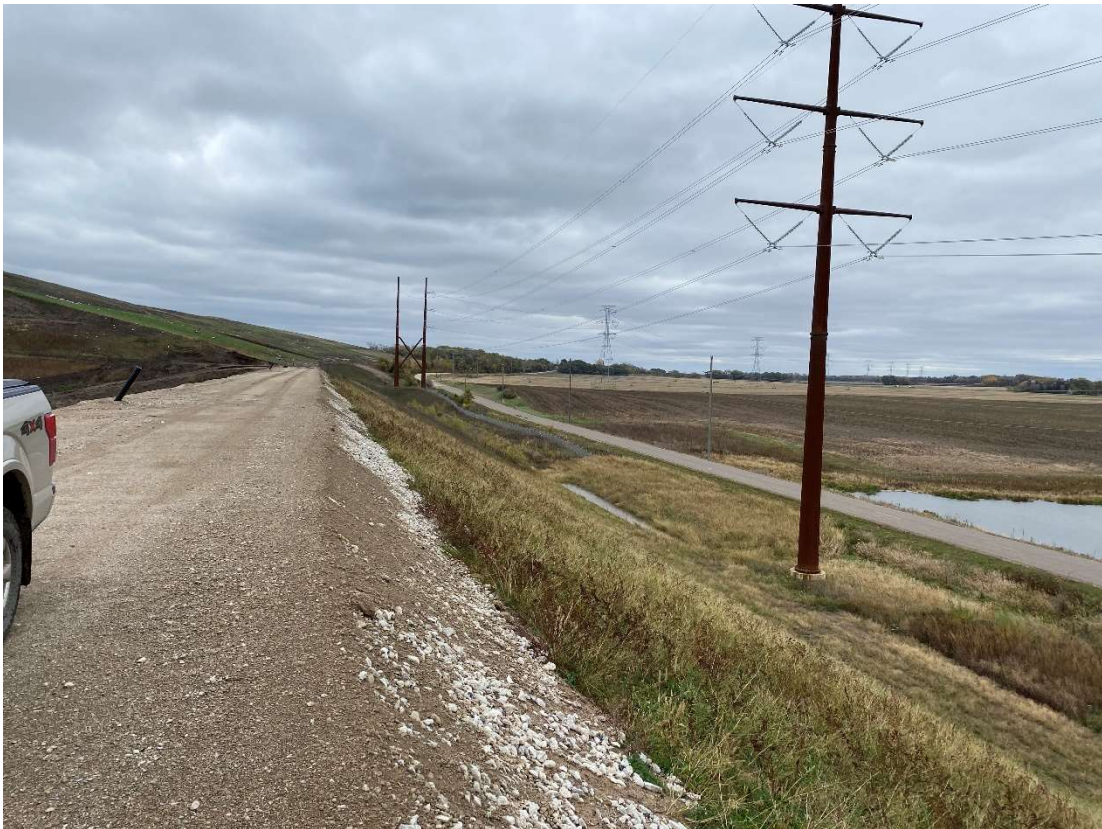
Location 8 – Cell 6, exterior of southern landfill berm, looking west

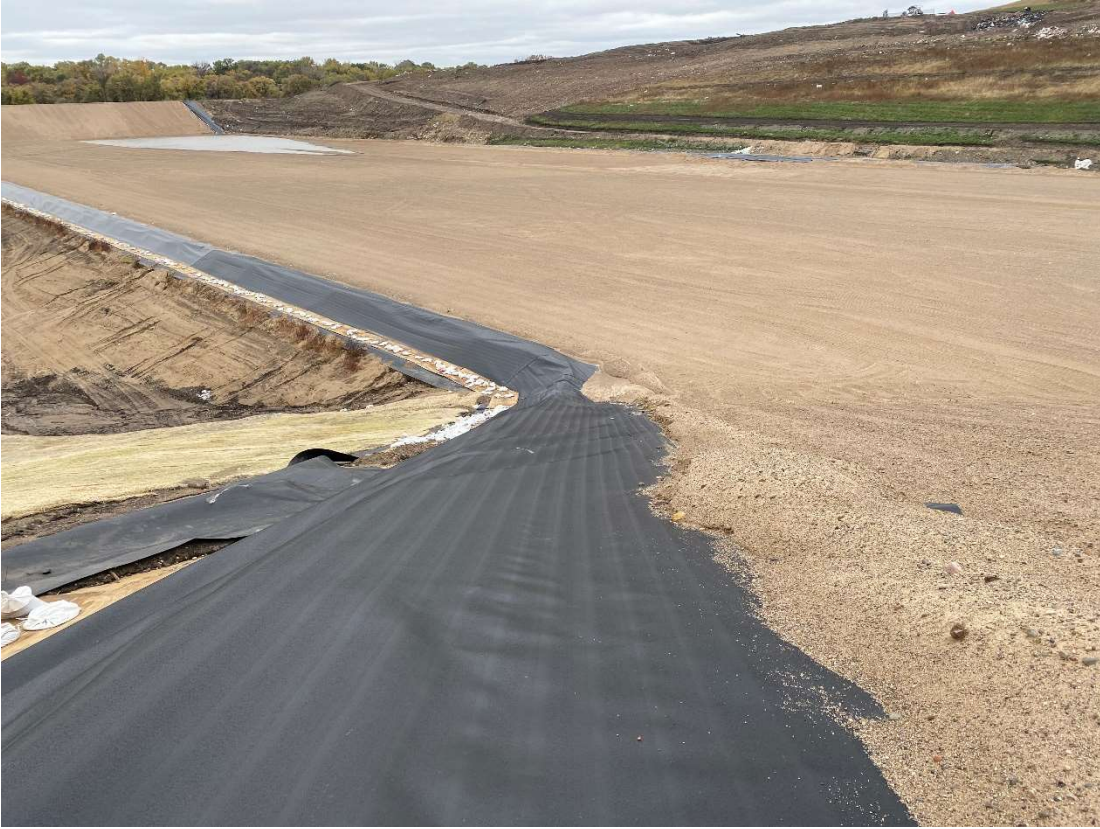
Location 8 – Cell 6, looking north along temporary phase construction berm

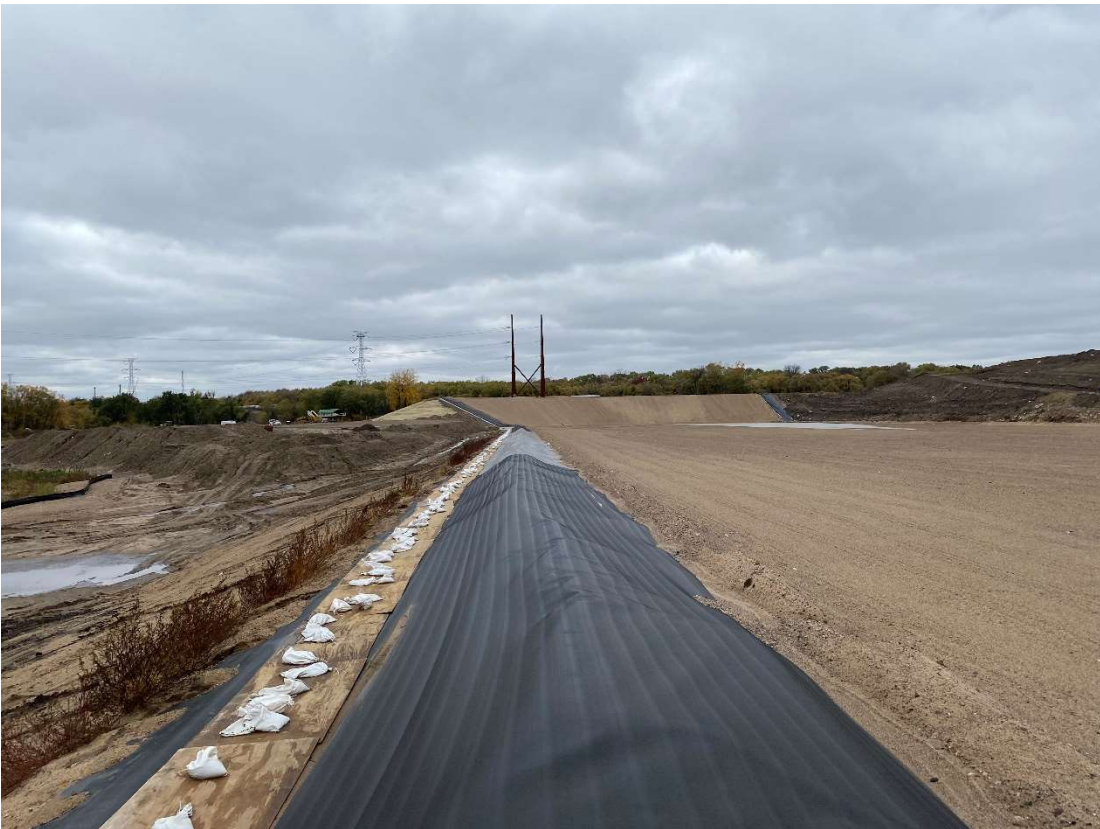
Location 9 – Cell 6, looking northwest along temporary phase construction berm

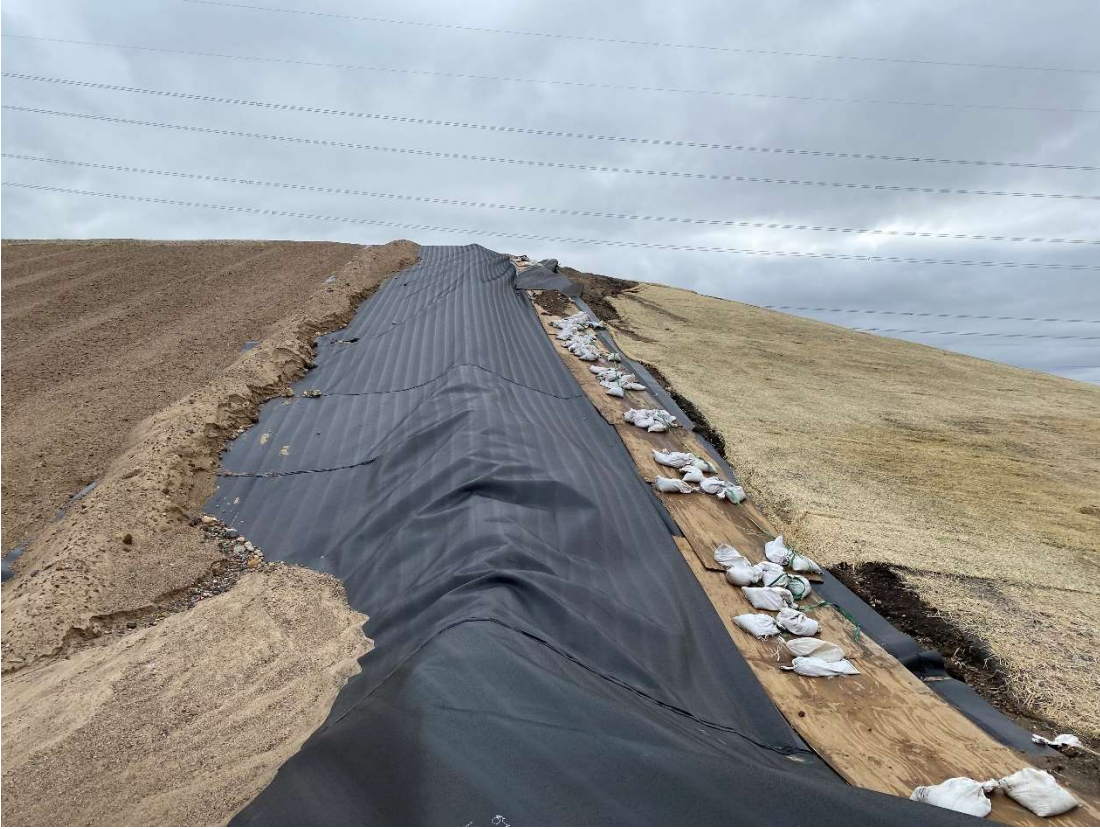
Location 9 – Cell 6, looking south along temporary phase construction berm

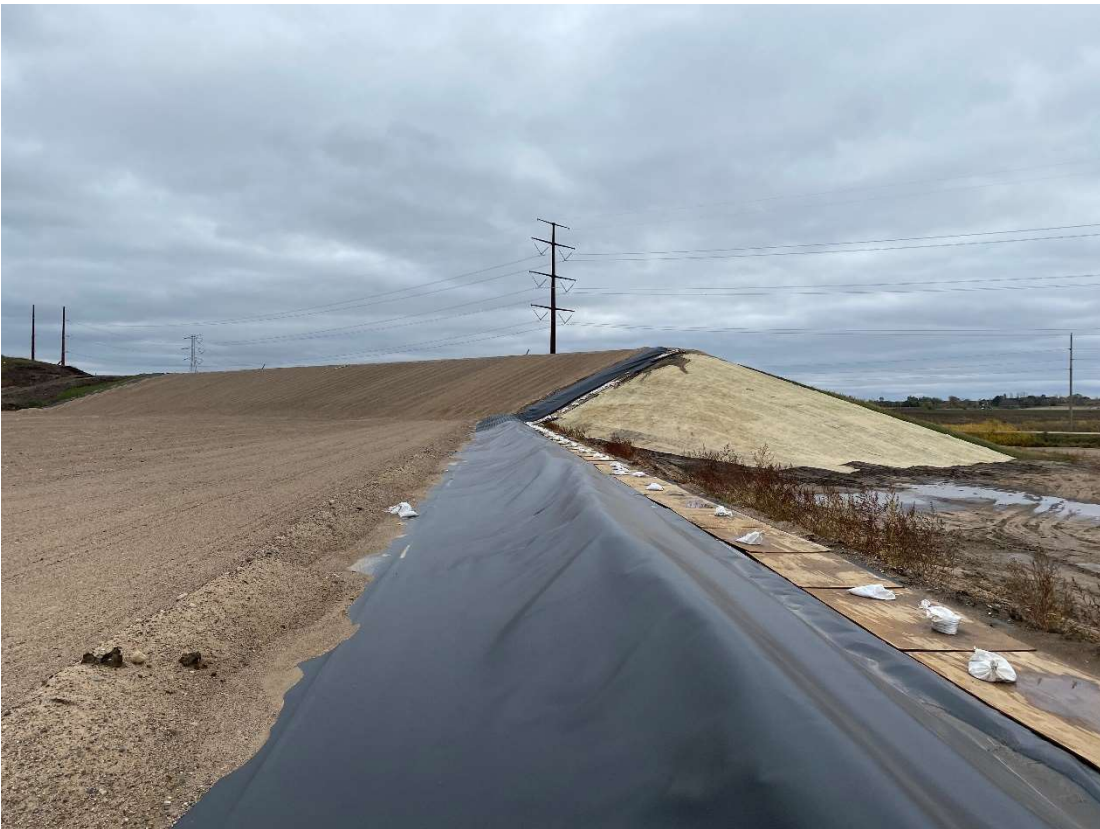
Location 10 – Cell 6, looking southeast along temporary phase construction berm

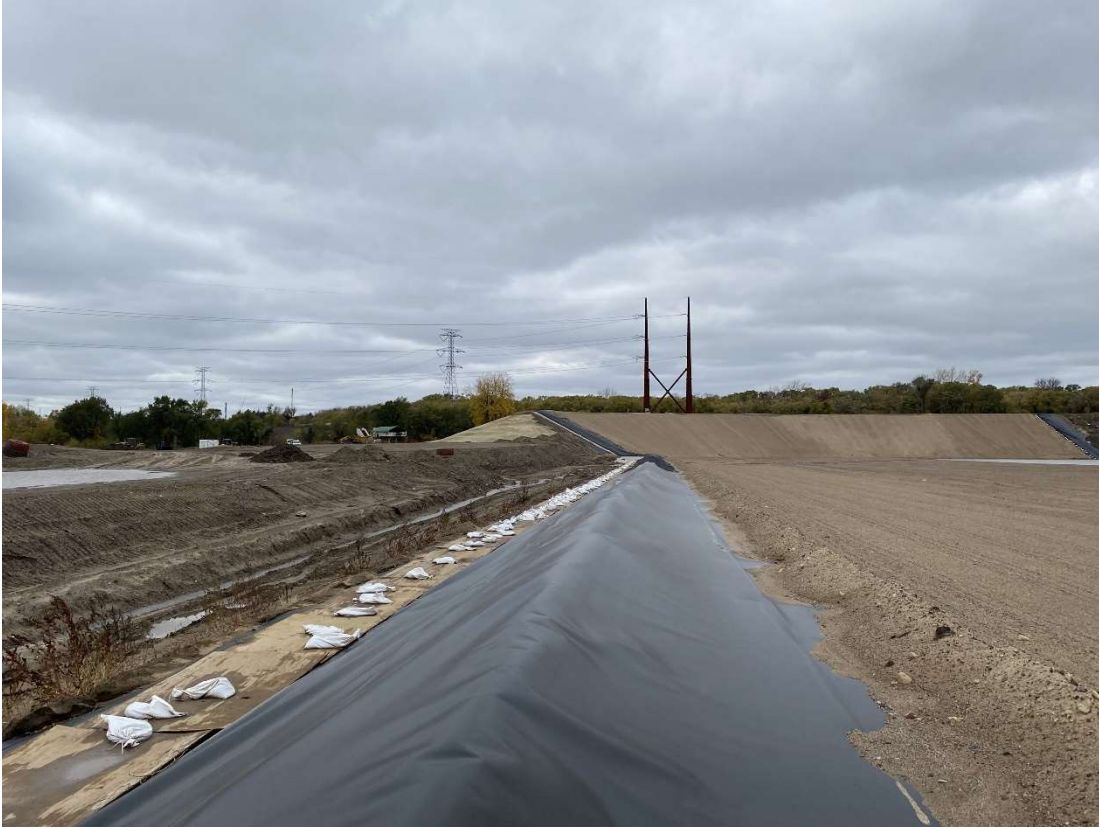
Location 10 – Cell 6, looking northwest along temporary phase construction berm

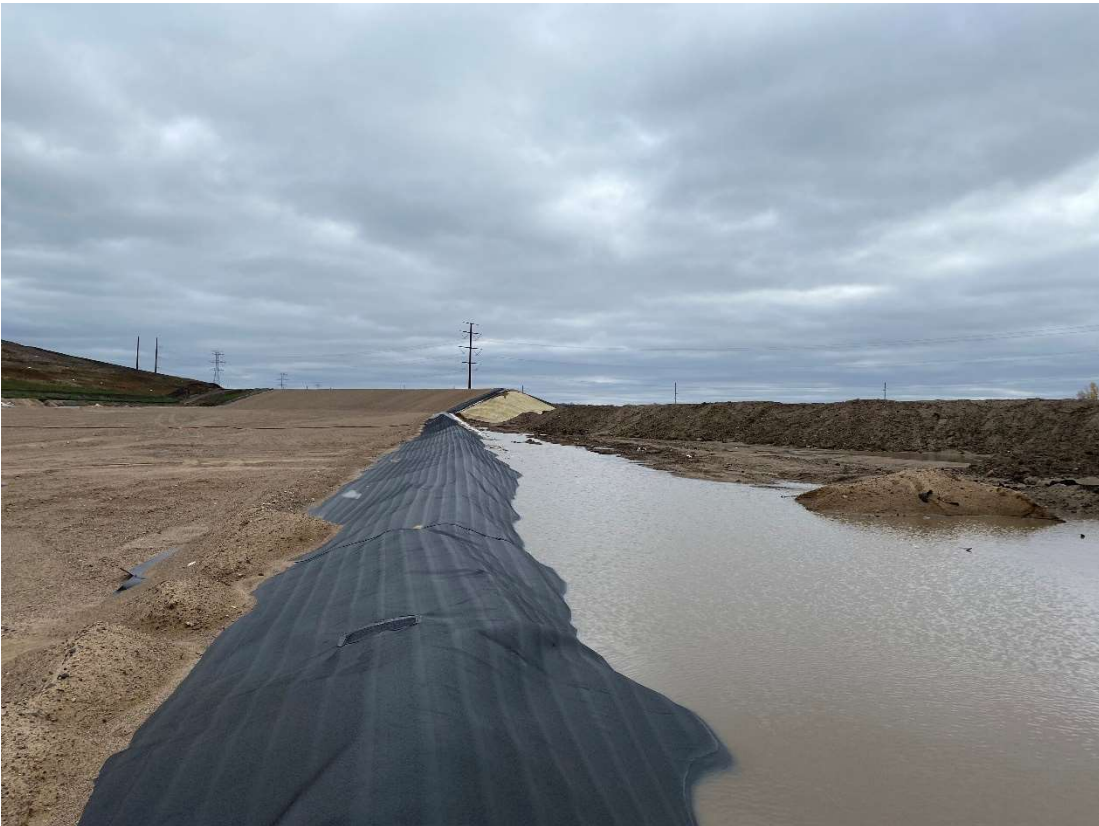
Location 11 – Cell 6, looking southeast along temporary phase construction berm

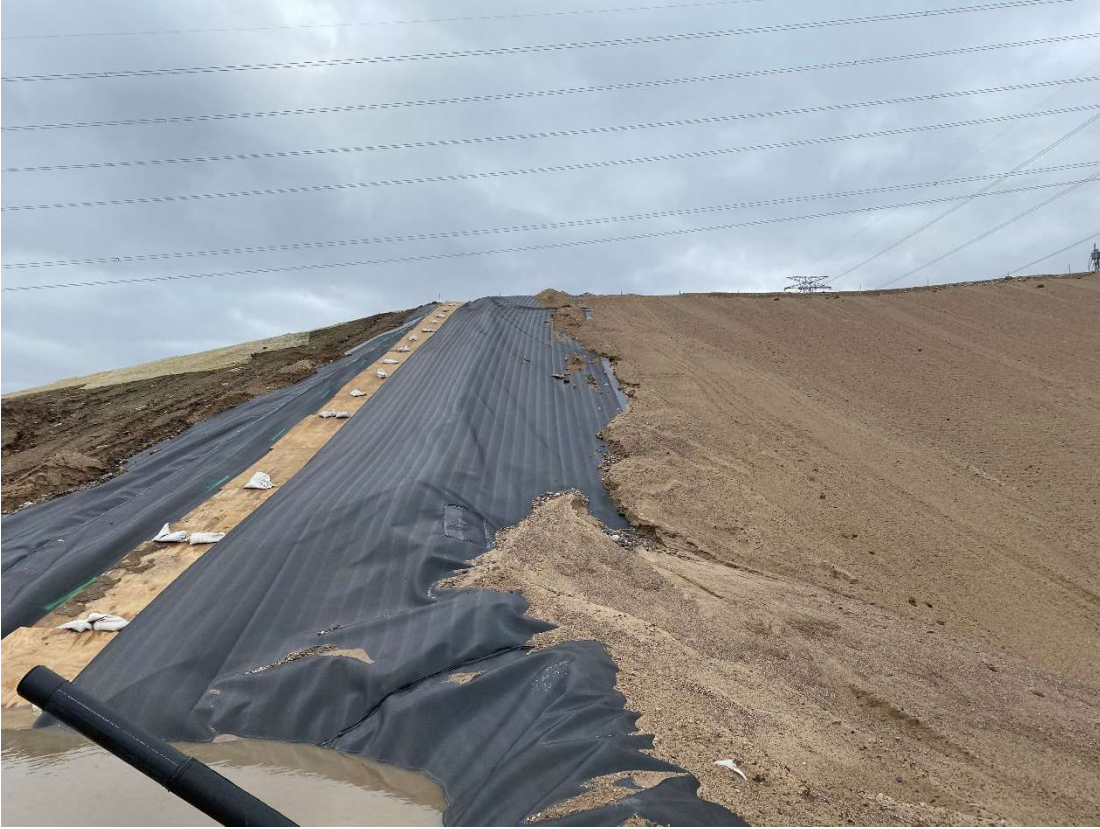
Location 11 – Cell 6, looking west along temporary phase construction berm

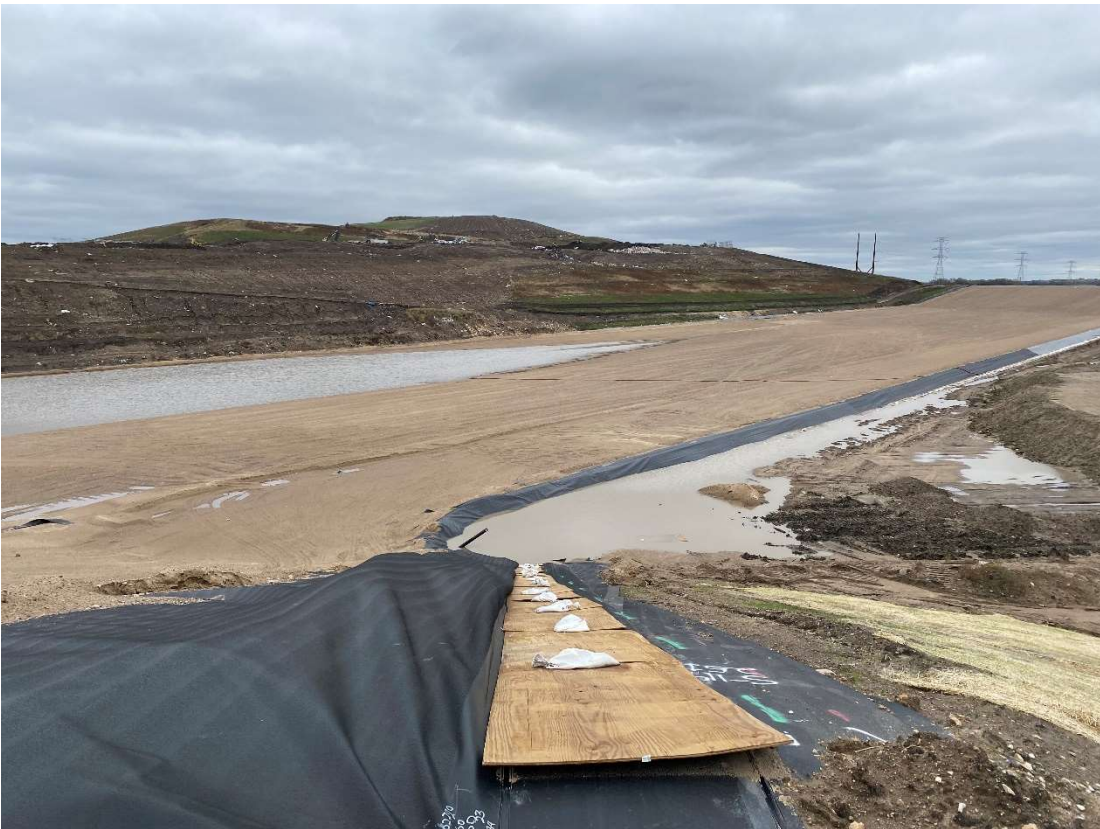
Location 12 – Cell 6, looking east along temporary phase construction berm

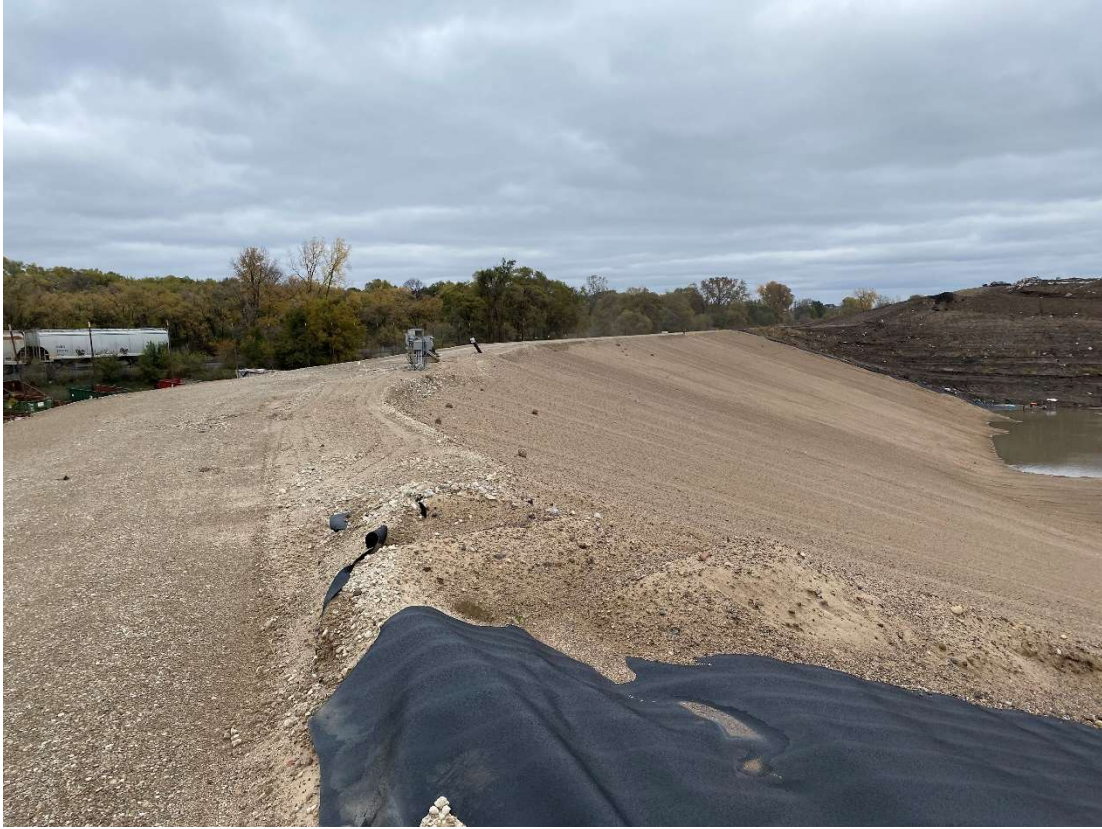
Location 12 – Cell 6, interior top of berm, looking north

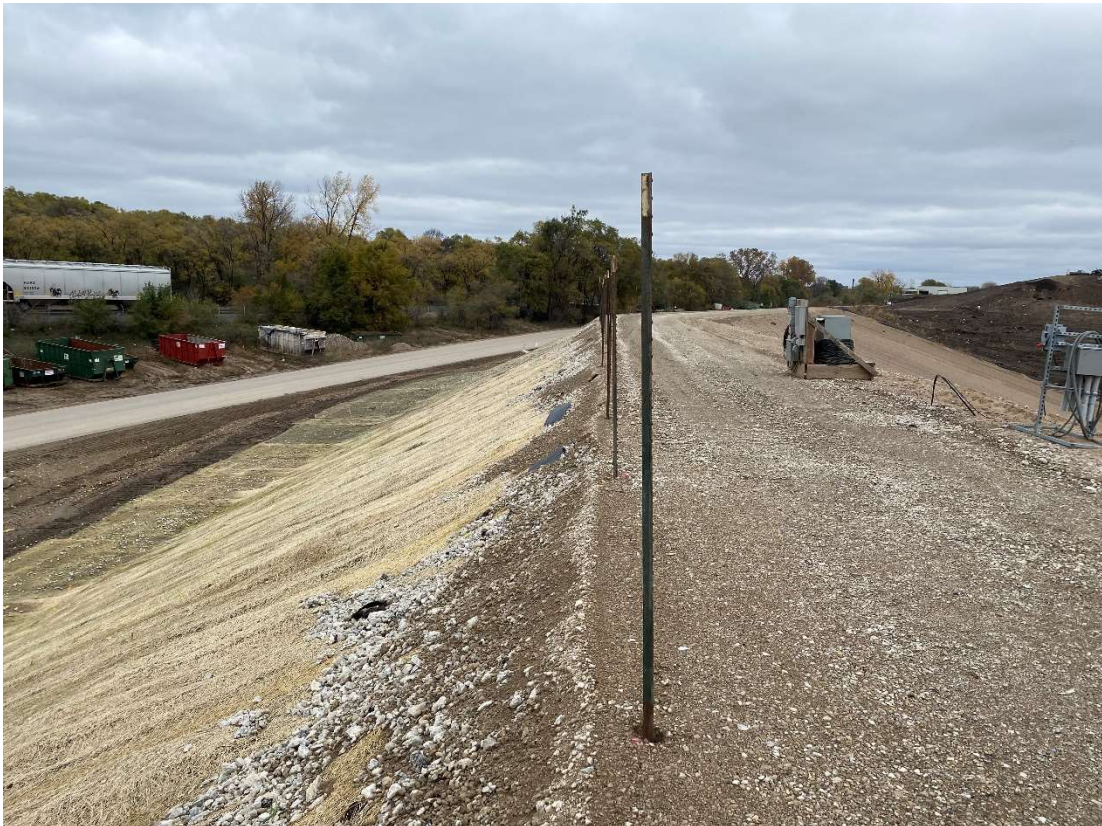
Location 13 – Cell 6, exterior top of berm, looking north

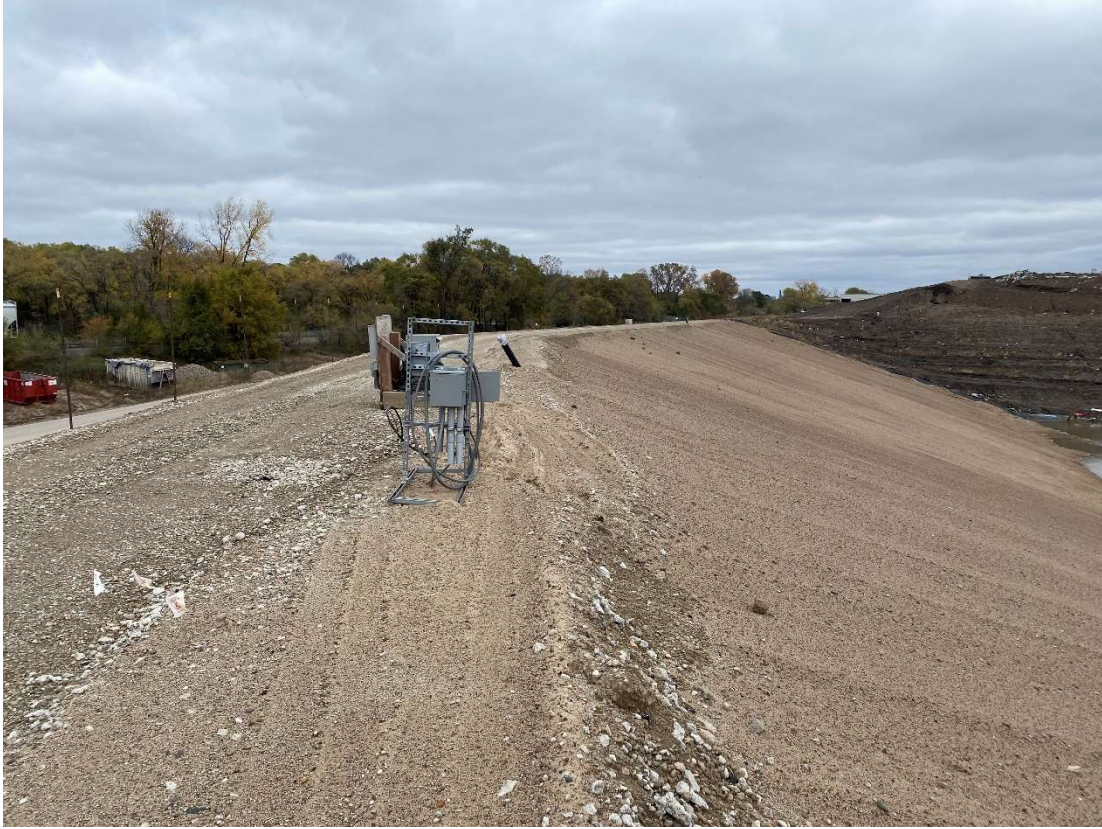
Location 13 – Cell 6, interior top of berm, looking north

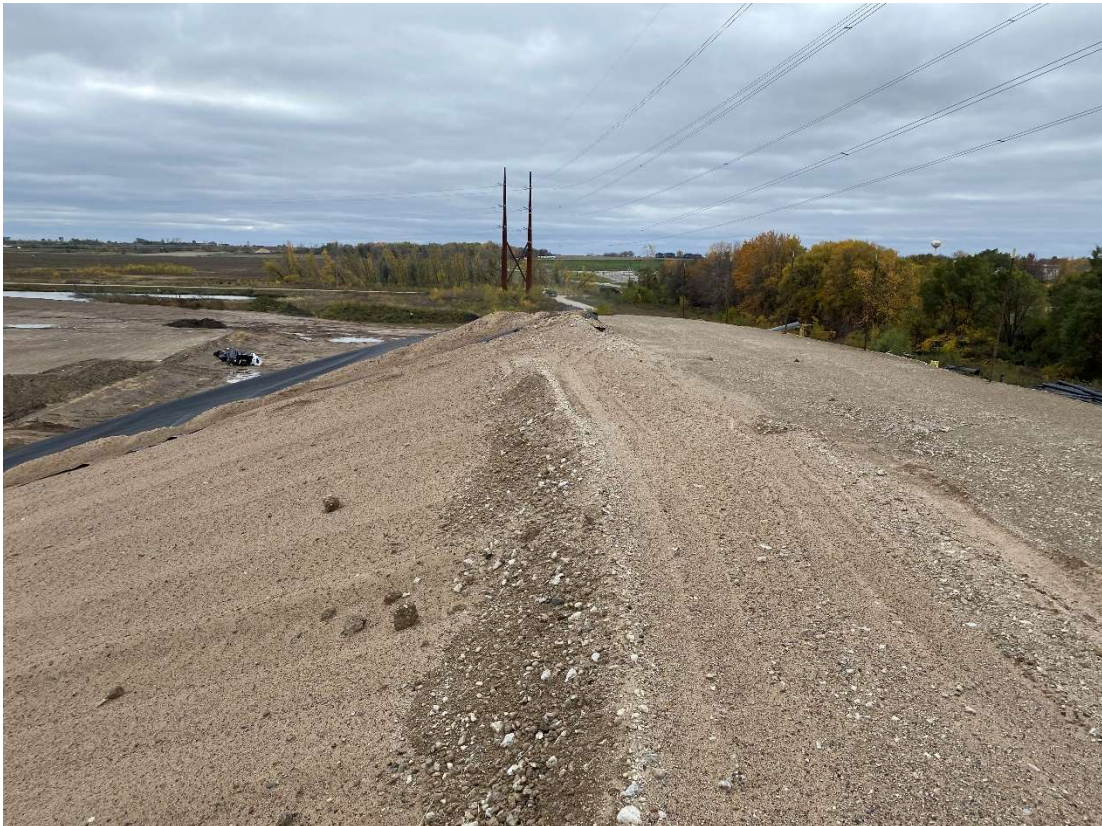
Location 13 – Cell 6, interior top of berm, looking south

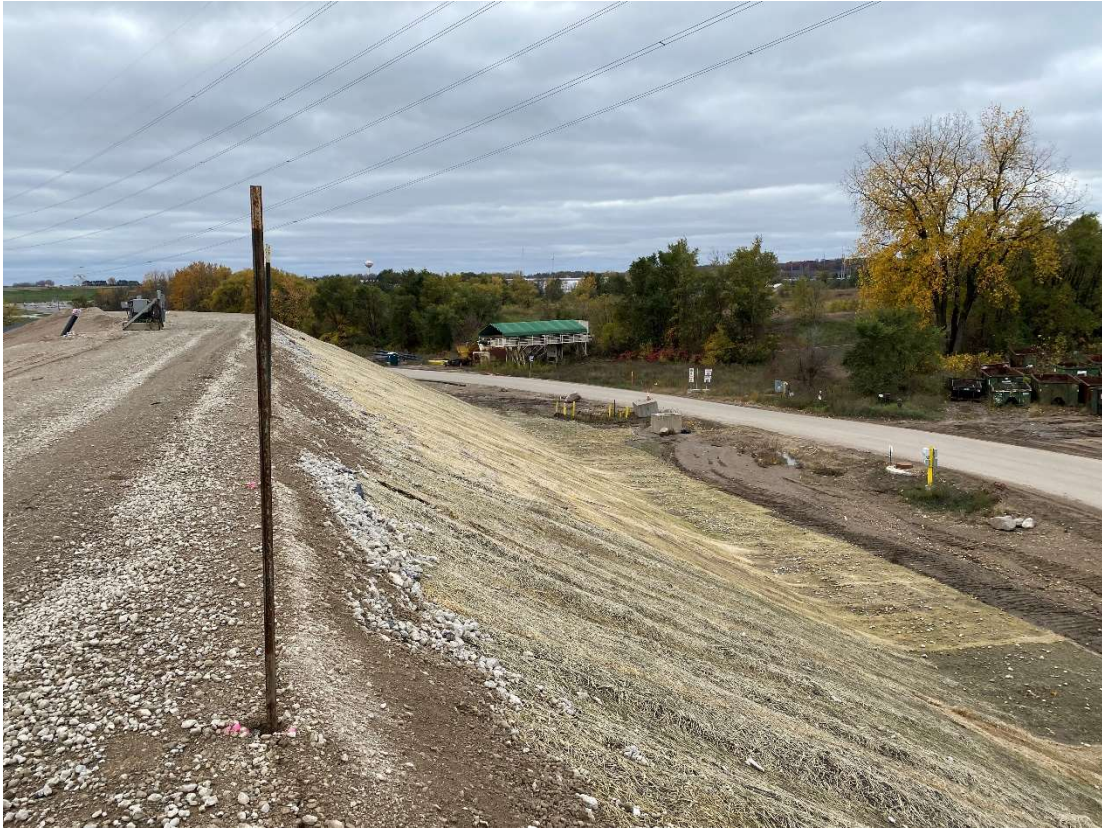
Location 14 – Cell 6, exterior top of berm, looking south

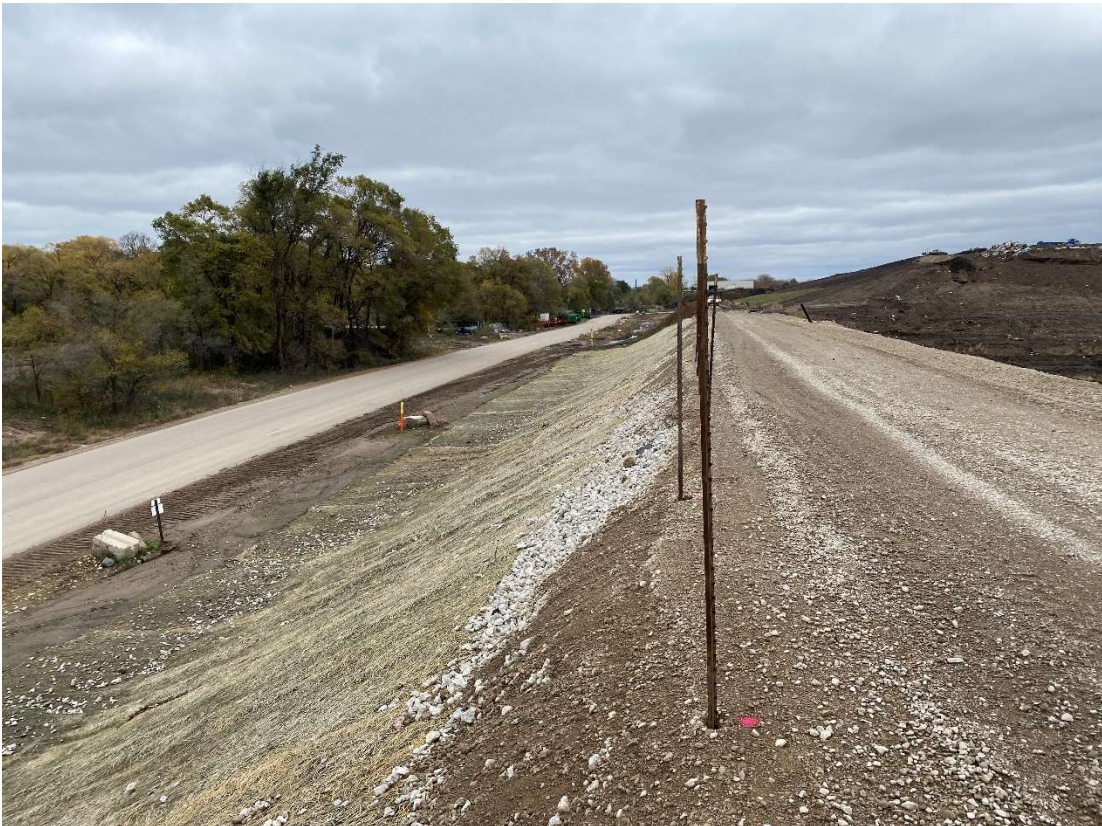
Location 14 – Cell 6, exterior top of berm, looking north

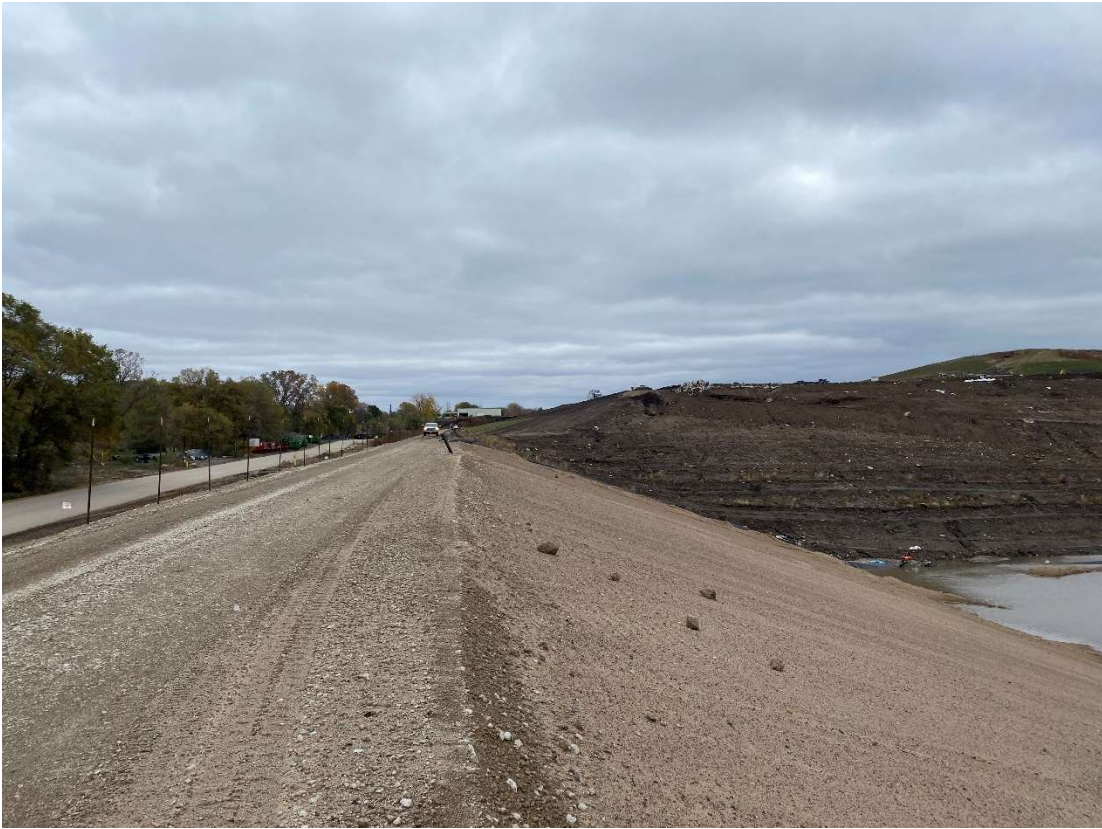
Location 14 – Cell 6, interior top of berm, looking north

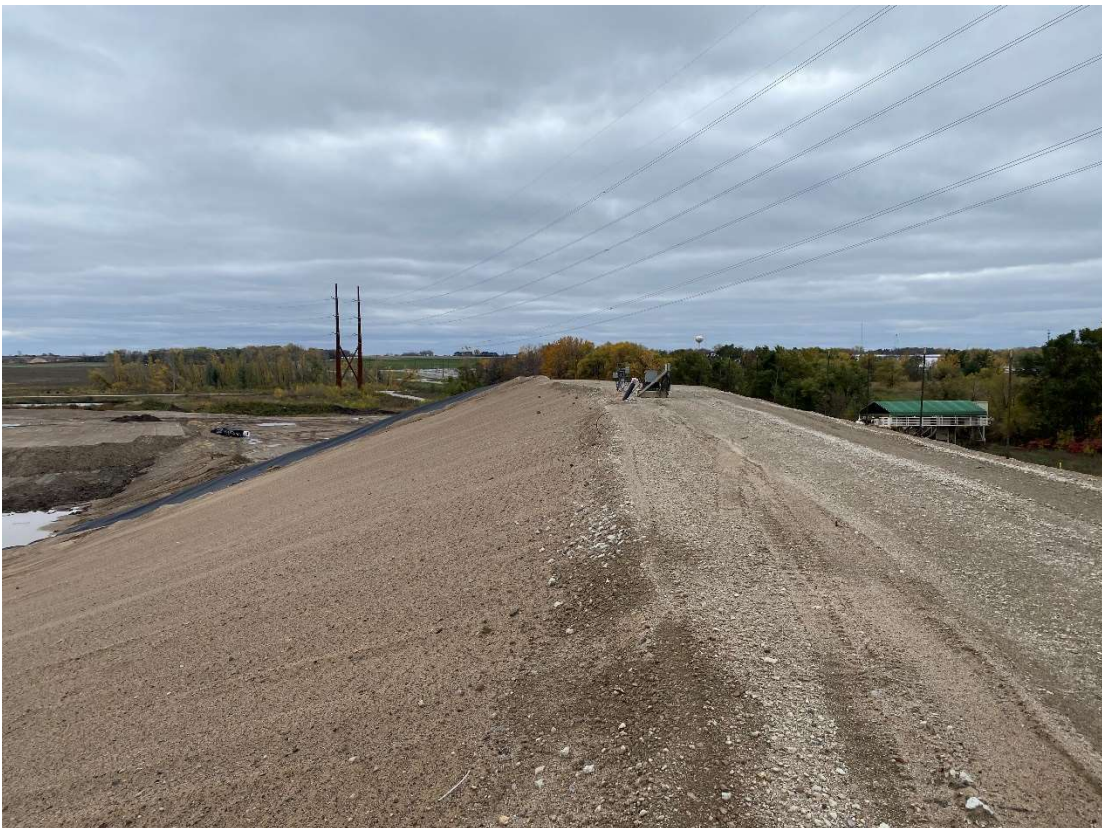
Location 14 – Cell 6, interior top of berm, looking south

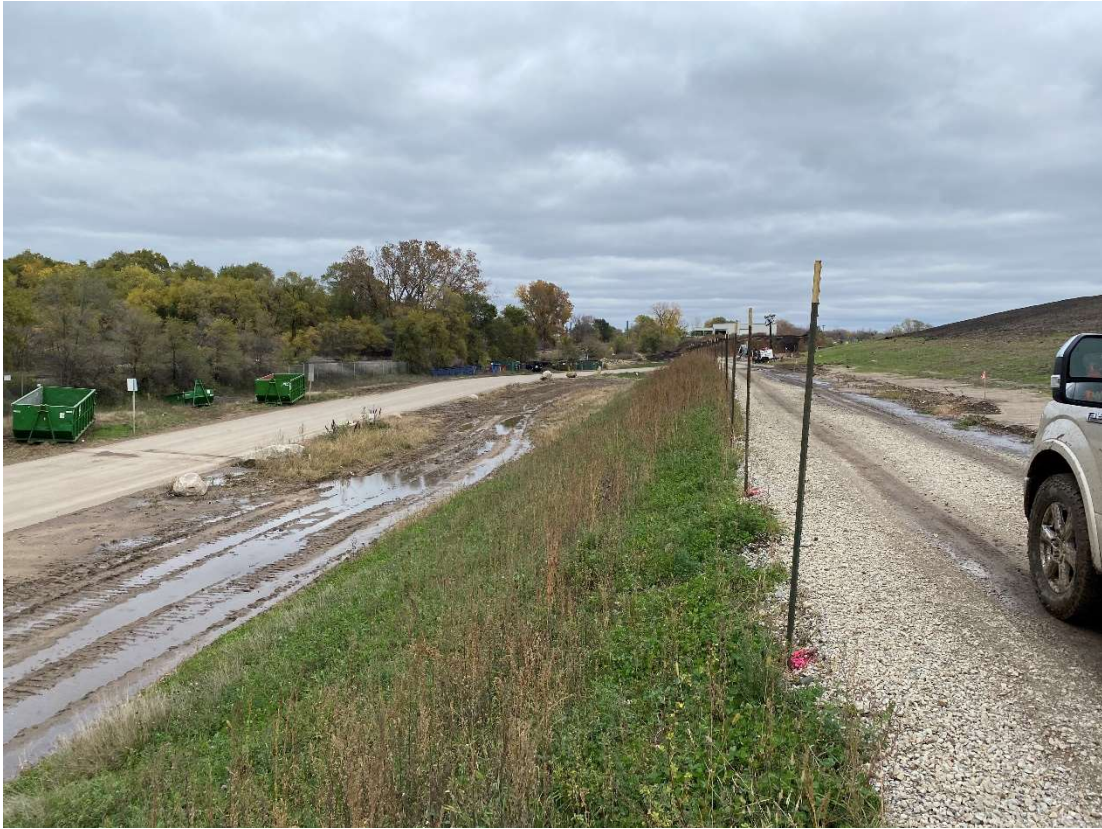
Location 15 – Cell 6 northwestern outer berm, looking northeast

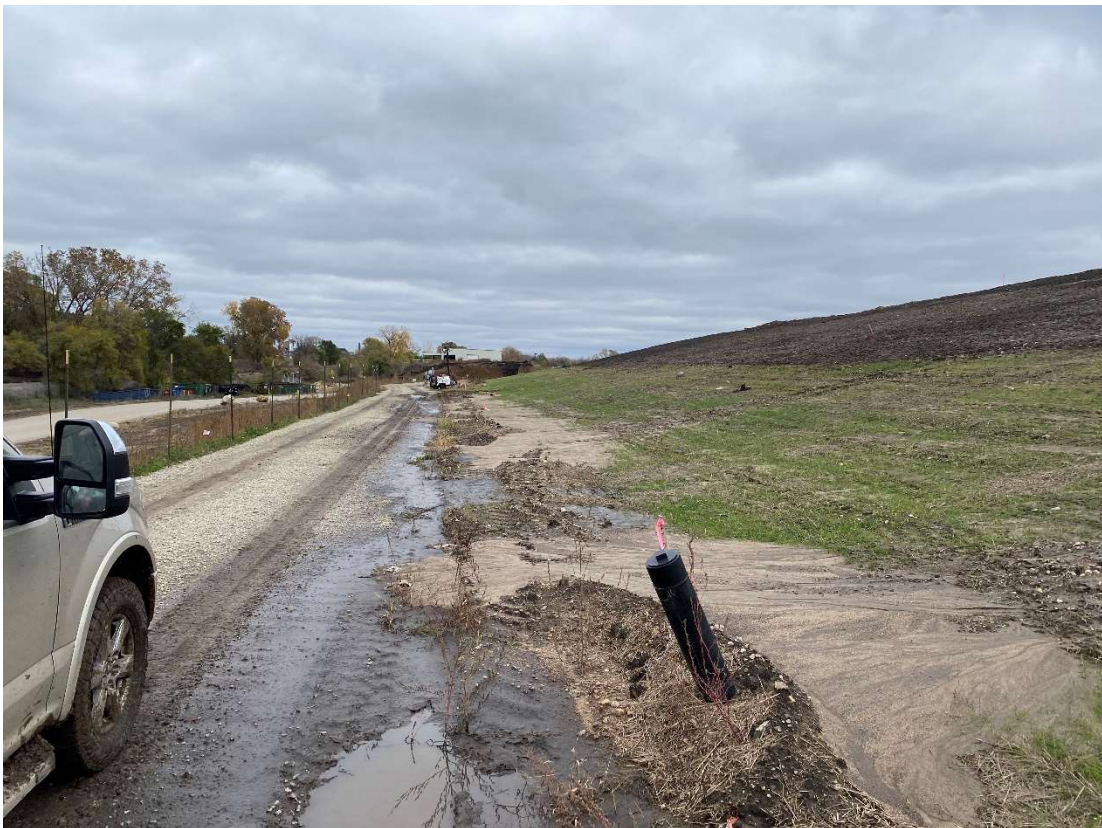
Location 15 – Cell 6 northwestern toe of waste slope, looking northeast

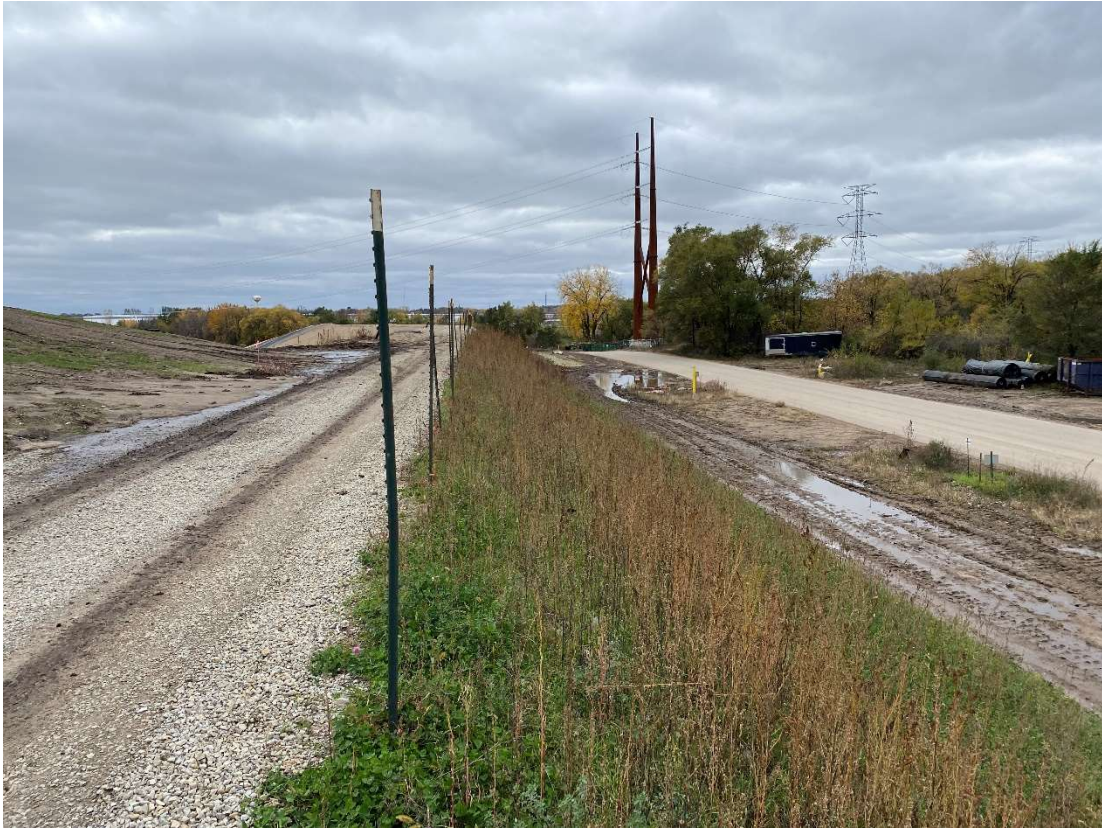
Location 15 – Cell 6 midpoint of northwestern outer berm, looking southwest

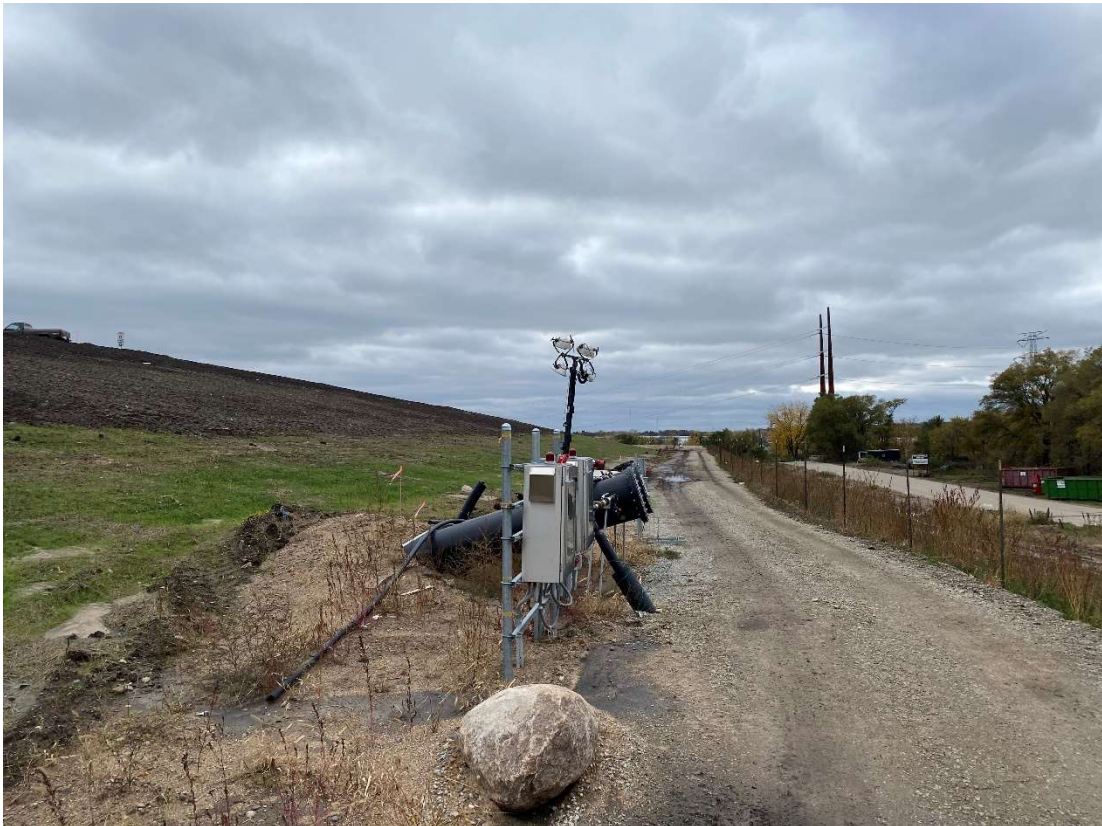
Location 16 – Cell 6 northwestern top of berm, looking southwest

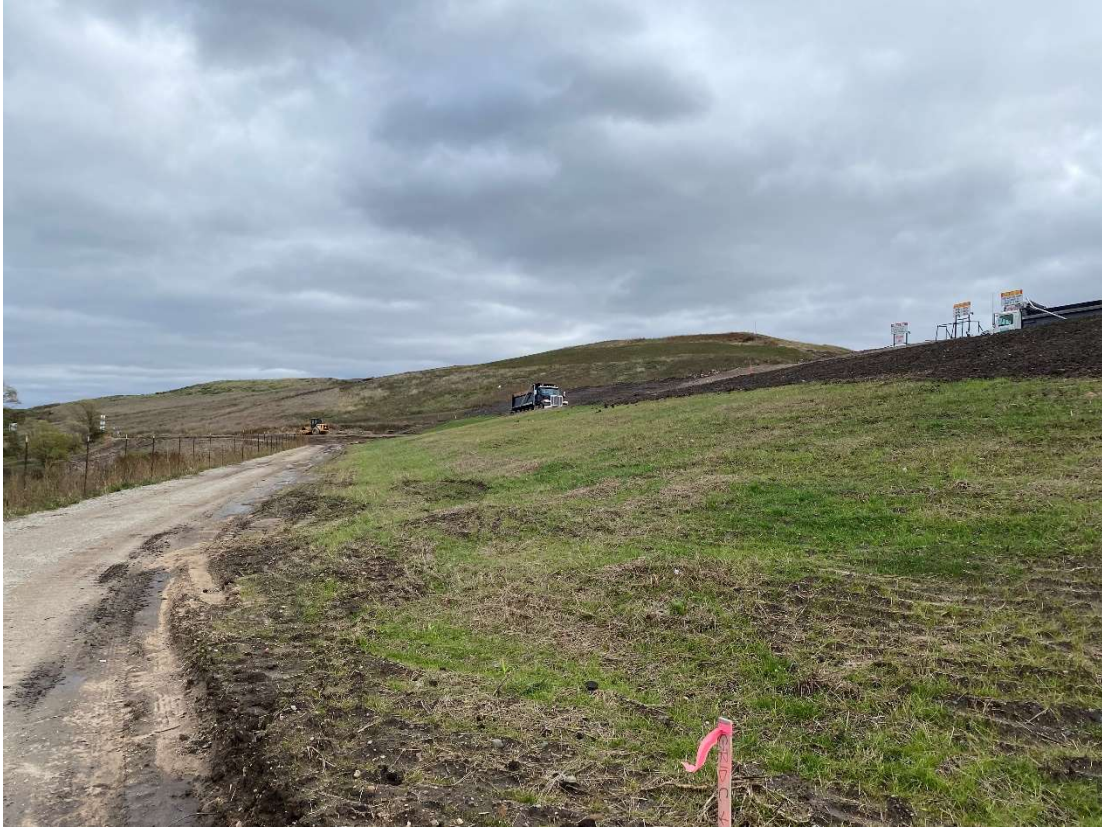
Location 16 – Cell 6 northern top of berm, looking northeast
