To:	Geoff Strack, P.E. Waste Connections	From:	Brad Sullivan, P.E., Stantec
File:	227704387	Date:	January 7, 2024

Reference: SKB Rosemount Industrial Waste Facility 2023 Annual CCR Inspection Report

Purpose

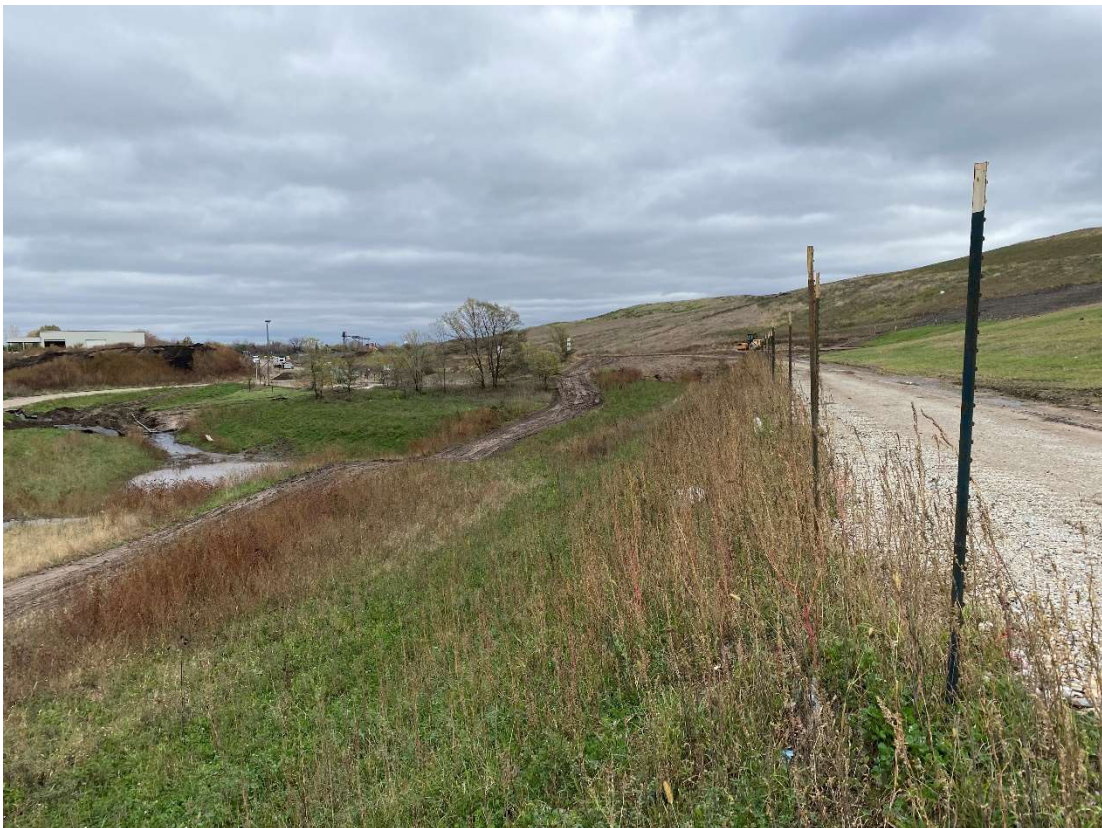
Location 16 – Cell 6 northern outer berm, looking northeast

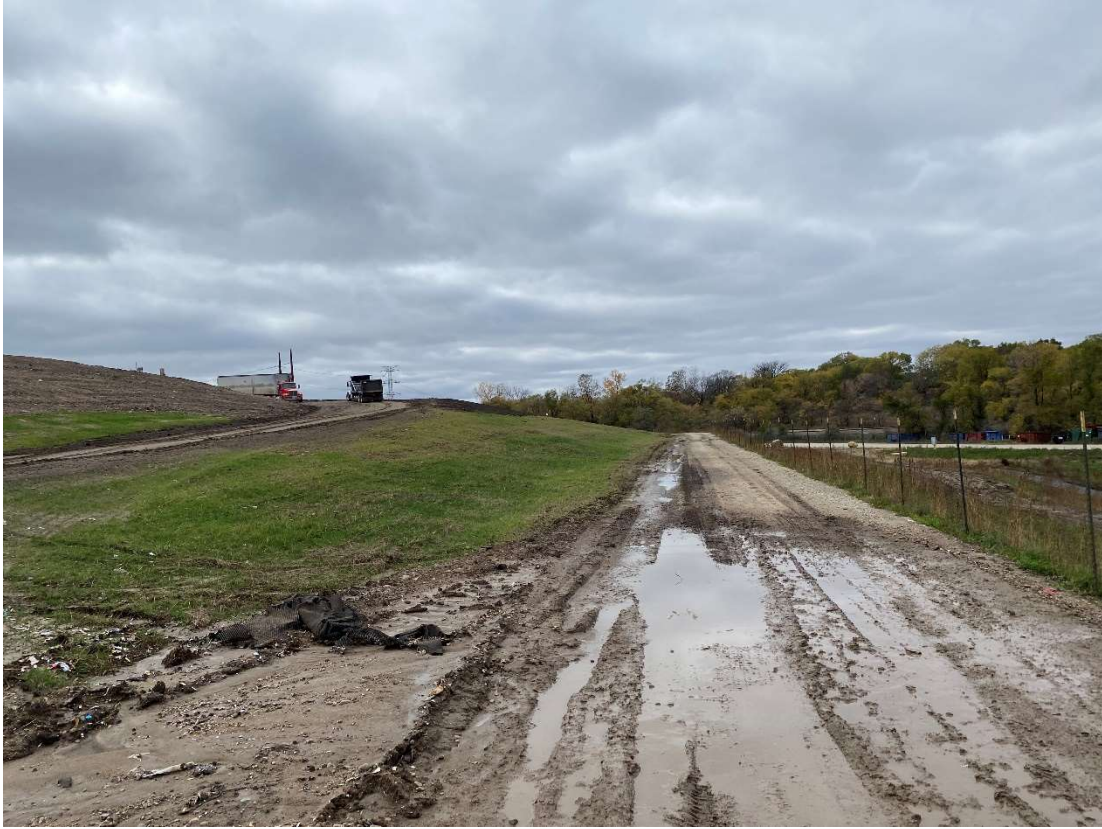
Location 17 – Cell 6 northern top of berm, looking southwest

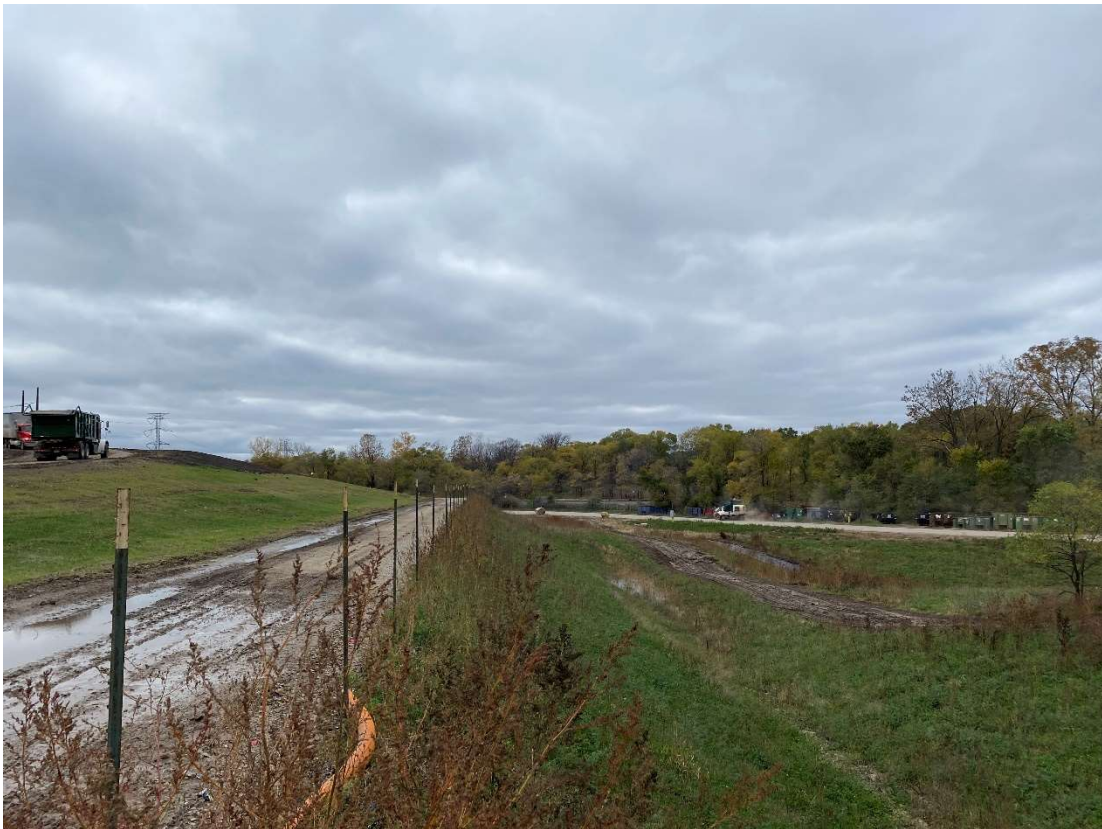
Location 17 – Cell 6 northern outer berm, looking southwest

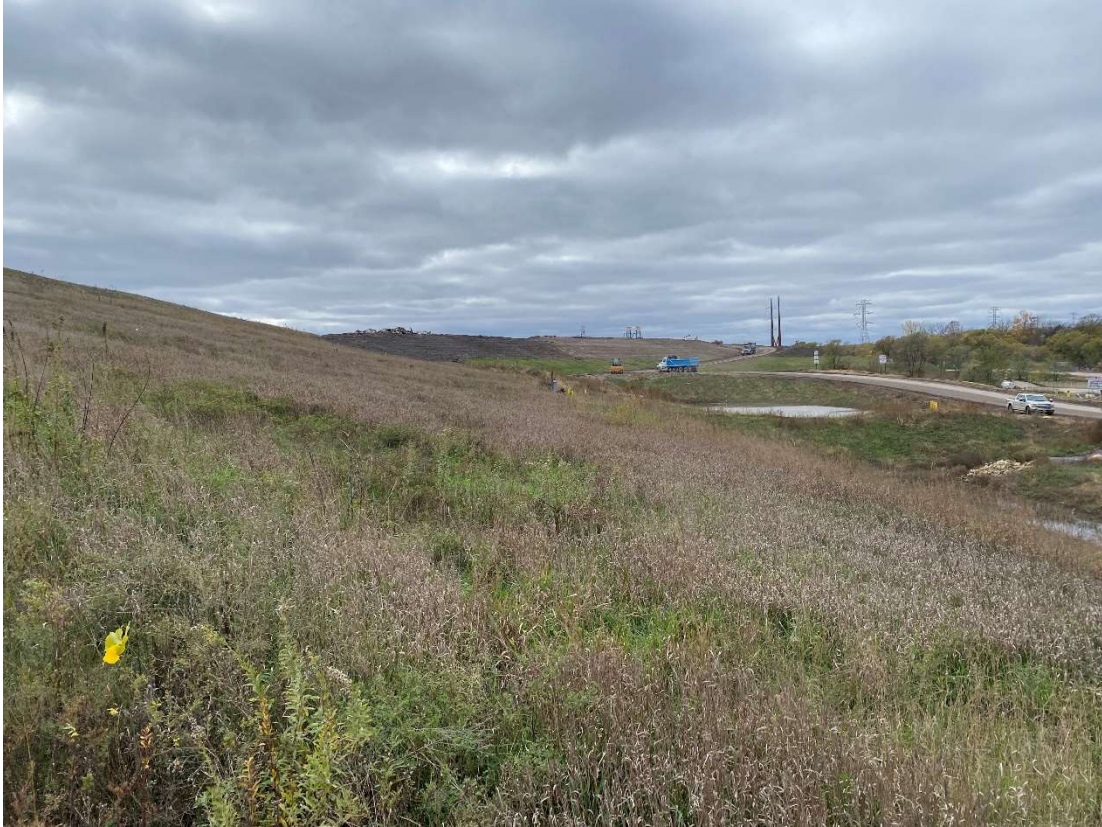
Location 18 – Cell 1 Toe of Waste Slope, looking southwest

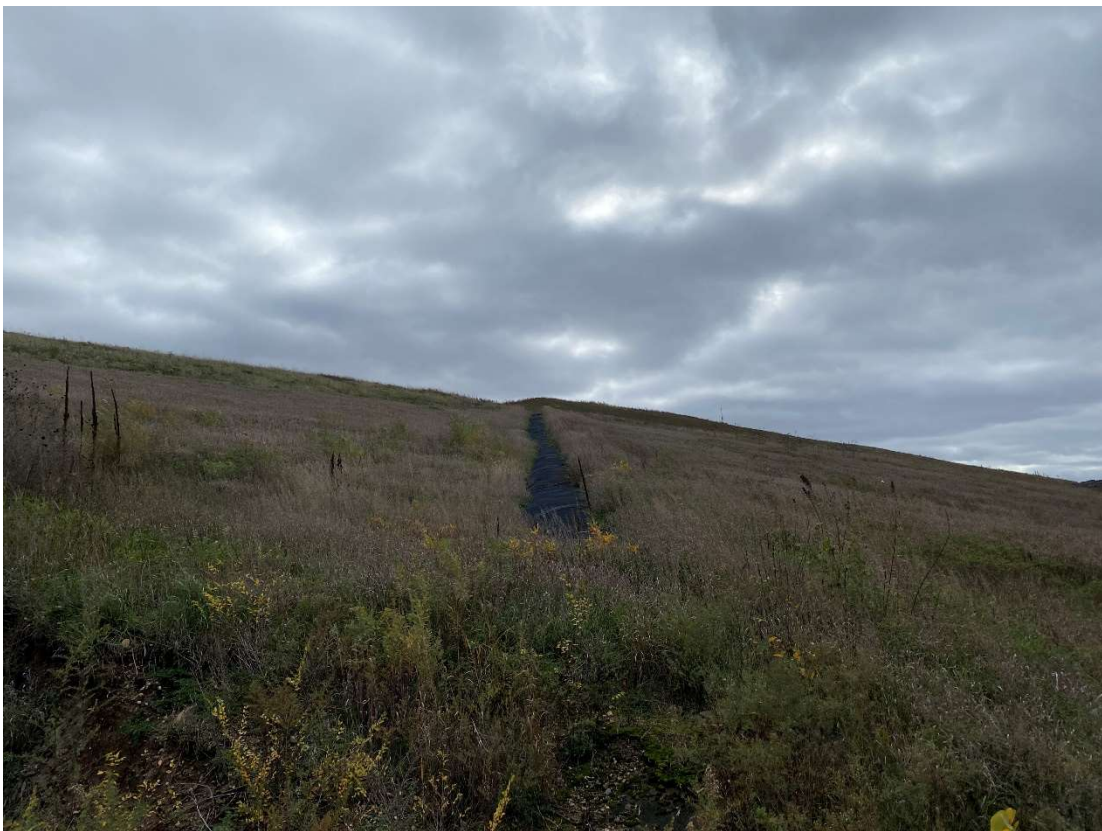
Location 18 – Cell 1 edge of cap, looking south
