From: Brad Sullivan, P.E., Stantec

Date: January 7, 2026

Reference: SKB Rosemount Industrial Waste Facility 2025 Annual CCR Inspection Report

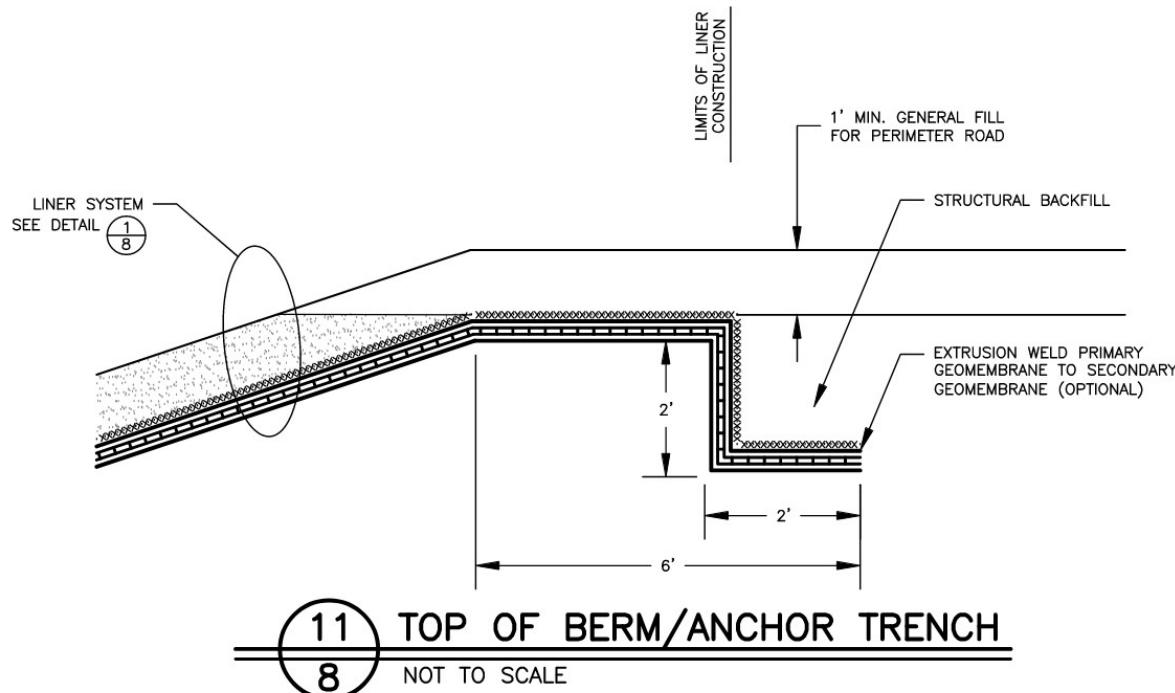
In general, most of the facility's landfill cell embankments were constructed using granular borrow material, which consisted of silty clay and clayey sand type soils. The fill was placed and compacted to 95% of Standard Proctor Dry Density in lift thicknesses ranging from 8 inches to 12 inches. The final subgrade surface was proof rolled prior to geosynthetics installation. The landfill lining systems varies from cell to cell, but all meet the requirements of CFR 257.70. A typical perimeter section from the 2021 Cell 6 Construction Drawings prepared by Tetra-Tech dated February 2021 is shown below.

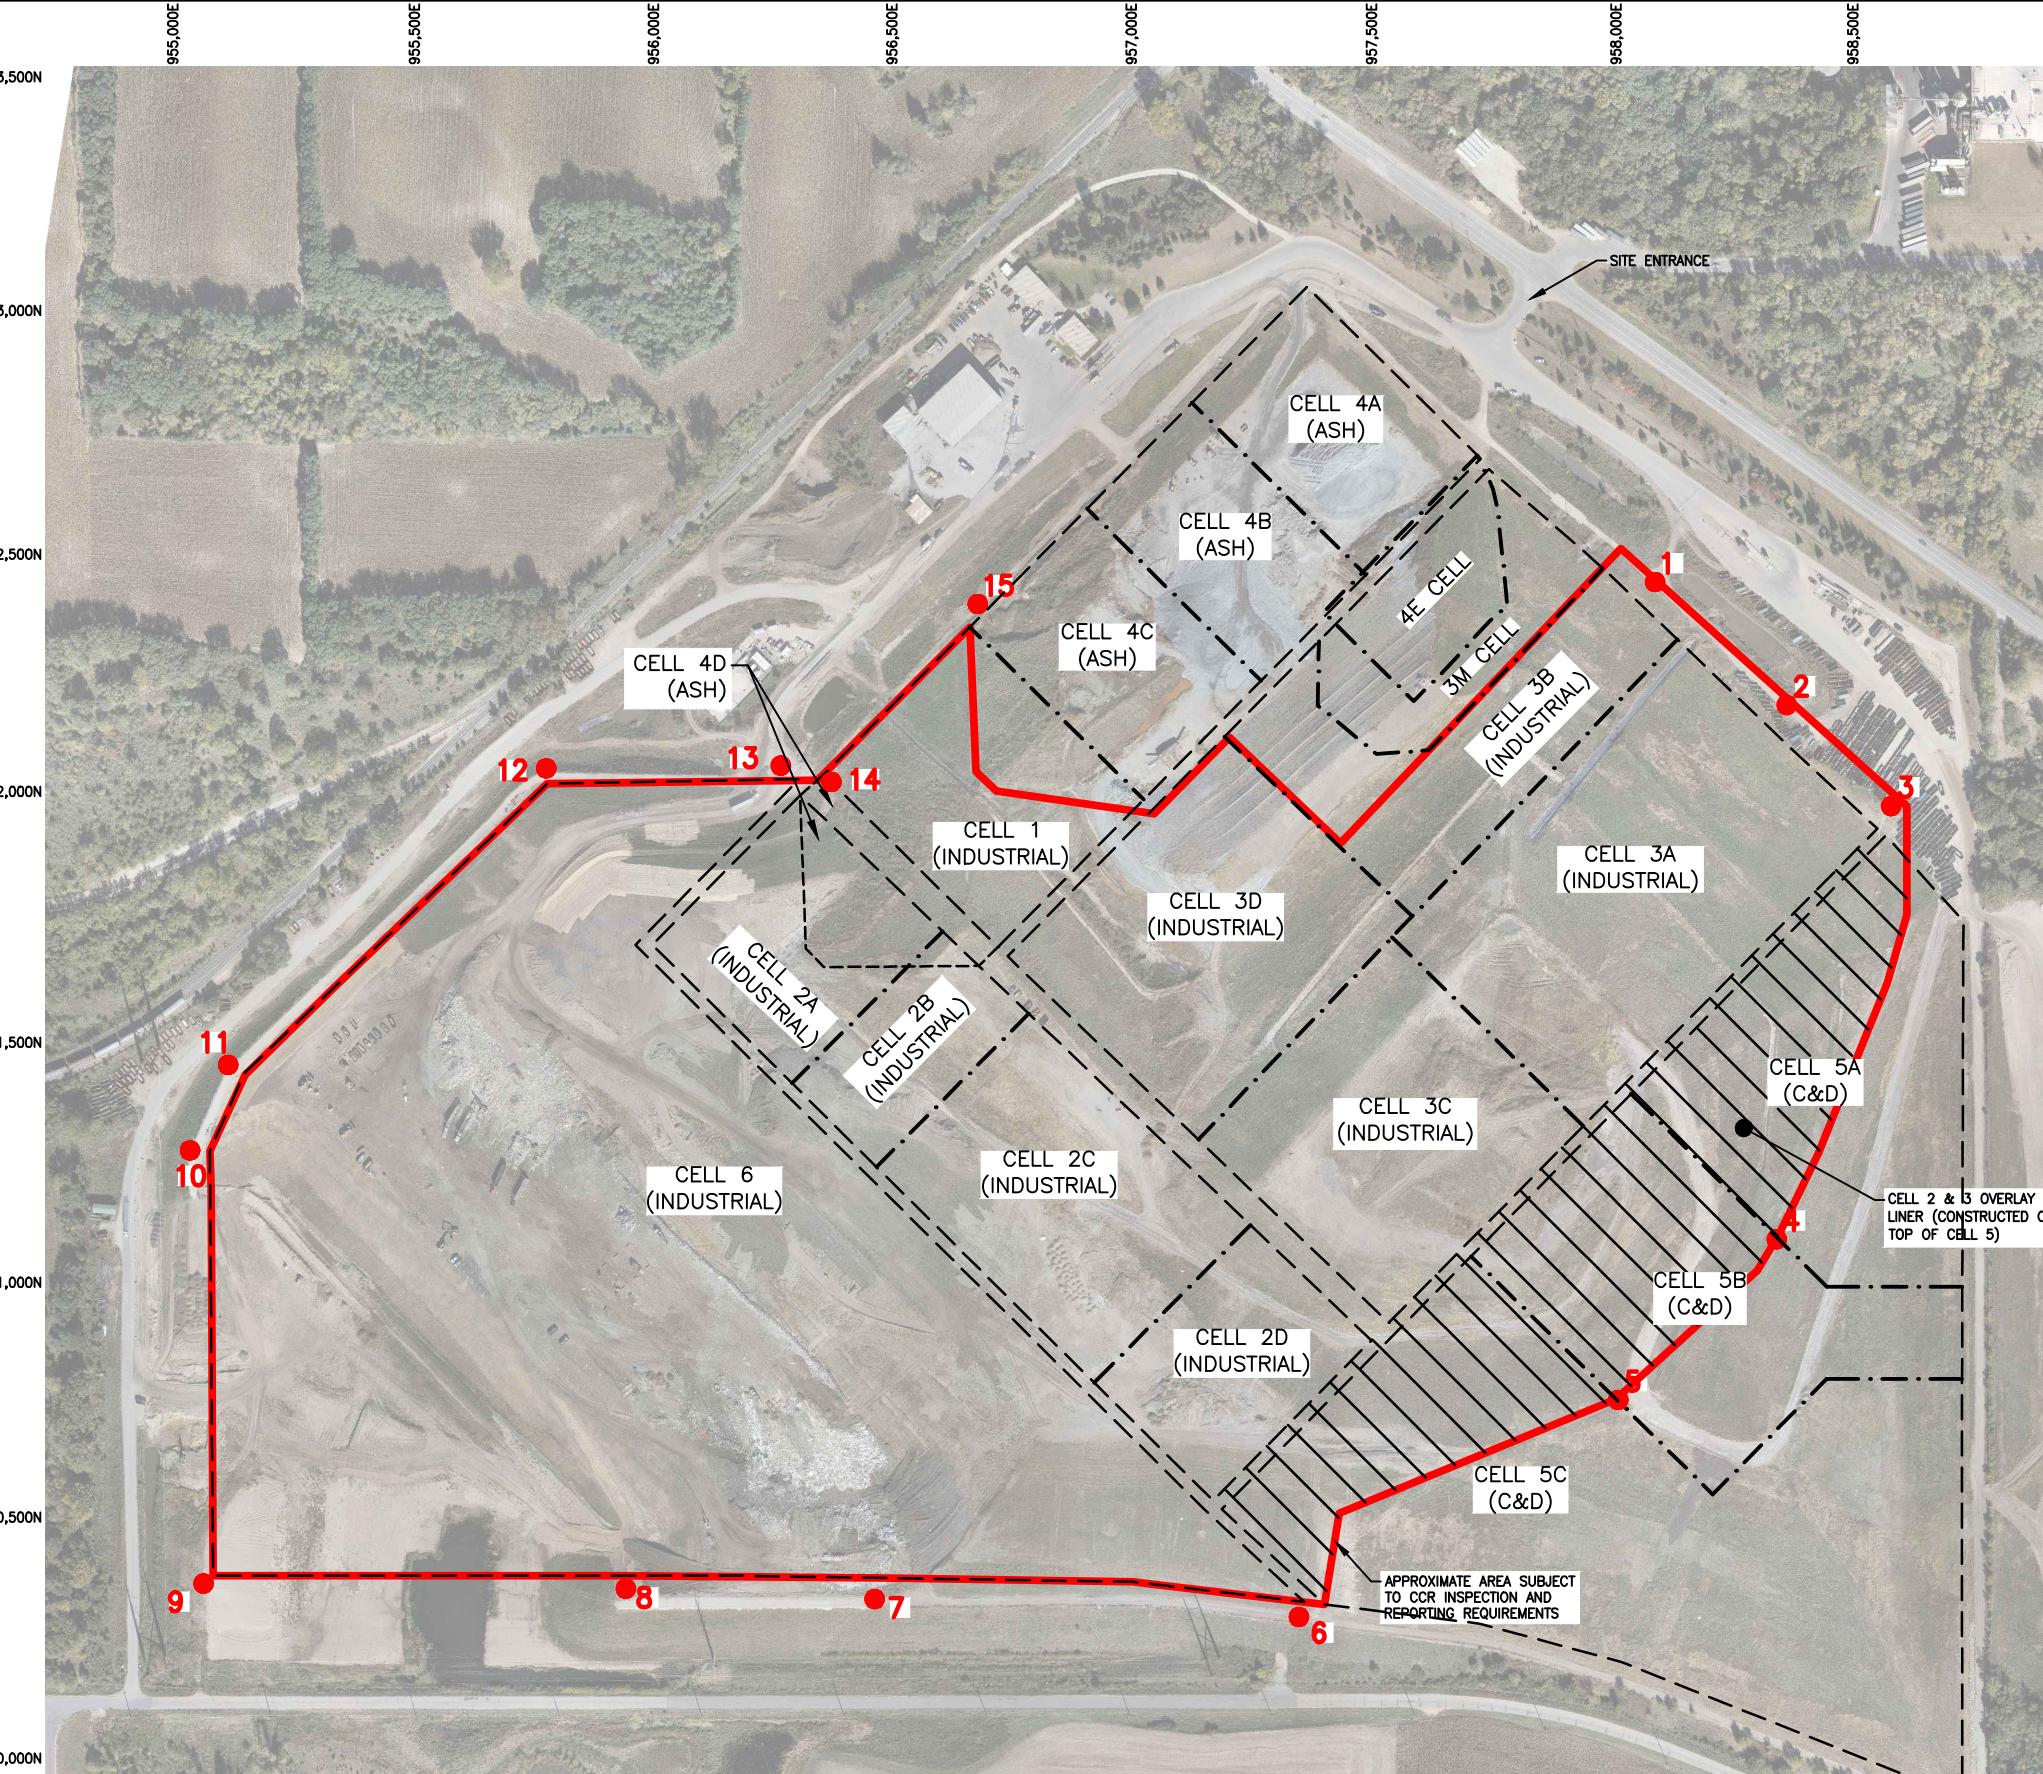
FIGURE 1 REV. 0

All industrial waste cells are permitted to accept CCR and operating records indicate that CCR material is contained in Cells 1, 2, 3, and 6. See Figure 1 for a facility site plan.

and 2024 aerial surveys confirm that the embankment and slope topography is substantially unchanged. The 2025 aerial survey is shown on Figure 1.

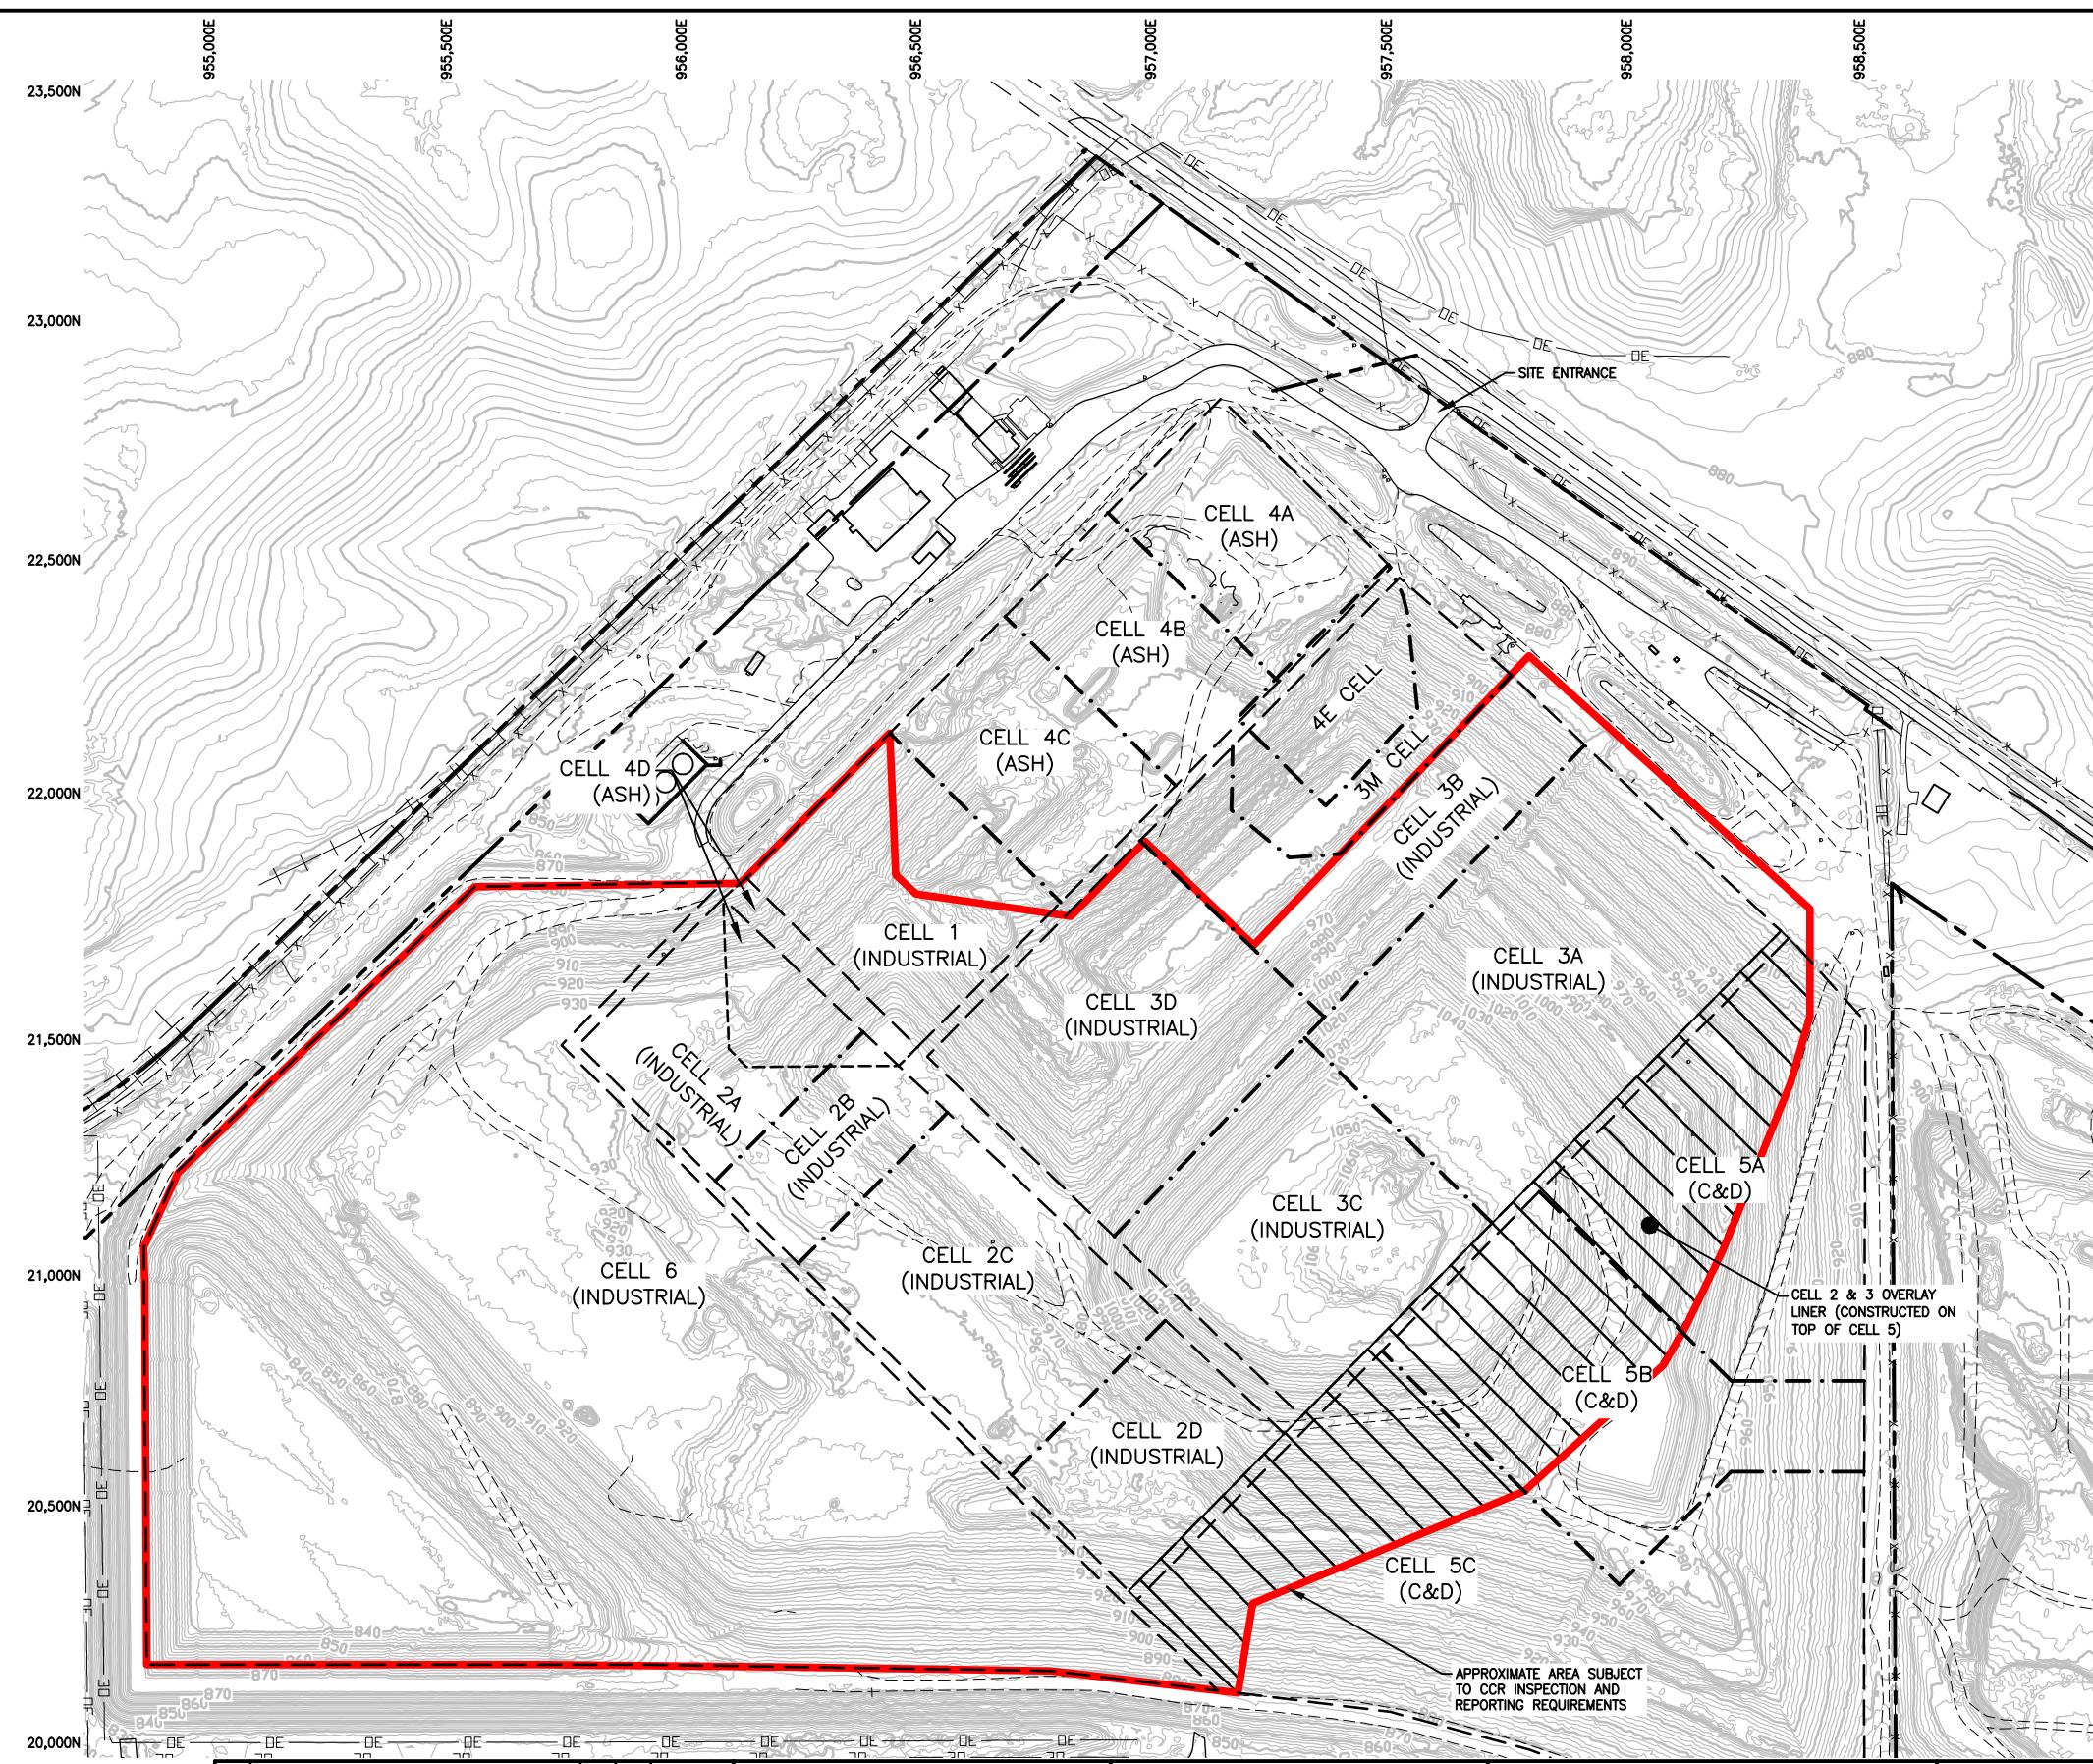
DWN BY	CHK'D	APP'D	DWG DATE	JAN. 2026
JUT	TJS	BWS	SCALE	AS NOTED
PROJECT NO.		SHEET NO.		
227704387		FIGURE 2		
		REV NO.		
		0

Photos of the landfill embankments and waste slopes were taken during the inspection. Figure 2 presents the photo locations, and Attachment 1 contains a photo log from the inspections.
