Technical Memo

To: Geoff Strack, SKB Environmental, Inc.
From: Dave Parenteau, PE (MN), Wenck Associates, Inc.
Date: January 9, 2018
Subject: Annual Inspection SKB Rosemount Industrial Waste Facility - Report of CCR Landfill Inspection
Wenck Project # B3053-0096

2018 Dike Integrity Inspection Report Photos SKB Rosemount Landfill

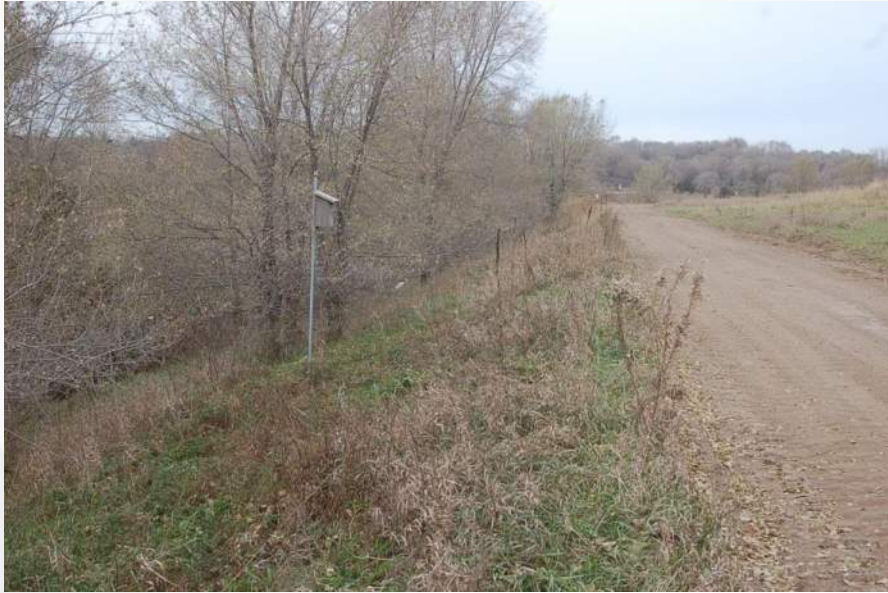
Photo 55 - Cell 2A/2B South Perimeter Berm

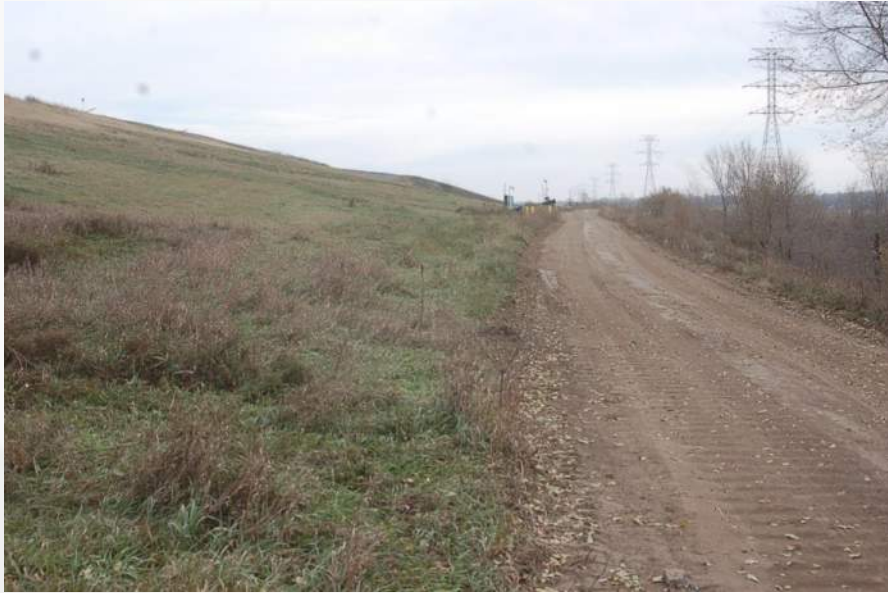
Photo 57 - Cell 2A/2B South Perim Rd/LF Toe

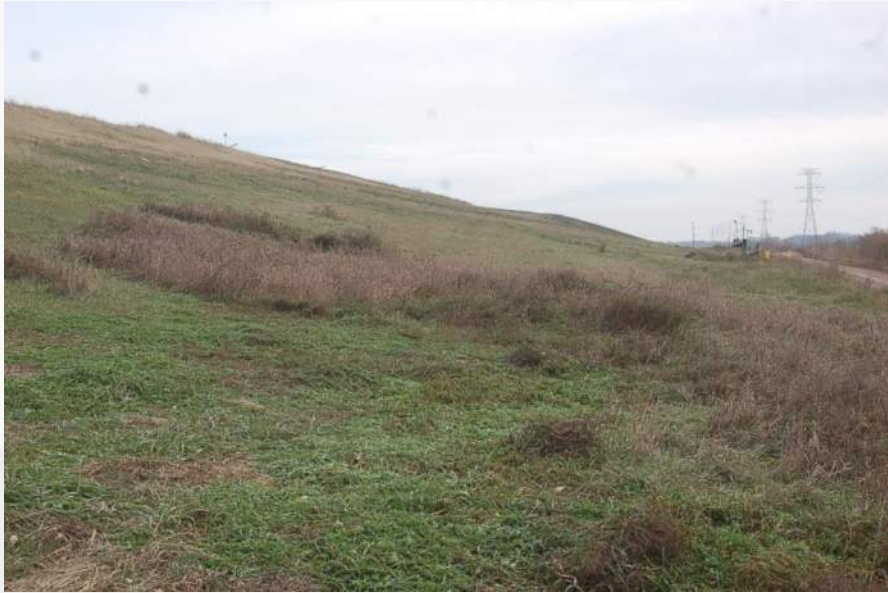
Photo 59 – Cell 2A/2B South Landfill Face

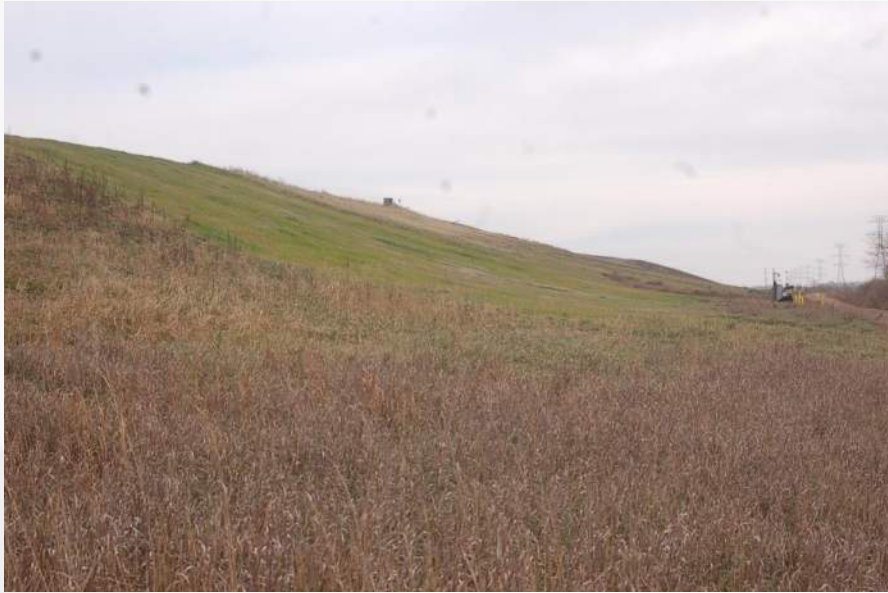
Photo 61 – Cell 2A South Landfill Face

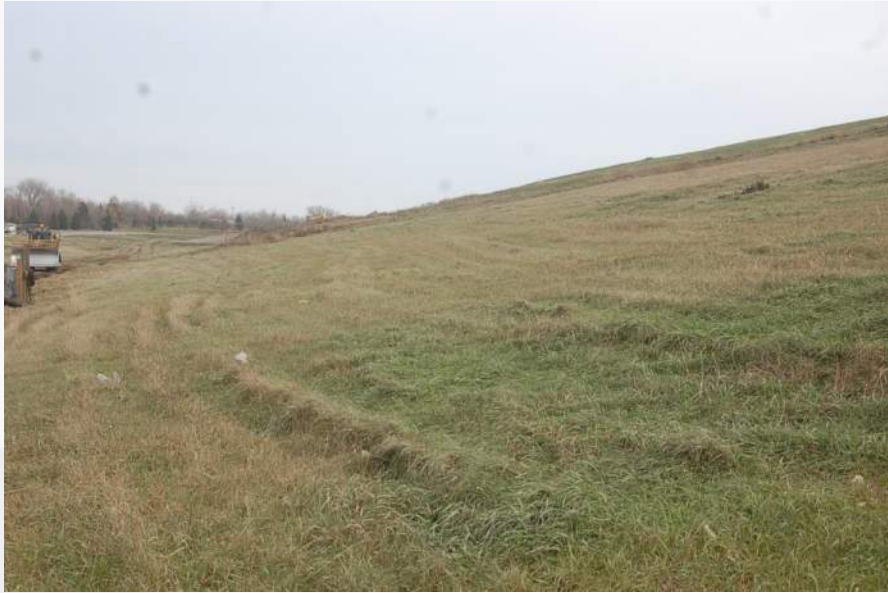
Photo 71 - Cell 1 West Landfill Face

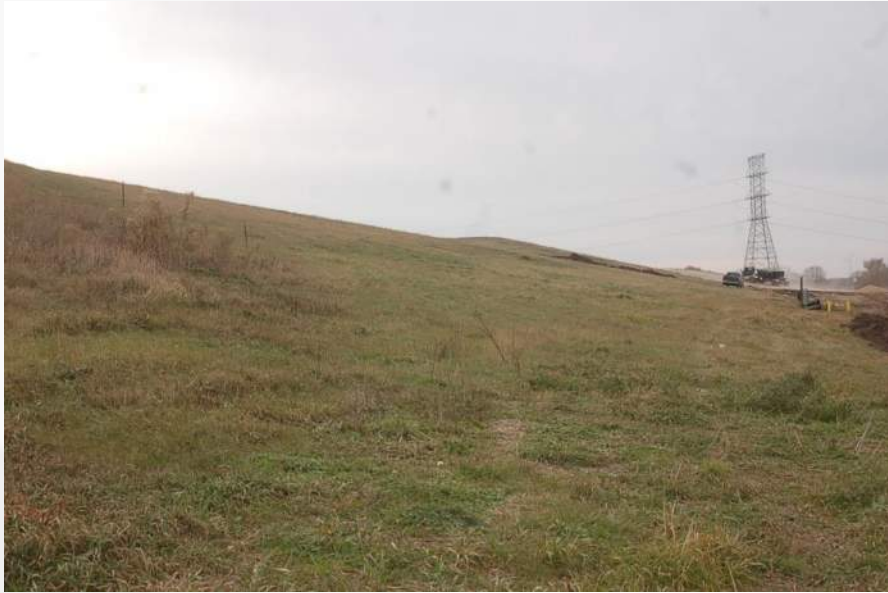
Photo 73 - Cell 1 West Landfill Face

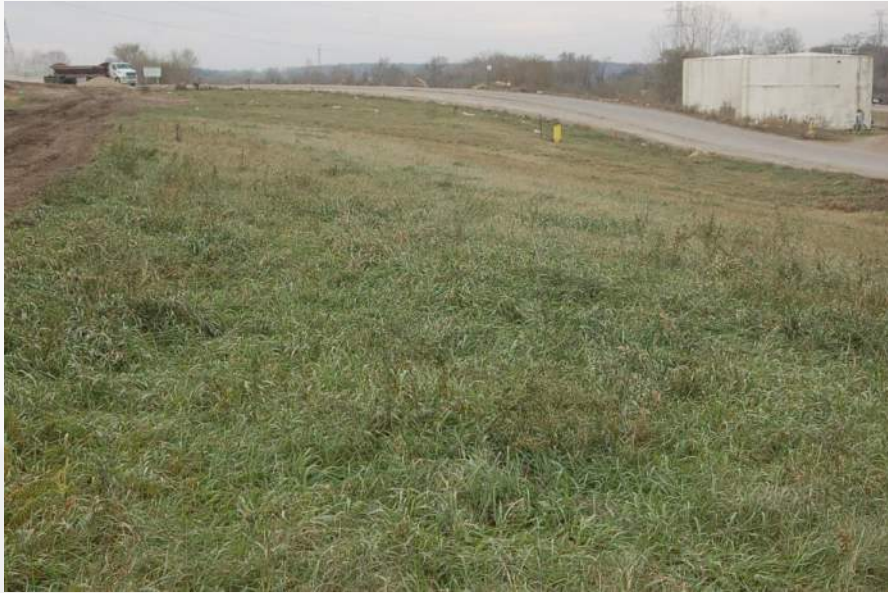
Photo 75 - Cell 1 West Perimeter Berm
