Technical Memo

Date: January 9, 2019

Subject: SKB Rosemount Industrial Waste Facility – 2018 Annual CCR Inspection
Wenck Project # B3053-0138

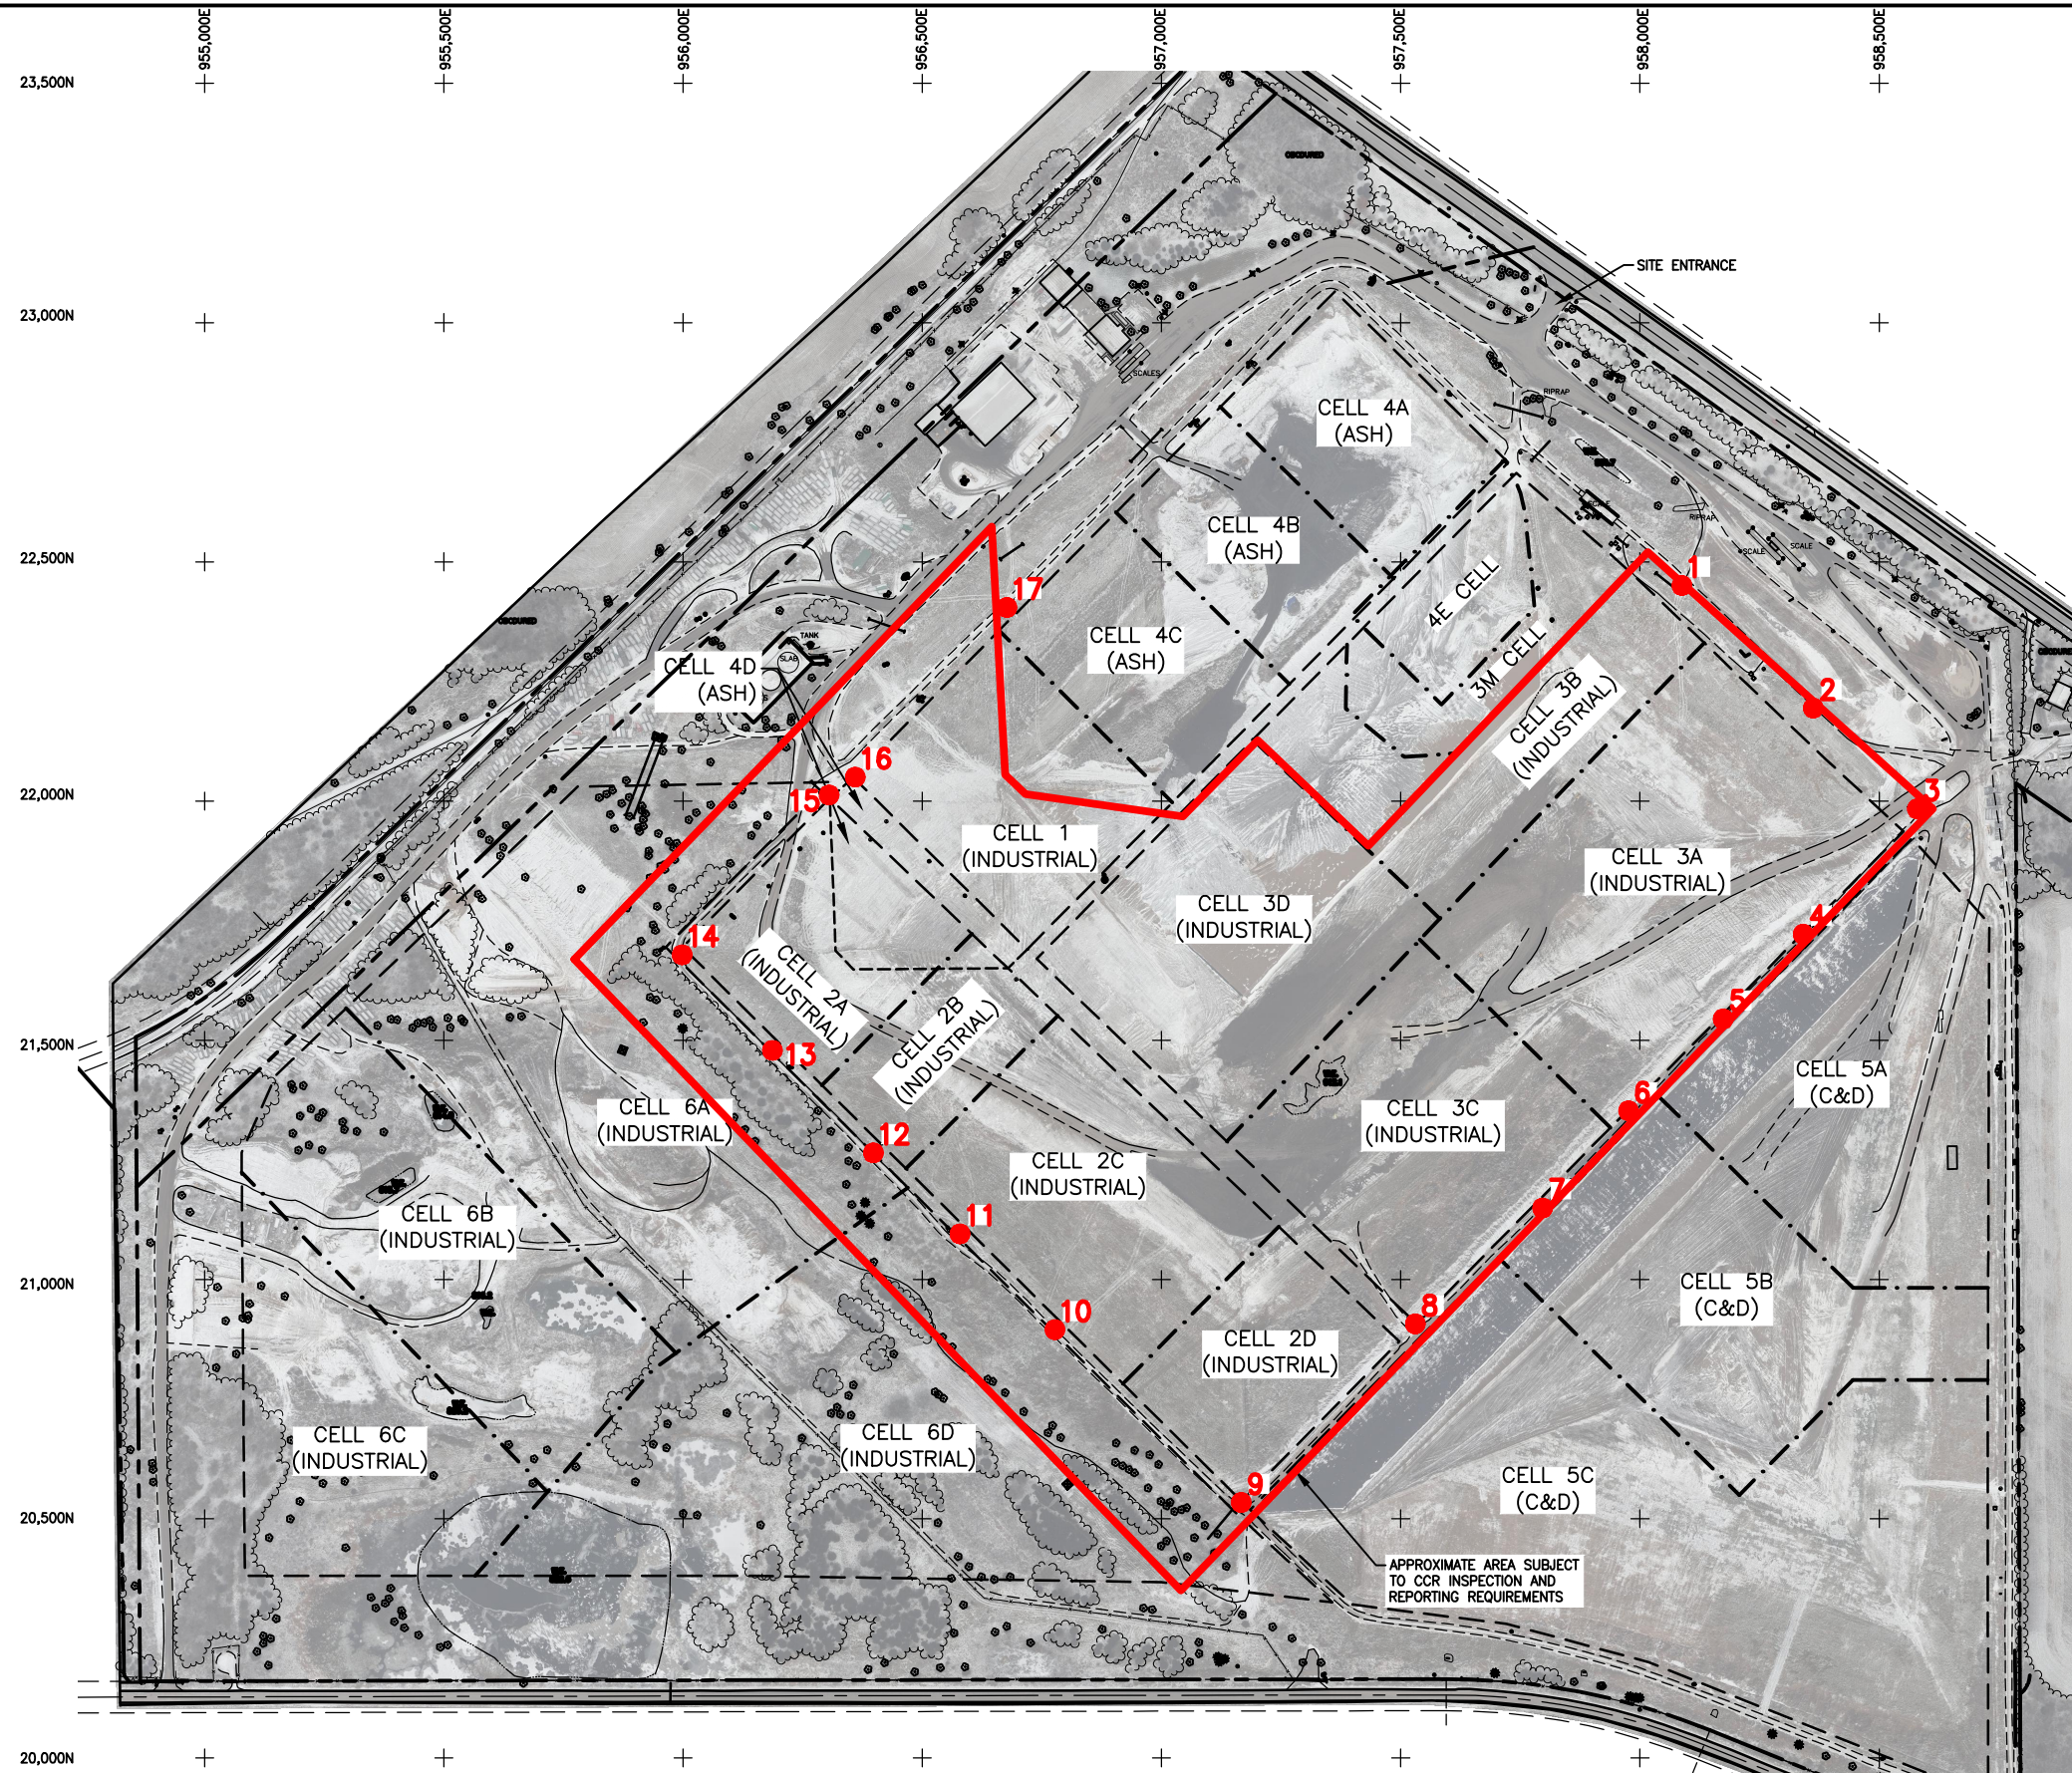
SHEET TITLE			
PHOTO LOCATIONS			
DWN BY	CHK'D	APP'D	DWG DATE
JVB	DMP	DMP	JAN. 2018
PROJECT NO.		SCALE	
3053-0138		AS NOTED	
SHEET NO.		REV NO.	
FIGURE 1		0

Photos of the landfill embankments and waste slopes were taken during the inspection. Figure 1 presents the photo locations, and Attachment 1 contains a photo log from the inspections.

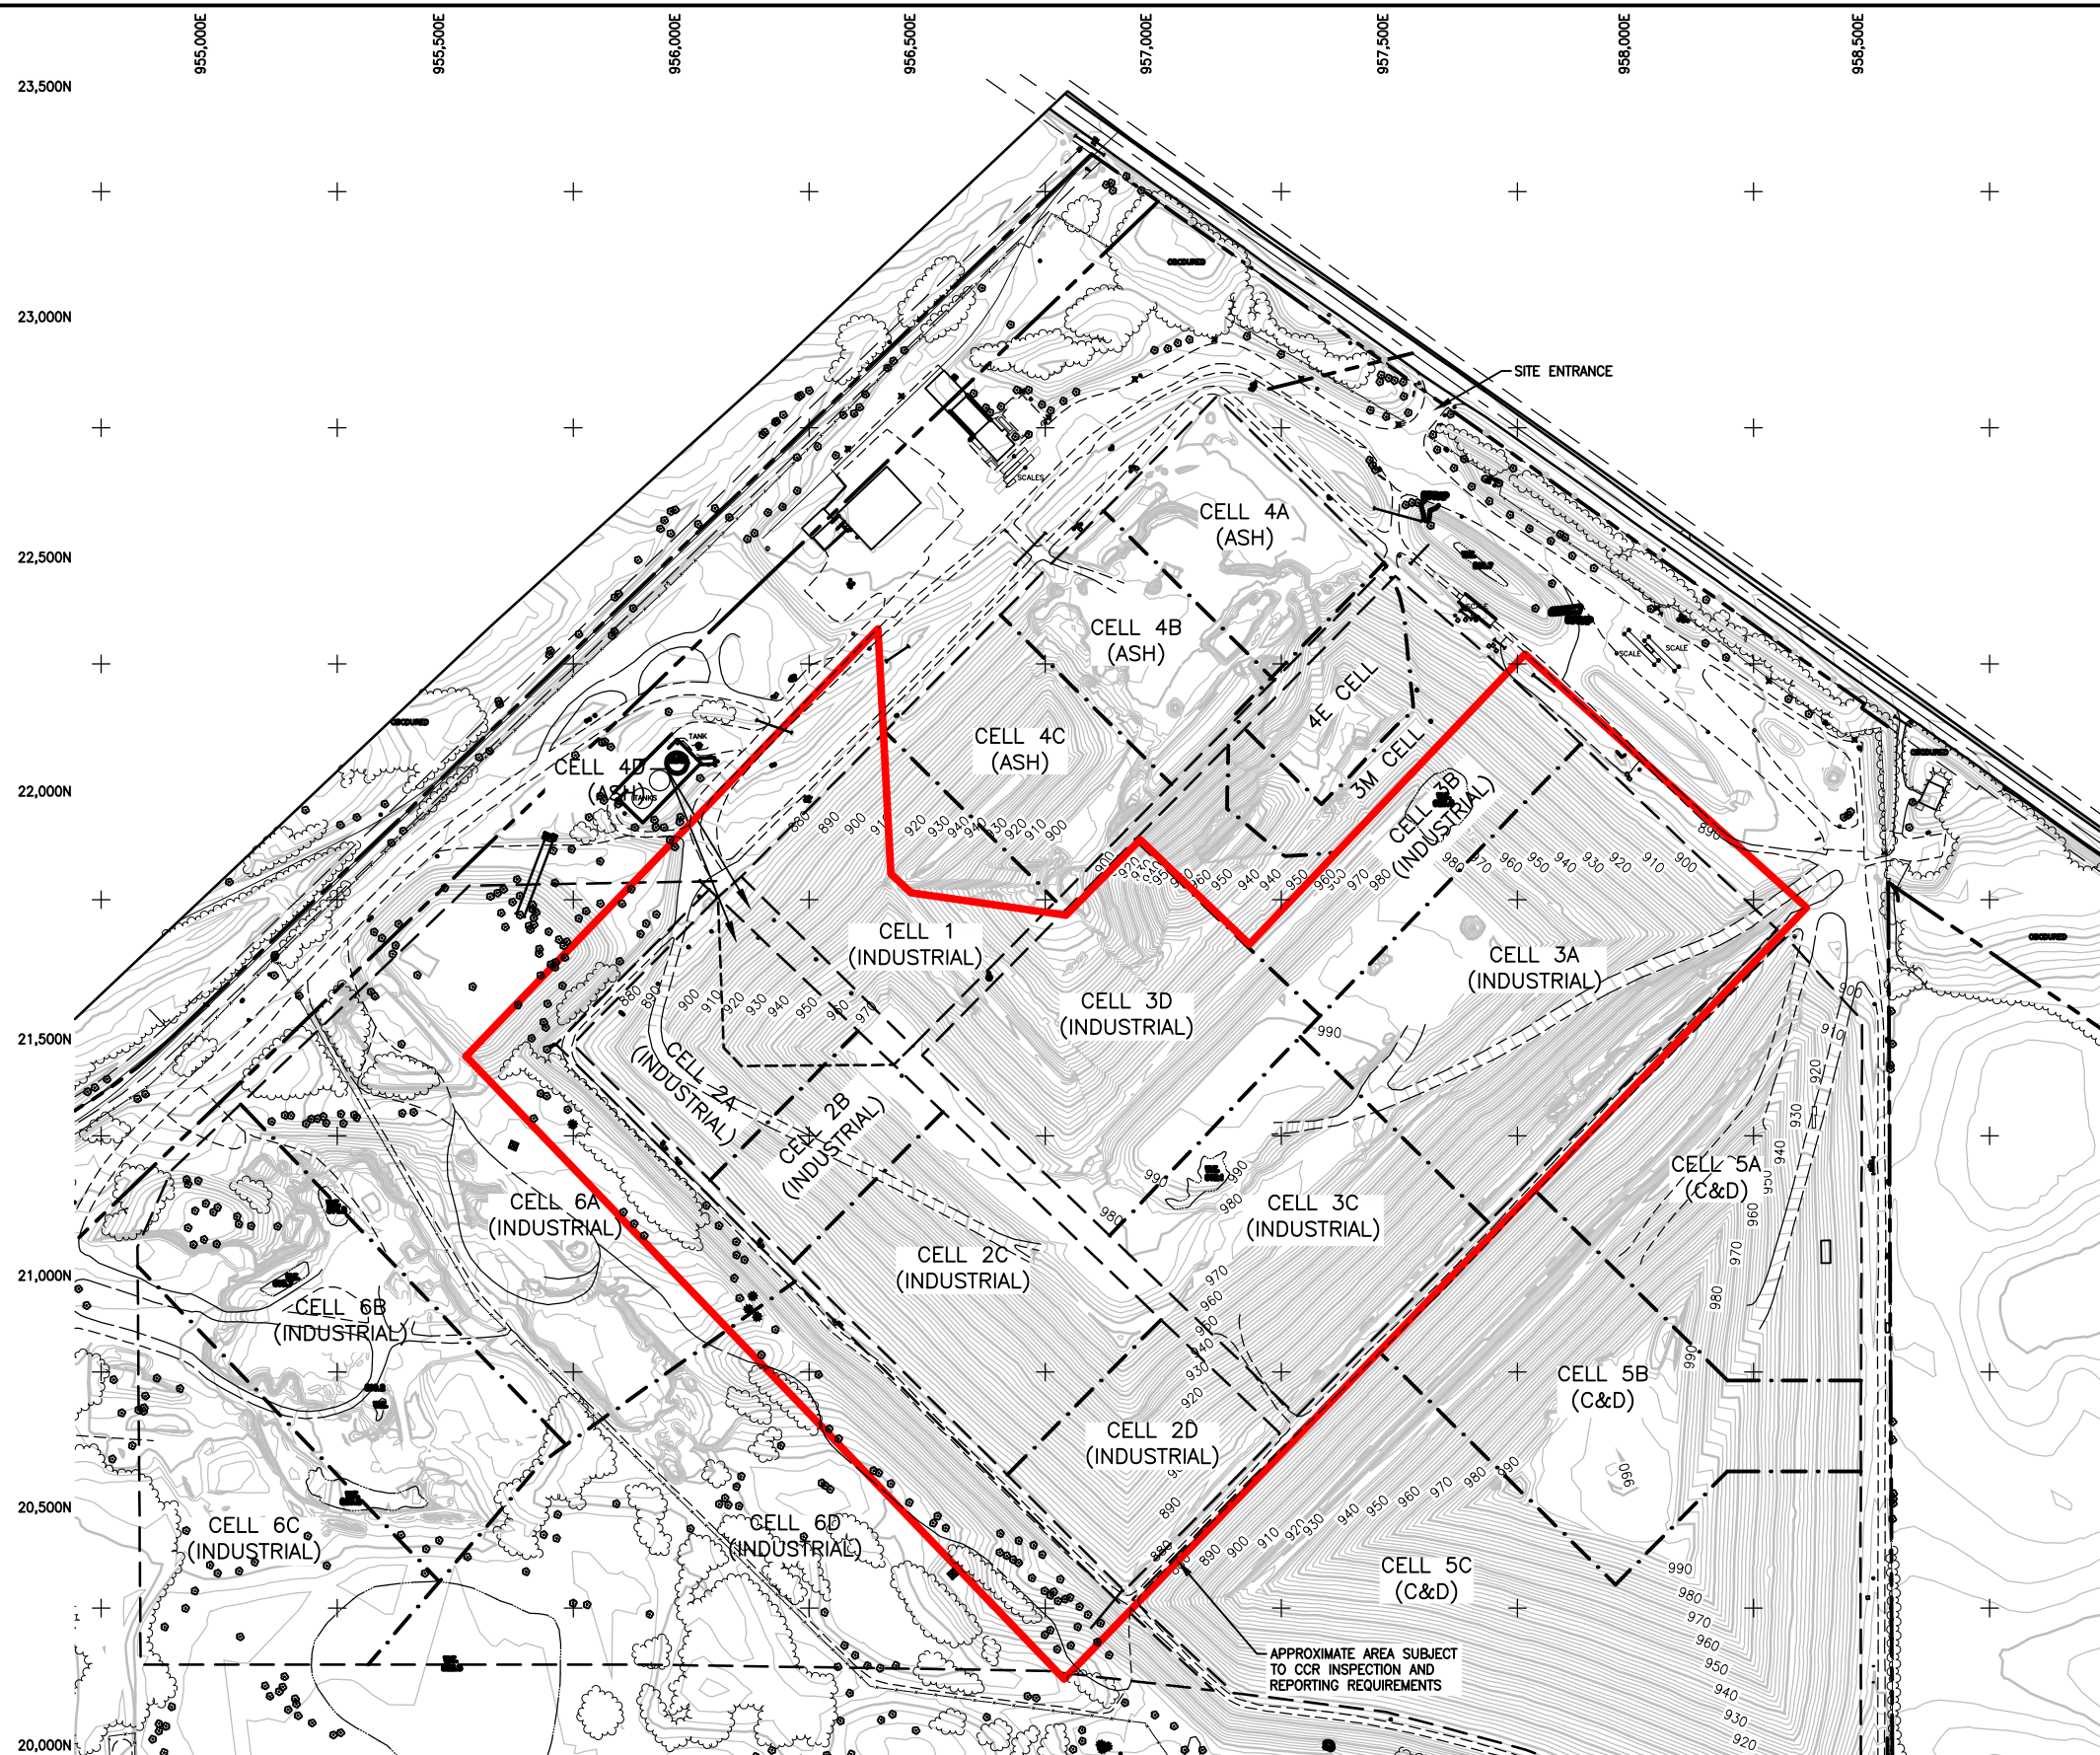
SHEET TITLE			
SITE MAP			
DWN BY	CHK'D	APP'D	DWG DATE
JVB	DMP	DMP	JAN. 2019
PROJECT NO.		SCALE	
3053-0138		AS NOTED	
SHEET NO.		REV NO.	
FIGURE 2		0

The annual aerial photogrammetry survey was performed on November 14, 2018, which the estimated in-place volume is based on. A comparison of the 2018 and 2017 aerial surveys confirm that the embankment and slope topography is substantially unchanged with no significant movement. The 2018 aerial survey is included as Figure 2.
