Technical Memo

To: Geoff Strack, SKB Environmental, Inc.
From: Dave Parenteau, PE (MN), Wenck Associates, Inc.
Date: January 9, 2018
Subject: Annual Inspection SKB Rosemount Industrial Waste Facility - Report of CCR Landfill Inspection
Wenck Project # B3053-0096

2018 Dike Integrity Inspection Report Photos SKB Rosemount Landfill

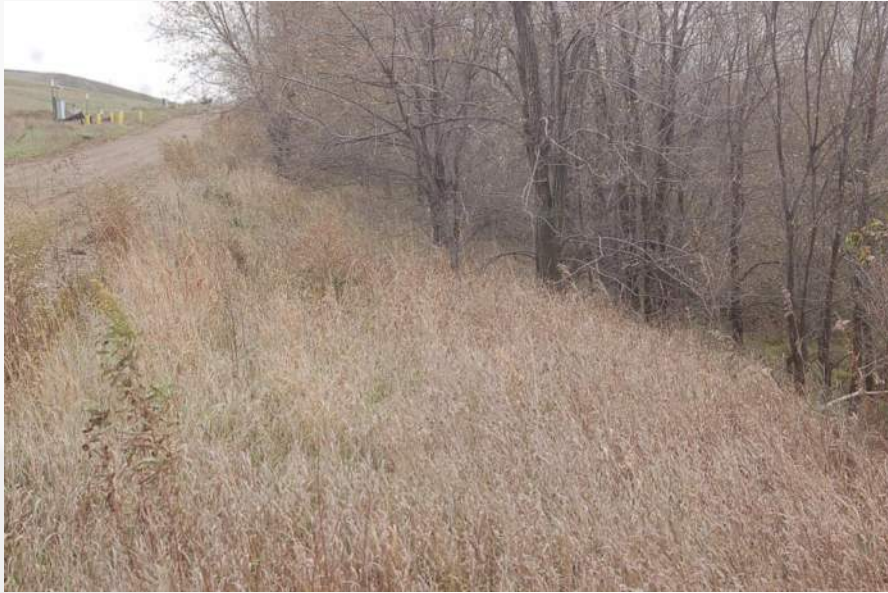
Photo 63 - Cell 2A South Perimeter Berm

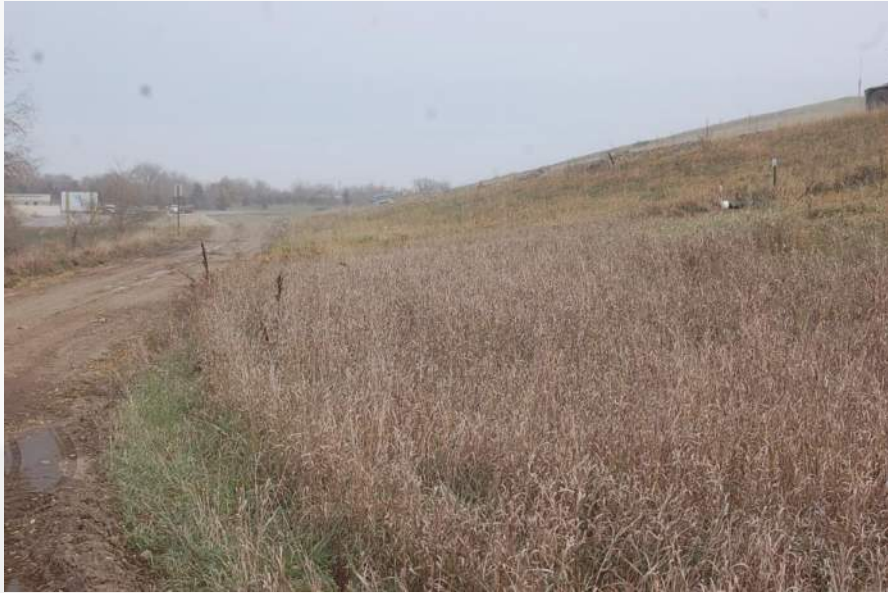
Photo 65 - Cell 2A West Perim Rd/LF Toe
